# Reflective Cracking Study: HVS Test Section Forensic Investigation

Partnered Pavement Research Program (PPRC) Contract Strategic Plan Element 4.10:  
Development of Improved Rehabilitation Designs for Reflective Cracking

California Department of Transportation  
Division of Research and Innovation  
Office of Roadway Research

University of California  
Pavement Research Center  
UC Davis, UC Berkeley

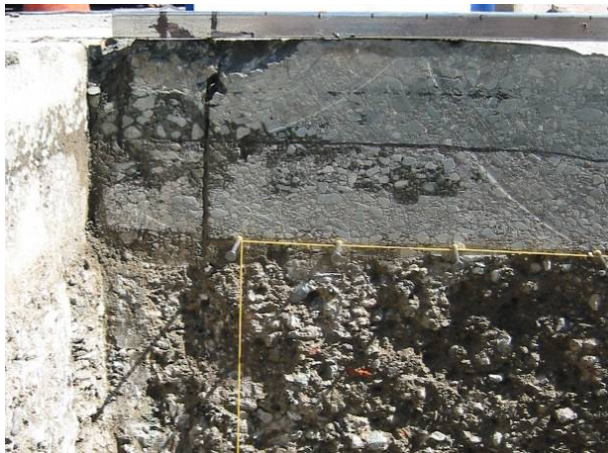
**Figure 3.16: 582RF moisture in asphalt concrete layer bonds.**

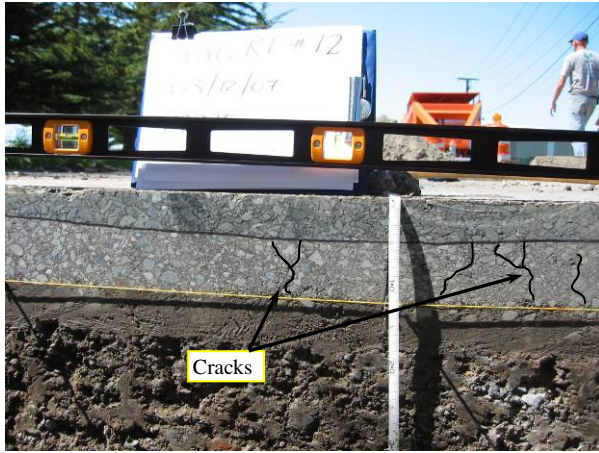
**Figure 3.32: 586RF cracks in underlying DGAC.**

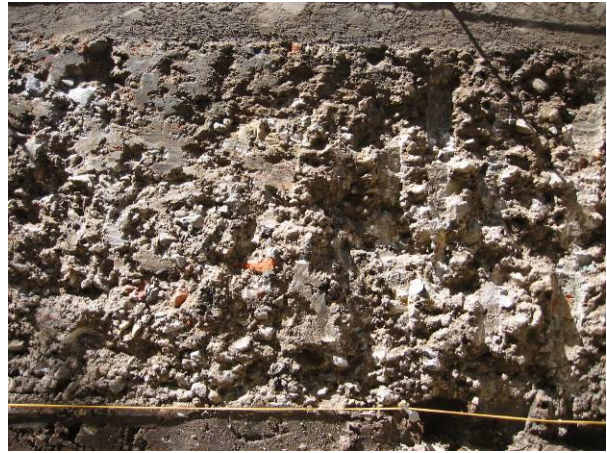
- Recementation of the base material was visibly apparent. A cement odor was present and strong hydrochloric acid and phenolphthalein reactions were noted.
- Moisture content in the base was rated as moist.
- The layer definition between the base and subgrade was clear. No punching of the base into the in situ material was noted.
- The subgrade was moist, dark brown clay with medium to high plasticity. Mottling was evident. Consistency was rated as hard and structure as slickensided. Some organic matter was noted. No hydrochloric acid or phenolphthalein reaction was recorded.

**Figure 3.33: 586RF strongly cemented base.**

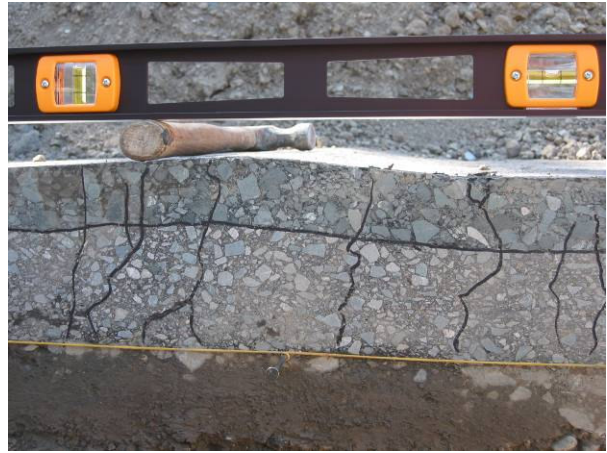
**Figure 3.37: 587RF#4 cracks in overlay and underlying DGAC.**

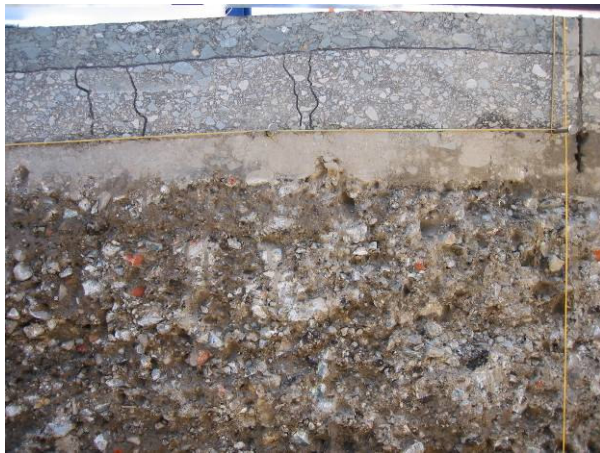
**Figure 3.38: 587RF#4 cracks in underlying DGAC.**

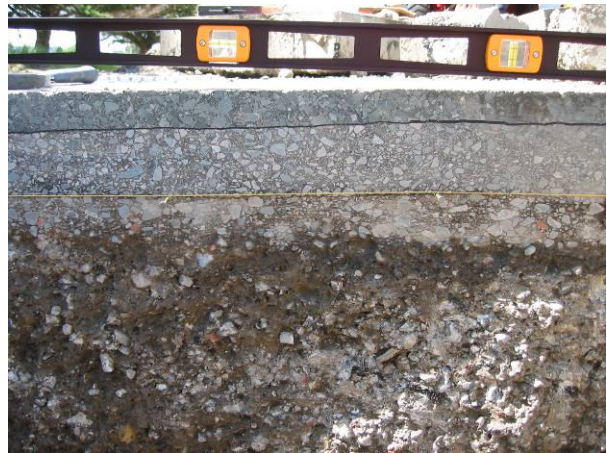
**Figure 3.39: 587RF#12 absence of visible cracks.**

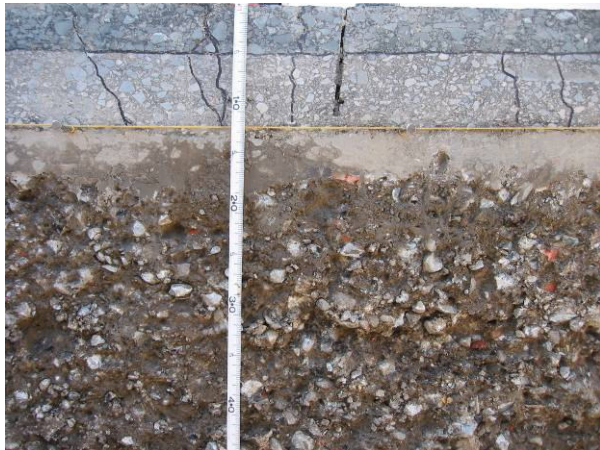
**Figure 3.40: 587RF#4 weaker cemented base material.**

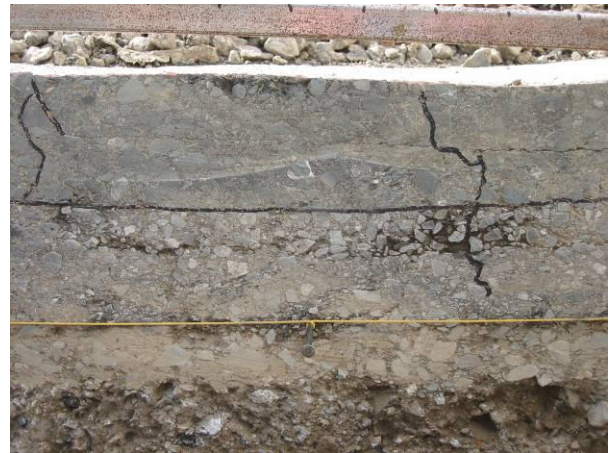
**Figure 3.47: 588RF cracks in overlay and underlying DGAC.**

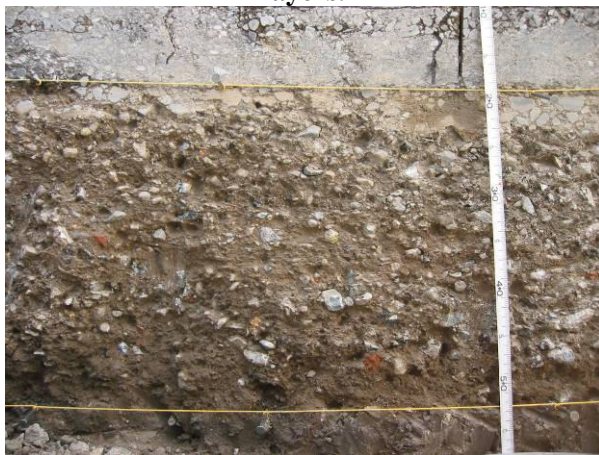
**Figure 3.48: 588RF#12 weaker cemented base material.**

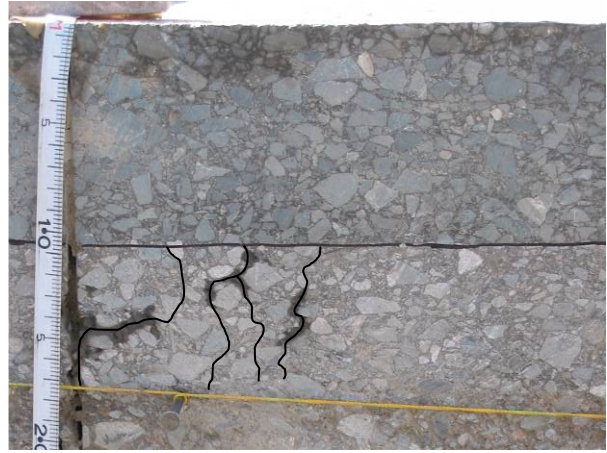
**Figure 3.59: 590RF cracks in DGAC layer.**

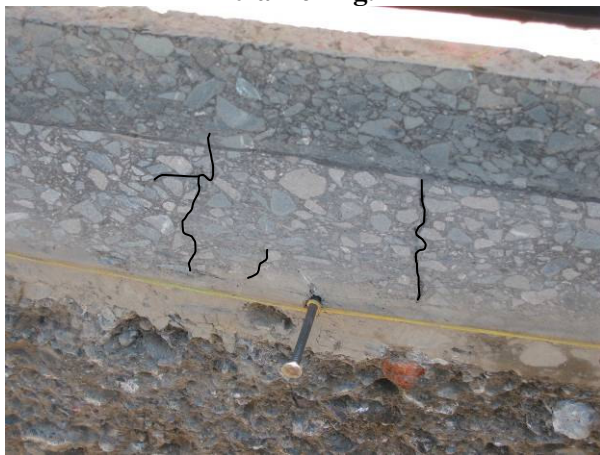
**Figure 3.66: 591RF cracks in underlying DGAC.**

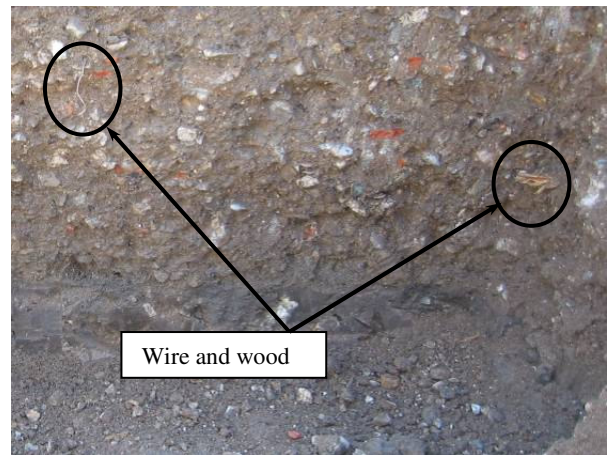
**Figure 3.67: 591RF wire and wood in base material.**

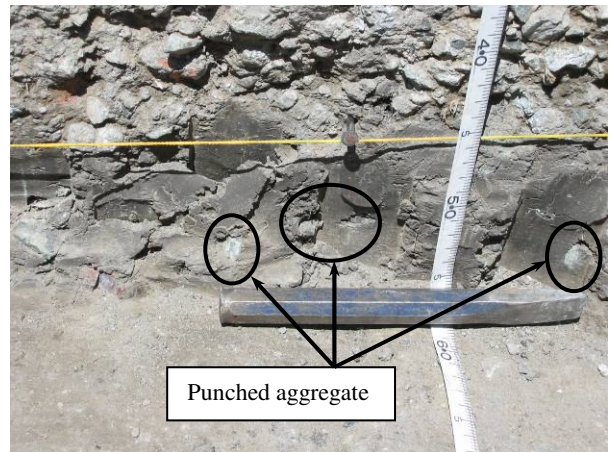
- The subgrade was moist, dark brown clay with medium to high plasticity. Some punching of aggregate from the base was recorded (Figure 3.69). Mottling was evident. Consistency was rated as hard and structure as slickensided. Some organic matter was noted. No hydrochloric acid or phenolphthalein reaction was recorded.

**Figure 3.69: 591RF aggregate punched into subgrade.**

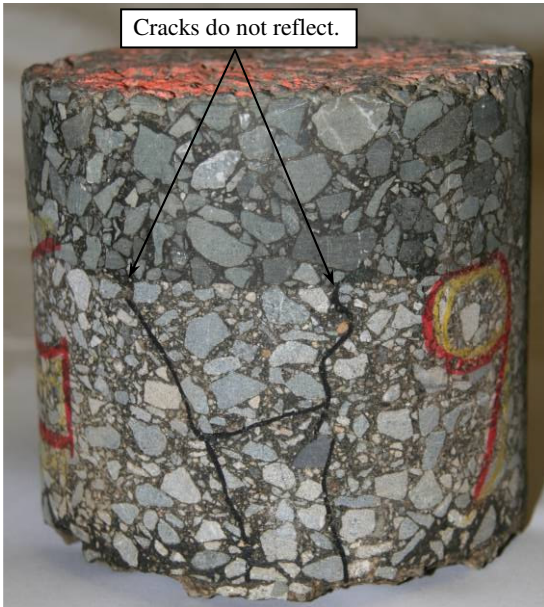
**Figure 3.70: MB15-G: Cracks on core.**

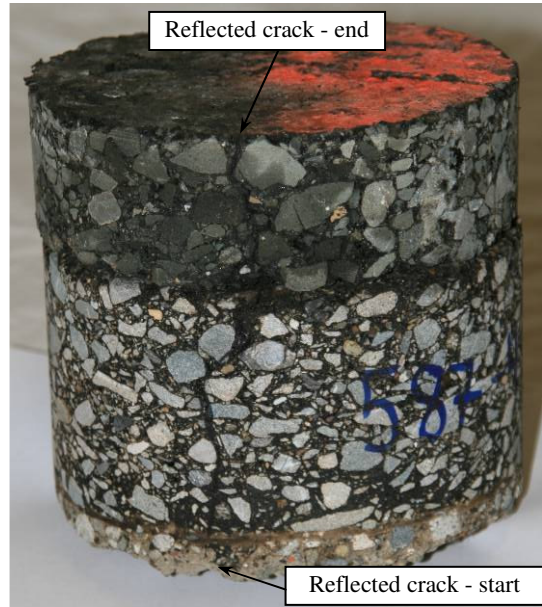
**Figure 3.71: RAC-G: Cracks on core.**

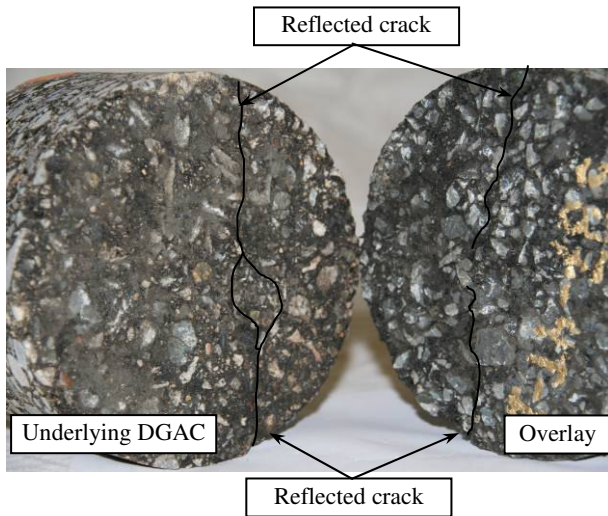
**Figure 3.72: RAC-G: Highlighted reflected crack through both layers.**

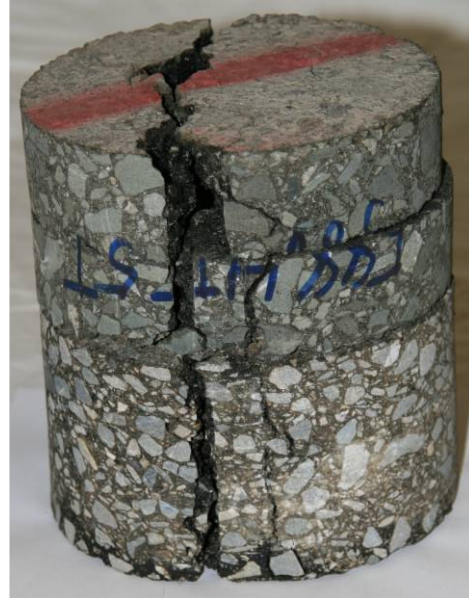
**Figure 3.73: AR4000-D: Cracks on core.**

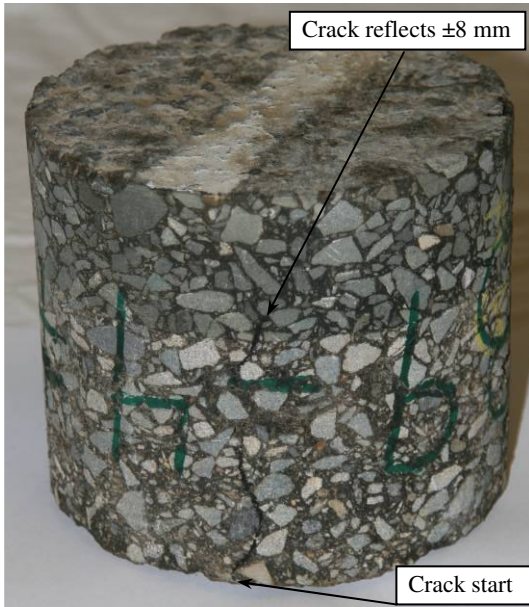
**Figure 3.74: 45 mm MB4-G: Cracks on core.**

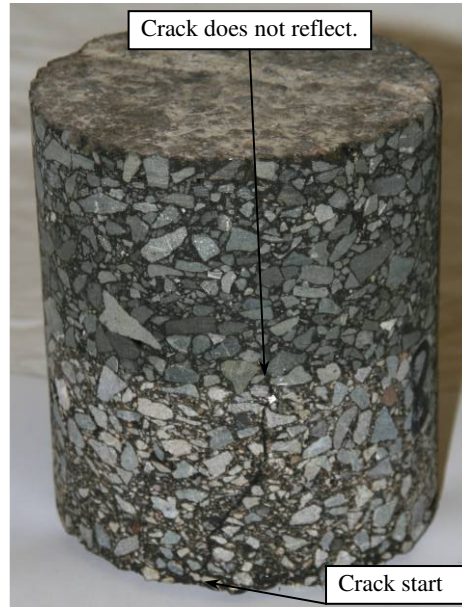
**Figure 3.75: 90 mm MB4-G: Cracks on core..**

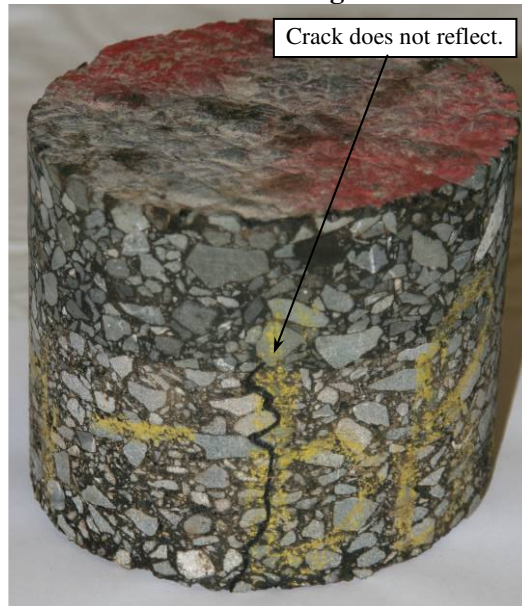
**Figure 3.76: MAC15-G: Cracks on core.**

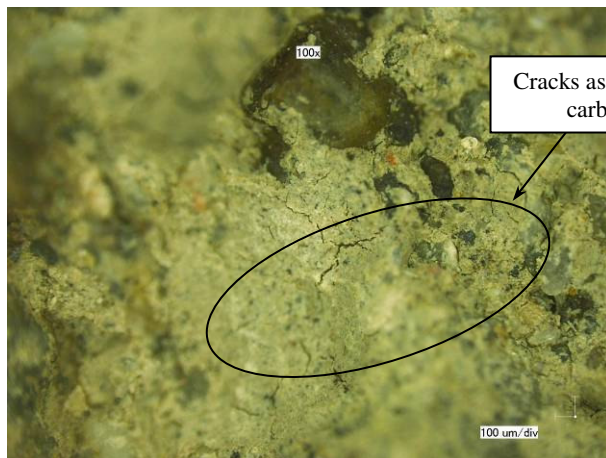
Sample 2 was exactly the same as Sample 1 except that the specimen was exposed to atmospheric carbon dioxide prior to preparation for the microscope studies. The overall effect is shown in Figure 3.80 (optical microscope at  $\pm 100\times$  magnification) and Figure 3.81 (SEM at  $\pm 55\times$  magnification), in which significant cracking is visible. This is the typical result of carbonation where the development of calcite (calcium carbonate,  $\text{CaCO}_3$ ) from lime (calcium hydroxide,  $\text{Ca}(\text{OH})_2$ ) in the material results in expansion and cracking of the material. Such cracking is unlikely to result from drying as it was not seen in the uncarbonated specimen, which was also dried, albeit under slightly different conditions. Figure 3.82 (optical microscope at  $\pm 100\times$  magnification), Figure 3.83 (optical microscope at  $\pm 200\times$  magnification), and Figure 3.84 (SEM at  $\pm 140\times$  magnification) show the presence of calcite crystals associated with the cracking in the carbonated sample, none of which were evident in the uncarbonated material. The well-crystallized nature of the material is indicative of recent formation (during the week before examination). There was also a conspicuous absence of calcium hydroxide, indicating severe carbonation.

**Figure 3.80: Optical microscope view ( $\pm 100\times$ ) of Sample 2.**

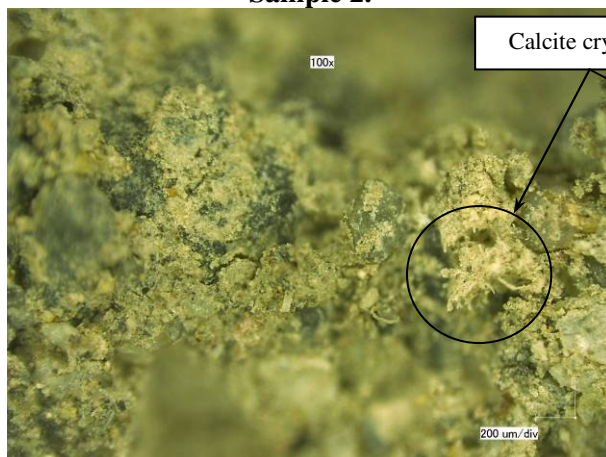
**Figure 3.82: Optical microscope view ( $\pm 100\times$ ) of calcite crystal development associated with cracks.**

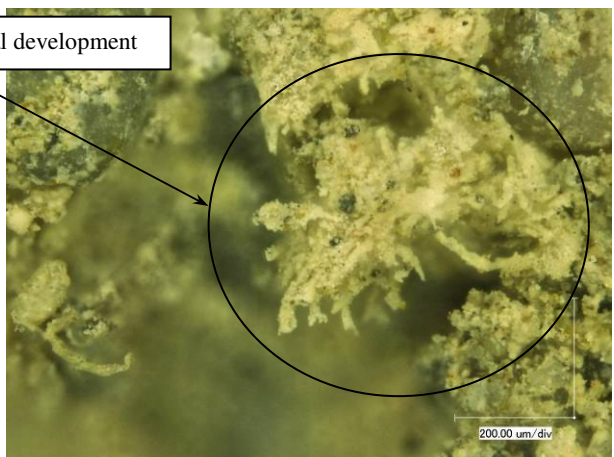
**Figure 3.83: Optical microscope view ( $\pm 200\times$ ) of calcite crystal development associated with cracks.**

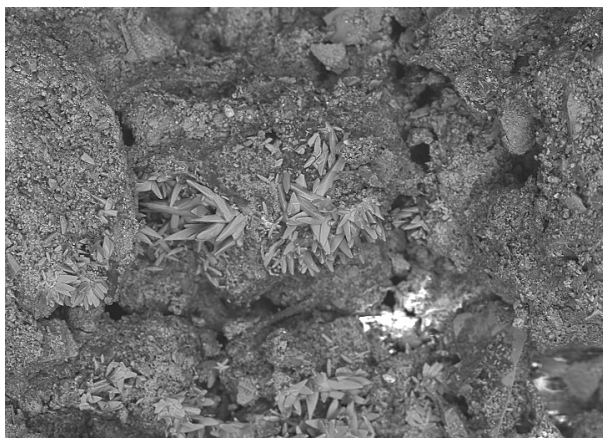
**Figure 3.84: SEM view ( $\pm 140\times$ ) of calcite crystal development associated with cracks.**
