Research Report – UCD-ITS-RR-13-33

Warm-Mix Asphalt Study: Field Test Performance Evaluation

DOCUMENT RETRIEVAL PAGE		Technical Memorandum: UCPRC-TM-2013-08			
Title: Warm-Mix Asphalt Study: Field Test Performance Evaluation					
Authors: D. Jones					
Technical Leads: T. Joe Holland (Caltrans) and Nathan Gauff (CalRecycle)					
Prepared for: Caltrans and CalRecycle		FHWA No.: CA142385D	Work submitted: 04/05/2014		Date December 2013
Strategic Plan Element No.: 4.18		Status: Final		Version No.: 1	
Abstract:					
<p>A number of warm-mix asphalt test sections were constructed in California between 2007 and 2010 to assess long-term performance under selected traffic and climate conditions. A range of pavement designs were assessed, but the six projects evaluated in this report focused on open-graded friction courses with polymer-modified (PG 58-34) and rubber-modified (PG 64-16) binders (three projects each). The main purpose of these experiments was to monitor performance under actual conditions and to quantify any benefits associated with using warm-mix asphalt under specific situations, such as with long hauls, in cool and/or damp conditions, under trafficking by large agricultura

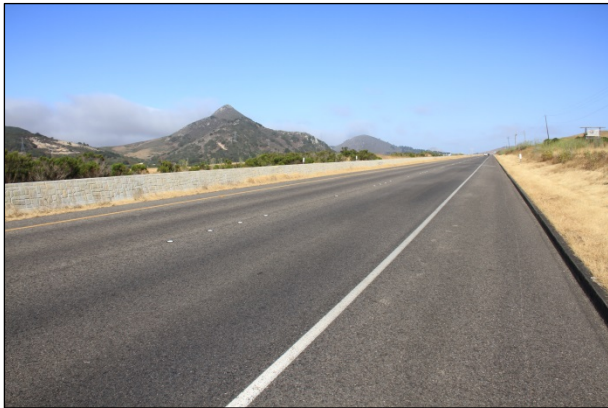
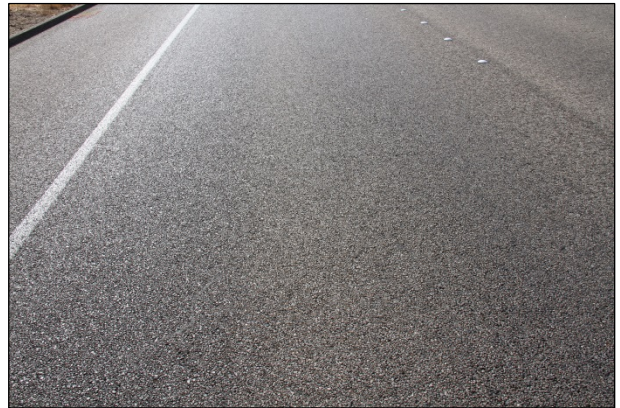
No deterioration compared to the May 2007 baseline measurements was noted on the sections after 60 months of traffic. The track marks were no longer visible on any of the sections.

Figure 3.3: Morro Bay Control, May 2012 (60 months), track marks no longer visible.

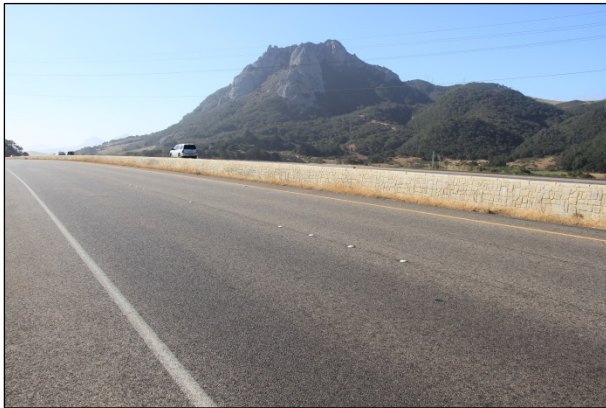
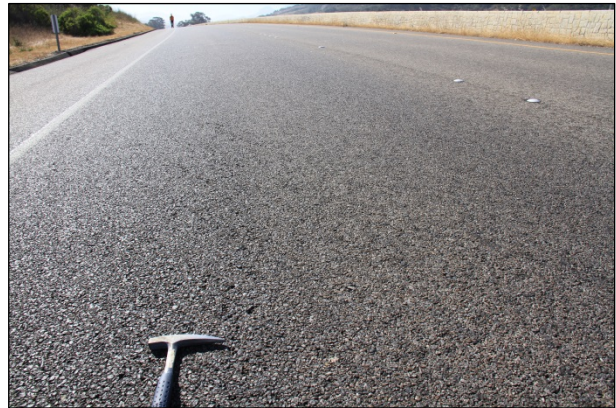
Figure 3.6: Morro Bay Advera, May 2012 (60 months), track marks no longer visible.

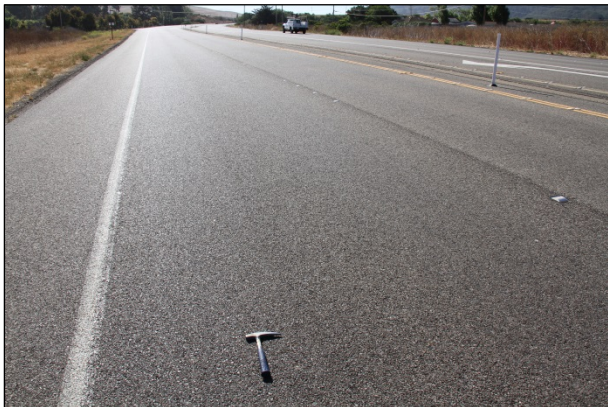
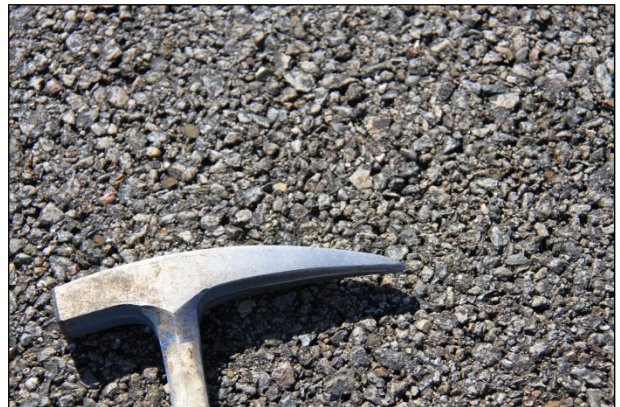
Figure 3.10: Morro Bay Evotherm, May 2012 (60 months), track marks no longer visible.

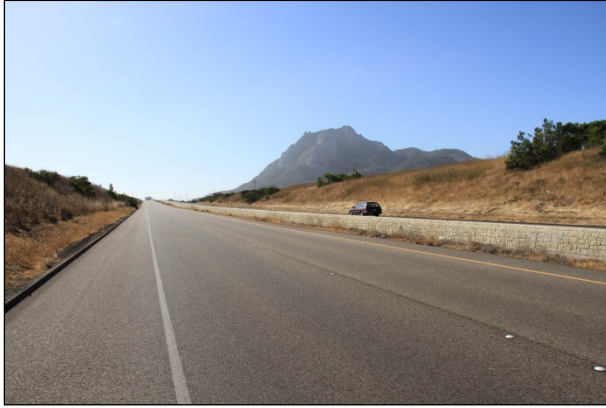
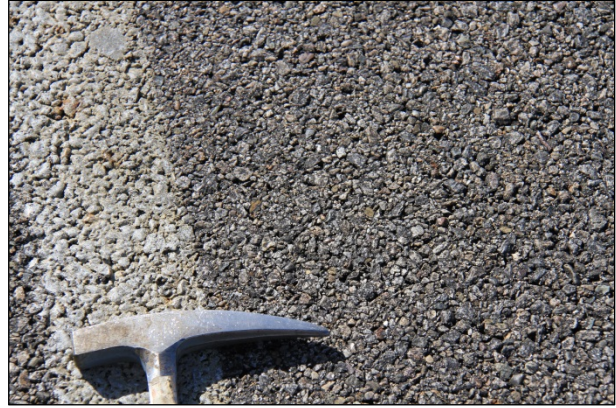
Figure 3.14: Morro Bay Sasobit, May 2012 (60 months), track marks no longer visible.

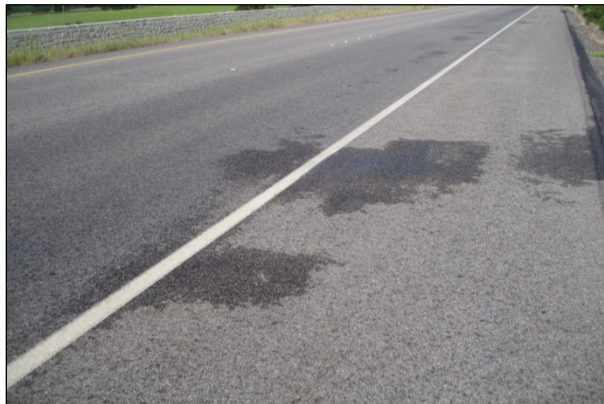
No deterioration compared to the May 2007 baseline measurements was noted on the sections after 73 months of traffic. Although the surface color of all sections was considerably lighter compared to new asphalt, the surface was still in very good condition and only minor stone loss, consistent with the age of the surface, was observed. Permeability through the open-graded friction course also remained effective on all sections (Figure 3.16).

Figure 3.16: Morro Bay Sasobit, June 2013 (73 months), showing effective drainage.

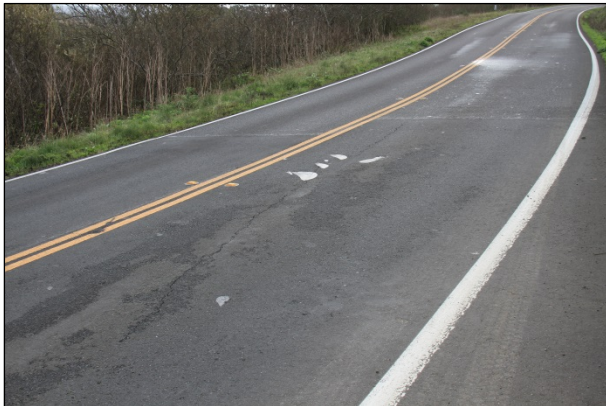
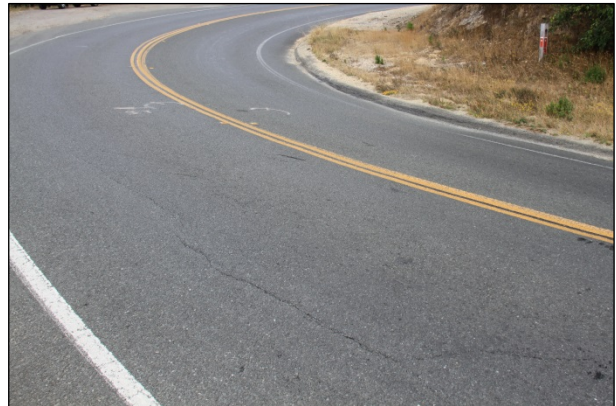
No deterioration compared to the December 2008 baseline measurements was noted on the section after 18 months of traffic. However, some longitudinal cracks were noted on the hill section around postmile 17. This was attributed to slope movement and not to performance of the warm-mix asphalt.

No deterioration compared to the December 2008 baseline measurements was noted on the sections after 23 months of traffic. The number and severity of the longitudinal cracks had not increased. Drainage through the OGFC was still effective.

Figure 4.3: Point Arena Evotherm, November 2010, showing longitudinal cracks.

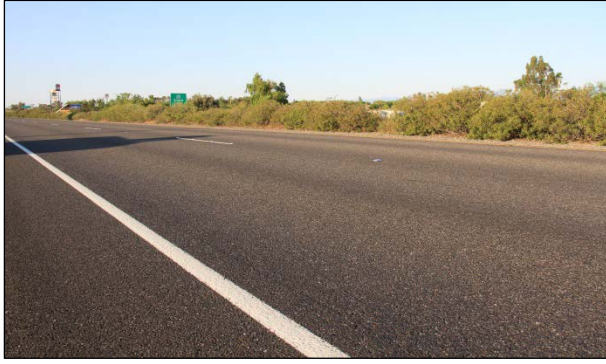
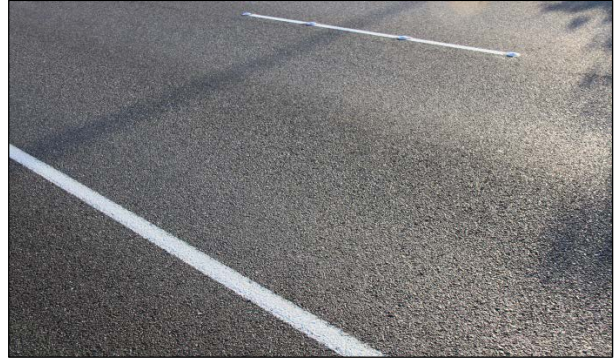
Rut depths of approximately 0.16 in. (4.0 mm) were measured on both the control and Evotherm sections. This indicated that rut performance on the hot- and warm-mix sections was similar after 12 months of trafficking and that binder oxidation rates had probably stabilized. No other deterioration compared to the June 2009 baseline measurements was noted on the sections after 12 months of traffic.

Figure 5.2: Orland Control, June 2011 (24 months). Note ruts in wheelpath.

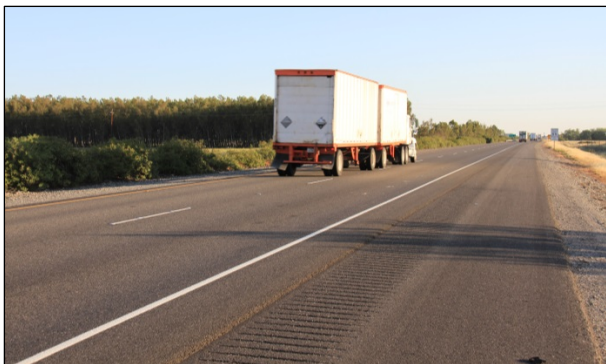
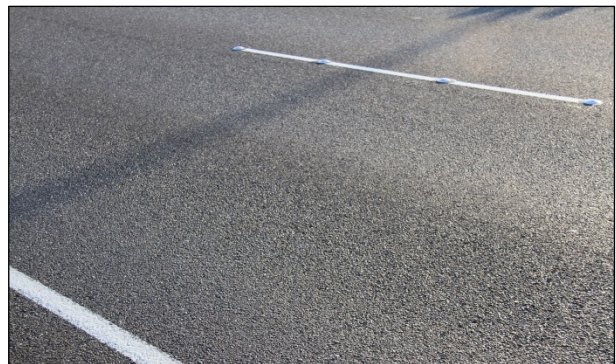
Minor rutting (average between 0.08 in. and 0.1 in. [2.0 mm and 3.0 mm]) was measured in the wheelpaths of the truck lane on the warm-mix section. No rutting was measured on the control section. The difference in rutting performance was attributed to lower oxidation of the binder in the warm-mix and consequent lower stiffness. Similar early rutting on warm-mix test sections was observed during accelerated loading tests conducted earlier in the warm-mix asphalt study (1). No other deterioration compared to the June 2009 baseline measurements was noted.

Figure 5.4: Orland Evotherm, June 2011 (24 months). Note ruts in wheelpath.

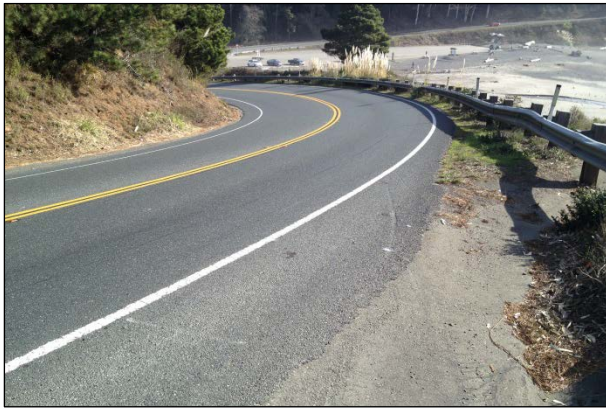
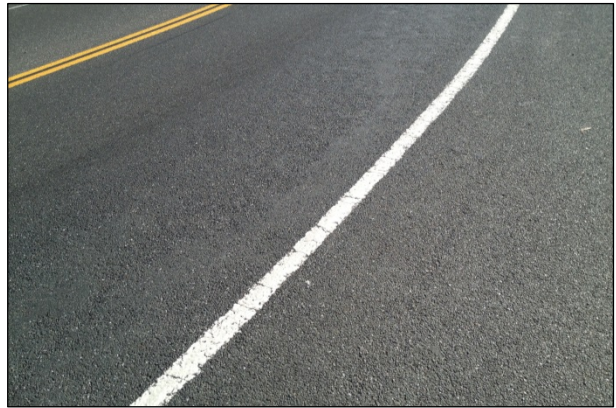
No deterioration compared to the July 2010 baseline measurements was noted on the sections after 30 months of traffic. However, minor raveling was noted on a short section of the outside wheelpath on a sharp bend on the Advera section.

No deterioration compared to the July 2010 baseline measurements was noted on the sections after 42 months of traffic. The raveling observed on the Advera section during the December 2012 visit had not deteriorated.

Figure 7.4: Mendocino Advera, December 2013 (42 months). Note raveling in outside wheel path.

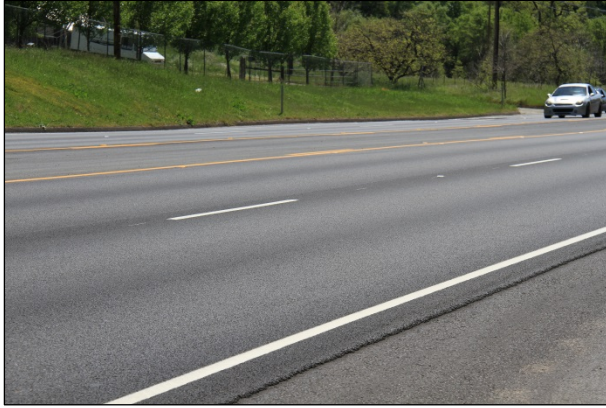
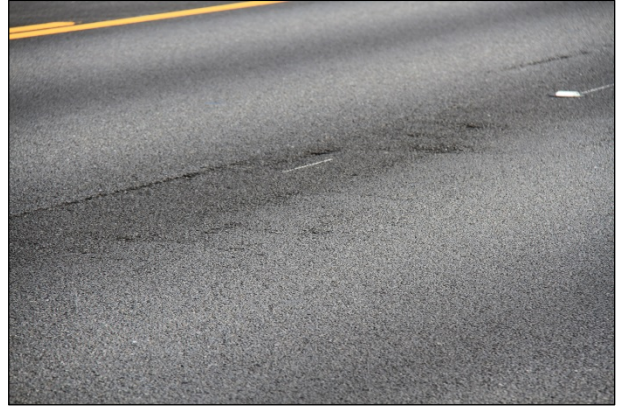
The road surface resembled a typical open-graded friction course and was given an overall rating of “good.” Some localized areas of what appeared to be segregation in the mix were noted. Some open longitudinal joints were also noted. No early stone loss was noted, and no other problems were observed. Water was effectively draining through the friction course and out through the sides of the road.

Figure 8.2: Auburn Evotherm, August 2010 (0 months). Note segregation and open joint.

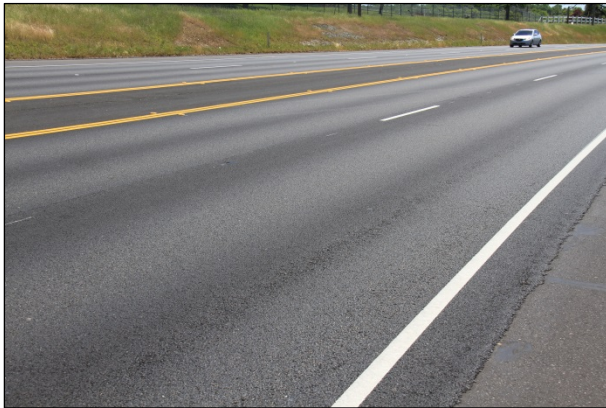
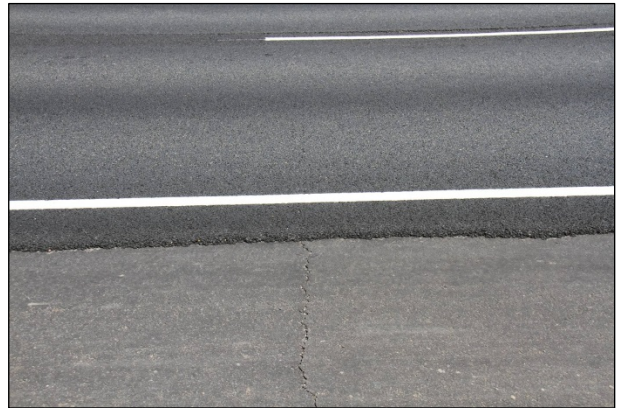
Reflected transverse cracking and some minor raveling in the outside wheelpath of the outside lanes was noted in some areas of the project. Given that no hot-mix control was available for comparison purposes, it was not clear whether these distresses were related to the warm-mix technology, to construction issues, or to other factors. No further deterioration compared to the August 2010 baseline measurements was noted.

Figure 8.3: Auburn Evotherm, July 2012 (24 months). Note deterioration and reflected crack.
