**Report of Trip to SR-86, District 11, Near Brawley, California**

**CALIFORNIA DEPARTMENT OF TRANSPORTATION**

**Technical Memorandum TM-UCB-PRC-2005-1**

February 15, 2005

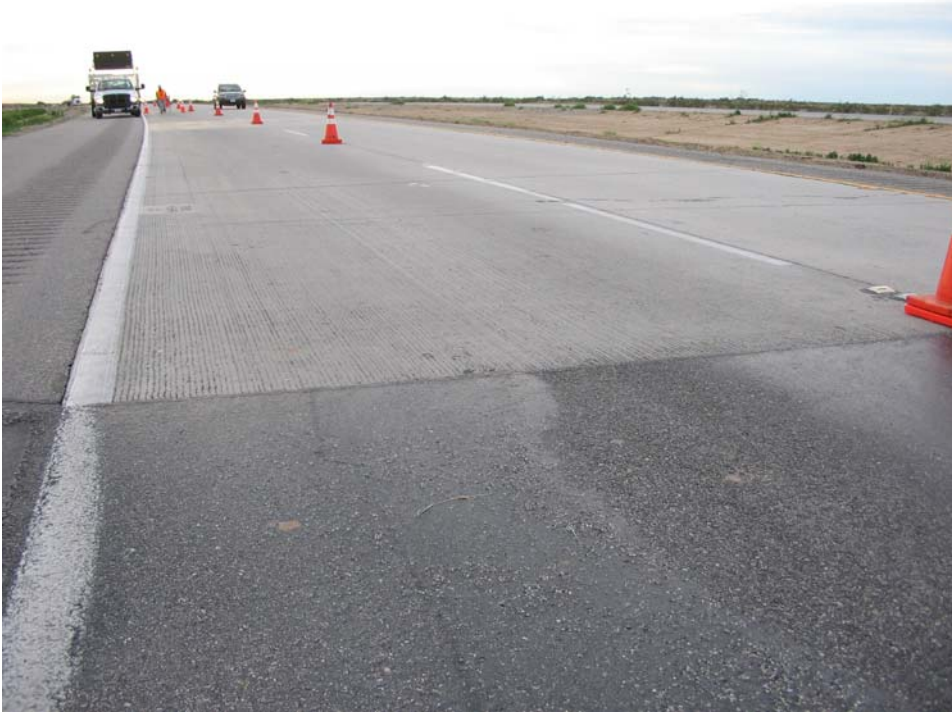
**Figure 4. Station 606, facing south; RAC chip seal construction starts at this point.**

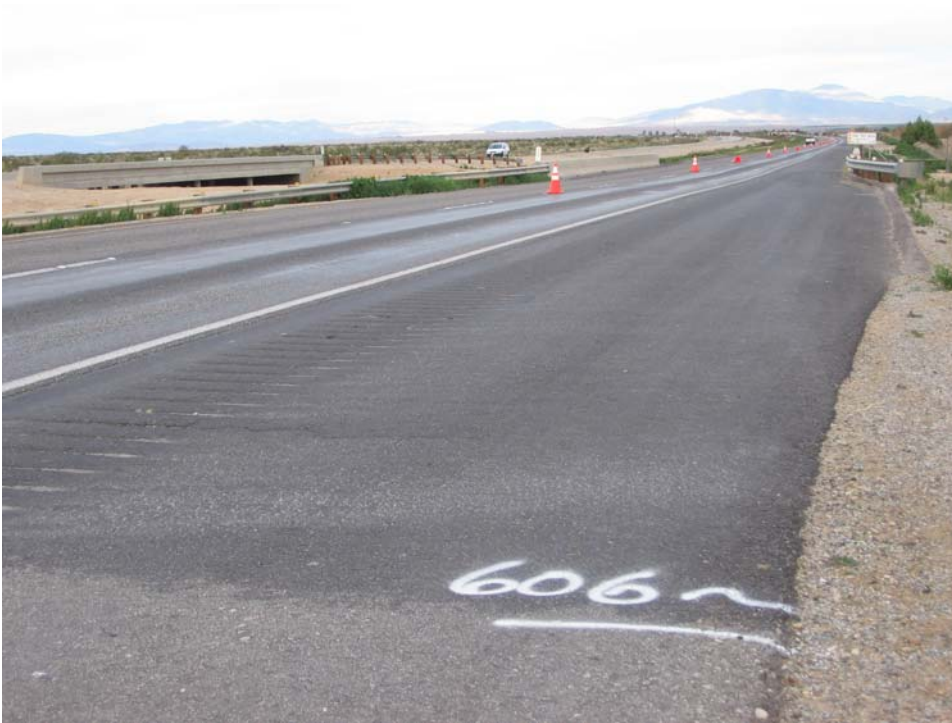
**Figure 5. Station 606, facing north – RAC chip-sealed section starts here.**

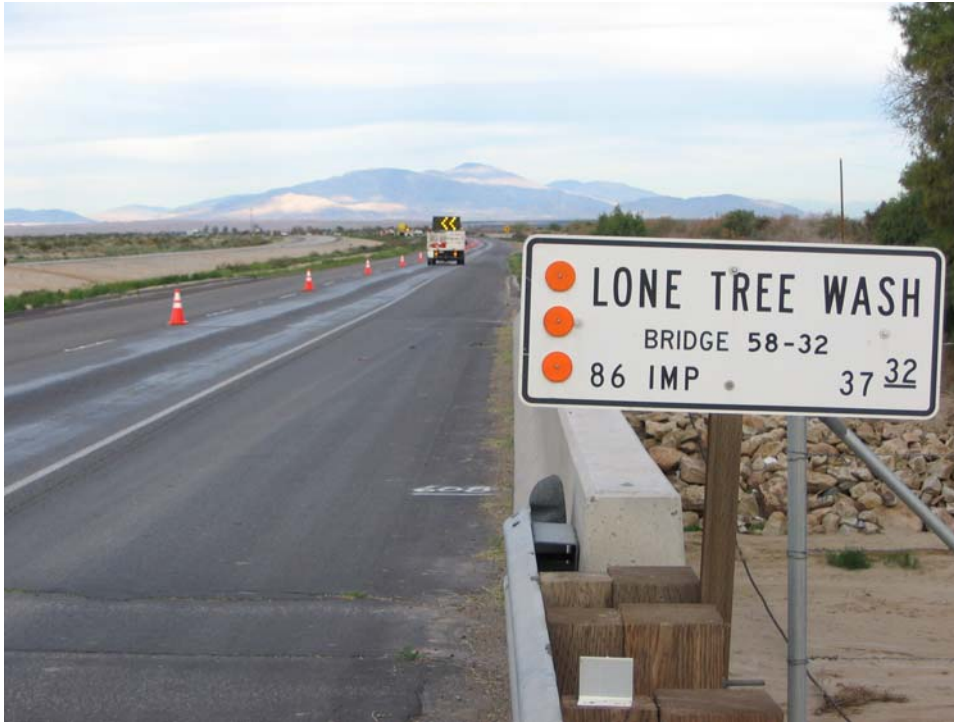
**Figure 6. Station 608 (PM 37.3), facing north—flushing evident in #2 lane.**

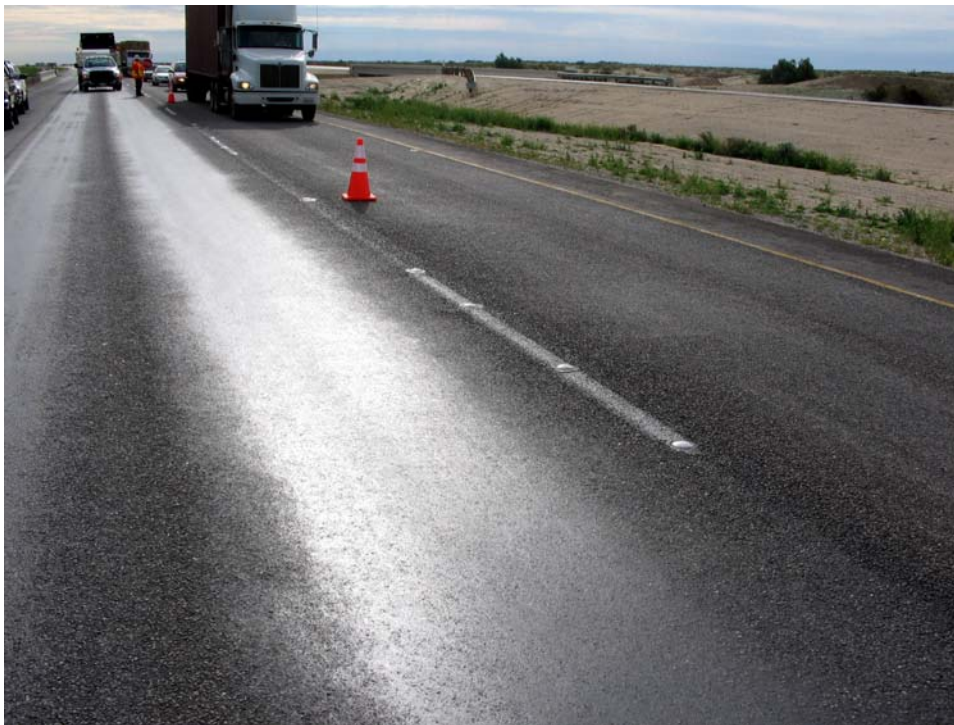
**Figure 7. Station 610+40, facing south—flushing evident in #2 lane.**

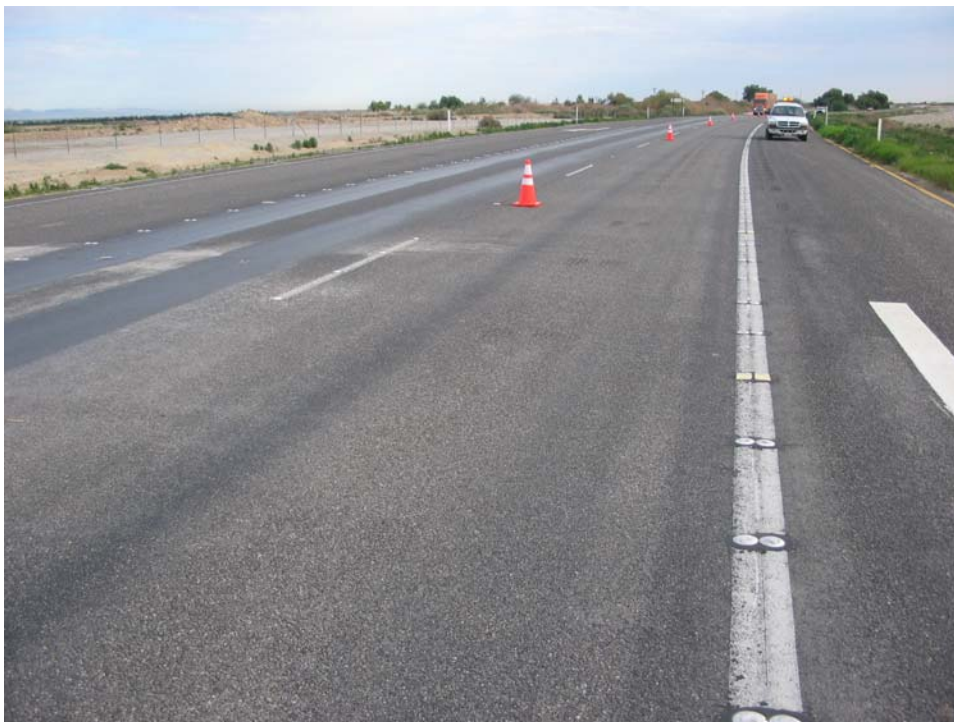
**Figure 9. Station 616+37, facing south—note that #1 lane is clear of flushing and rutting while #2 lane shows clear evidence of flushing and rutting.**

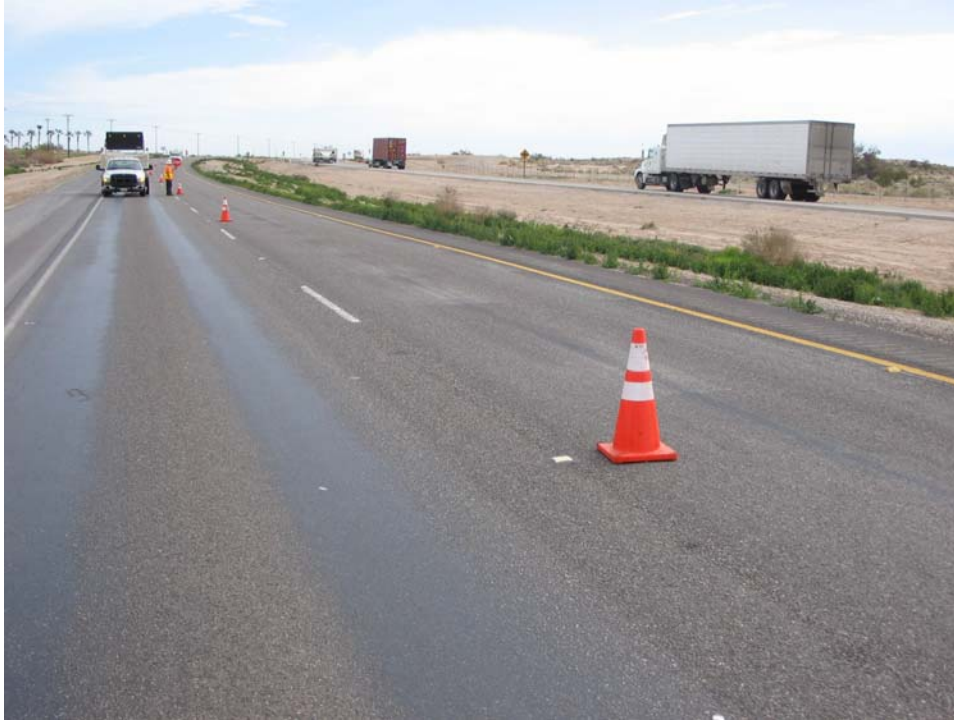
**Figure 12. Station 652+40, facing south—flushing evident in #2 lane.**

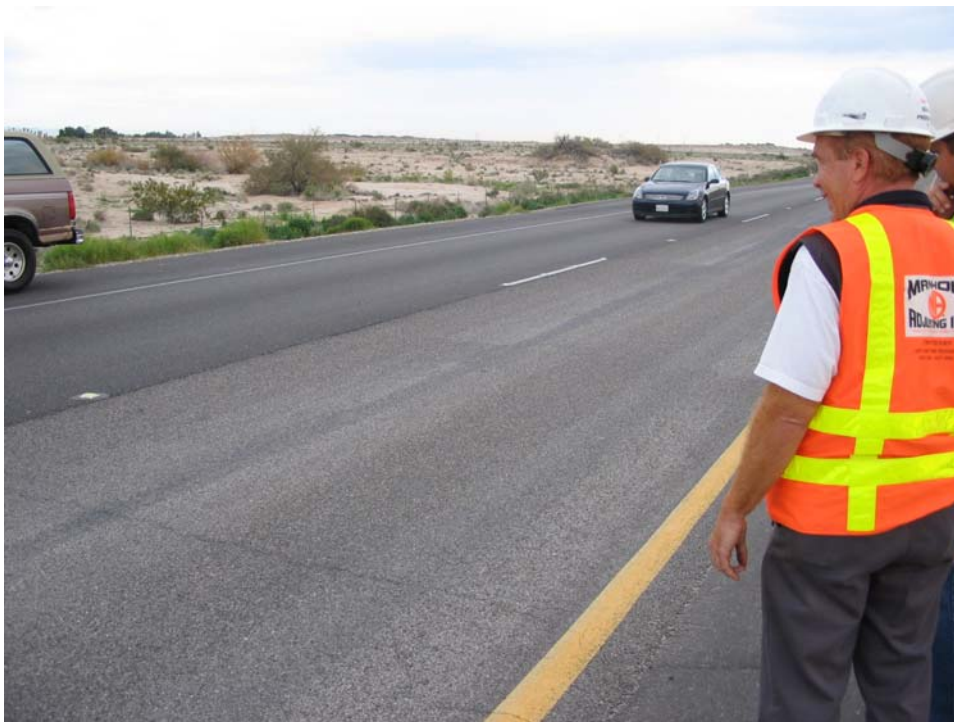
**Figure 13. Station 688, facing south—OGAC + RAC chip sealed #2 lane without evidence of distress.**

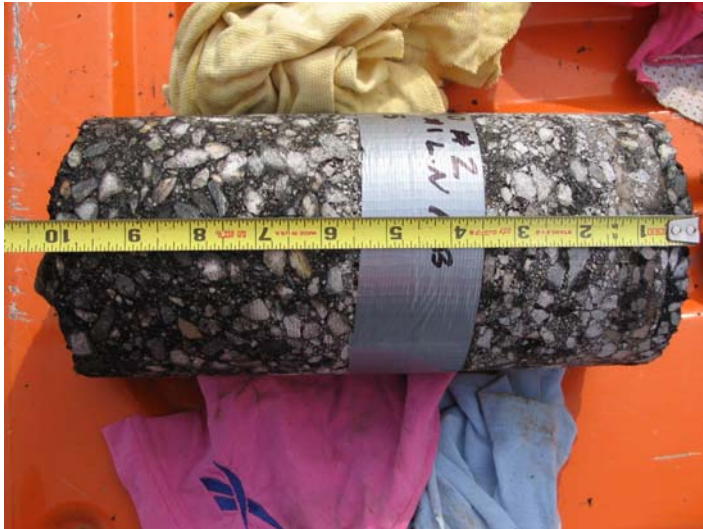
Core Location	610+40 No. 2	
Overall Core Thickness	258 mm	
Chip Seal Thickness	11 mm	
Rut Depth	Left Wheelpath	Right Wheelpath
	N/A	N/A

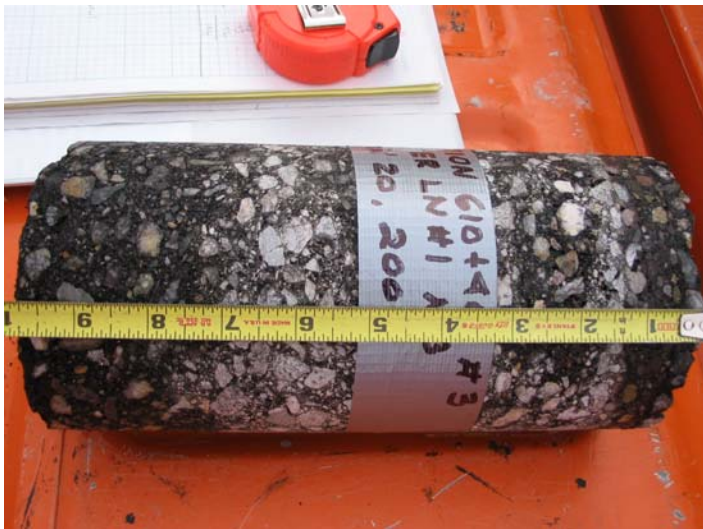
Core Location	610+40 No. 3	
Thickness (1st layer beneath chip seal only)	118 mm	
Chip Seal Thickness	10 mm	
Rut Depth	Left Wheelpath	Left Wheelpath
	N/A	N/A

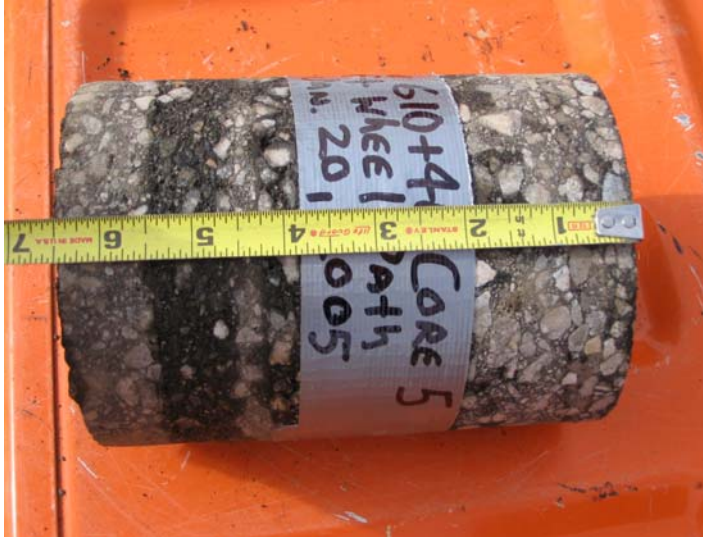
Core Location	610+40 No. 5	
Overall Core Thickness	165 mm	
Chip Seal Thickness	9 mm	
Rut Depth	Left Wheelpath	Right Wheelpath
	2 mm	2 mm

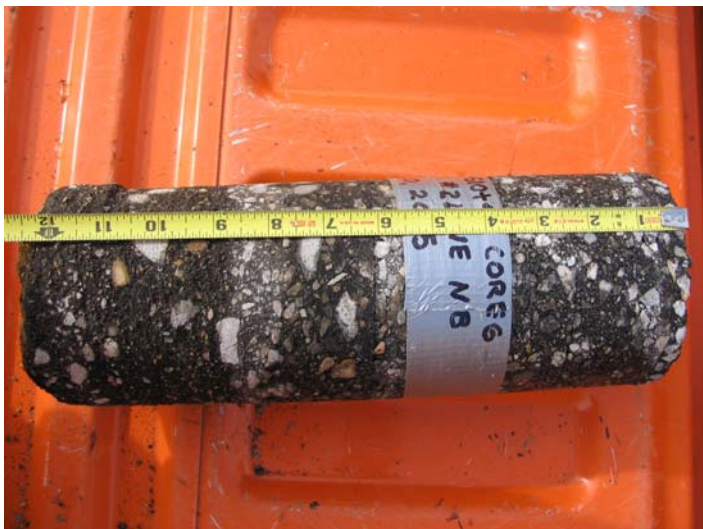
Core Location	610+40 No. 6	
Thickness (1st layer beneath chip seal only)	154 mm	
Chip Seal Thickness	10 mm	
Rut Depth	Left Wheelpath	Right Wheelpath
	2 mm	2 mm

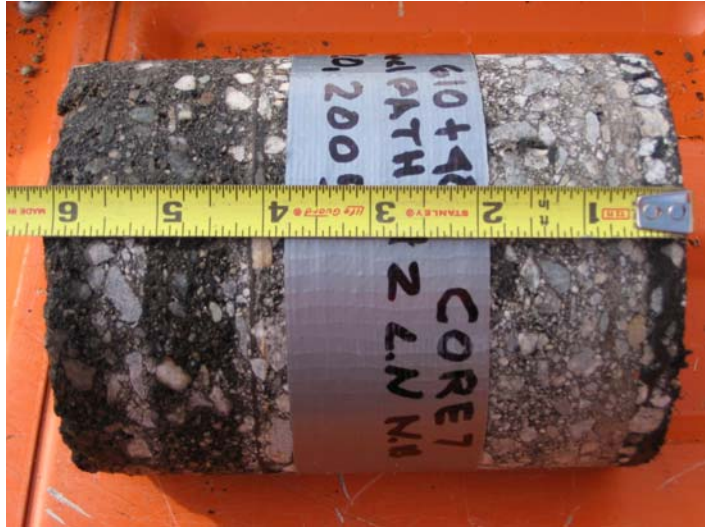
Core Location	610+40 No. 7	
Overall Core Thickness	157 mm	
Chip Seal Thickness	13 mm	
Rut Depth	Left Wheelpath	Right Wheelpath
	2 mm	2 mm

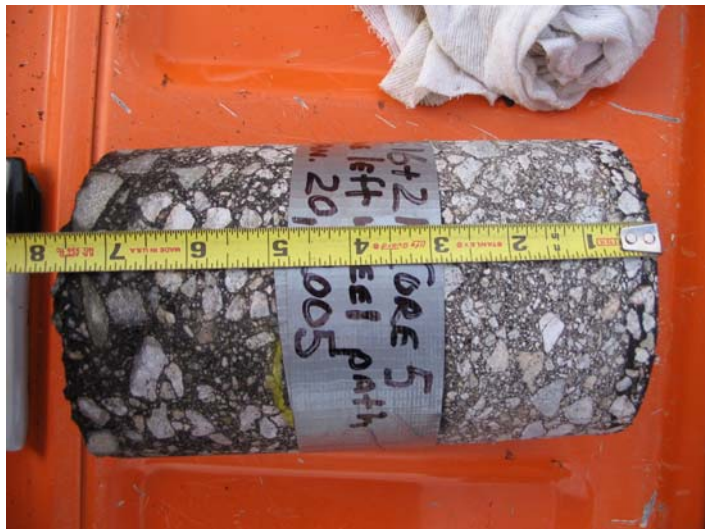
Core Location	Station 616+21, Location 5	
Overall Core Thickness	199 mm	
Chip Seal Thickness	14 mm	
Rut Depth	Left Wheelpath	Right Wheelpath
	23 mm	33 mm

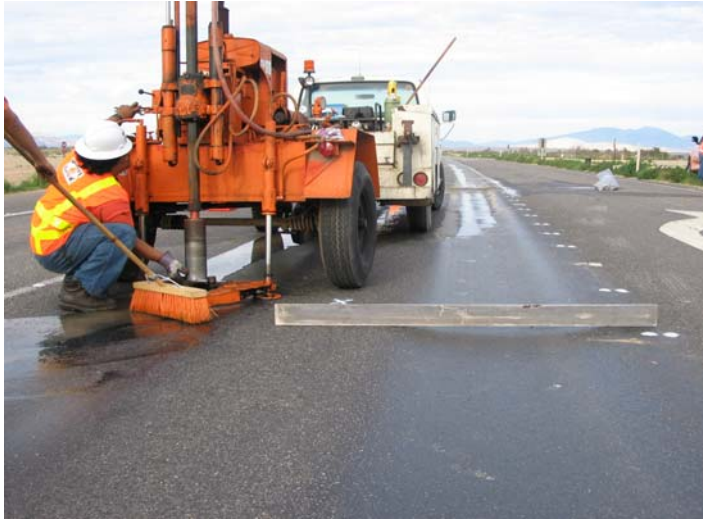
Core Location	616+21, Location 6	
Overall Core Thickness	211 mm	
Chip Seal Thickness	13 mm	
Rut Depth	Left Wheelpath	Right Wheelpath
	23 mm	33 mm

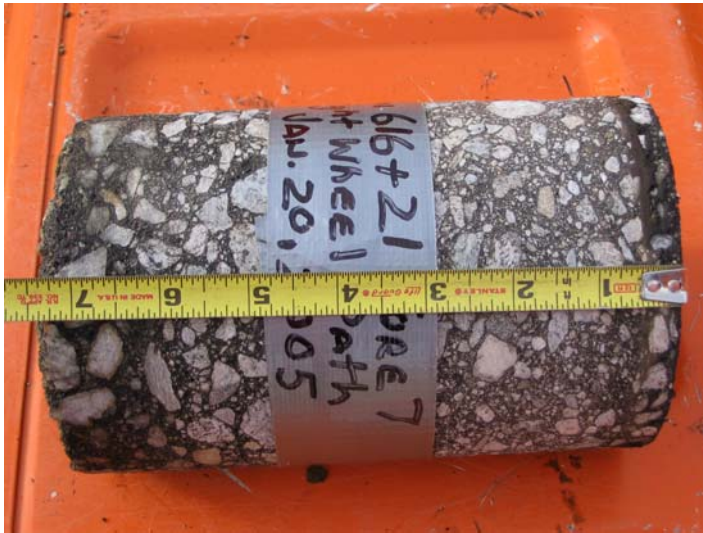
Core Location	616+21, Location 7	
Overall Core Thickness	190 mm	
Chip Seal Thickness	14 mm	
Rut Depth	Left Wheelpath	Right Wheelpath
	23 mm	33 mm

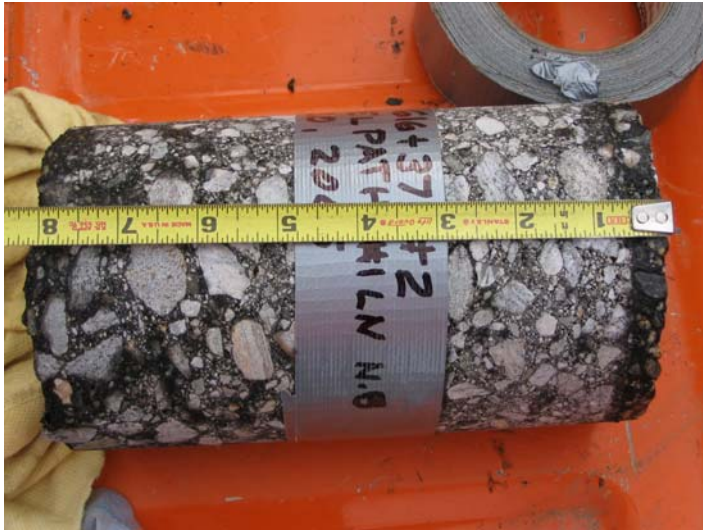
Core Location	Station 616+37, Location 2	
Overall Core Thickness	209 mm	
Chip Seal Thickness	11 mm	
Rut Depth	Left Wheelpath	Right Wheelpath
	N/A	N/A

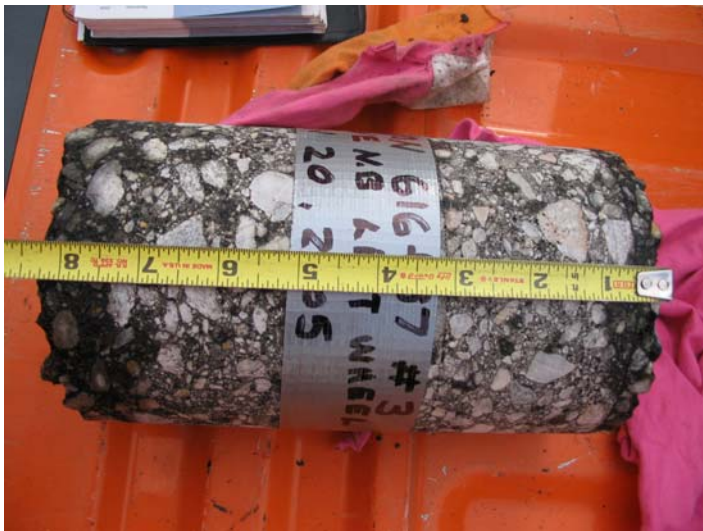
Core Location	Station 616+37, Location 3	
Overall Core Thickness	209 mm	
Chip Seal Thickness	11 mm	
Rut Depth	Left Wheelpath	Right Wheelpath
	N/A	N/A

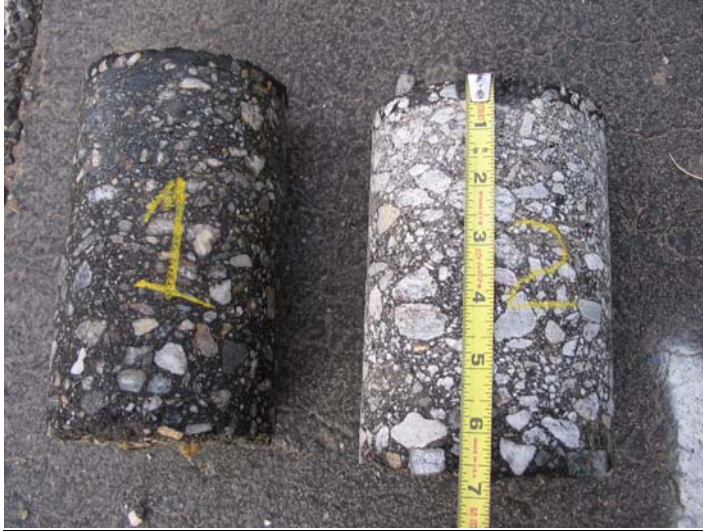
Core Location	Station 616+37, Location 4	
Overall Core Thickness	211 mm	
Chip Seal Thickness	13 mm	
Rut Depth	Left Wheelpath	Right Wheelpath
	18 mm	38 mm

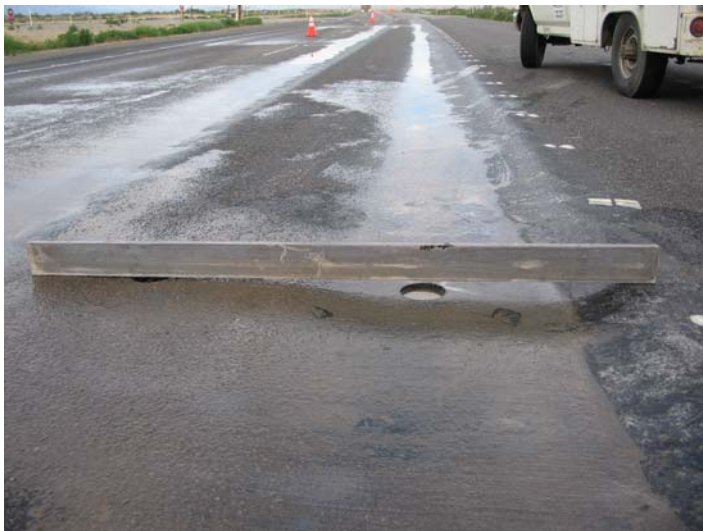
Core Location	Station 616+37, Location 5	
Overall Core Thickness	194 mm	
Chip Seal Thickness	12 mm	
Rut Depth	Left Wheelpath	Right Wheelpath
	18 mm	38 mm

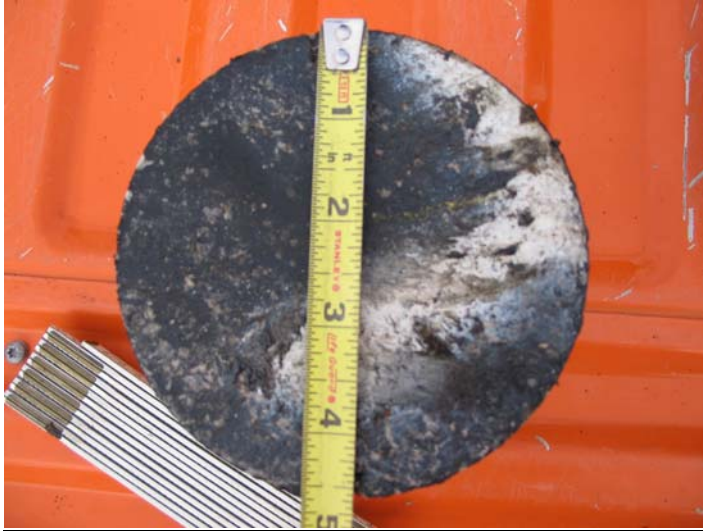
Core Location	Station 616+37, Location 6	
Overall Core Thickness	196 mm	
Chip Seal Thickness	15 mm	
Rut Depth	Left Wheelpath	Right Wheelpath
	18 mm	38 mm

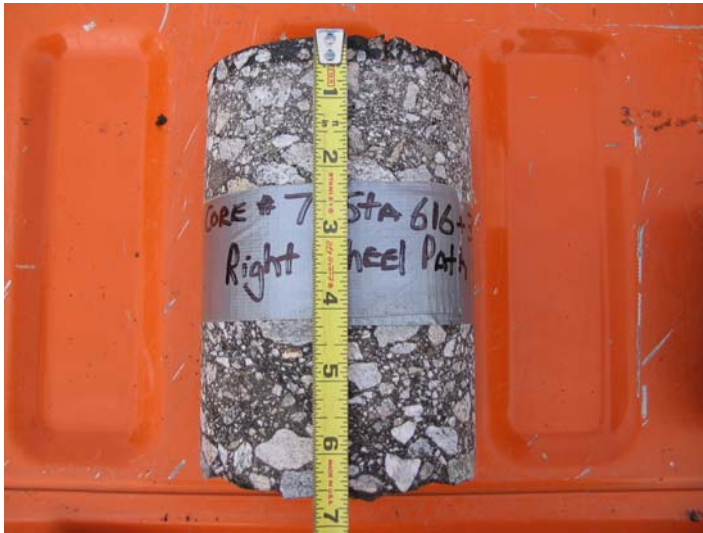
Core Location	Station 616+37, Location 7	
Overall Core Thickness	170 mm	
Chip Seal Thickness	10 mm	
Rut Depth	Left Wheelpath	Right Wheelpath
	18 mm	38 mm

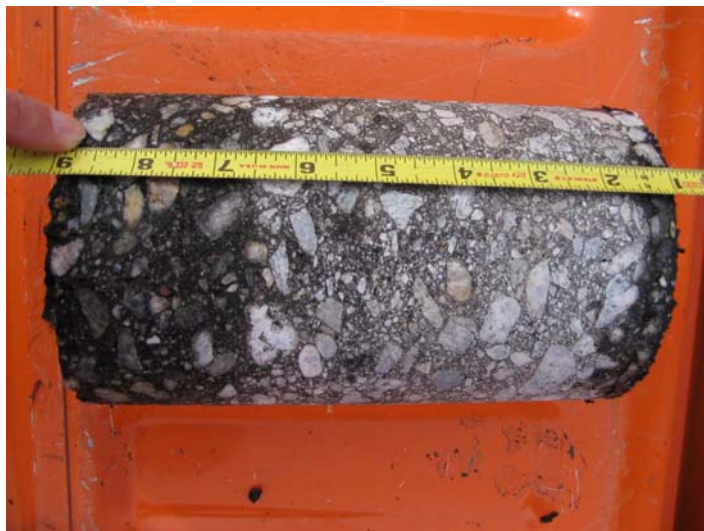
Core Location	Station 617+60, Location 5	
Overall Core Thickness	206 mm	
Chip Seal Thickness	12 mm	
Rut Depth	Left Wheelpath	Right Wheelpath
	6 mm	16 mm

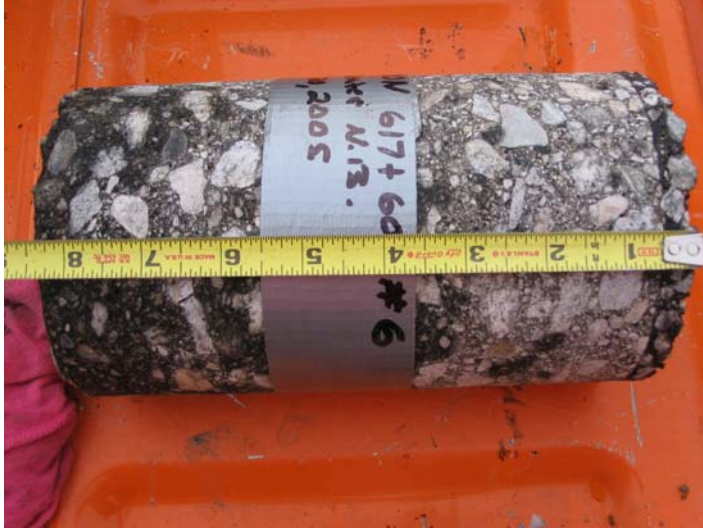
Core Location	Station 617+60, Location 6	
Overall Core Thickness	215 mm	
Chip Seal Thickness	12 mm	
Rut Depth	Left Wheelpath	Right Wheelpath
	6 mm	16 mm

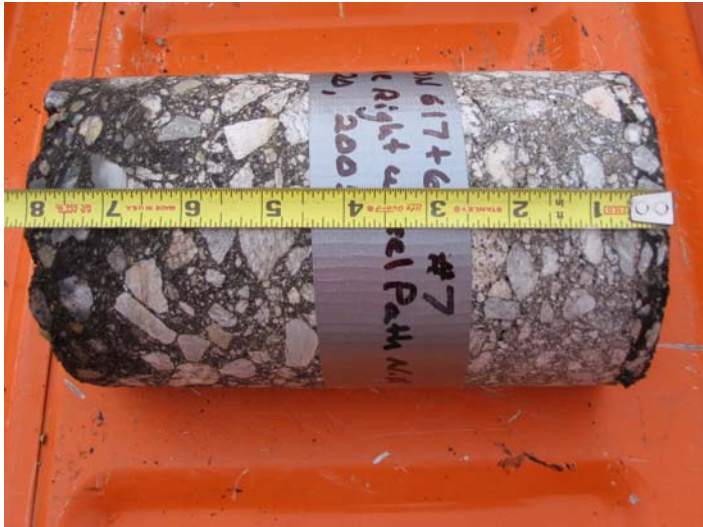
Core Location	Station 617+60, Location 7	
Overall Core Thickness	206 mm	
Chip Seal Thickness	11 mm	
Rut Depth	Left Wheelpath	Right Wheelpath
	6 mm	16 mm

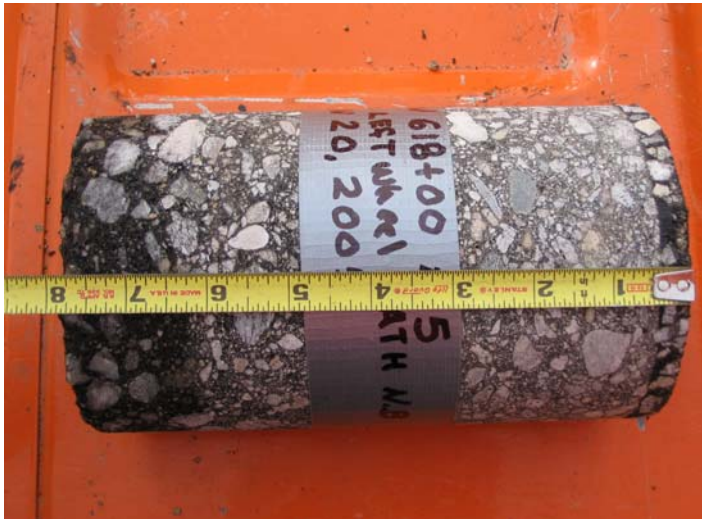
Core Location	Station 618+00, Location 5	
Overall Core Thickness	201 mm	
Chip Seal Thickness	10 mm	
Rut Depth	Left Wheelpath	Right Wheelpath
	11 mm	16 mm

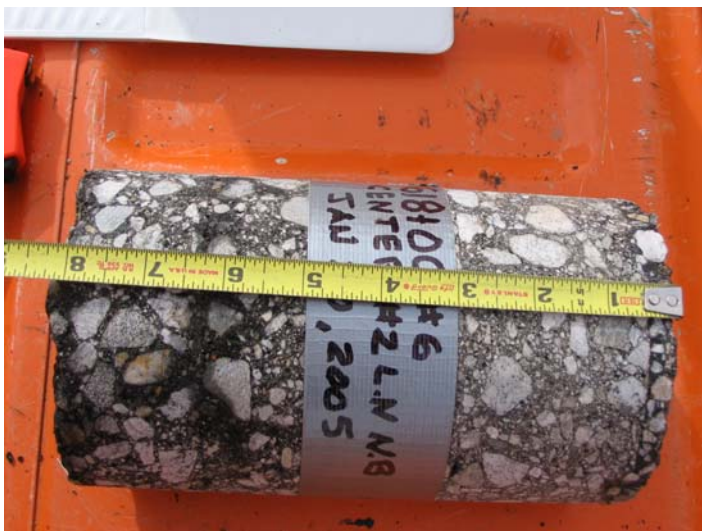
Core Location	Station 618+00, Location 6	
Overall Core Thickness	207 mm	
Chip Seal Thickness	10 mm	
Rut Depth	Left Wheelpath	Right Wheelpath
	11 mm	16 mm

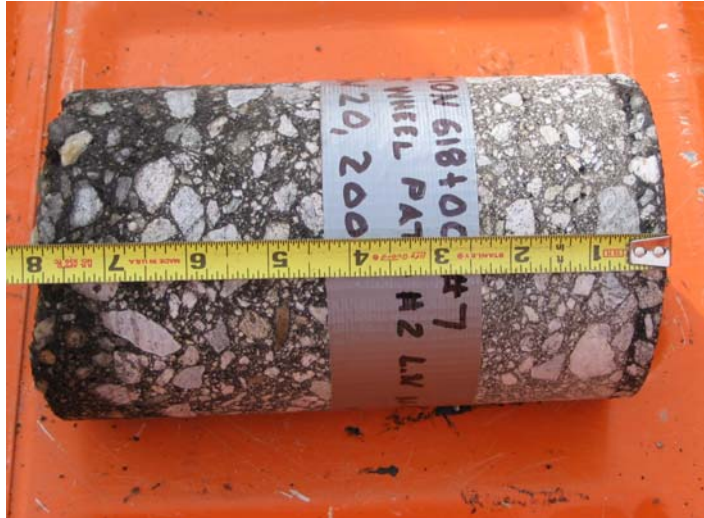
Core Location	Station 618+00, Location 7	
Overall Core Thickness	202 mm	
Chip Seal Thickness	10 mm	
Rut Depth	Left Wheelpath	Right Wheelpath
	11 mm	16 mm

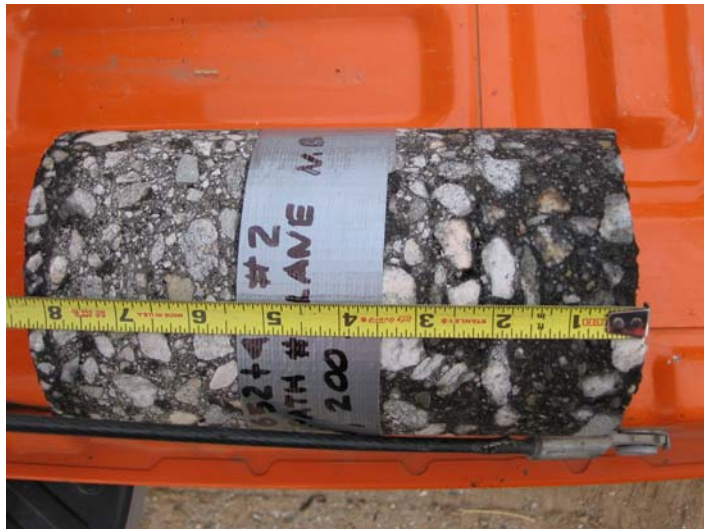
Core Location	Station 652+40, Location 2	
Overall Core Thickness	210 mm	
Chip Seal Thickness	10 mm	
Rut Depth	Left Wheelpath	Right Wheelpath
	N/A	N/A

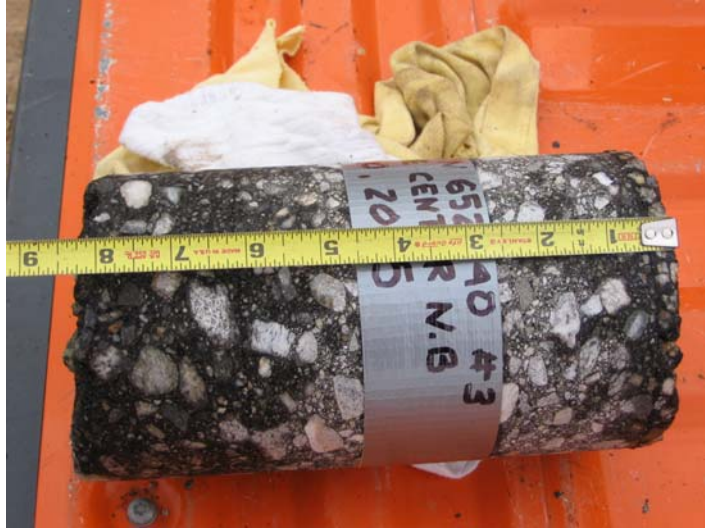
Core Location	Station 652+40, Location 3	
Overall Core Thickness	217 mm	
Chip Seal Thickness	11 mm	
Rut Depth	Left Wheelpath	Right Wheelpath
	N/A	N/A

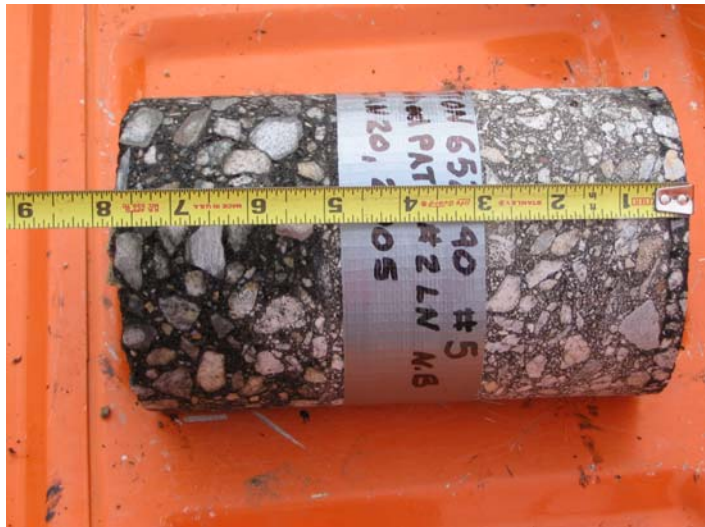
Core Location	Station 652+40, Location 5	
Overall Core Thickness	198 mm	
Chip Seal Thickness	10 mm	
Rut Depth	Left Wheelpath	Right Wheelpath
	12 mm	18 mm

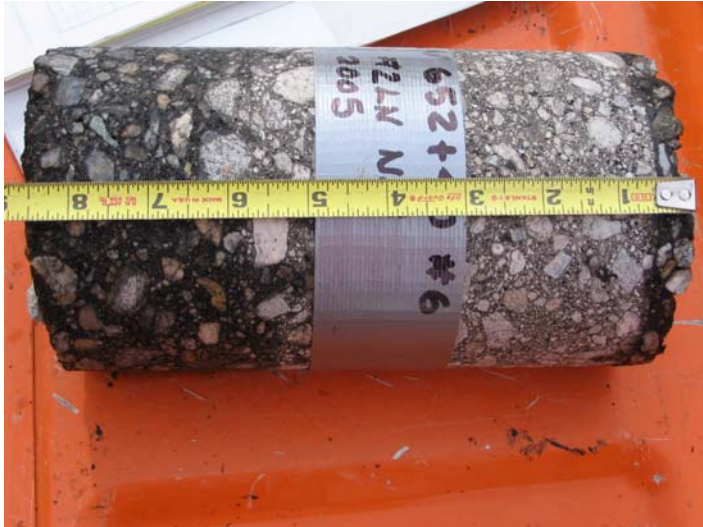
Core Location	Station 652+40, Location 6	
Overall Core Thickness	216 mm	
Chip Seal Thickness	11 mm	
Rut Depth	Left Wheelpath	Right Wheelpath
	12 mm	18 mm

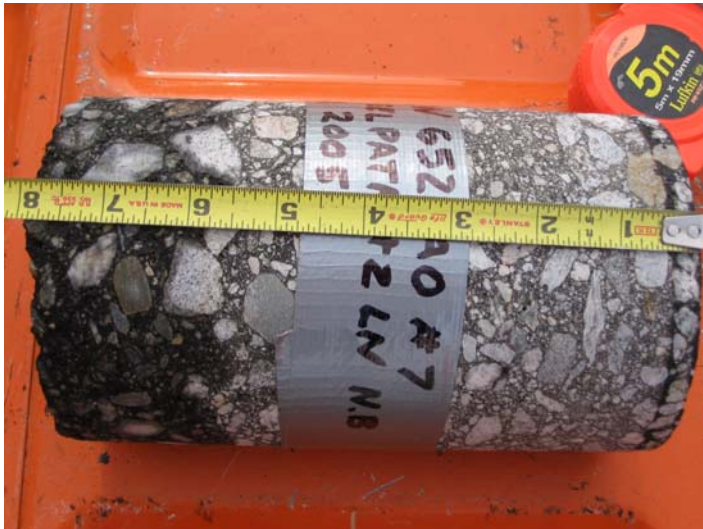
Core Location	Station 652+40, Location 7	
Overall Core Thickness	199 mm	
Chip Seal Thickness	9 mm	
Rut Depth	Left Wheelpath	Right Wheelpath
	12 mm	18 mm

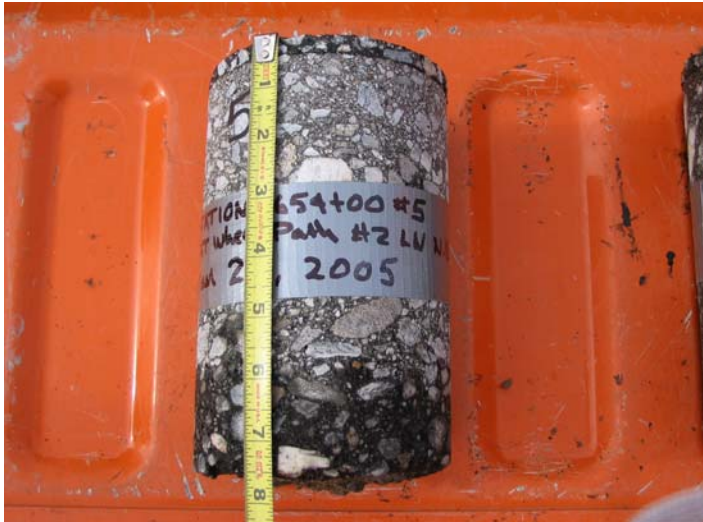
Core Location	Station 654+00, Location 5	
Overall Core Thickness	191 mm	
Chip Seal Thickness	10 mm	
Rut Depth	Left Wheelpath	Right Wheelpath
	2 mm	11 mm

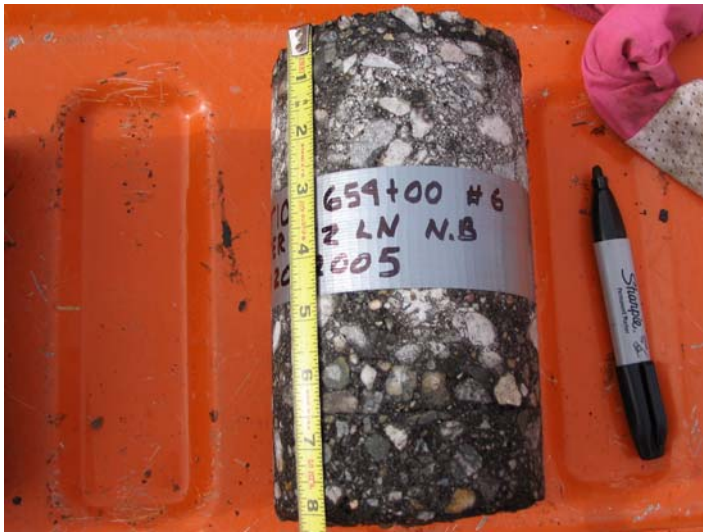
Core Location	Station 654+00, Location 6	
Overall Core Thickness	206 mm	
Chip Seal Thickness	12 mm	
Rut Depth	Left Wheelpath	Right Wheelpath
	2 mm	11 mm

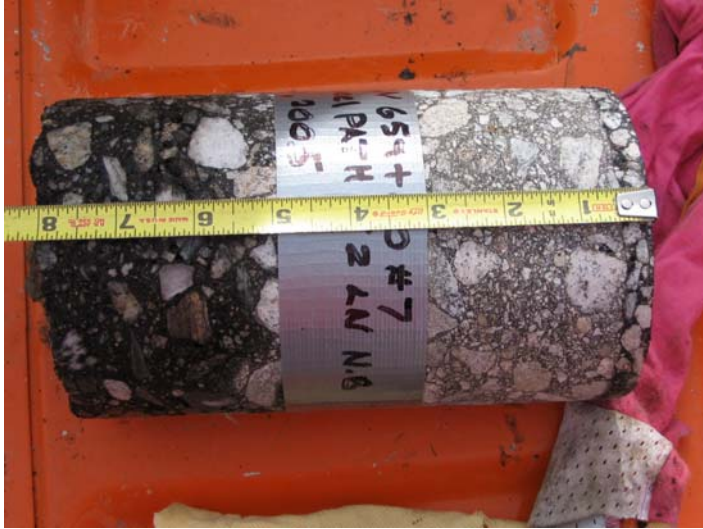
Core Location	Station 654+00, Location 7	
Overall Core Thickness	204 mm	
Chip Seal Thickness	10 mm	
Rut Depth	Left Wheelpath	Right Wheelpath
	2 mm	11 mm

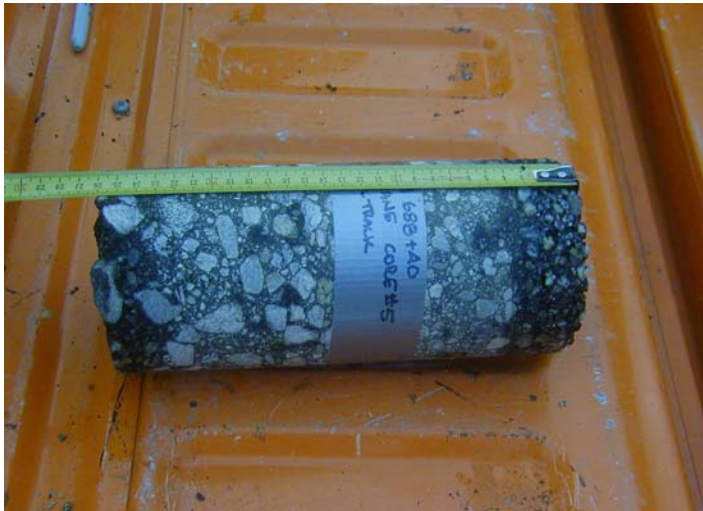
Core Location	Station 688+40, Location 5	
Overall Core Thickness	261 mm	
OG / Chip Seal Thickness	28 mm / 10 mm	
Rut Depth	Left Wheelpath	Right Wheelpath
	0 mm	0 mm

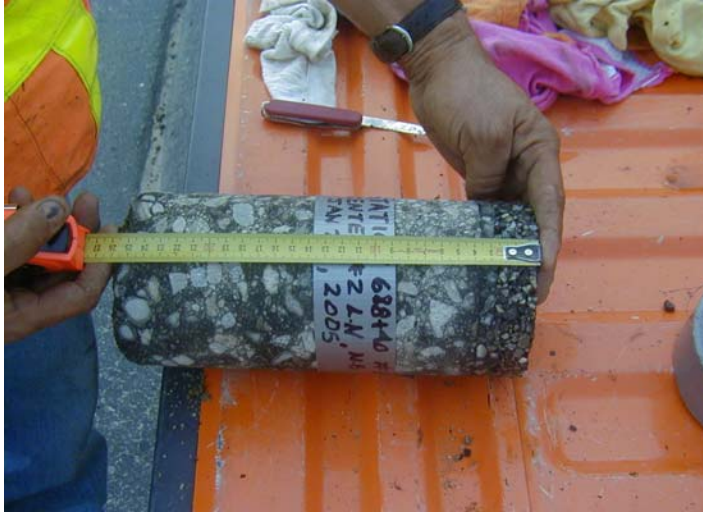
Core Location	Station 688+40, Location 6	
Overall Core Thickness	257 mm	
OG / Chip Seal Thickness	27 mm / 10 mm	
Rut Depth	Left Wheelpath	Right Wheelpath
	0 mm	0 mm

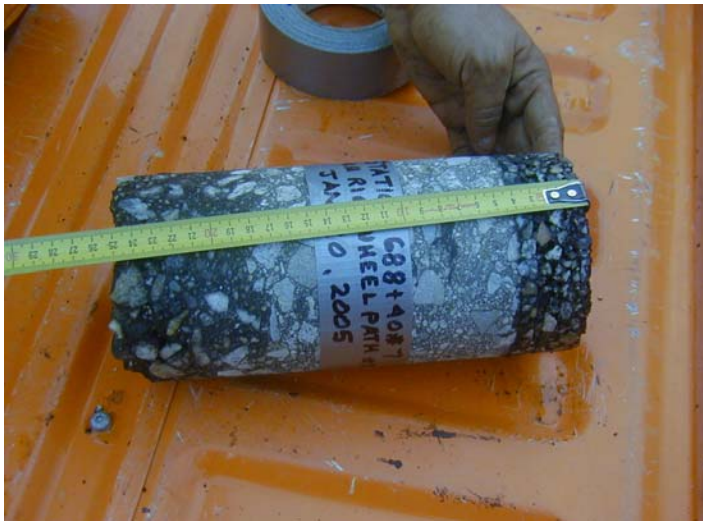
Core Location	Station 688+40, Location 7	
Overall Core Thickness	250 mm	
OG / Chip Seal Thickness	29 mm / 10 mm	
Rut Depth	Left Wheelpath	Right Wheelpath
	0 mm	0 mm

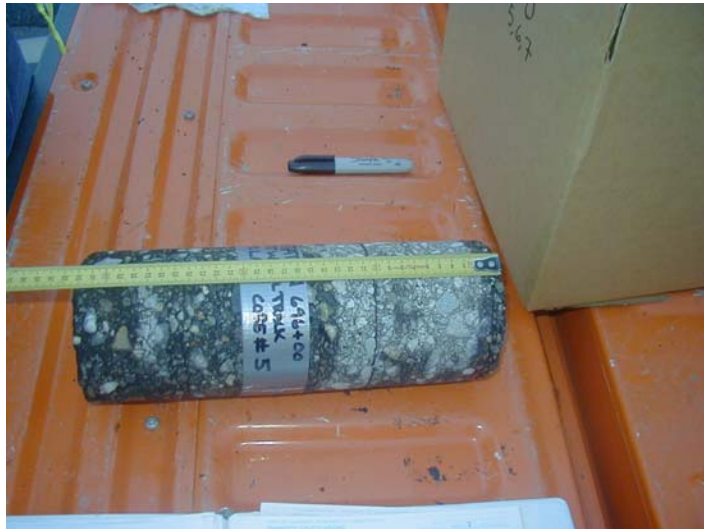
Core Location	Station 696+00, Location 5	
Overall Core Thickness	324 mm	
OG Layer Thickness	12 mm	
Rut Depth	Left Wheelpath	Right Wheelpath
	N/A	N/A

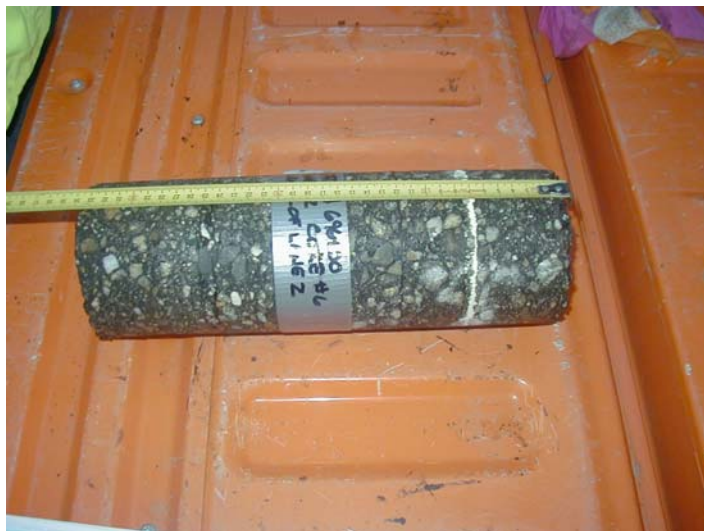
Core Location	Station 696+00, Location 6	
Overall Core Thickness	335 mm	
OG Layer Thickness	7 mm	
Rut Depth	Left Wheelpath	Right Wheelpath
	N/A	N/A

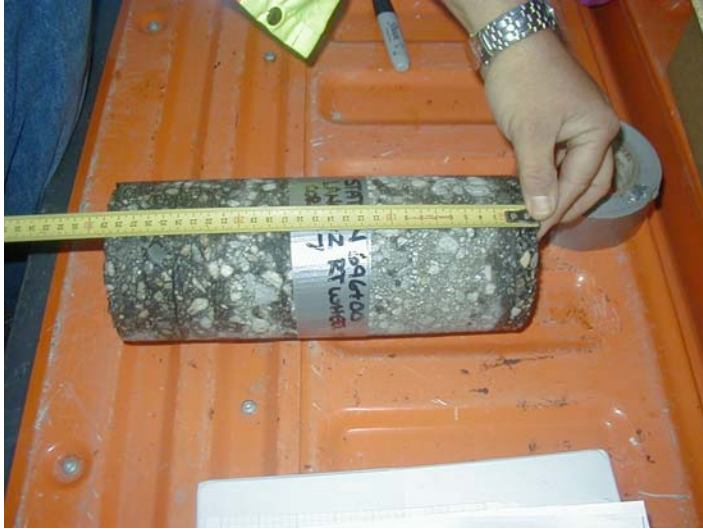
Core Location	Station 696+00, Location 7	
Overall Core Thickness	290 mm	
OG Layer Thickness	17 mm	
Rut Depth	Left Wheelpath	Right Wheelpath
	N/A	N/A
