**Report of Field Site Visit
District 3, Sacramento
Interstate 5, PM 17.2-17.9
RAC-O Overlay**

Work Conducted Under PPRC Strategic Plan Task 4.16

Technical Memorandum TM-UCB-PRC-2005-7

June 2005

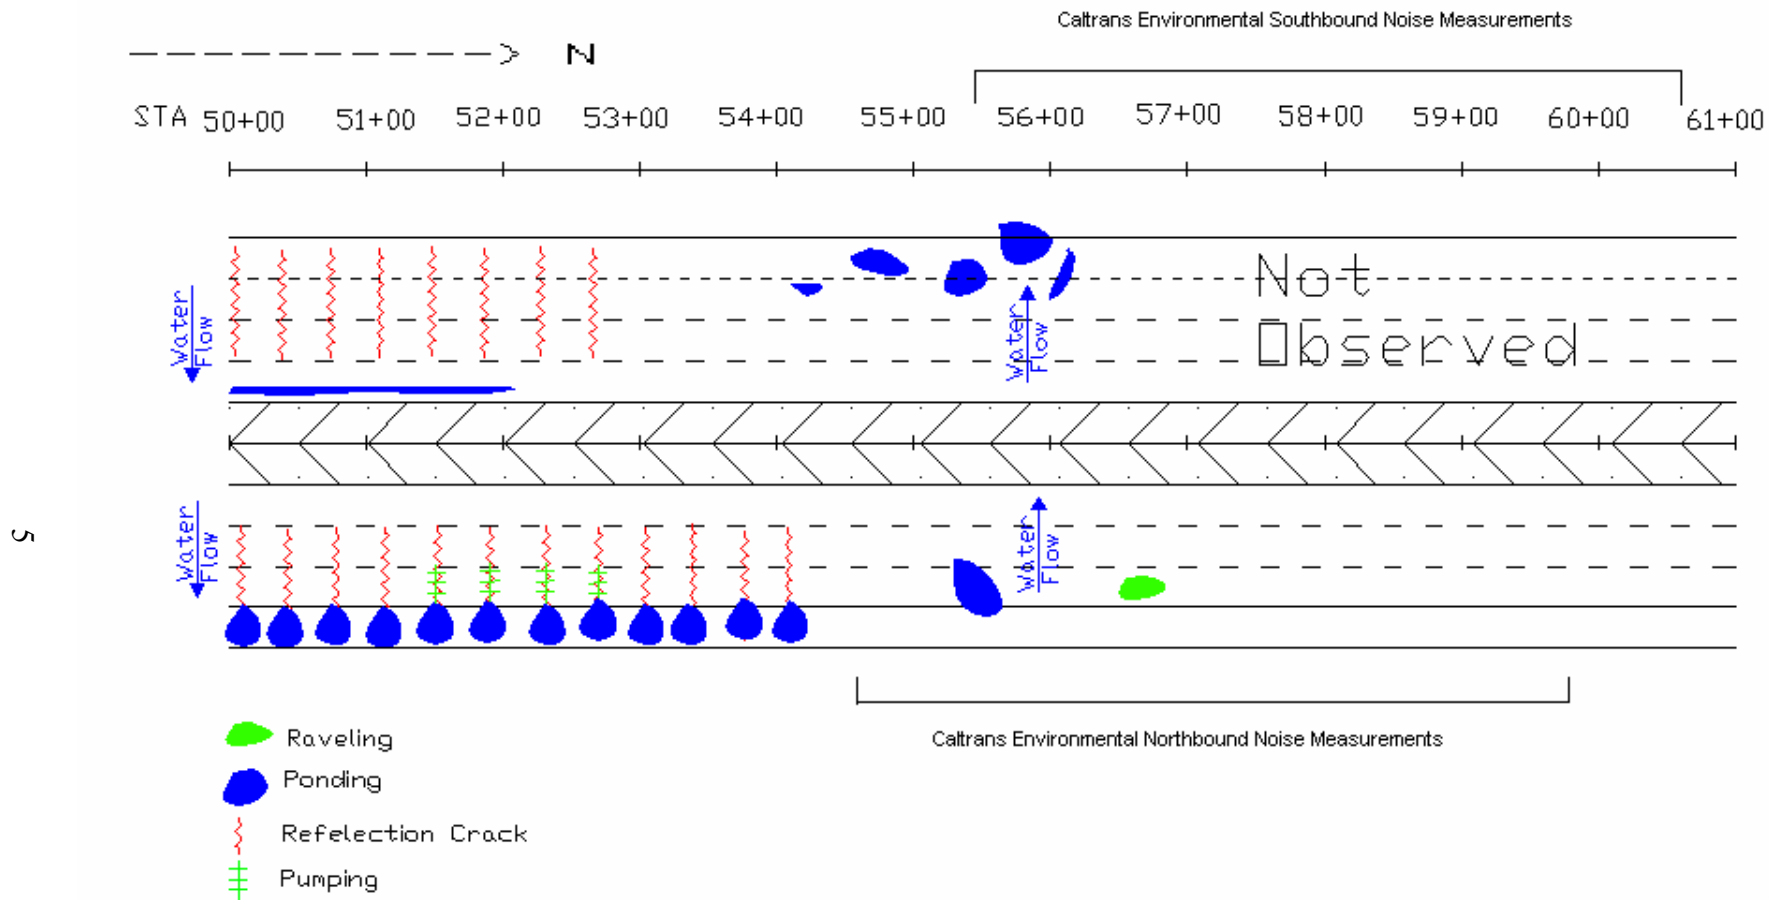
Figure 2. Plan of the section and the distresses (from Caltrans Environmental).

Ponding was present in the same locations as the reflection cracking. Water flowed easterly (from outside to inside lanes) on the southern portion of the project as shown in Figure 2. Moving northward against traffic in the southbound lane, the section climbs a mild hill, and then descends and the super-elevation reverses in the middle of the section, with water in the northern part of the southbound direction flowing westerly (from inside to outside lanes). Figures 7 through 12 show the pavement and ponding on the southbound direction of the site as the viewer progresses against traffic.

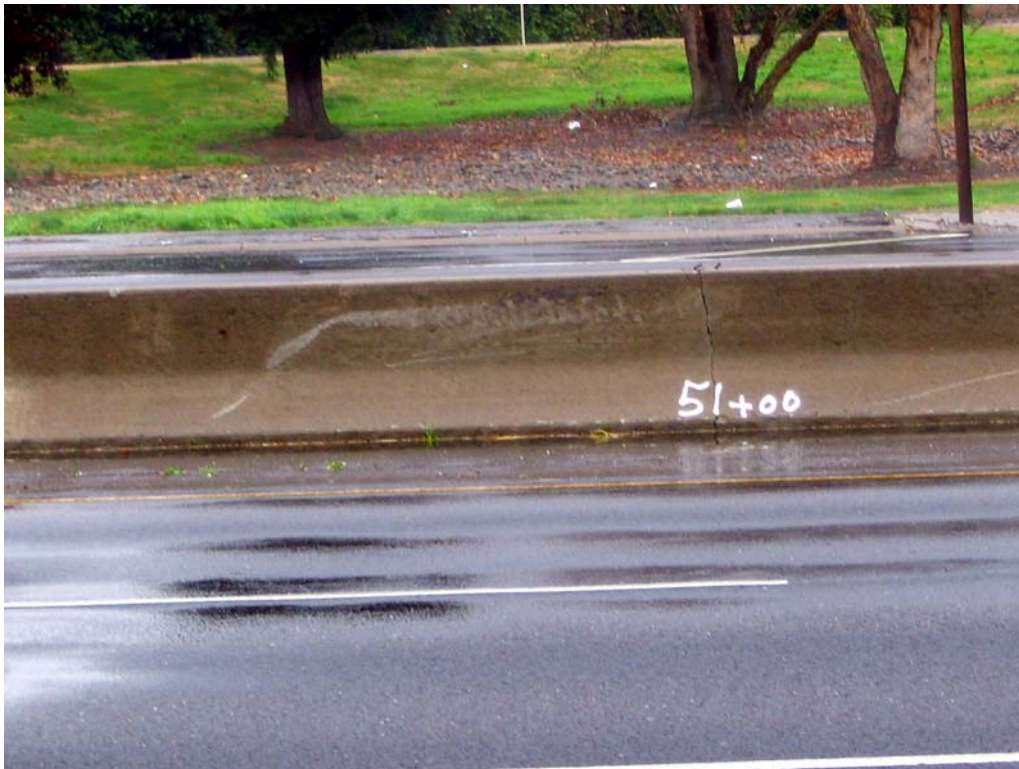
Figure 8. Ponding at Station 51+00 (inside lanes, southbound).

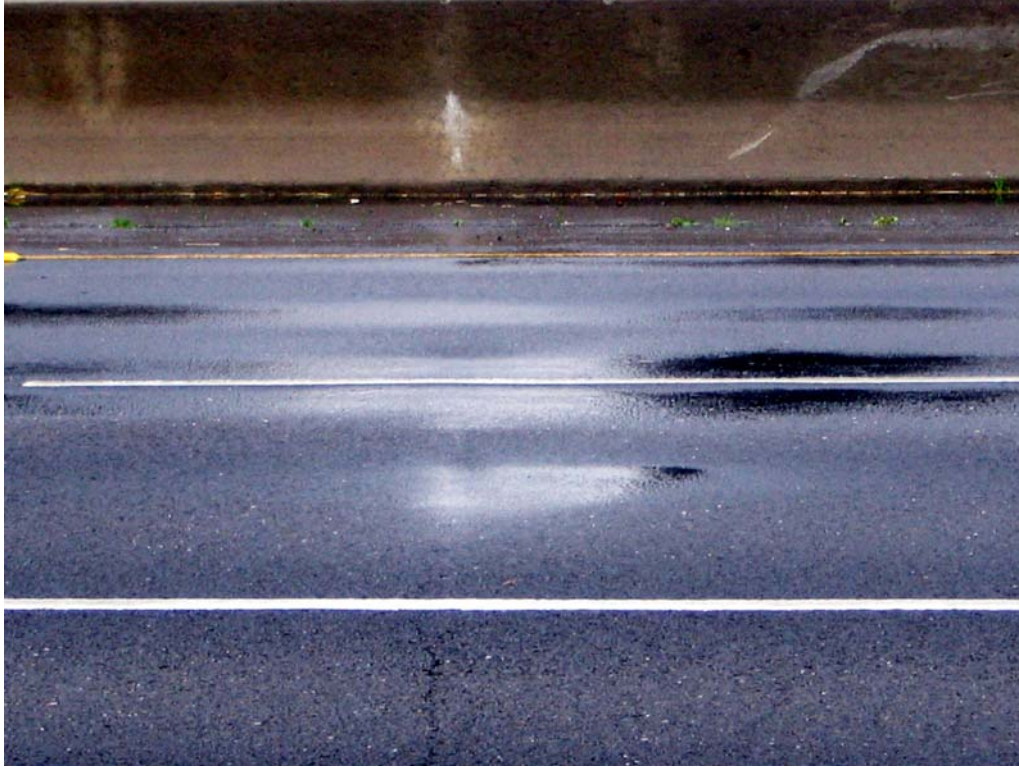
Figure 9. Ponding between Station 51+00 and Station 51+60 (inside lanes, southbound).

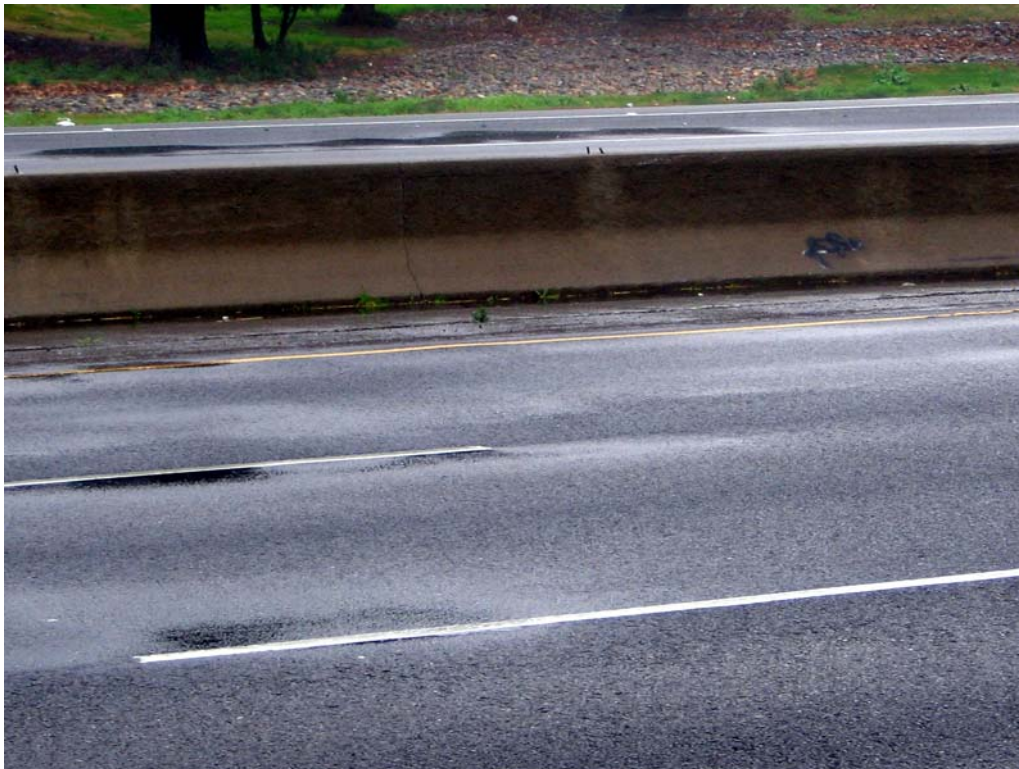
Figure 10. Ponding between Station 51+00 and Station 51+60 (inside lanes, southbound).

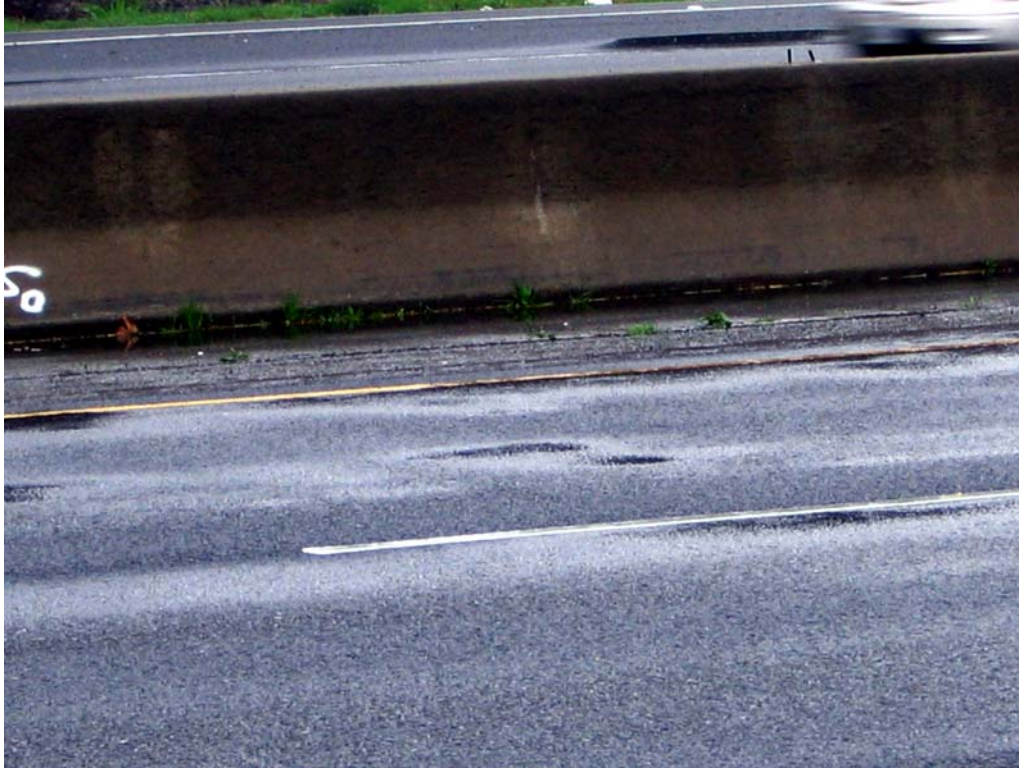
Figure 11. Ponding at Station 51+60 (inside lanes, southbound).

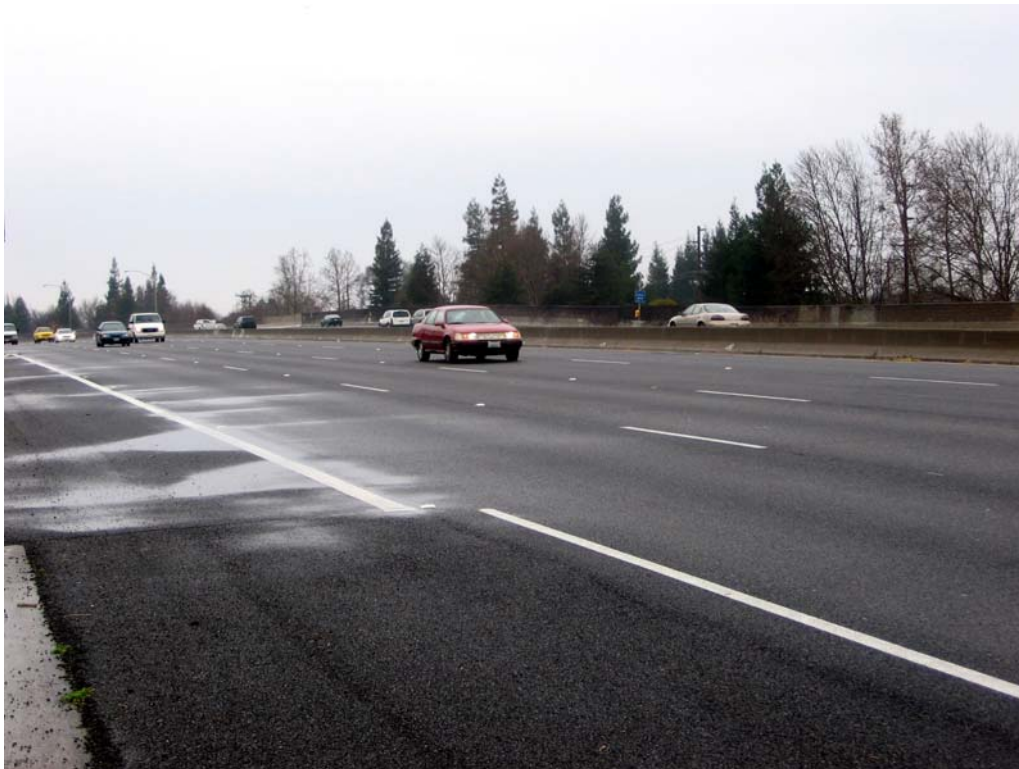
Figure 12. Ponding looking north from Station 55+00 (outside lanes, southbound).

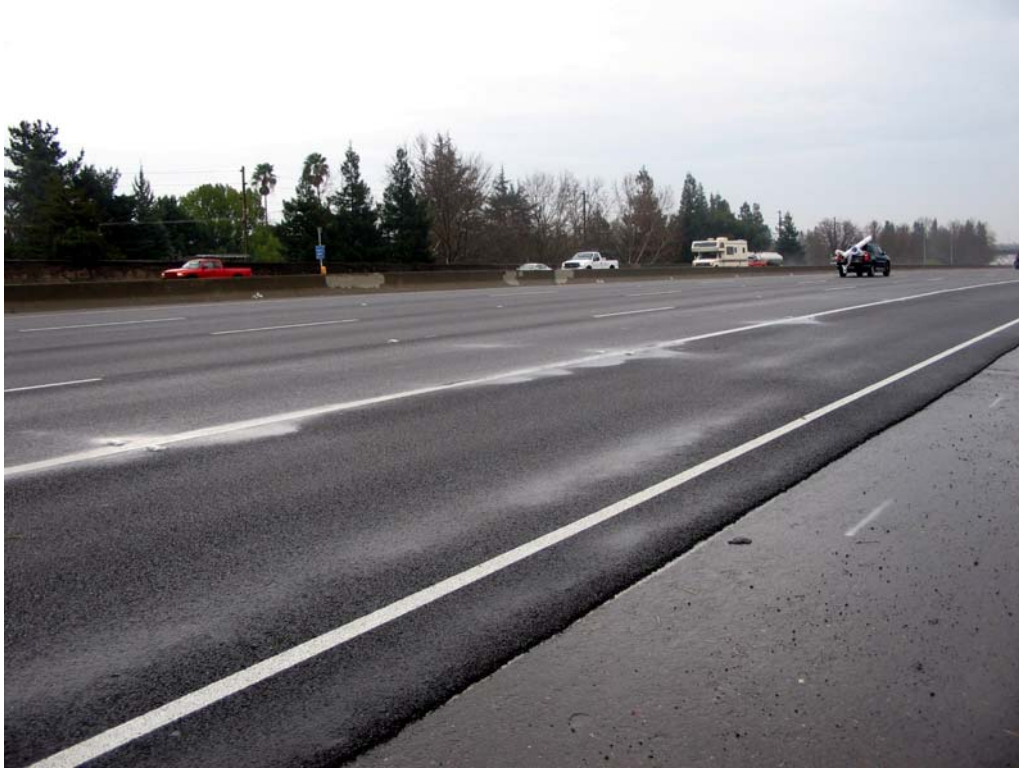
Polishing and mild rutting were observed in the truck lanes. Figure 13 shows the polishing and mild rutting on the outer lane of the southbound direction.

Figure 13. Polishing and mild rutting near Station 54+50 (outside lanes, southbound).

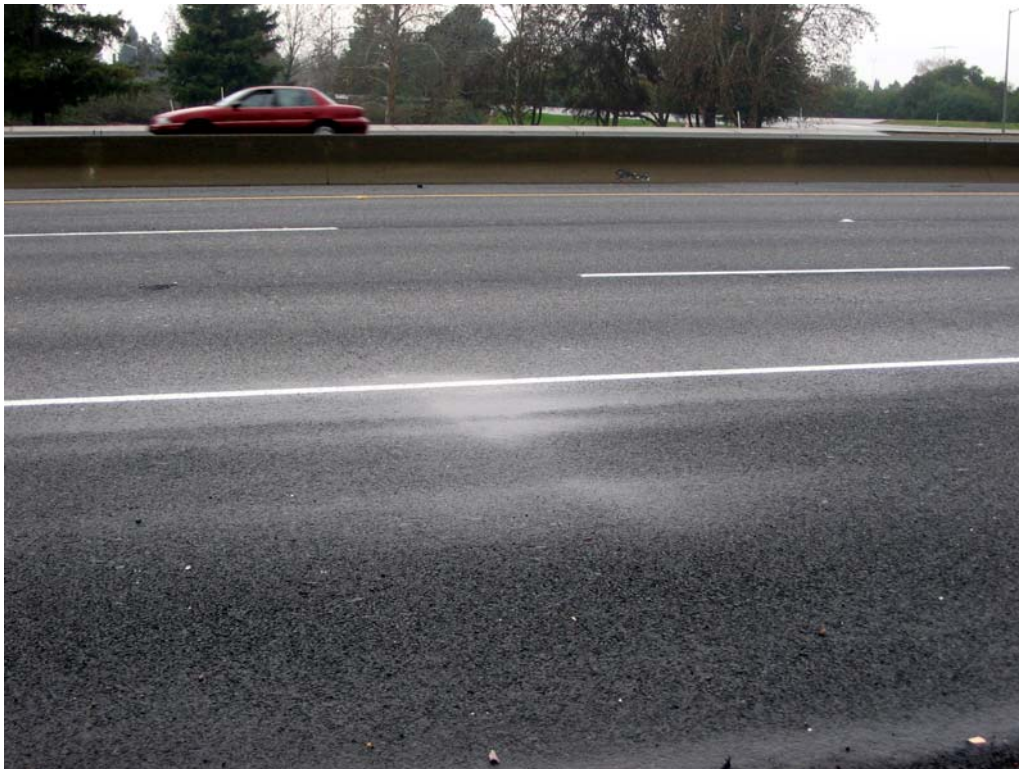
As in the southbound direction, reflection cracking was evident in the outside lanes on the south end of the northbound direction and were less frequent in the northern portion. Also, pumping of fines was evident at some transverse joints in the south end of the northbound direction. Figure 14 shows the reflection cracking while Figures 15 and 16 show reflection cracking and pumping of fines.

Figure 14. Reflection cracking between Station 51+00 and 52+00 (northbound lanes).

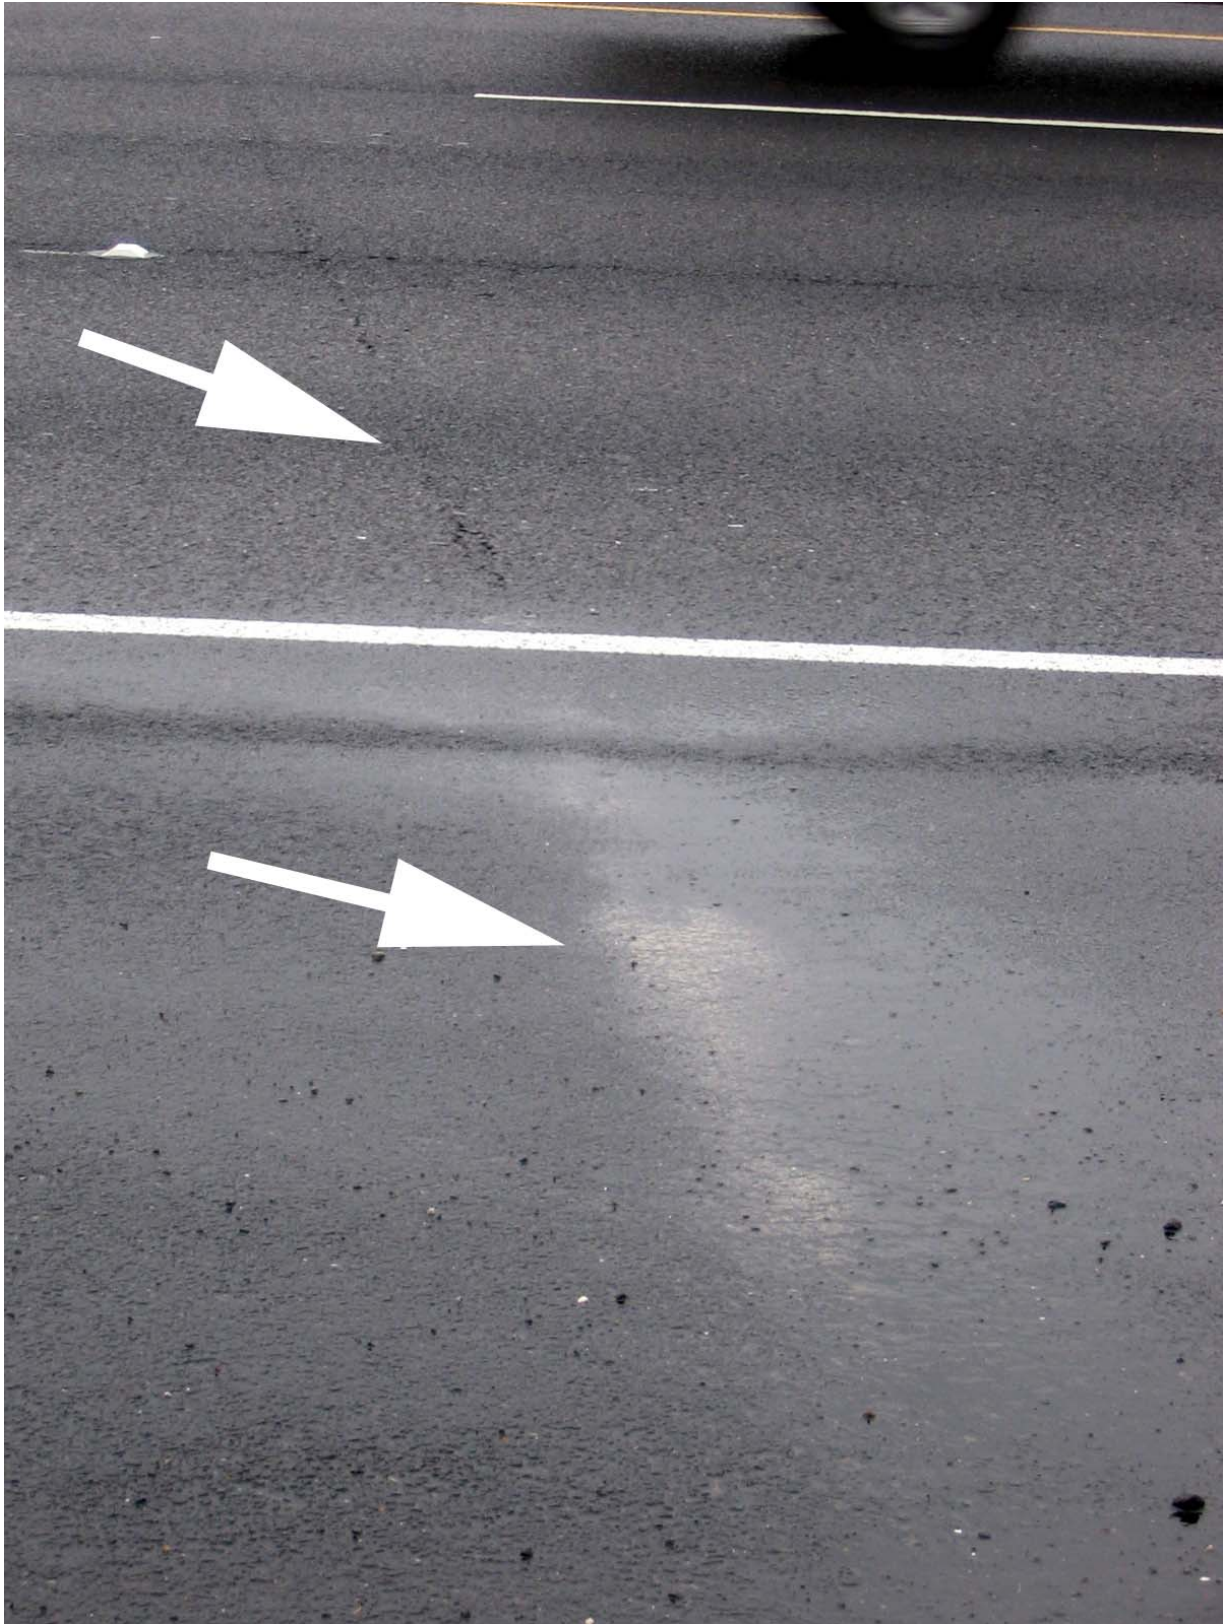
Figure 15. Reflection cracking and pumping of fines between Station 52+00 and 53+00 (northbound lanes).

- It is hypothesized that water flow and the resulting ponding and pumping of fines may be contributing to premature clogging of the pores resulting in different noise performance through the southbound section, and the slight difference between the average northbound and southbound direction measurements. However, from the Caltrans Environmental presentation it appears that the section of the northbound lanes with pumping was not included in the noise measurements.

To test the hypothesis that water flow, ponding, and pumping are contributing to differences in clogging within the project, it is recommended that the following additional work be performed within a lane closure on the northbound and southbound directions and the segments of the noise study in each direction:

- Permeability evaluation.
- Extraction of cores to test for air-void content and overlay thickness.

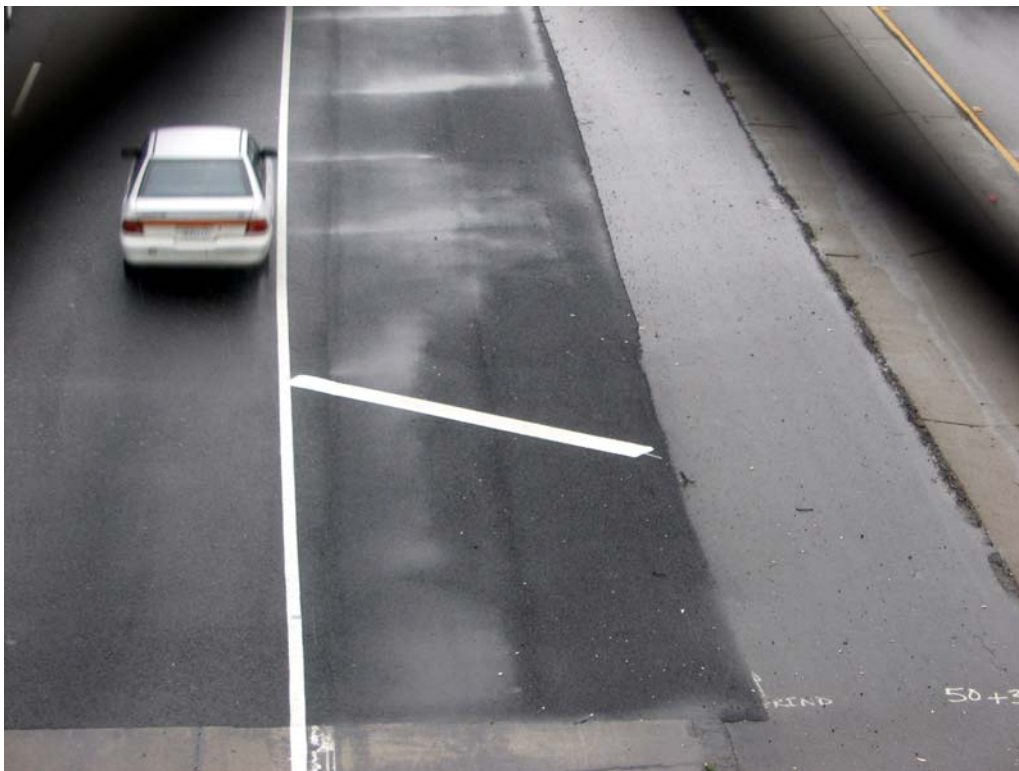
As in the southbound direction, water flow was easterly on the southern portion of the project and westerly on the northern portion of the project. Therefore, in the northbound direction, ponding occurred on the outside lanes at the southern portion and inside lanes in the northern portion. Figures 17 through 21 show the ponds on the northbound direction.

Figure 17. Ponding at Station 50+00 (outside lanes, northbound).

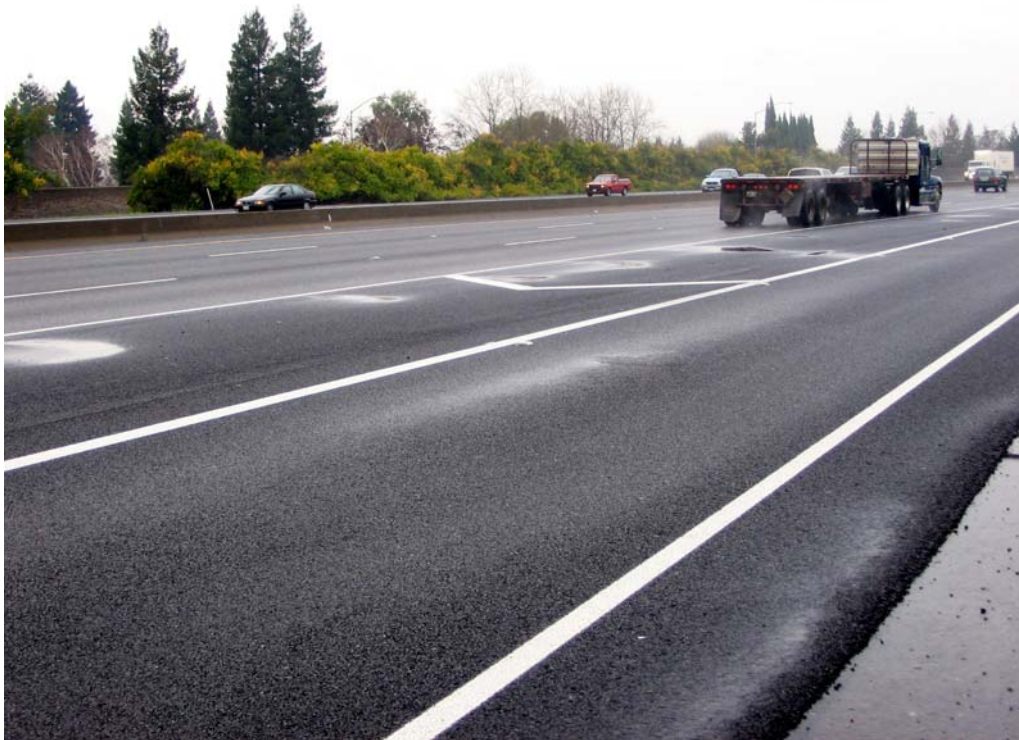
Figure 19. Ponding between Station 53+00 and Station 54+00 (outside lanes, northbound)

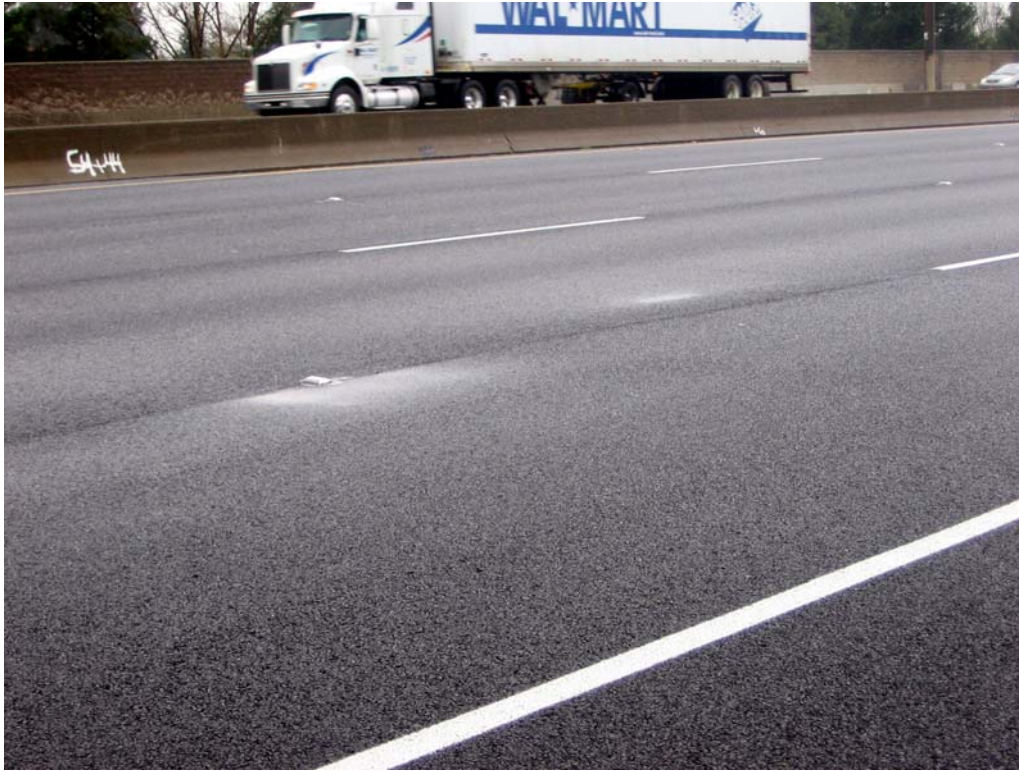
Figure 20. Ponding between at Station 54+44 (inside lanes, northbound).

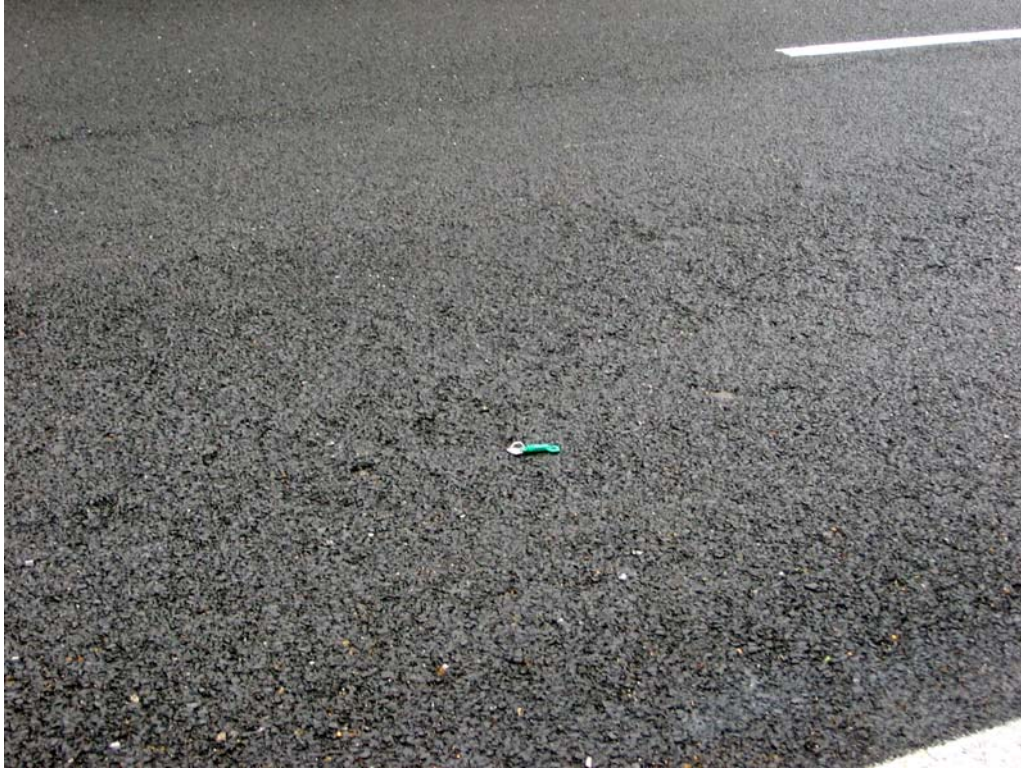
Raveling and a 1-2 inch diameter hole were observed at Station 56+80 on the northbound direction (Figures 22–24).

Figure 22. Raveling at Station 56+80 (northbound direction).

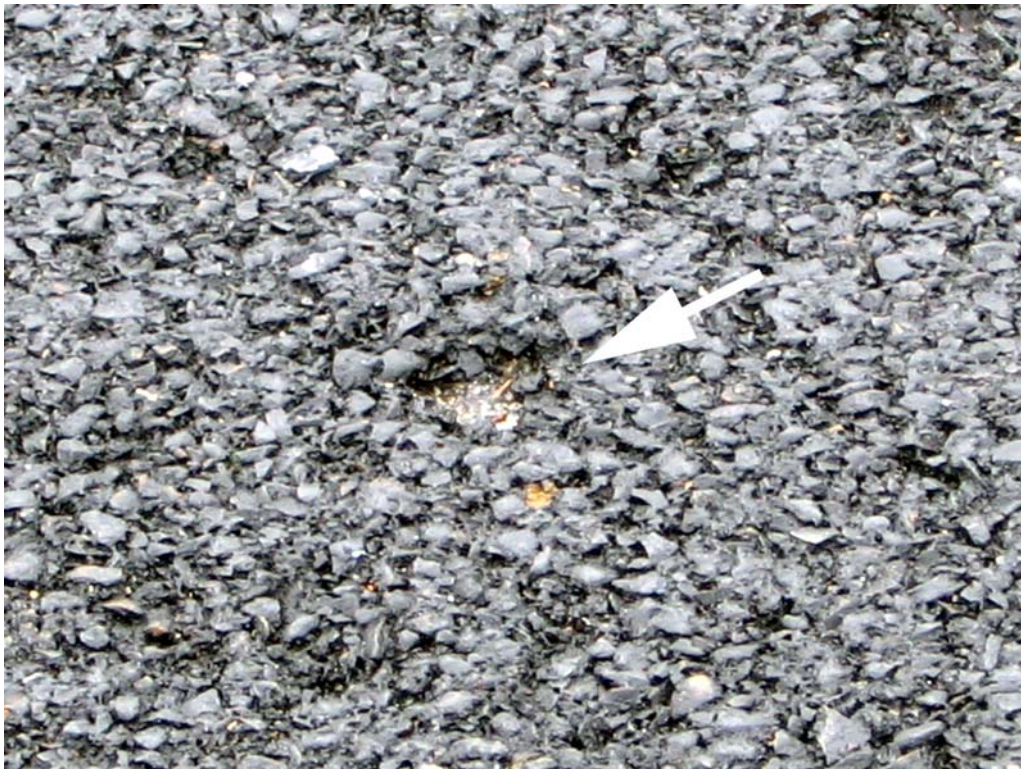
Figure 23. Hole at Station 56+80 (northbound direction).
