**Technical Memorandum:  
Evaluation of New Patching Material for Open-Graded  
Asphalt Concrete (OGAC) Wearing Courses**

**By Karl Frick  
California Department of Transportation**

**TM-UCB-PRC-2005-9**

June 2005

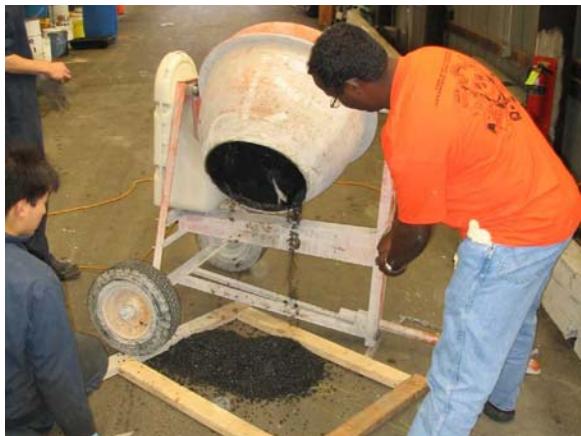
**Figure 1. Patch material being placed in wooden frame on top of DGAC pavement.**

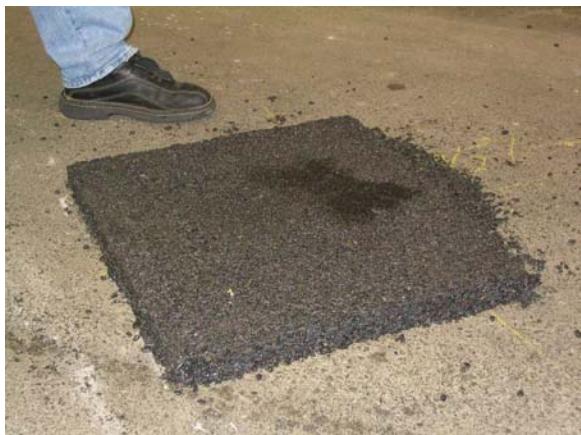
**Figure 2. Water on surface of patch material.**

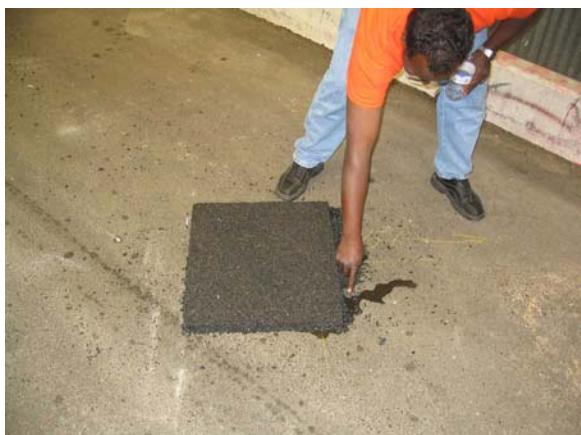
**Figure 3. Water draining from downslope side of patch material.**

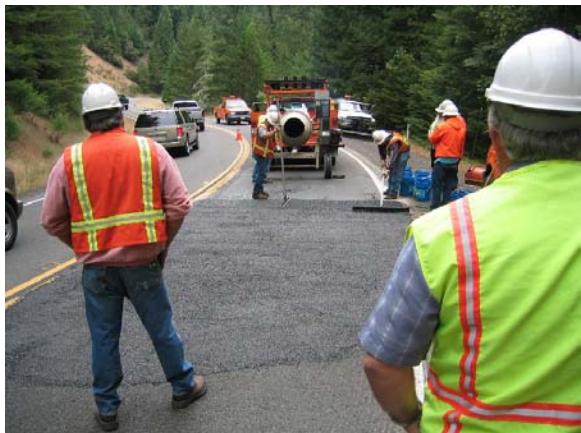
Modified FloMix was spread full lane over a length of several meters at the Highway 20 test site by a District 1 maintenance crew (Figure 4). The patch was about 1.5 cm thick and was tapered at the ends and edges. This was considered to be a severe test condition for the patch material for a couple of reasons. First, the thickness was less than desired for optimal drainage characteristics. Secondly, the patch was large in addition to being thin, and had no confinement at the edges.

**Figure 4. Placement of patch material on Highway 20 field site.**

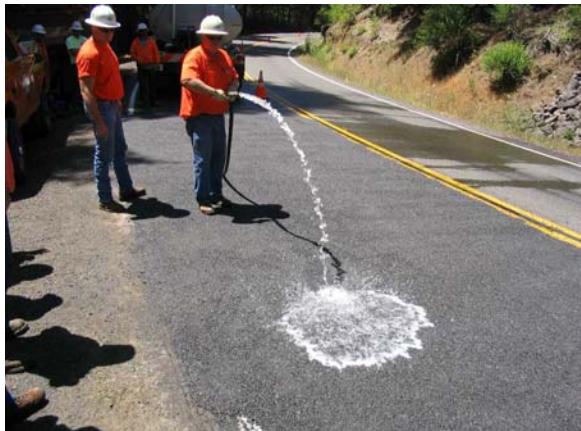
**Figure 5. Application of water to patched area.**

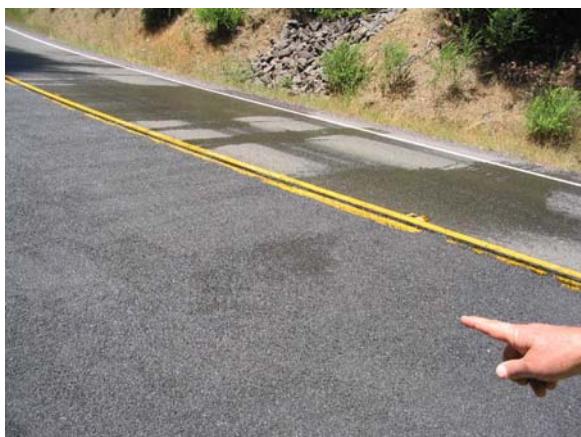
**Figure 6. Water draining from downslope side of patched area.**

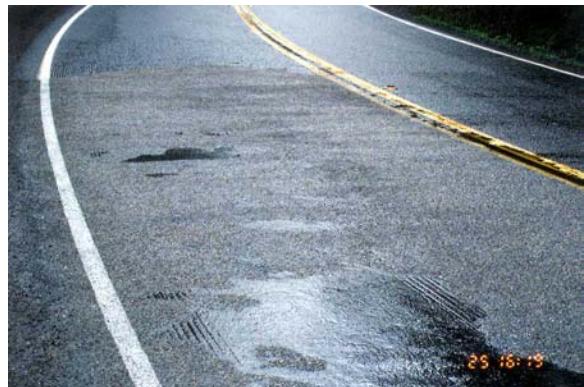
A water truck was brought in before the lane was opened to traffic. The truck made two passes, giving the patch a thorough soaking both times (Figure 5). The majority of the water drained through the patch, as anticipated, and drained out the downhill edge of the patch (Figure 6). The test site was then opened to traffic and the patch was monitored for durability. Unfortunately the patch was not durable and began chipping off of the underlying DGAC within a few months. Figure 7 shows the rough patch area after a year. Note the areas where the patch material has raveled completely away.

**Figure 7. Deteriorated patch site showing significant raveling and roughness after one year.**

Based upon the results of this research, the use of modified FloMix for OGAC patching is not recommended. The workability and drainage characteristics of the material were good, but

the material did not meet the field durability criteria. The material may have acceptable durability if applied in a less severe condition, such as filling medium-sized potholes, however this has not yet been evaluated.
