Research Report: UCPRC-RR-2006-02

Construction and Test Results on Dowel Bar Retrofit HVS Test Sections 556FD, 557FD, 558FD, and 559FD: State Route 14, Los Angeles County at Palmdale

This work was completed as part of Partnered Pavement Research Program Strategic Plan Item 4.8 “Dowel Bar Retrofit of Rigid Pavements”

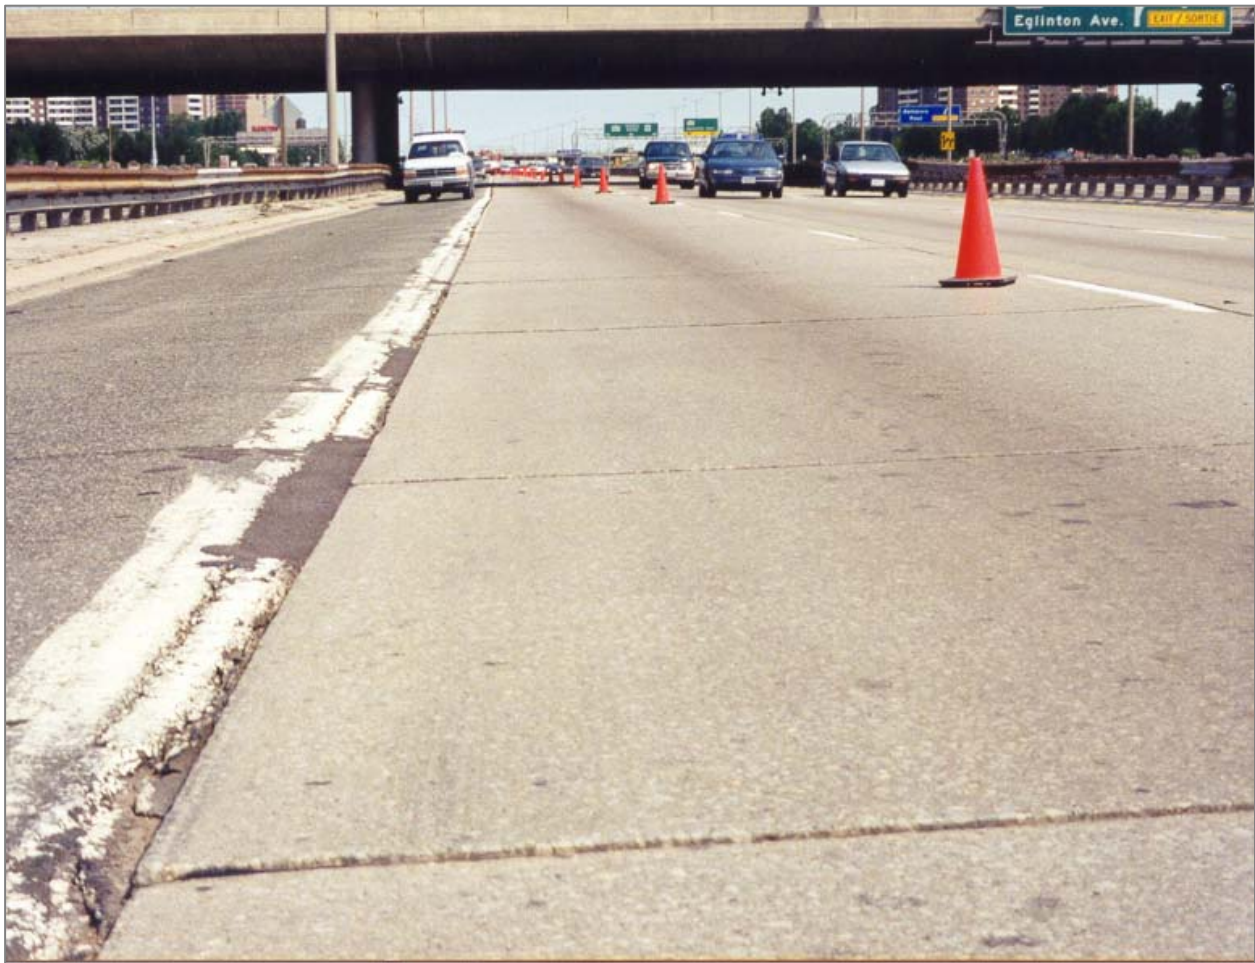
Figure 1.1. Upstream view showing faulting on an undoweled concrete pavement (courtesy of L. Khazanovich).

The smoothness of newly constructed rigid pavements is controlled by the paving process. The primary cause of increases in roughness (or lack of smoothness) on rigid pavements after construction is the development of faulting on transverse joints, and faulting of transverse cracks when they occur. The smoothness of a concrete pavement through its life is therefore controlled by its initial smoothness and the development of faulting under traffic loading. Faulting, sometimes referred to as “step-faulting,” is the difference in height between two concrete slabs at a transverse joint or crack, as shown in Figure 1.1. As faulting develops, the edge of the “upstream” slab at the joint becomes higher than the edge of the “downstream” slab.

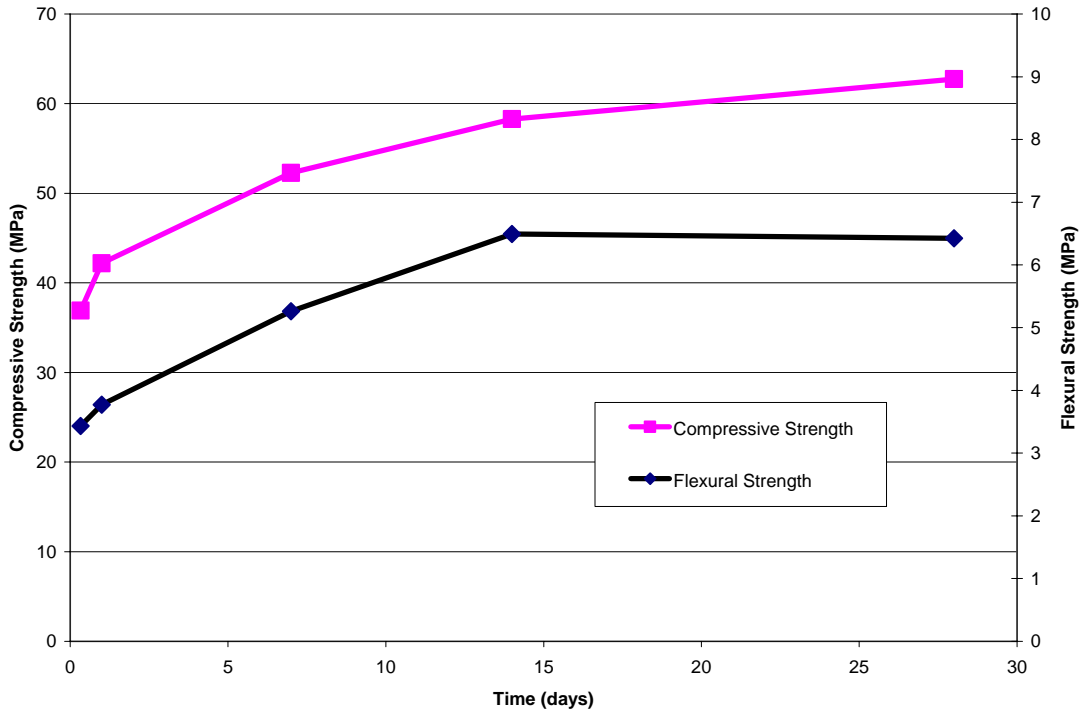
Figure 2.27. Average compressive and flexural strengths from field-prepared backfill grout specimens.

Grout tests. Beam and cylinder specimens of the mixed backfill grout material were made from material sampled at the site. The beams and cylinders were measured for 3rd point loading modulus of rupture and compressive strength. The results showed that the grout met Caltrans specifications for flexural strength and for compressive strength at twenty-four hours. The specification for compressive strength at three hours (0.125 days) could not be checked because of a travel delay for the testing contractor. The test at eight hours (0.33 days) indicated high early strength for the mix, but conformity with the three-hour strength requirement can not be determined.

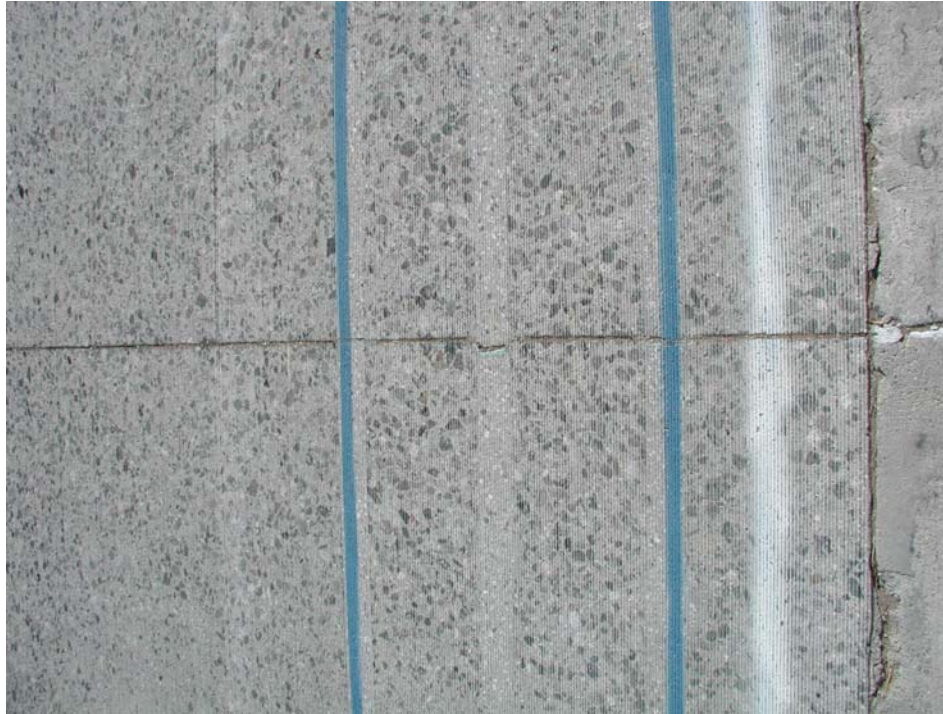
Figure 2.35. Photograph of Joint 36, Section 557FD, in March 2002, showing generally good condition.

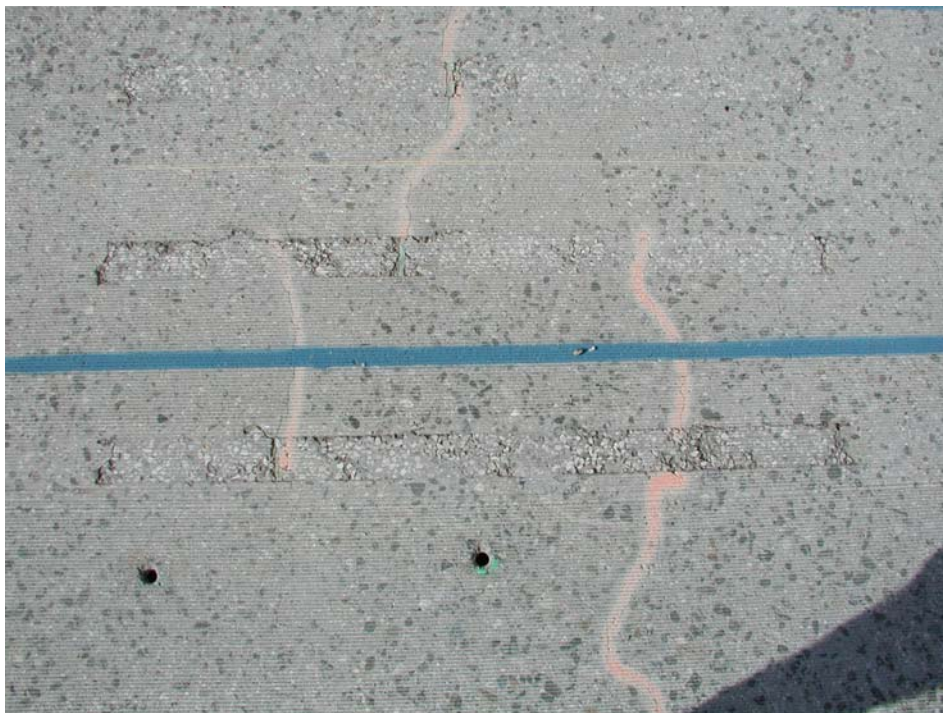
Figure 2.36. Photograph of Crack 1, Section 559FD, in March 2002, showing lack of fines, transverse cracking, and separation at edges.

Grout appearance. Some slots showed what appeared to be a lack of fine materials in the grout. Inspection two years after construction and after all HVS testing was completed showed some transverse cracking in the grout in the dowel slots. The grout did not come out of any of the slots, and the cracks remained tightly interlocked.

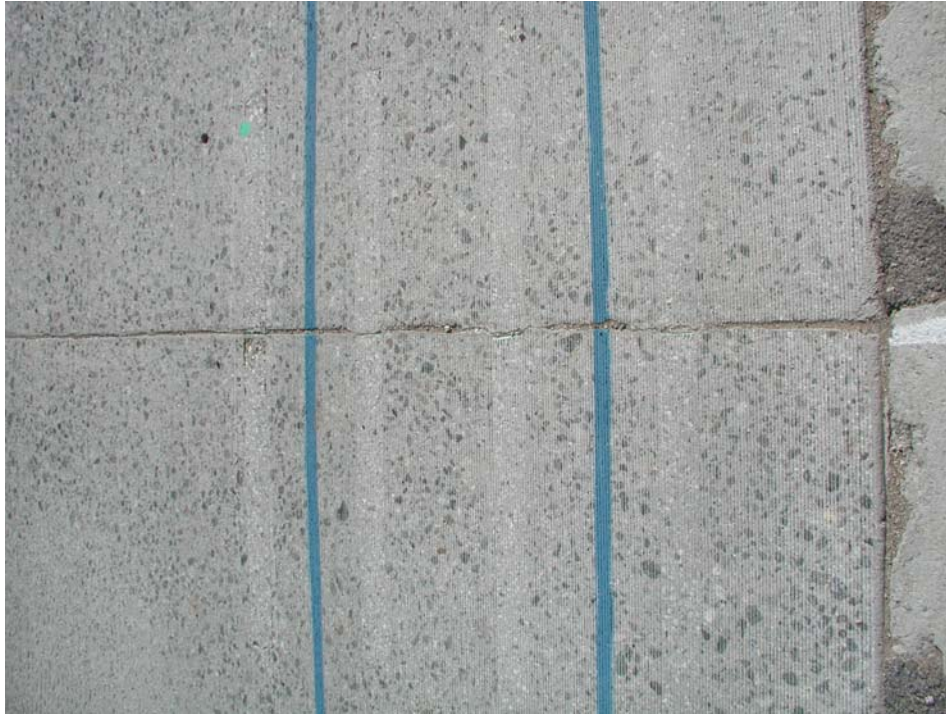
Figure 2.37. Photograph of Joint 33, Section 559FD, in March 2002, showing a small amount of lack of fines and separation at the edges of the dowel slot closest to the slab center.

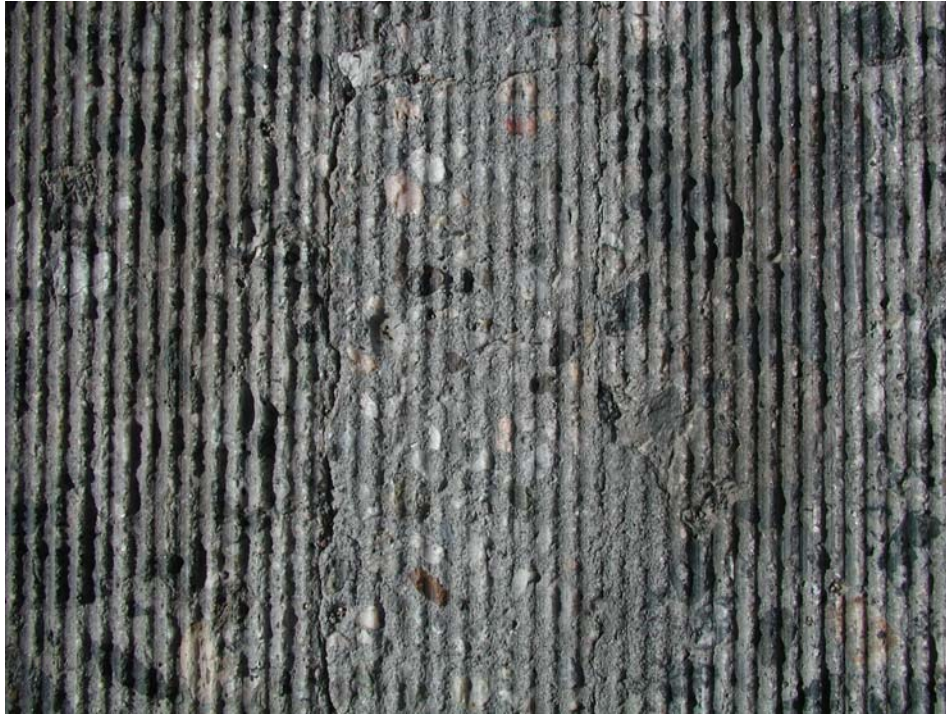
Figure 2.39. Photograph of DBR slot, Section 559FD, Slab 39, in June 2002, showing some separation of grout and slab.

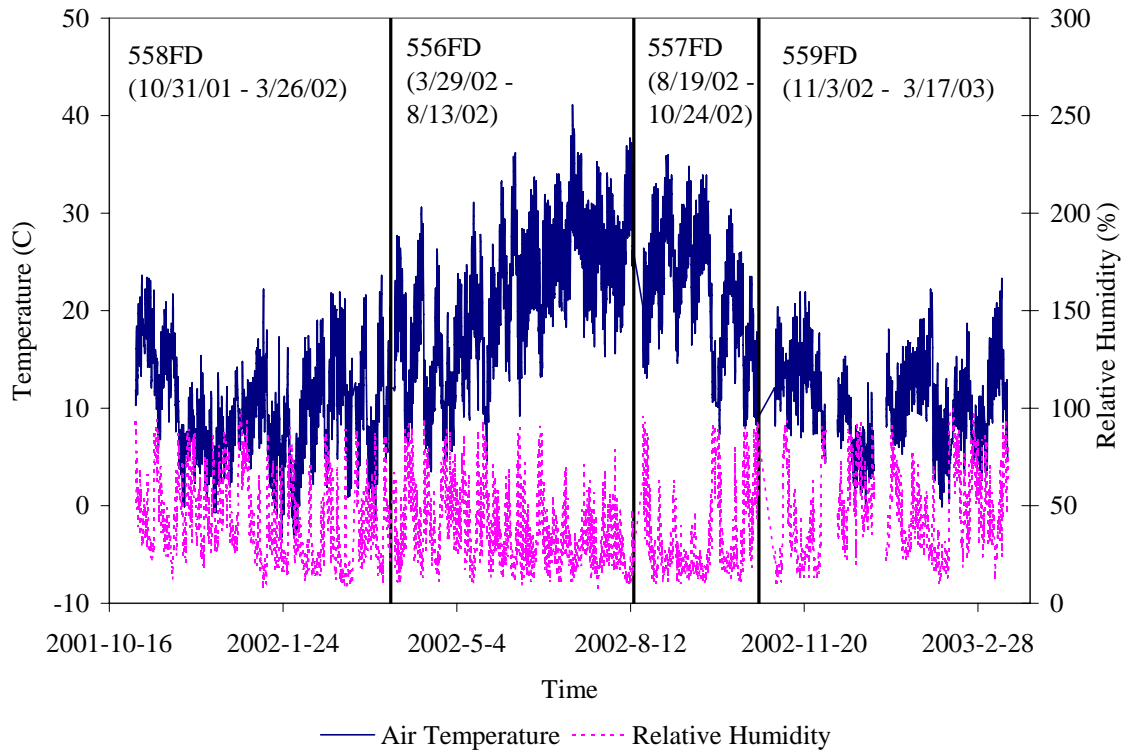
Figure 6.1. Air temperature and relative humidity across all Palmdale DBR HVS tests.

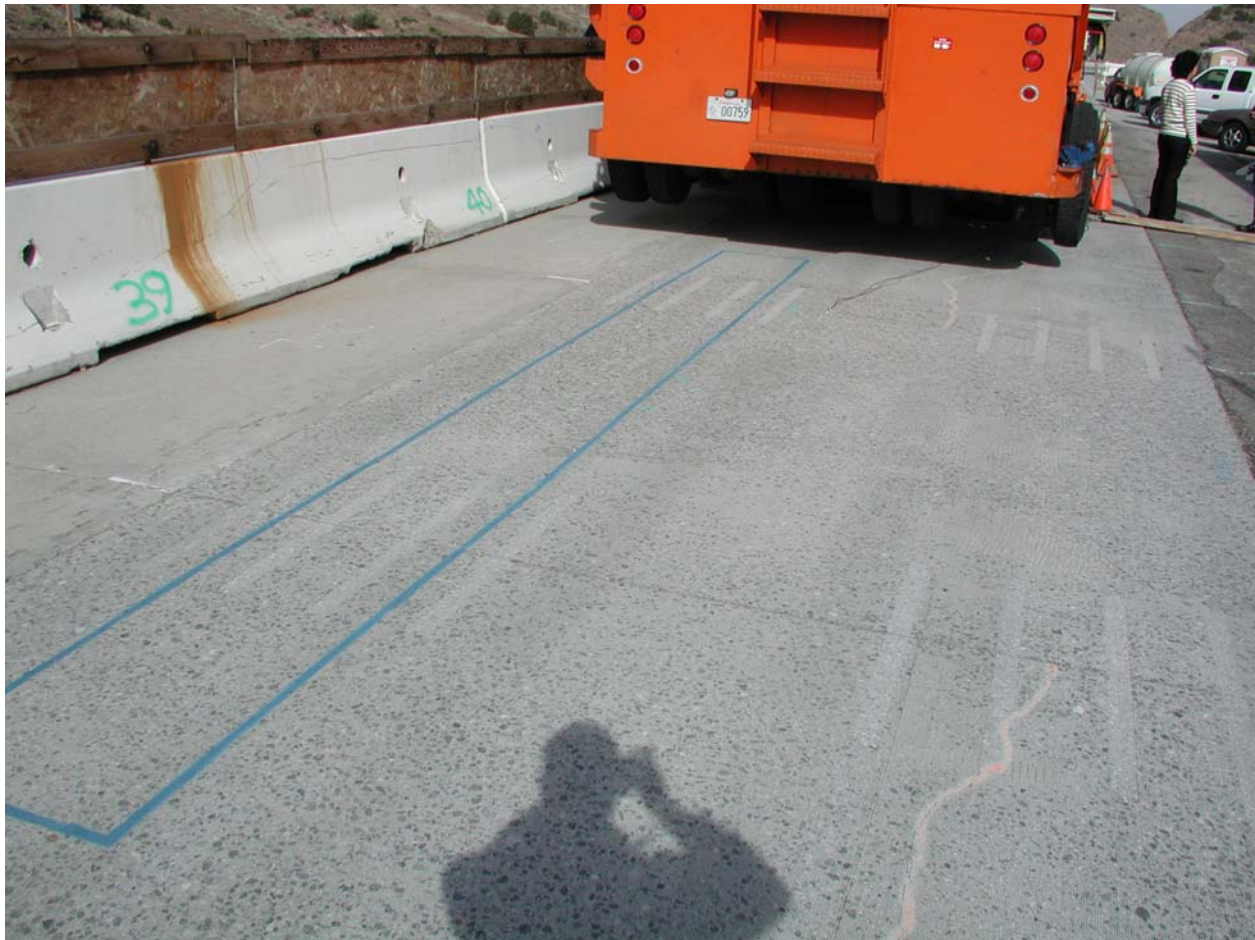
Figure 6.2. HVS Test Section 556FD prior to HVS testing.

The condition of Section 556FD prior to HVS testing in March 2002 is shown in Figure 6.2. Figure 6.3 shows a close-up of Joint 38 and Figure 6.4 shows a close-up of Joint 39.

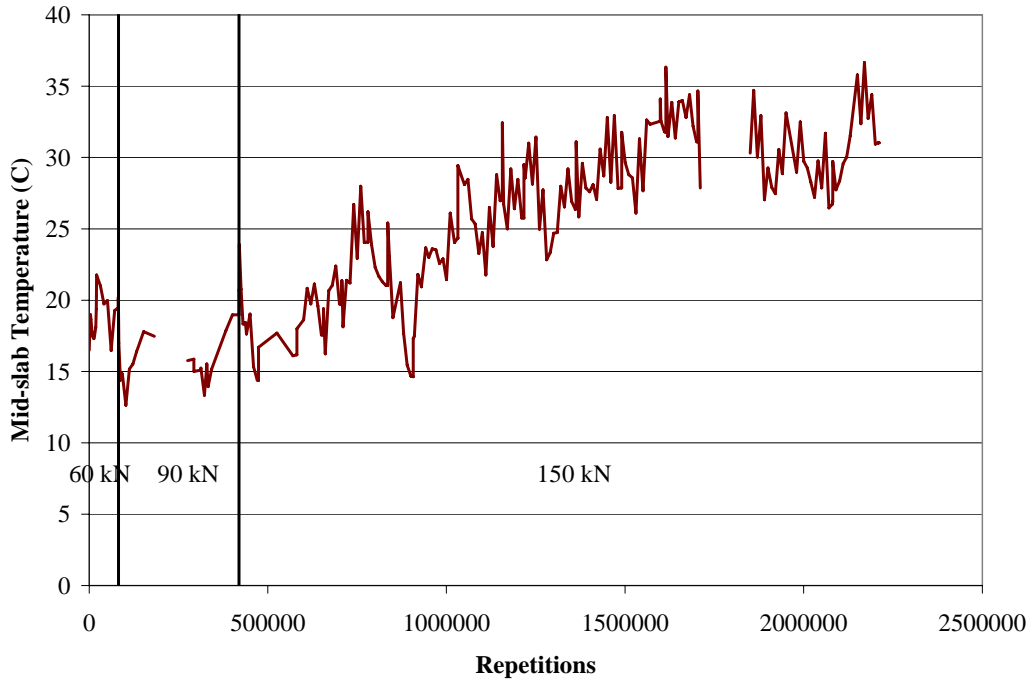
Figure 6.7. Mid-slab temperatures for HVS Test Section 556FD.

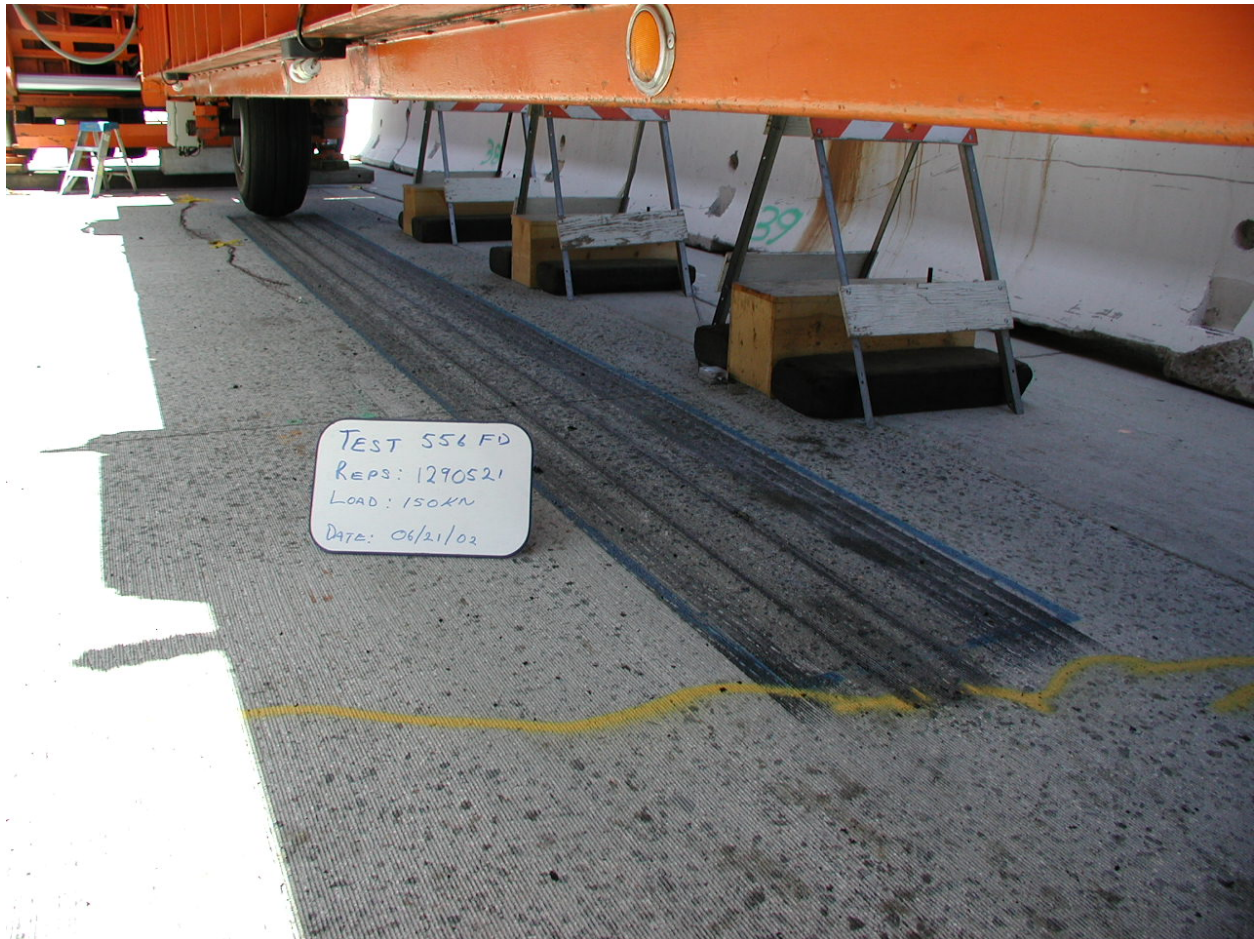
Figure 6.22. Cracking in Slab 40 at end of wheelpath after approximately 1.291 million repetitions.

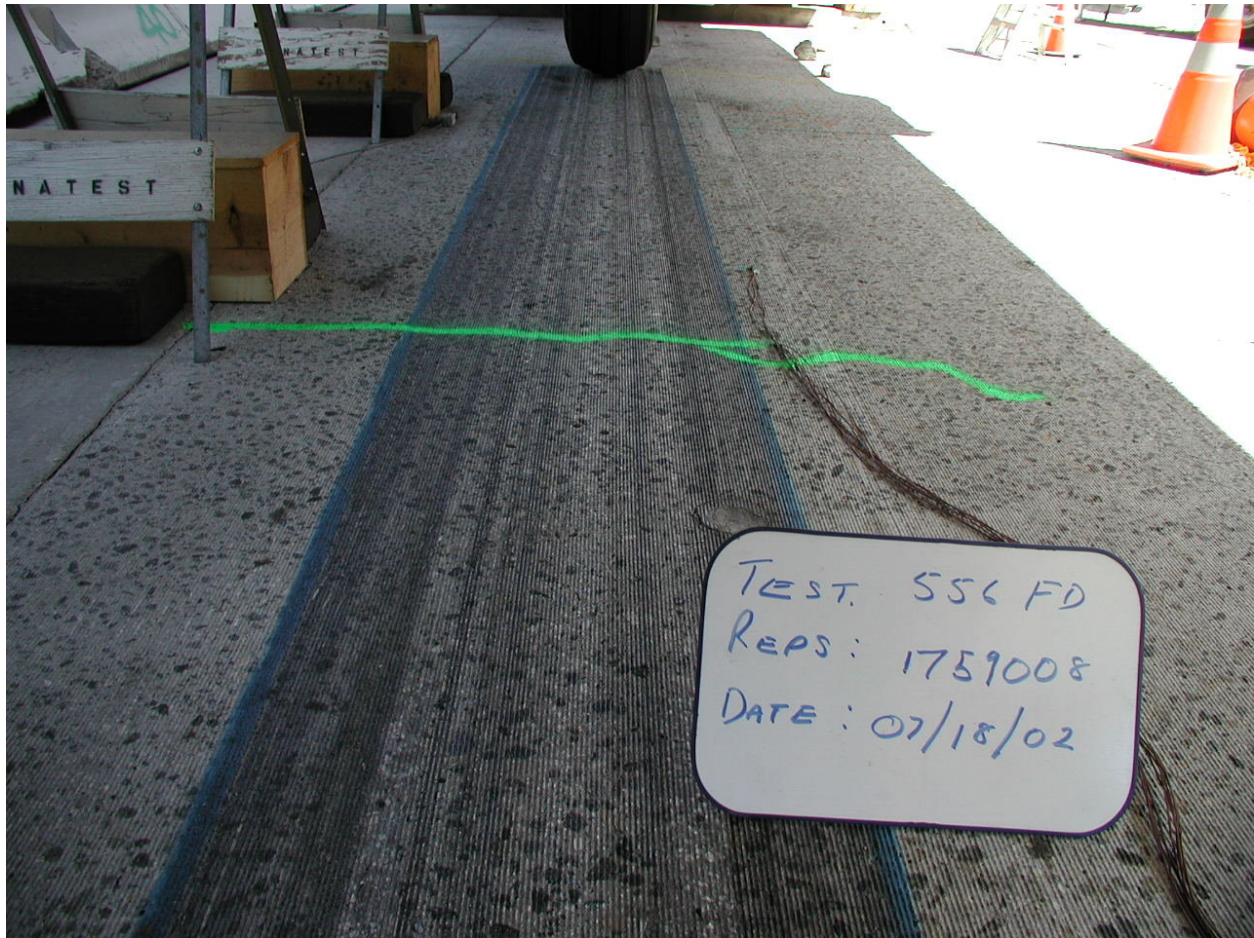
Figure 6.23. Cracking in the center slab (Slab 39) after 1.759 million repetitions.

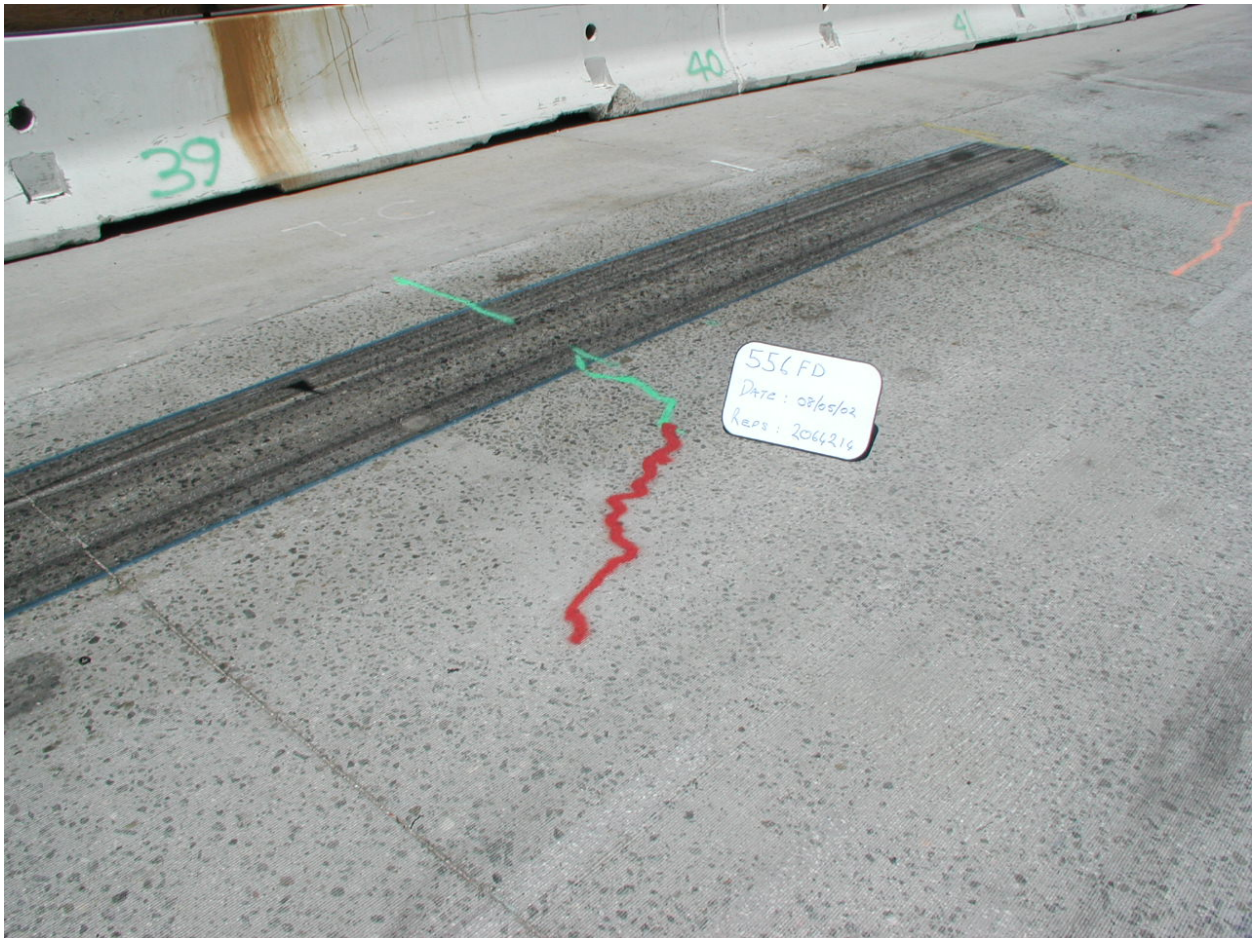
Figure 6.24. Cracking in Slab 39 after 2.066 million repetitions.

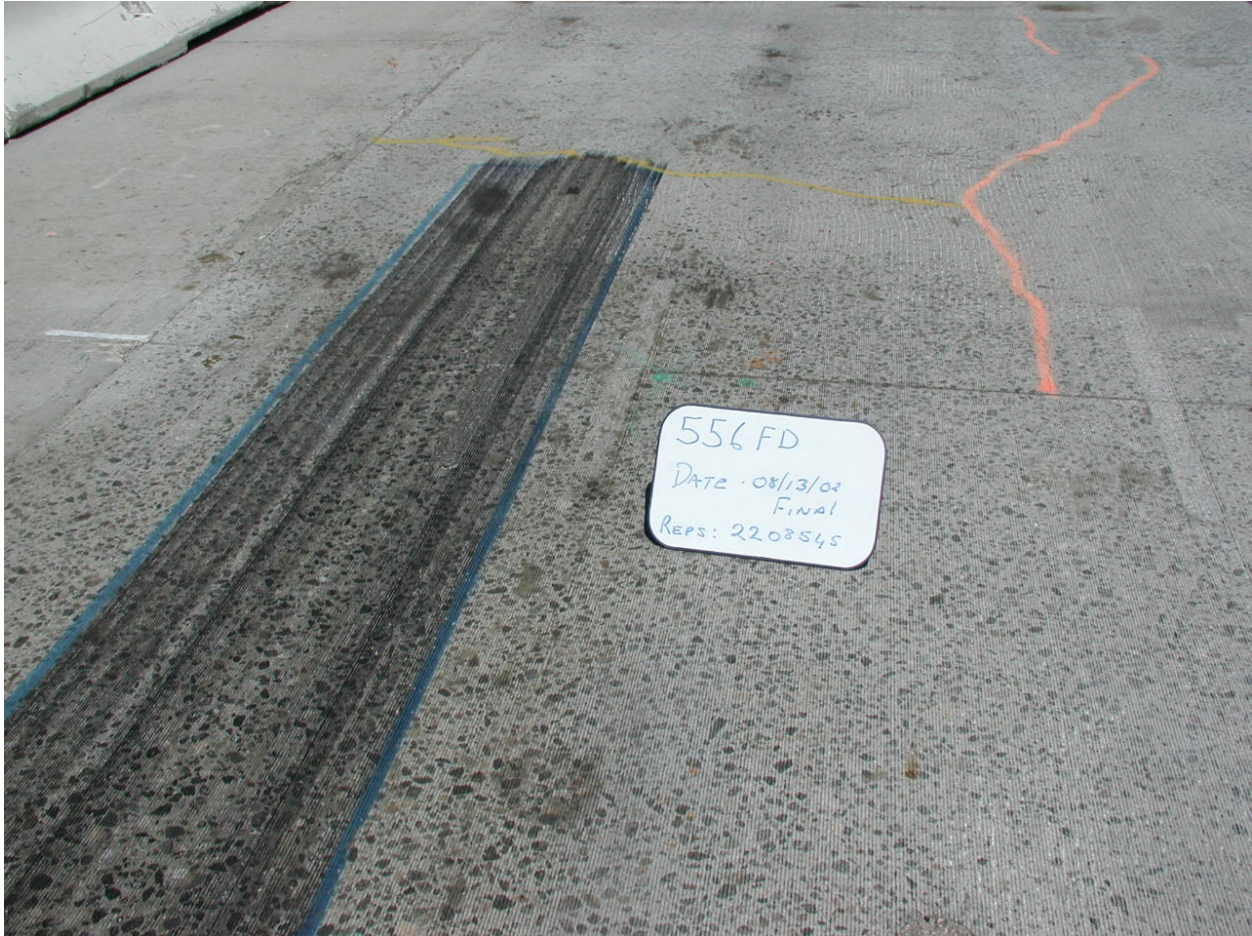
Figure 6.26. Close-up of Joint 39 at end of HVS loading after 2.209 million repetitions.

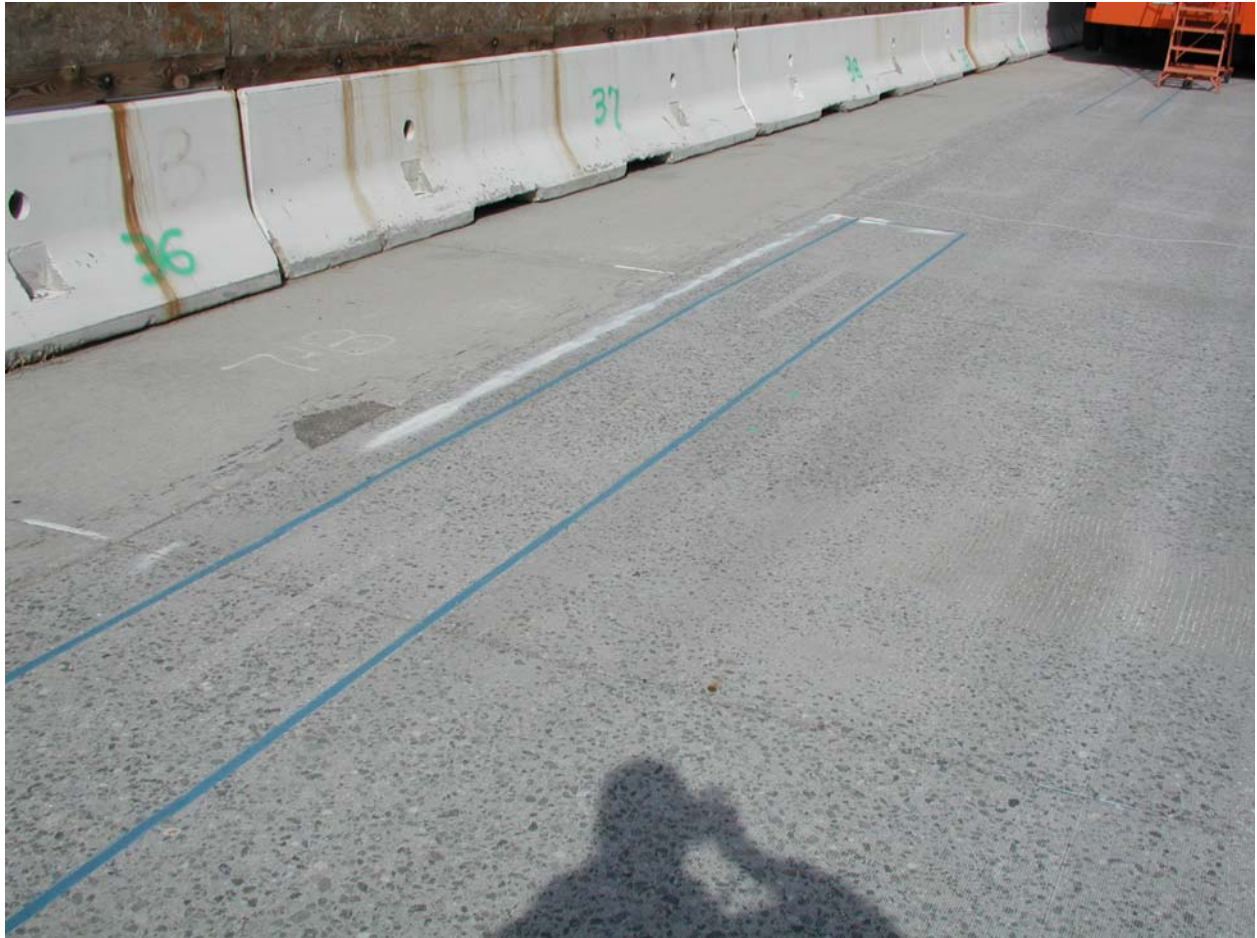
Figure 6.27. HVS Test Section 557FD prior to HVS testing.

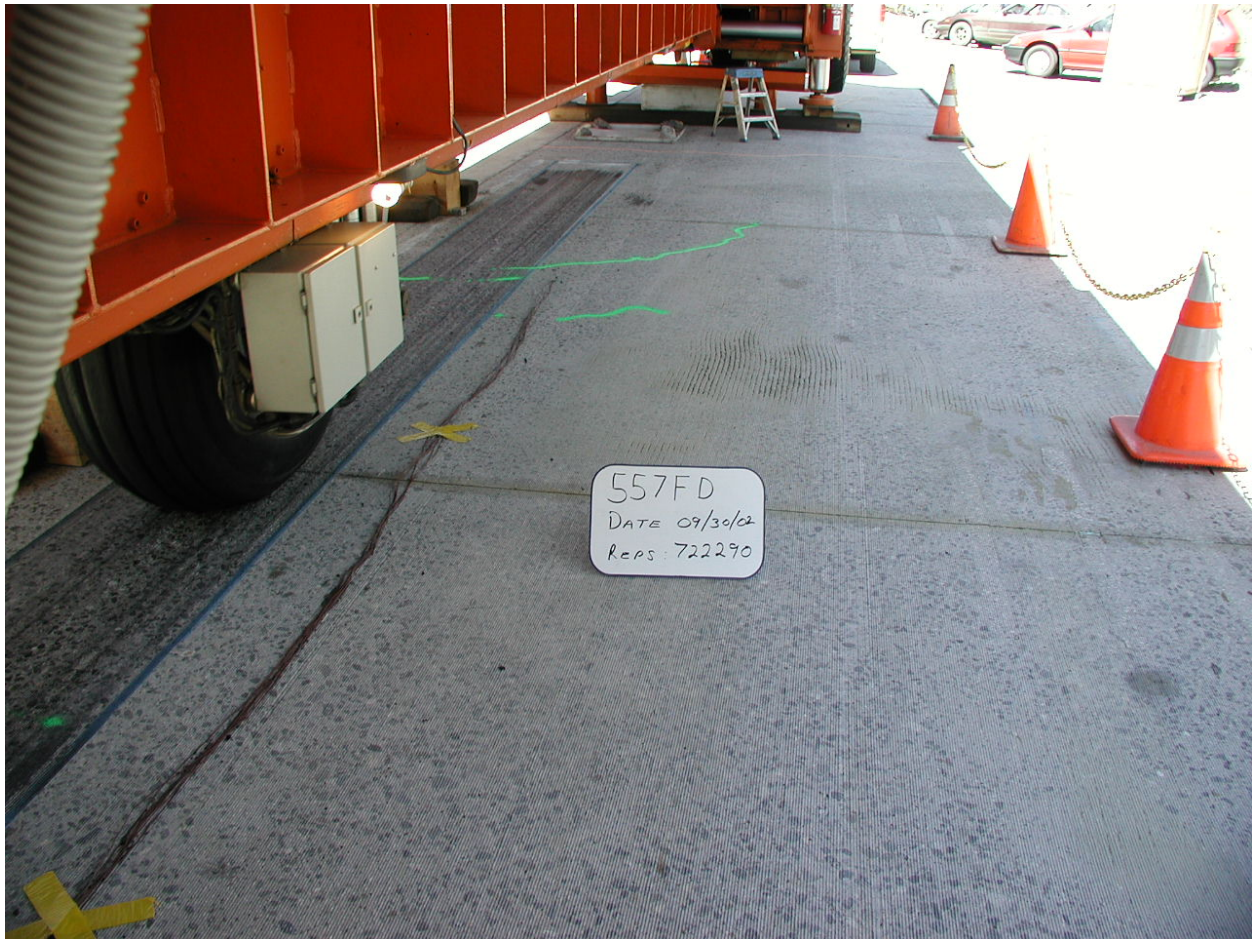
Figure 6.47. Mid-slab transverse cracking in Slab 36 after 722,290 repetitions.

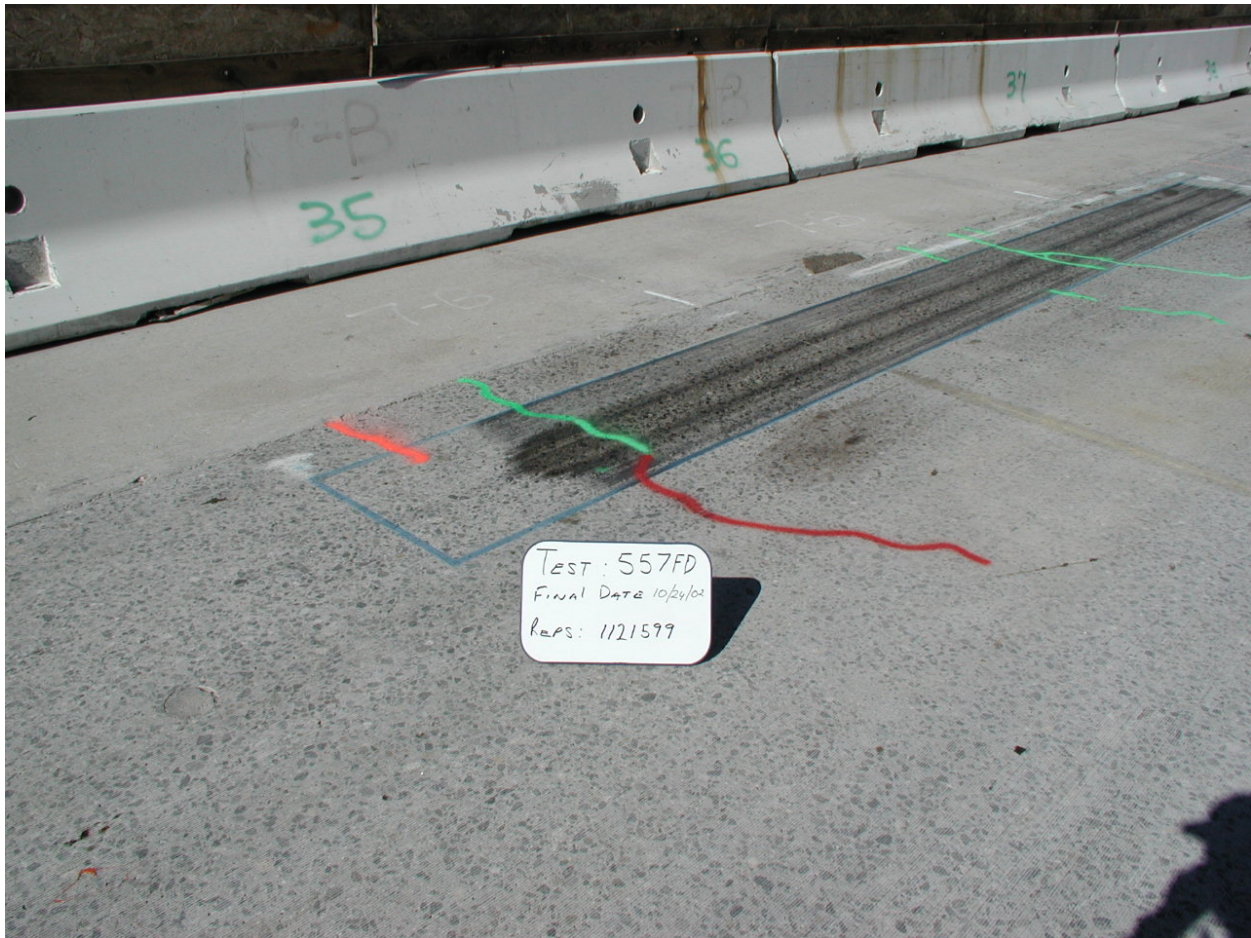
Figure 6.49. Final condition of Section 557FD after 1.122 million repetitions.

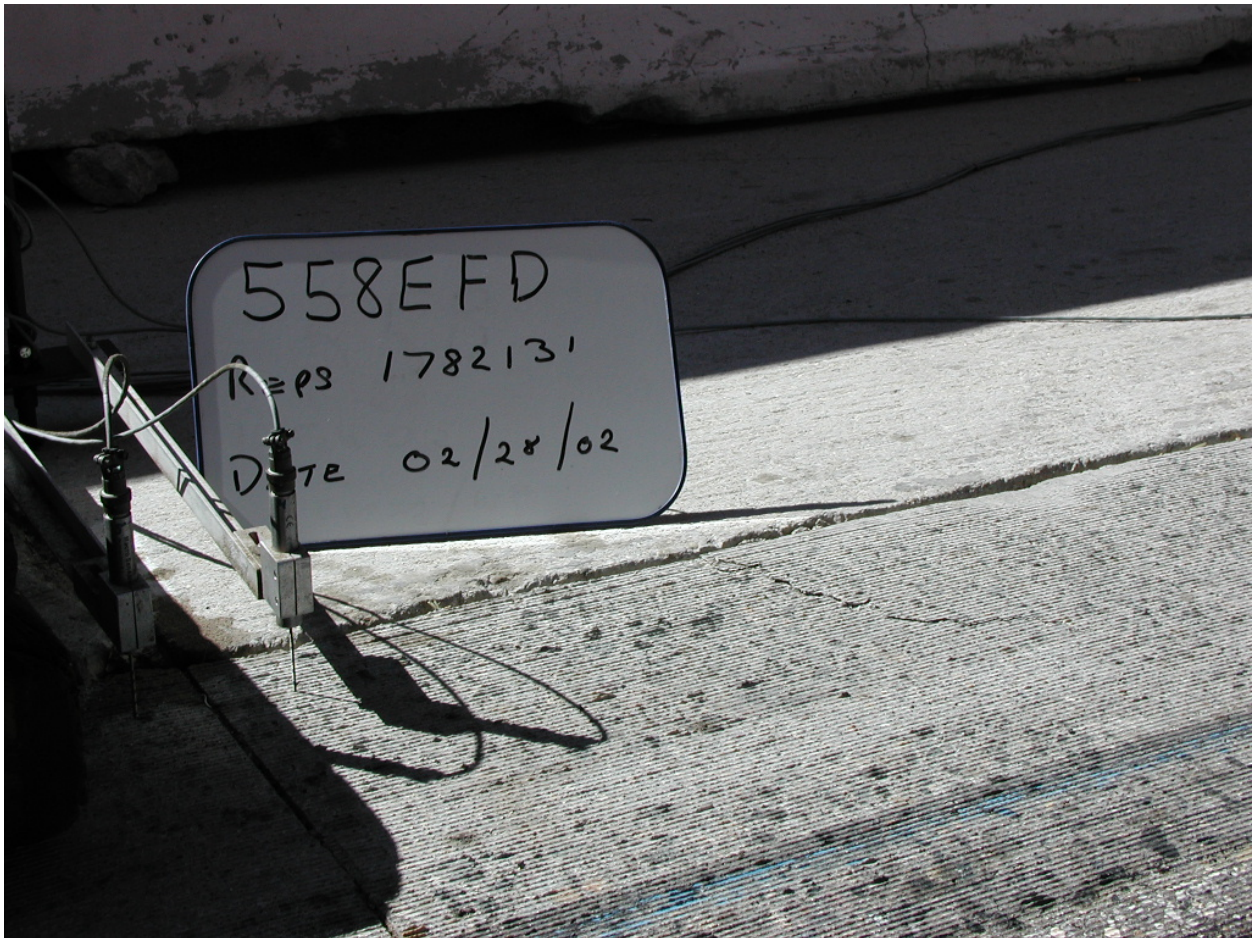
Figure 6.71. First new crack on Section 558FD from slab edge to back of outside dowel bar slot on Joint 41 at 1.782 million load repetitions.

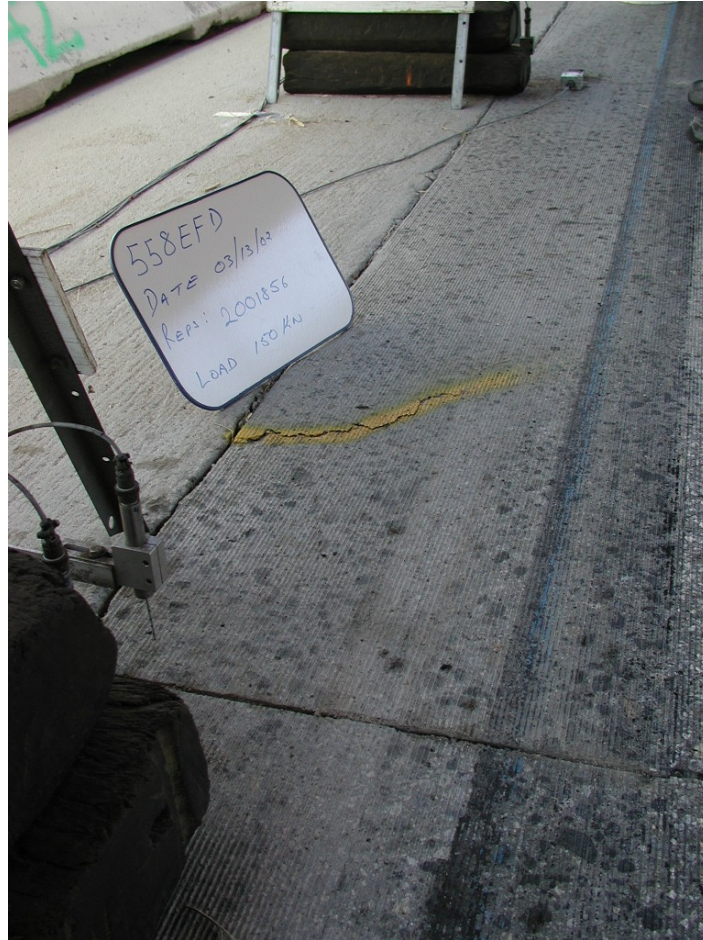
Figure 6.72. Close-up of first new crack after 2.002 million load repetitions.

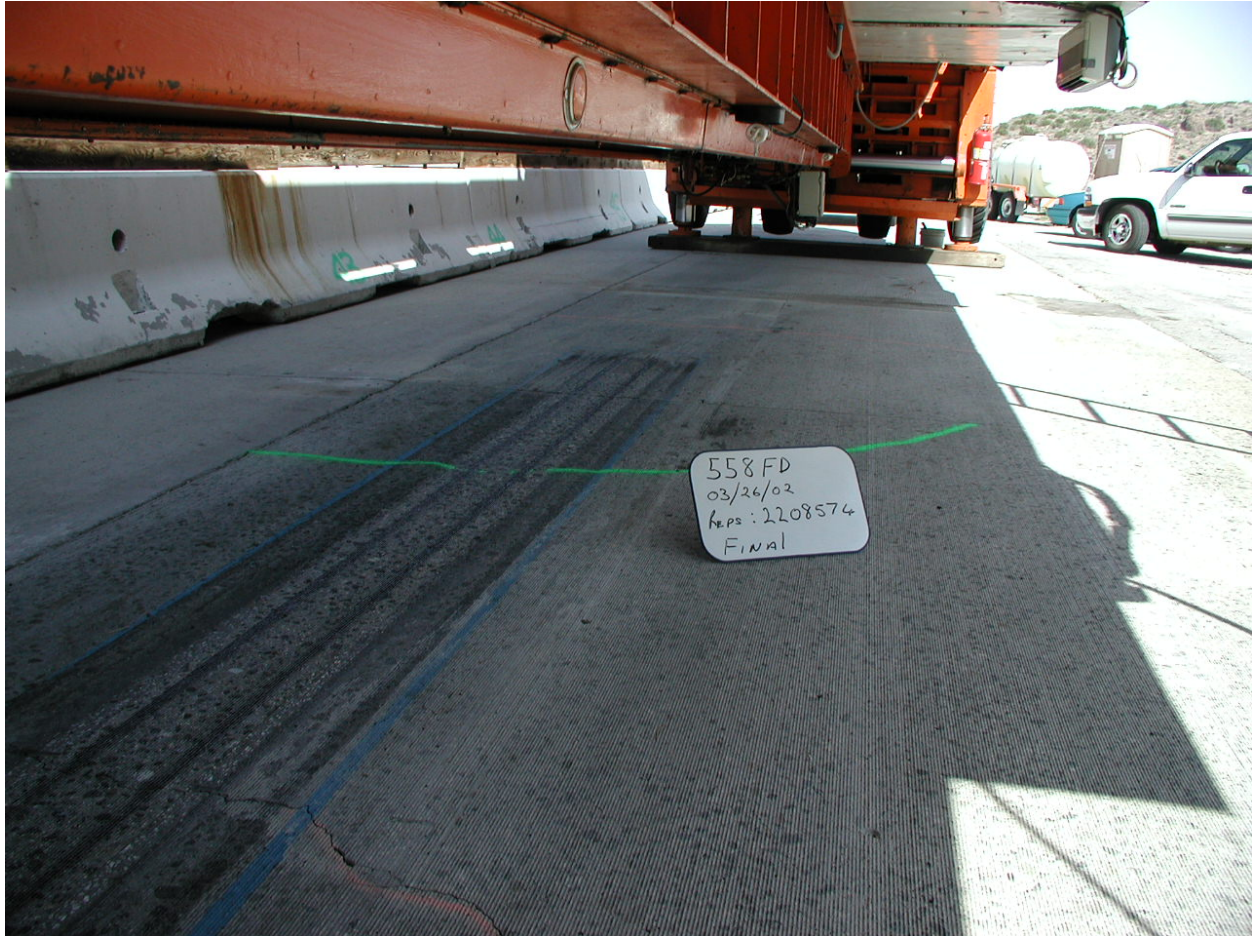
Figure 6.74. Final condition of mid-slab transverse crack and Crack 2 after 2.209 million repetitions.

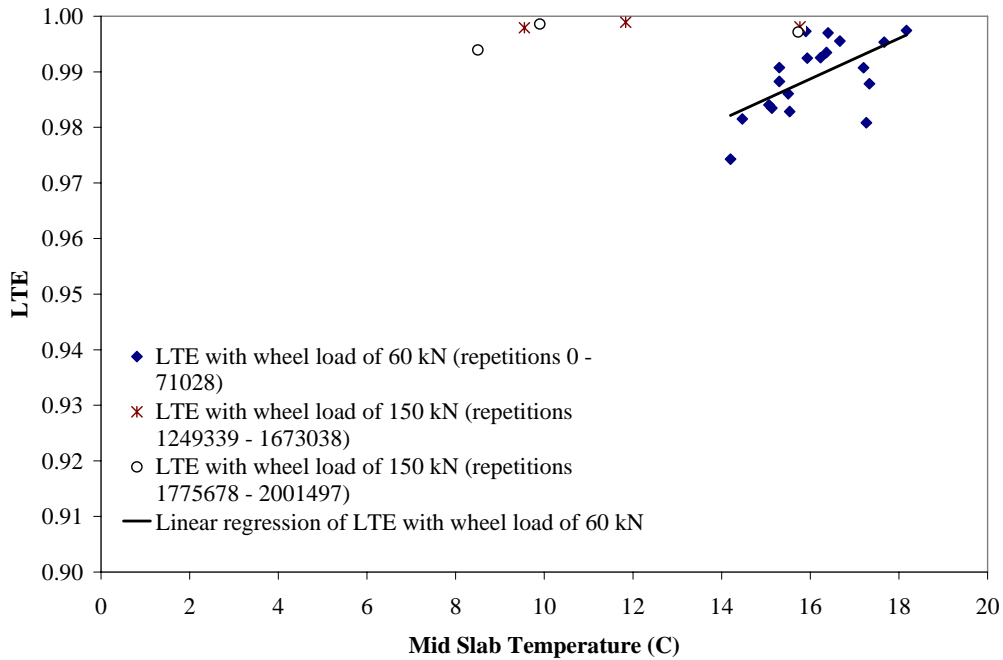
Figure 6.95. JDMD 5 LTE vs. mid-slab temperature on Section 559FD (with measuring load of 60 kN; Joint 32, epoxy-coated steel dowel, 4/wheelpath).

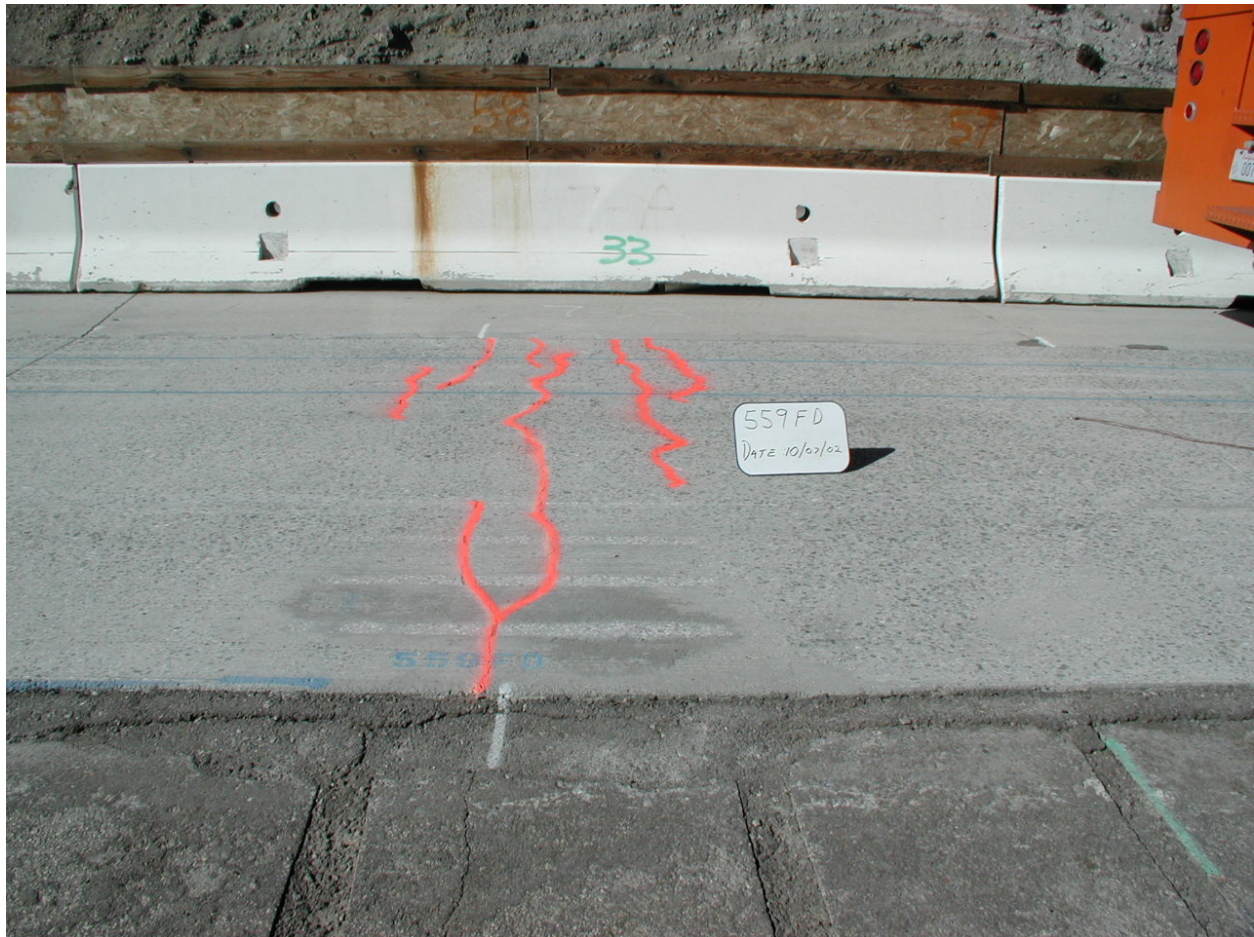
Figure 6.96. Final condition of Slab 33 showing additional cracking around Crack 1 after 2.001 million repetitions.
