Research Report: UCPRC-RR-2006-10

Construction and Preliminary HVS Tests of Pre-Cast Concrete Pavement Slabs

Work Conducted as part of Partnered Pavement Research Center Strategic
Plan Element No. 4.17: HVS testing of pre-cast PCC panels in District 8

University of California
Pavement Research Center
UC Davis and Berkeley

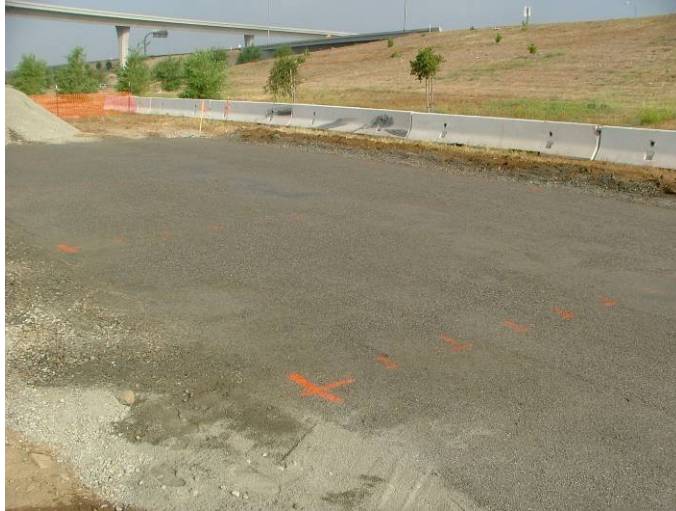
Figure 5. Precise setting out of the corner locations of the pre-cast slabs.

After completion of the construction of the sand bedding layer, the exact corner locations of the slabs are marked on the surface of the sand. The pre-cast slabs are placed strictly according to this predetermined grid and not with a constant gap width. This is done to prevent creep of the slabs which could result in the last of the pre-cast slabs butting up against an existing slab when a section of pavement is replaced. Figure 5 shows the markings for the placement of the pre-cast slabs.

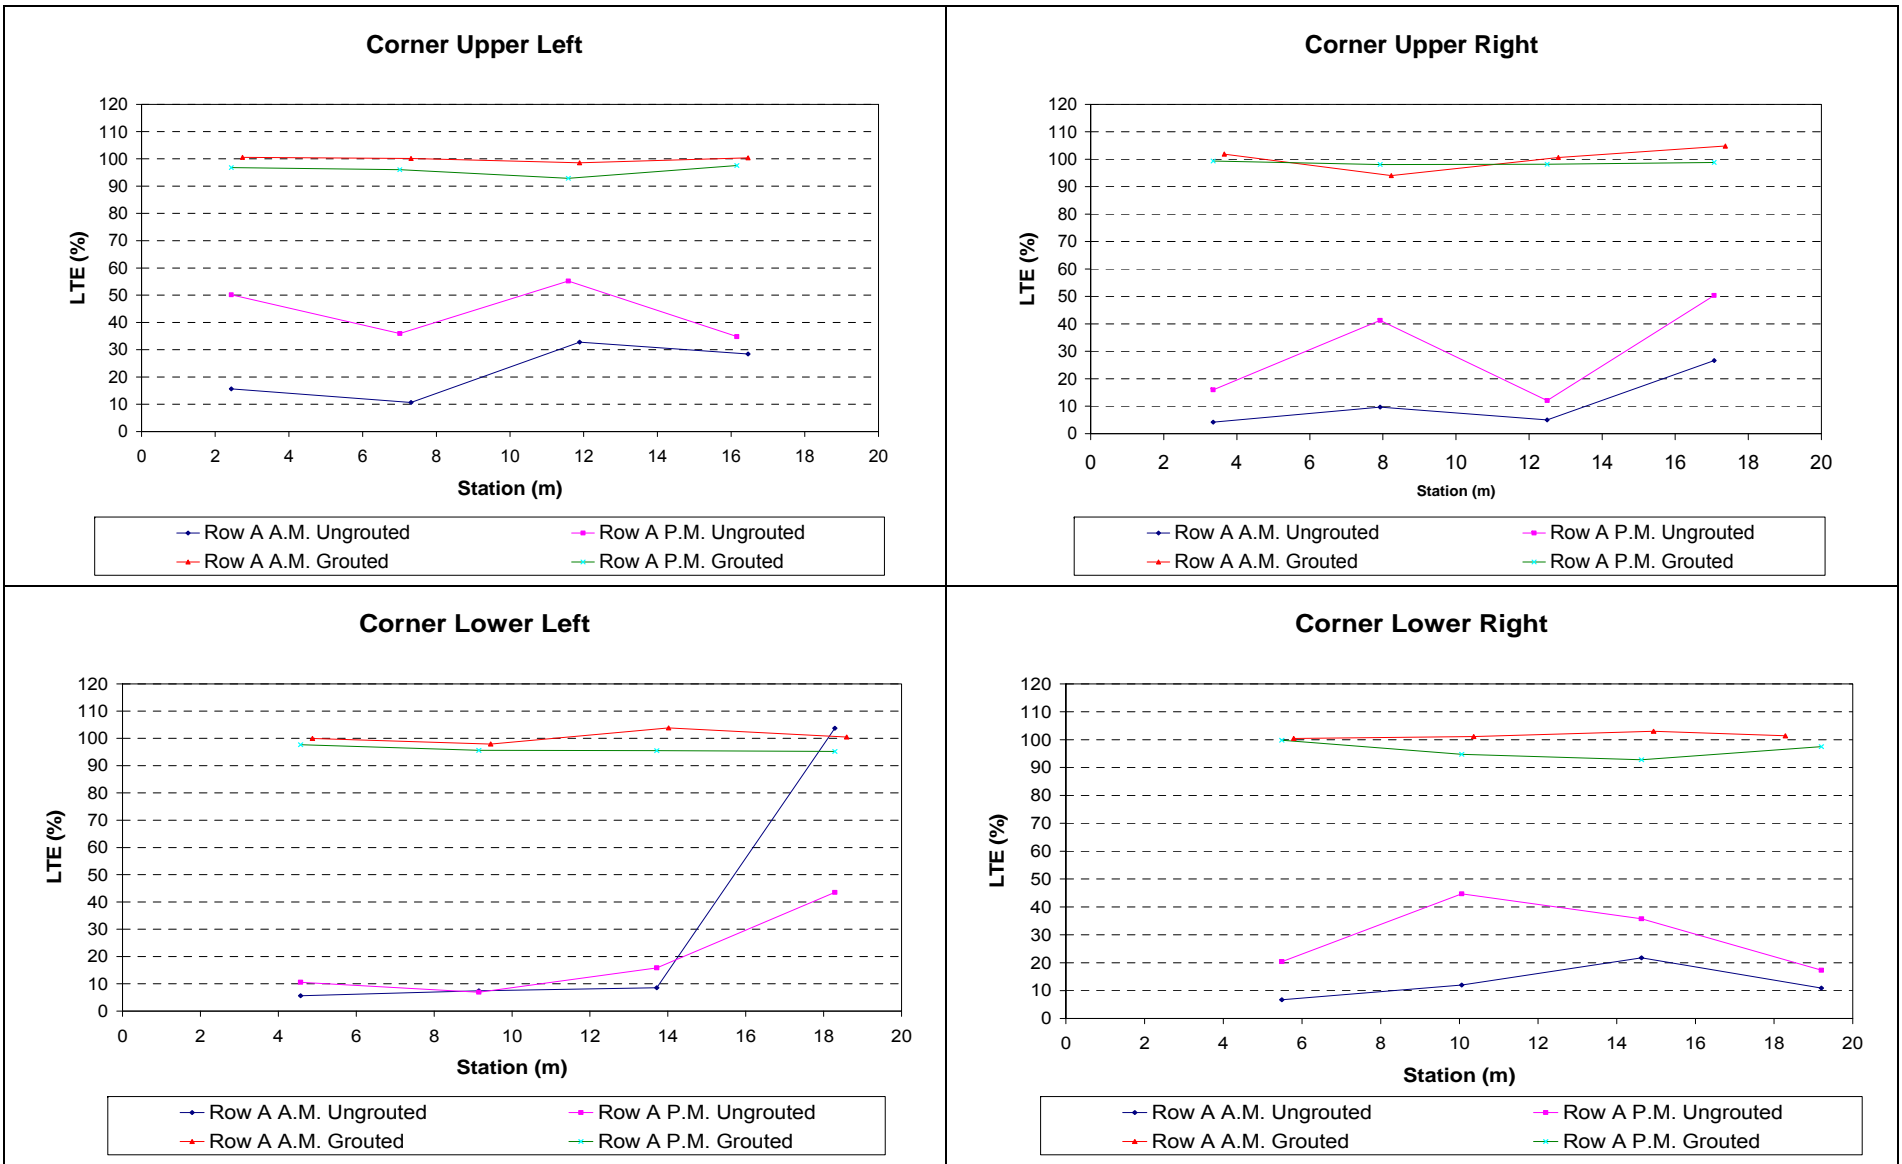
Figure 23. Transverse joint LTE data from the corners of the slabs: Row A.

The LTE values are significantly higher after grouting than before. It is obvious that there is little load transfer prior to the grouting, with LTE values in the range of 5 to 40 percent, and an average of 16 percent. These values are low, but reveal some LTE through the support layer, as the dowels are loose and the faces of the joint are not in contact. Trafficking with the HVS on the ungrouted slabs did not cause a reduction in LTE (which was not high, as explained). Regardless of the level of LTE in the ungrouted condition, the grouting caused load transfer to increase to close to 100 percent. This illustrates that most of the LTE in the completed system was transmitted through the grout and dowels. Table 6 shows the average and the range of the measured LTE. The results

The effect of temperature on LTE is clearly visible. The average surface temperature recorded during FWD data collection during the daytime was 41°C (106°F) and during the nighttime it was 21°C (70°F). During nighttime, the edges tend to curl upward due to slab contraction and a negative temperature differential in the concrete (the surface being colder than the bottom). This curling effect reduces the load transfer by reducing slab contact with the base at the joints and corners, which reduces load transfer through the underlying layers. The opposite happens during daytime when the slabs expand, which causes an increase in load transfer. These temperature effects were less visible after grouting, which illustrates the effectiveness of the steel dowels and the grouting in restricting relative vertical movement across the joints even under the influence of temperature changes.

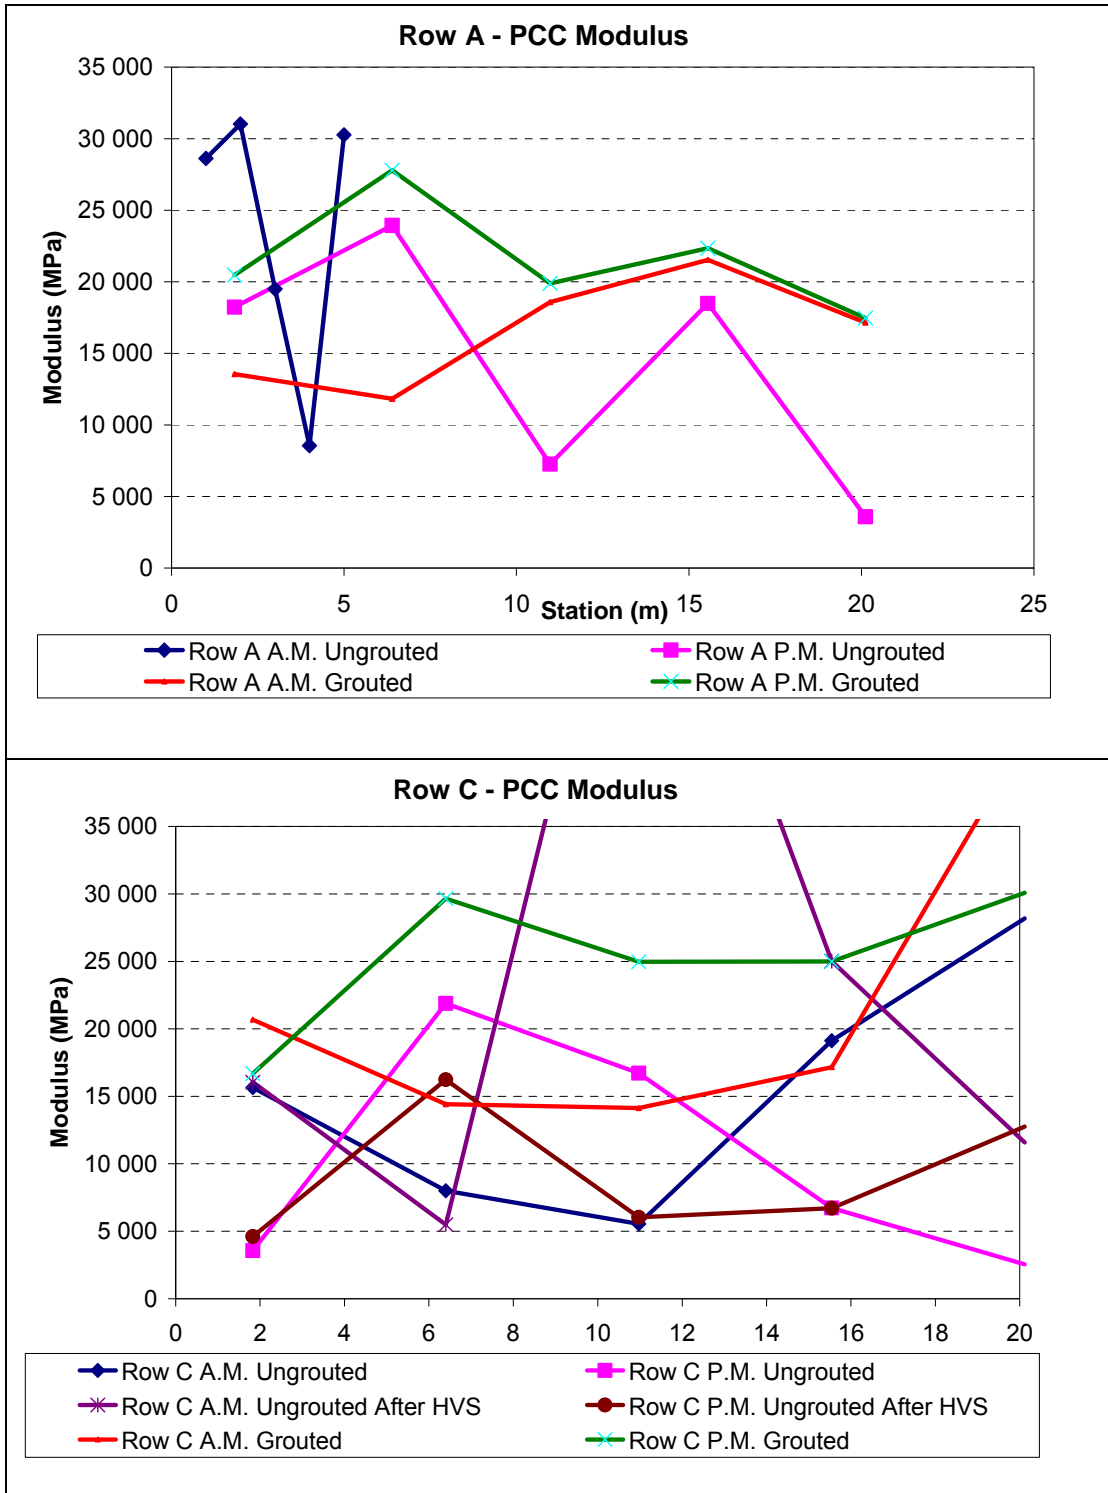
Figure 29. Backcalculated stiffness of concrete layer.

The backcalculation results from deflection taken before grouting should be interpreted with caution. At that stage the slabs were not properly connected and slab rocking could be the cause of the high degree of variation in the data as seen in the graphs. The data after grouting are more consistent and in agreement with what are expected values. As seen in the tables and graphs, there is significant variation within and between the various data sets. As explained before, the effect of the ungrouted (not connected) slabs on the variation in surface deflections is amplified during the backcalculation process. A significant amount of scatter is visible in the graphs. After grouting the trends are more consistent with a lower degree of variation between the various slabs.

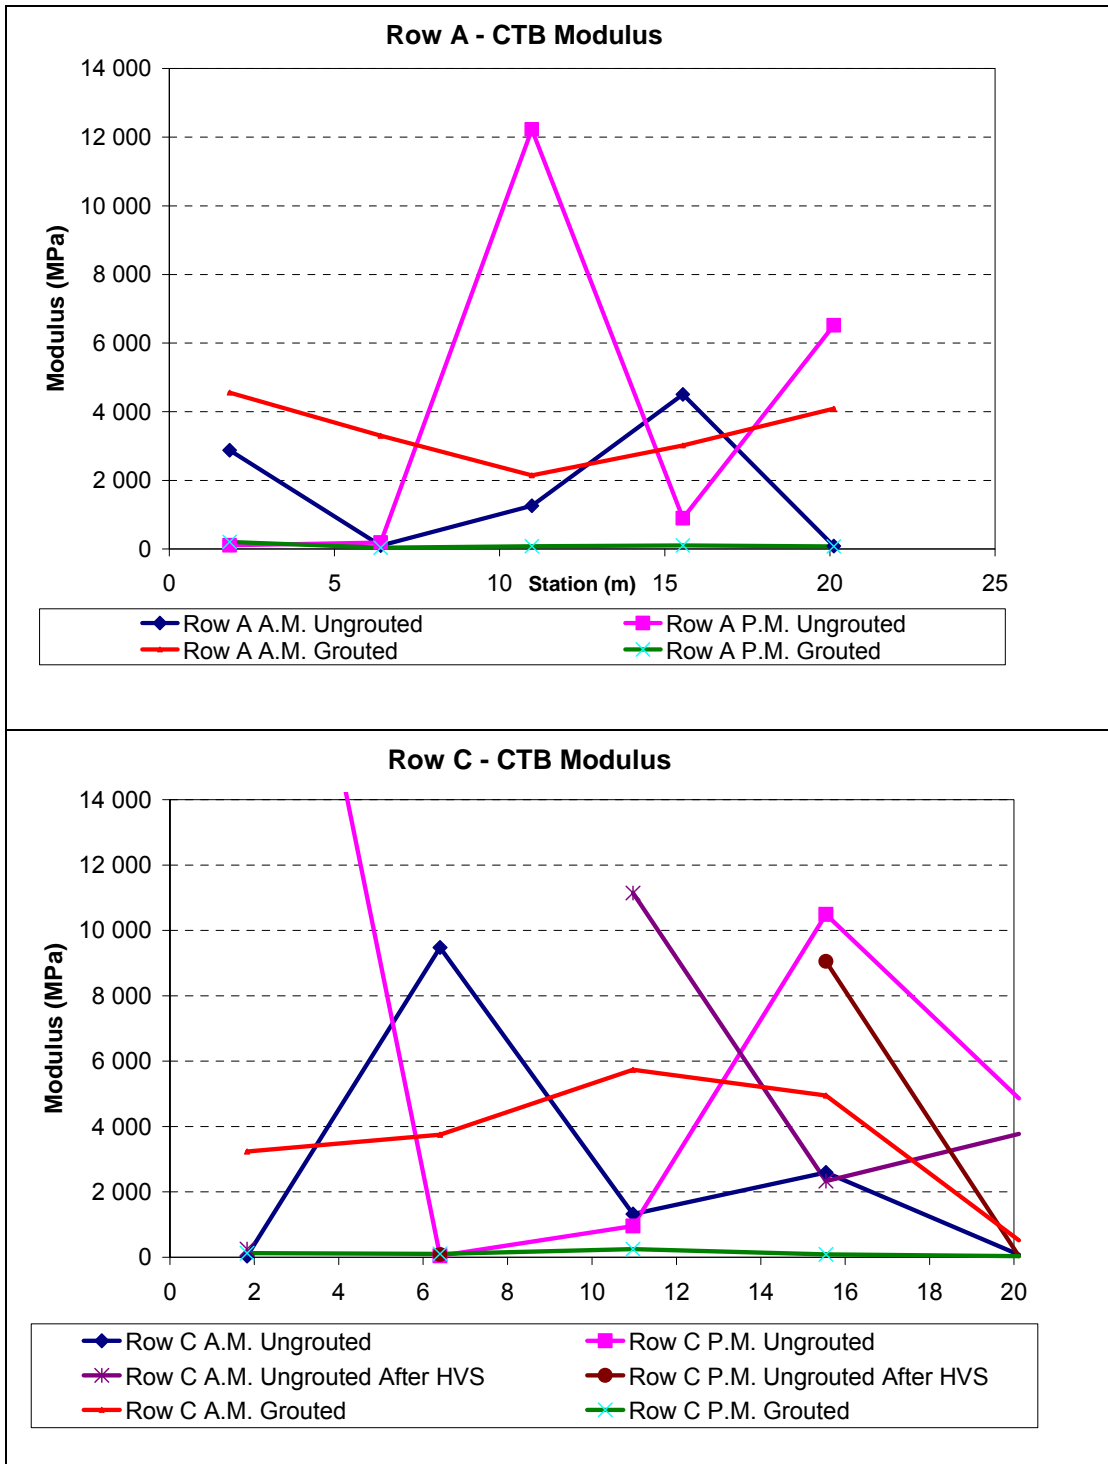
Figure 30. Backcalculated stiffness of CTB layer.

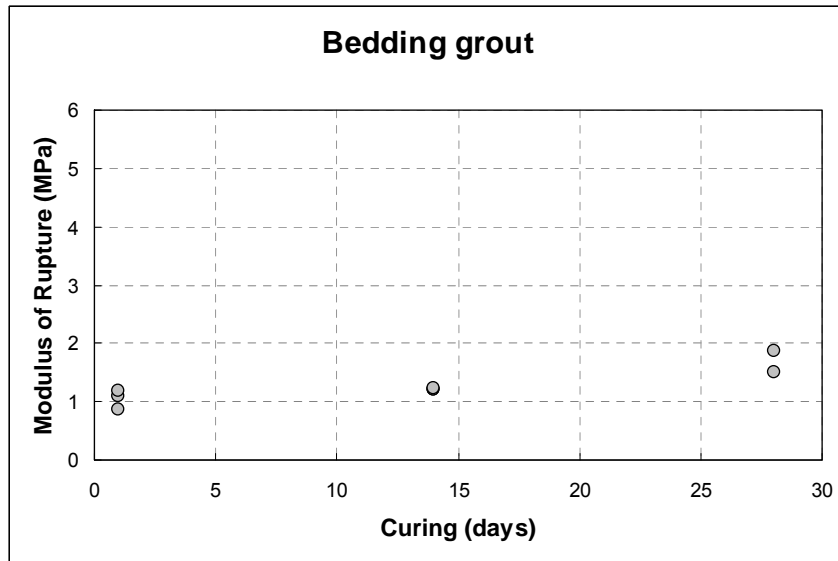
Figure 33. Bedding grout modulus of rupture plotted against curing time.

Beams of 150 by 150 by 450 mm (6 by 6 by 18 in.) were cast from the dowel and bedding grouts at the time of grouting. These beams were tested after one, fourteen, and twenty-eight days curing to determine the modulus of rupture. Table 10 summarizes the modulus of rupture results which are plotted in Figure 32 for the dowel grout and in Figure 33 for

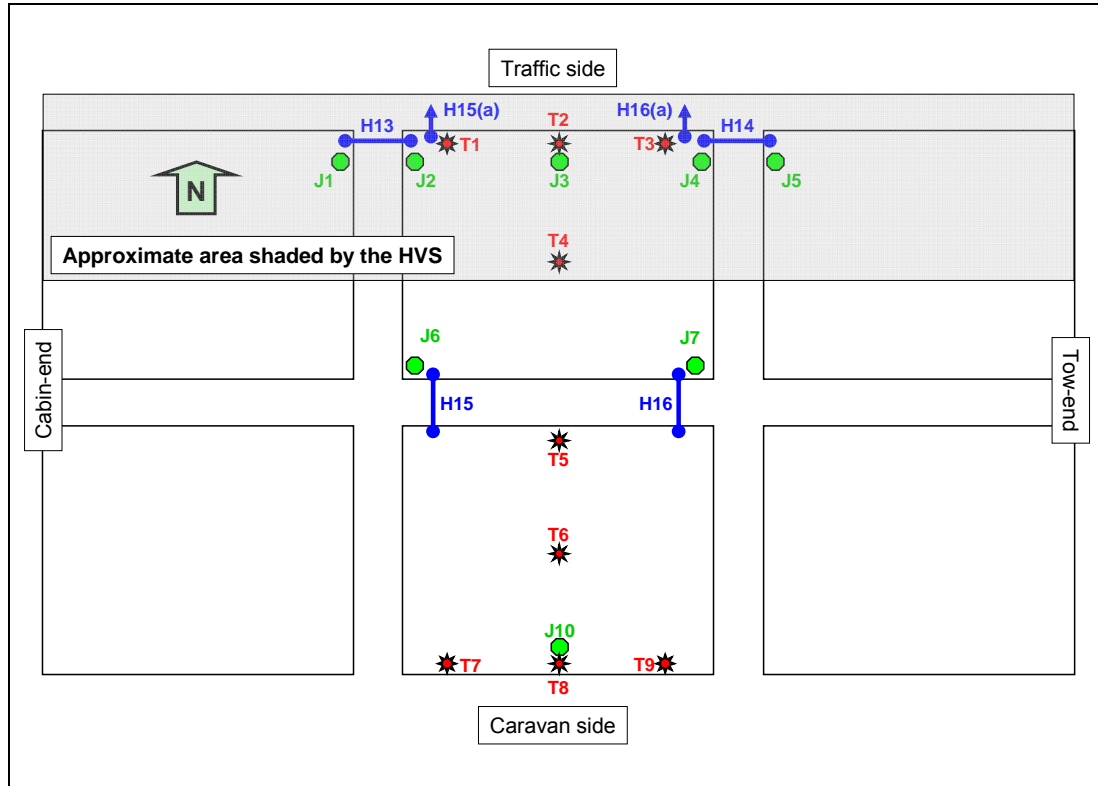
Figure 49. Thermocouples and JDMDs monitored during the first ungrouted test, 597FDUG.

Figure 49 shows the instrumentation layout for the first ungrouted test, 597FDUG which started at 06h06 on May29, 2005, and ended at 17h27 on May 30, 2005, at 16,002 repetitions of a 60-kN load applied in unidirectional mode from the cabin to the tow-end of the HVS (from west to east or from left to right in terms of the layout shown in Figure 49).

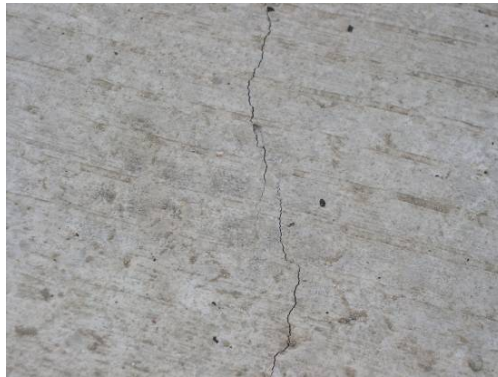
Figure 104. Part of a nontraffic-related transverse crack noticed on both sections after completion of the ungrouted tests.
