Reflective Cracking Study: Initial Construction, Phase 1 HVS Testing, and Overlay Construction

Partnered Pavement Research Program (PPRC) Contract Strategic Plan Element 4.10:
Development of Improved Rehabilitation Designs for Reflective Cracking

California Department of Transportation
Division of Research and Innovation
Office of Roadway Research

University of California
Pavement Research Center
UC Davis, UC Berkeley

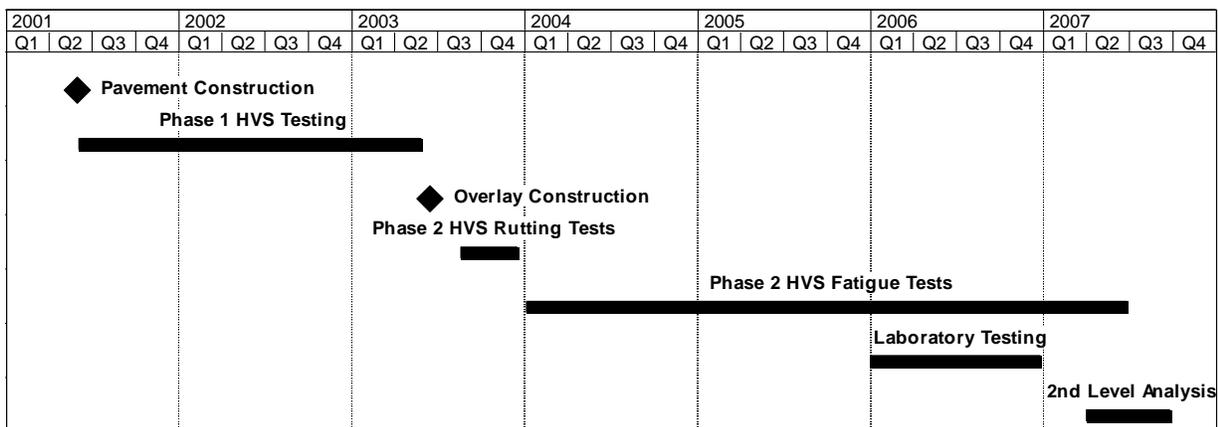
Figure 1.1: Timeline for the Reflective Cracking Study.

An overview of the project timeline is shown in Figure 1.1.

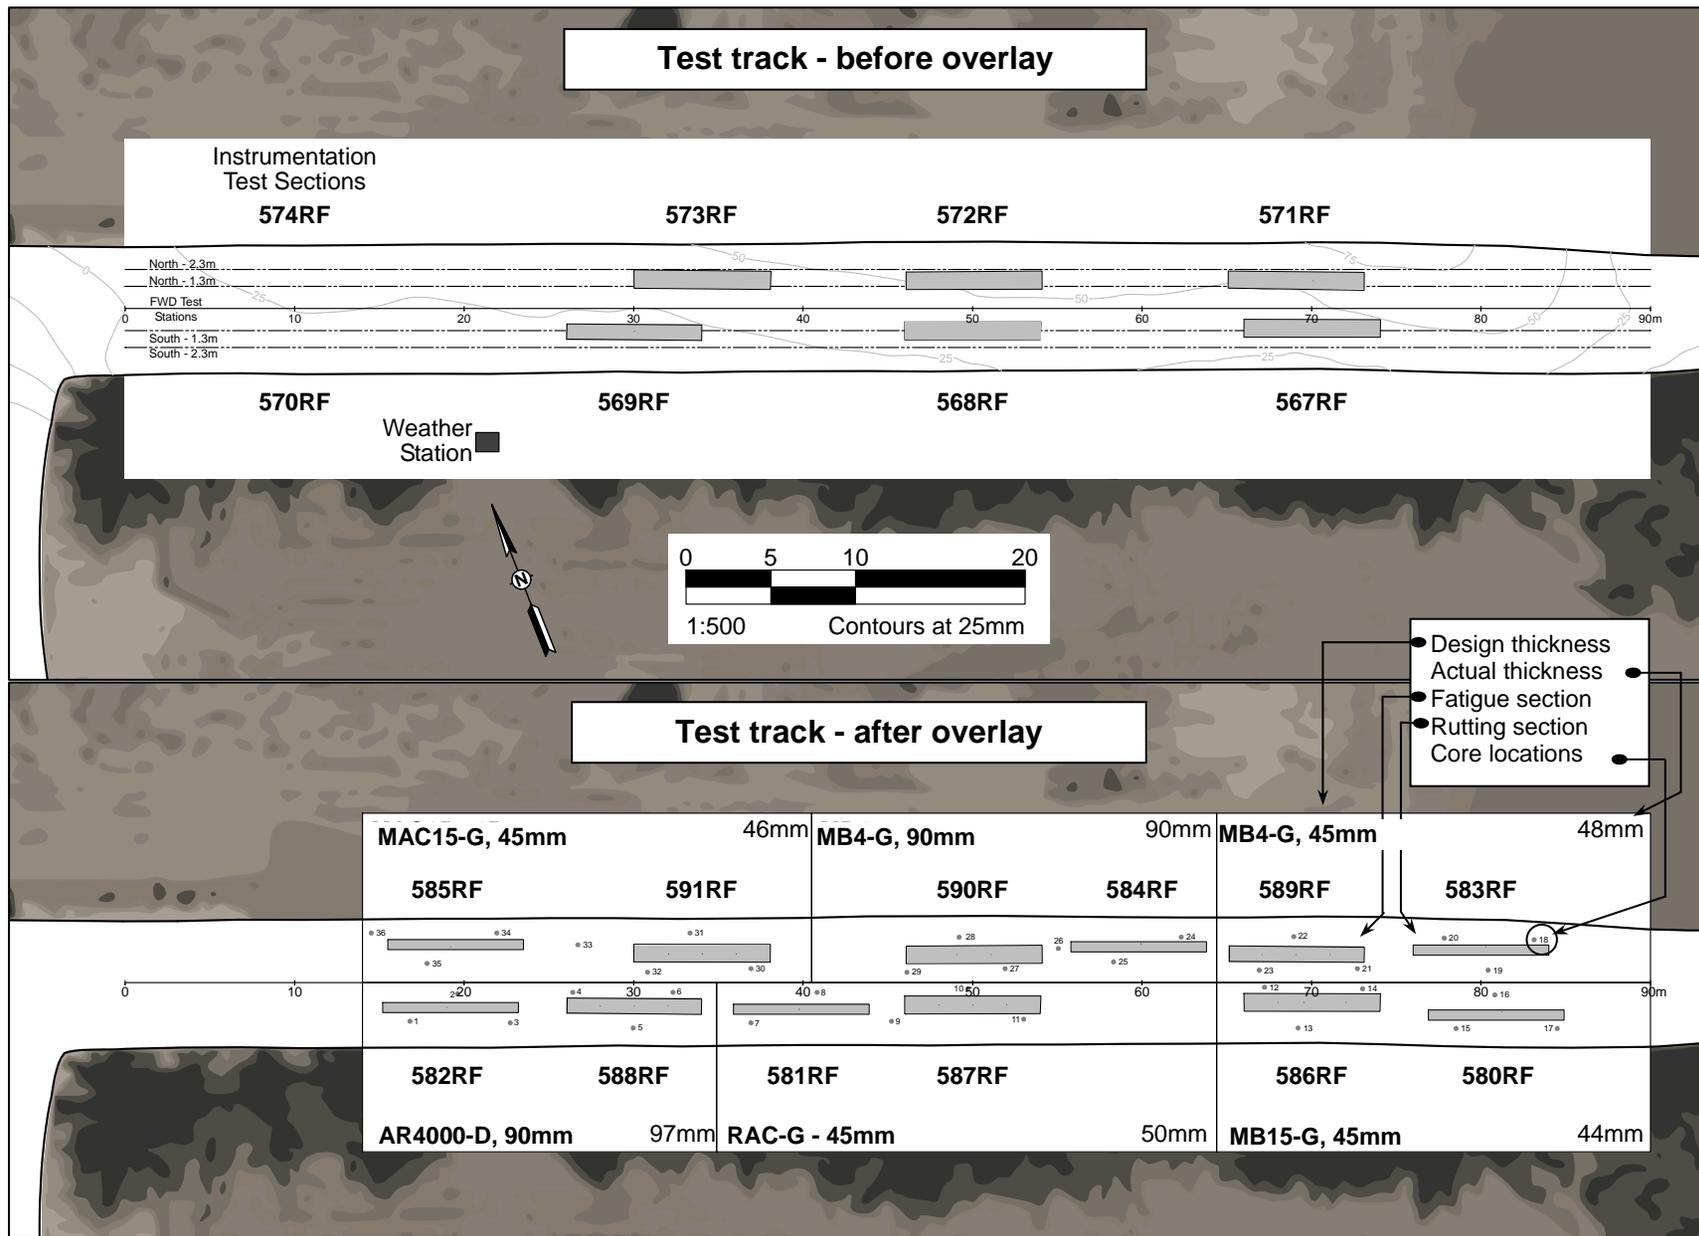
Figure 2.3: Layout of Reflective Cracking Study project.

The site for the project is located at the Pavement Research Center at the University of California Richmond Field Station (RFS). The site is located on Lark Drive between Avocet Way and Building 280. Figures 2.1 and 2.2 show the location of the project and Figure 2.3 shows the layout of the HVS test sections at the test site.

Two days after completion of the test pavement, failure was observed near the end of the pavement near the instrumented test section (Section 574RF). This area was not part of the overlay experiment (see Figure 2.3). The probable reason for this failure was high moisture content in the aggregate base.

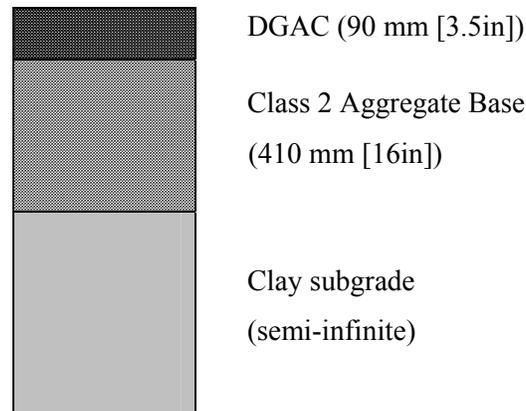
Figure 2.4: Test track pavement design

The pavement for the first phase of HVS trafficking was designed according to the Caltrans Highway Design Manual Chapter 600 using the computer program NEWCON90. Design thickness was based on a tested subgrade R-value of 5 and a Traffic Index of 7 (~121,000 ESALs) (3). The pavement design for the test road is illustrated in Figure 2.4.

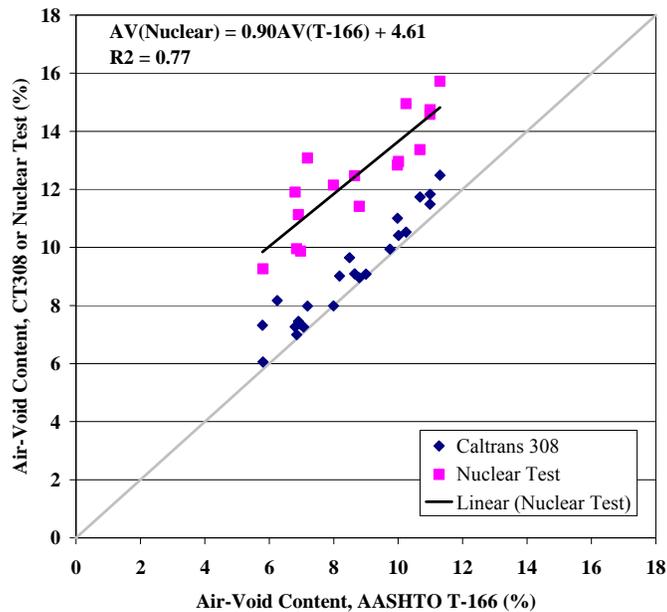
Figure 3.1: Relationship between air-void content measurements.

Nuclear density measurements and extracted cores were obtained to determine the air-void content distribution in the asphalt content layer after construction. The data were also used to establish a relationship between the nuclear test and laboratory test air-void contents. Laboratory air-void contents were determined on extracted cores according to Caltrans CT308 and AASHTO T-166 test procedures at locations where nuclear readings were obtained. Acceptance was based on AASHTO T-166 test results. Figure 3.1 shows the relation between Caltrans CT308, the nuclear device air void data, and AASHTO T-166 air void data. As shown in the figure, the average measured air-void content difference between AASHTO T-166 and the nuclear device was 4.6 percent.

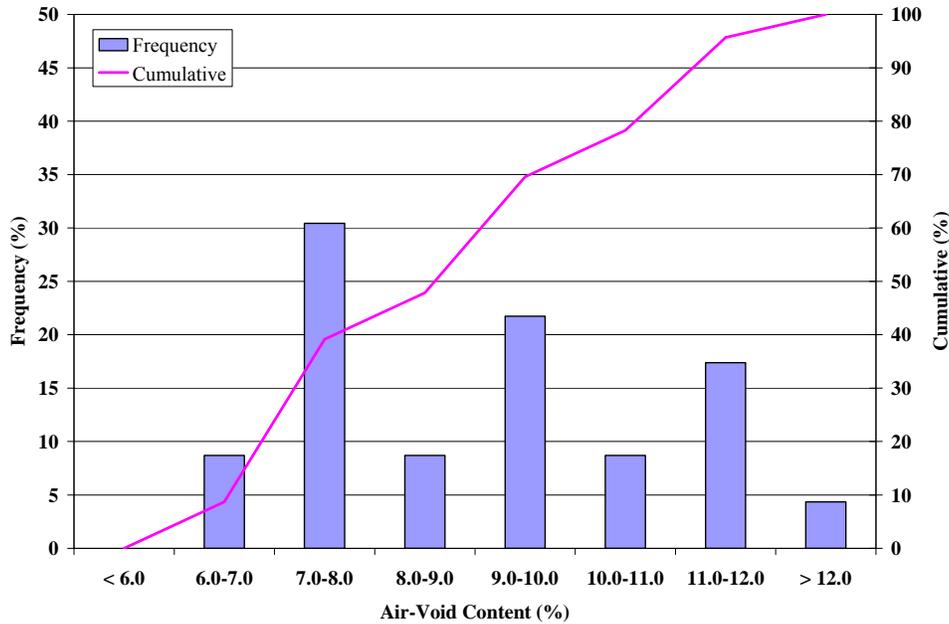
Figure 3.2: Air-void content relative frequency and cumulative histogram.

caused by the asphalt mix in the hopper of the paver cooling while waiting for the next truck to deliver mix to the site. Because the cooled mix in the paver was not completely remixed with the new hot mix, proper compaction of the cooled mix was not possible. As a result, some areas had higher air voids. These segregated areas were excluded from consideration when selecting the sub-sections for accelerated pavement testing.

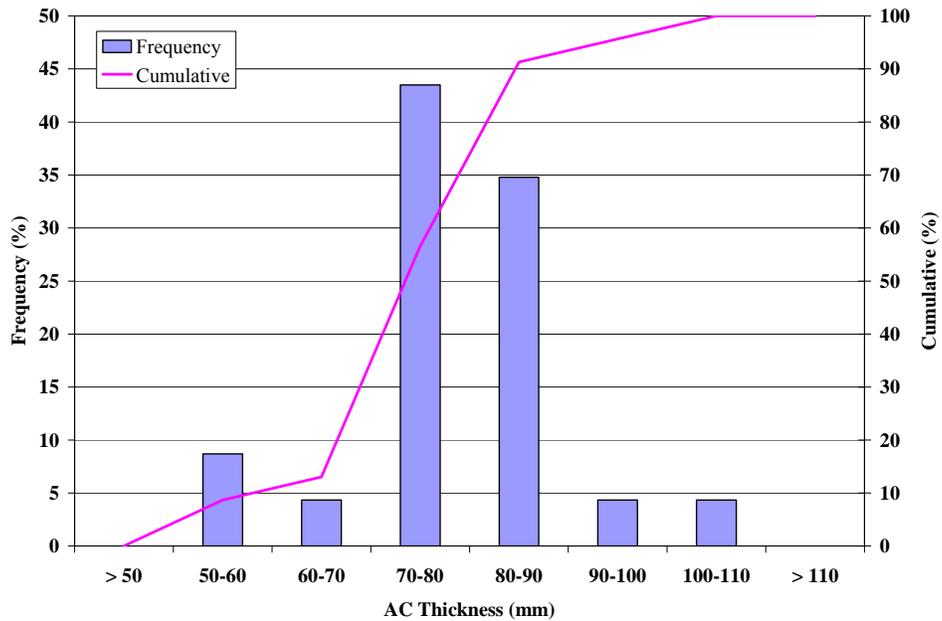
Figure 3.4: Relative frequency and cumulative histogram for asphalt concrete thickness.

Extracted cores were also used to determine the distribution of asphalt concrete thickness along the test section. Figure 3.4 shows the relative frequency and cumulative histogram for the asphalt concrete thickness. The data show that about 76 percent of the asphalt concrete cores were between 70 and 90 mm thick. The average thickness along the pavement section was 79.0 mm with a standard deviation of 9.9 mm. The design thickness for this project was 90 mm.

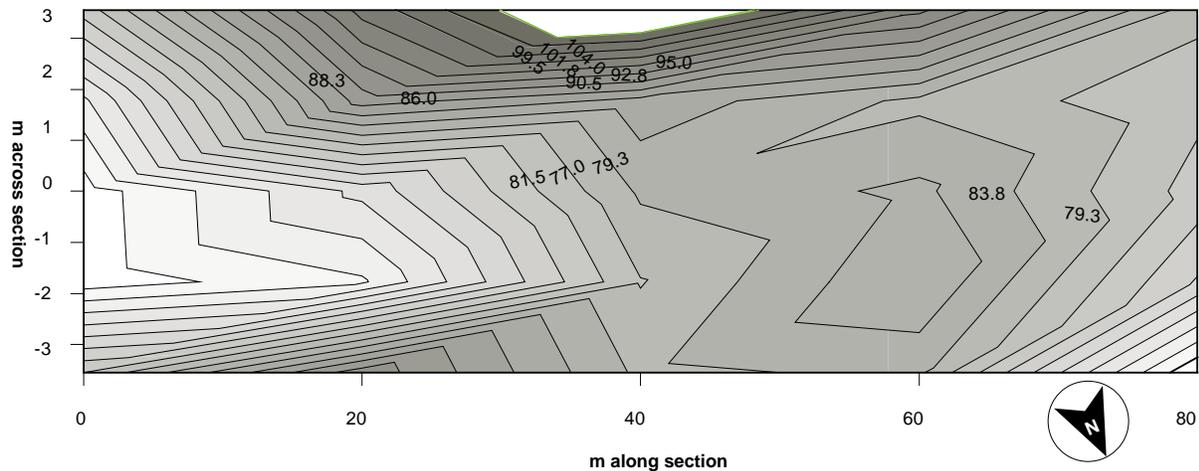
Figure 3.5: Distribution of asphalt concrete thickness across pavement section.

Figure 3.5 shows the distribution of the pavement thicknesses across the entire section. Distribution of thickness along the project can also influence the fatigue and rutting performance of the test sections. An increase in pavement thickness increases the service life of the pavement by reducing the tensile strain at the bottom of the asphalt concrete, thereby increasing the fatigue performance of the asphalt concrete. Increased thickness also reduces the state of the stresses in the unbound layers, which improves the rutting performance of the granular base and subgrade.

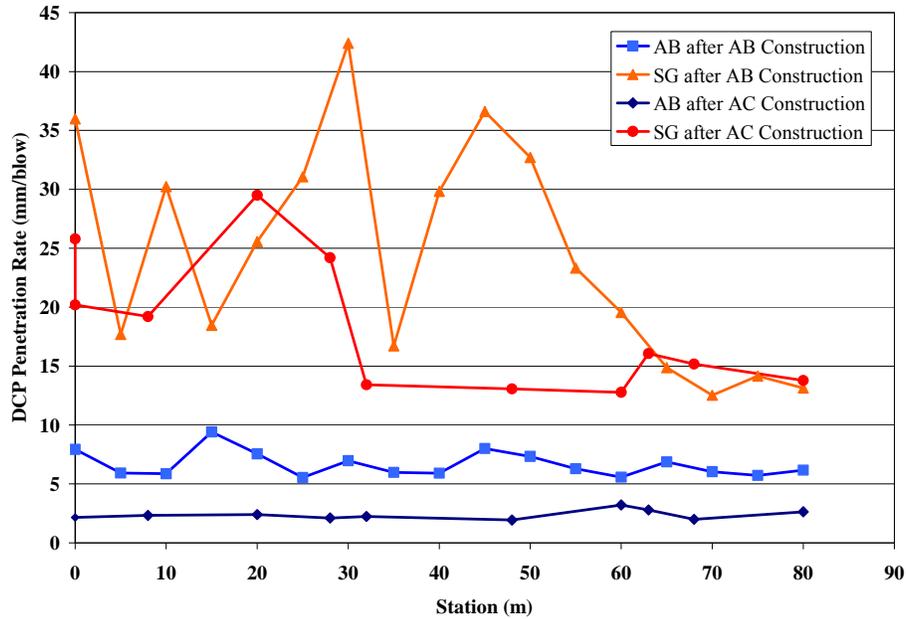
Figure 3.7: DCP data for unbound materials.

Figure 3.7 summarizes Dynamic Cone Penetrometer (DCP) tests in terms of penetration rates in the aggregate base and subgrade along the pavement section. These were obtained after construction of the aggregate base and asphalt concrete layers. DCP tests were performed at the same 17 locations where asphalt concrete cores were extracted. Average penetration rates for the aggregate base and subgrade before placing the asphalt concrete were 6.4 mm/blow and 23.4 mm/blow, respectively with standard deviations of 1.0 mm/blow and 9.0 mm/blow, respectively. After placing the asphalt concrete layer, the average penetration rates in the aggregate base and subgrade were 2.4 mm/blow and 17.8 mm/blow, respectively with standard deviations of 0.4 mm/blow and 5.4 mm/blow, respectively.

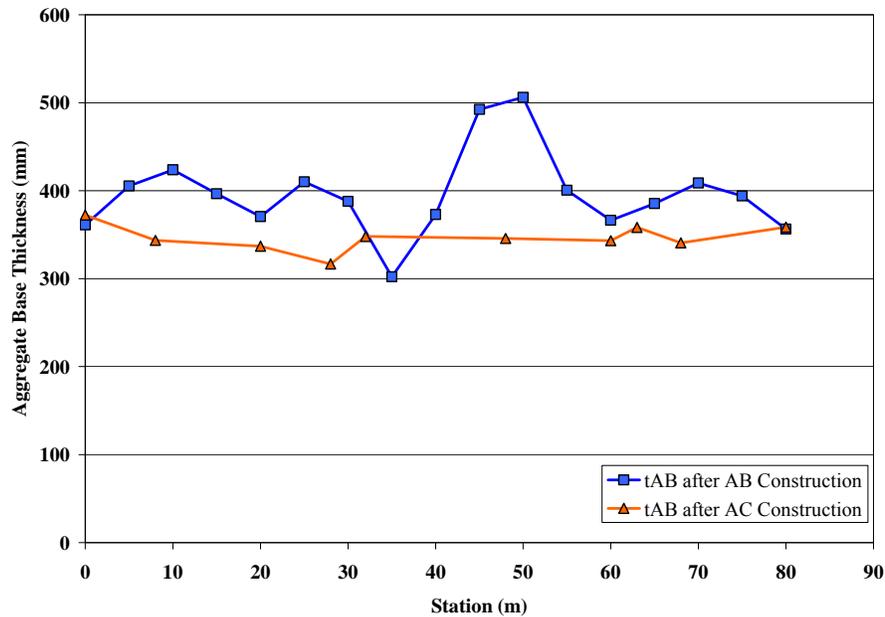
Figure 3.8: Thickness of aggregate base estimated from DCP measurements.

Aggregate base thicknesses along the pavement section were estimated from DCP data at the point where the slopes of the penetration rates of the aggregate base and subgrade intersect. The average thickness of the aggregate base was 375 mm with a standard deviation of 47 mm (design thickness was 410 mm). Figure 3.8 shows aggregate base thickness along the pavement section. The data indicate a difference between the thickness obtained before and after placing the asphalt concrete. The results are not conclusive at this point because they were obtained at different locations.

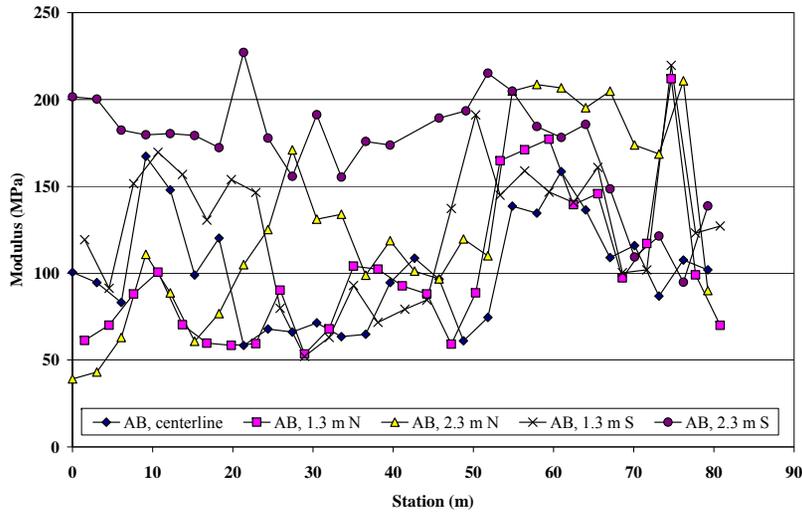
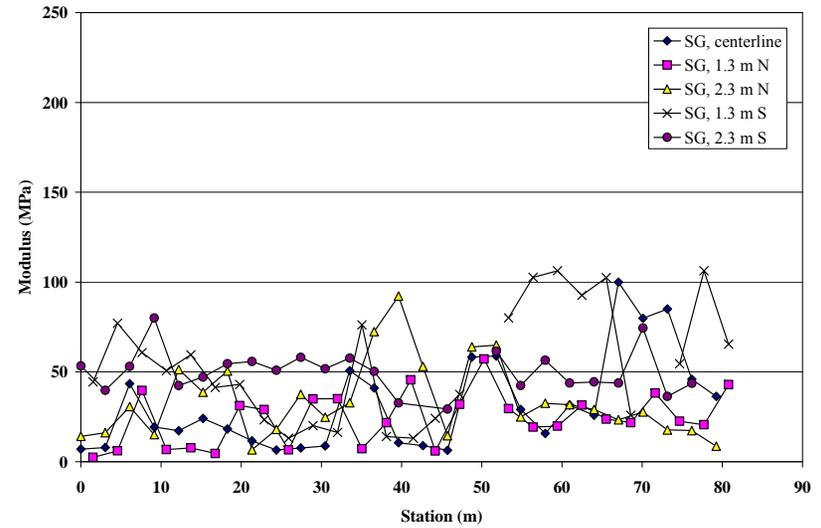
FWD testing was conducted on top of the aggregate base using 22.2- and 40-kN loads. Back-calculated moduli under the 40-kN load for the aggregate base and subgrade are presented in Figures 3.9 and 3.10, respectively. Significant variability was observed in the moduli of both layers. The average modulus for the aggregate base was 125 MPa with a standard deviation of 48 MPa, while the average modulus for the subgrade was 38 MPa with a standard deviation of 25 MPa. Relative frequency and cumulative histograms for moduli of the aggregate base and subgrade are presented in Figures 3.11 and 3.12, respectively. At this stage, the calculated modulus of the aggregate base was lower than representative values for similar California aggregate base materials. The lower value was attributed to absence of confinement provided by the asphalt concrete wearing course.

Figure 3.9: FWD determined aggregate base modulus (tested on base).

Figure 3.10: FWD determined subgrade modulus (tested on base).

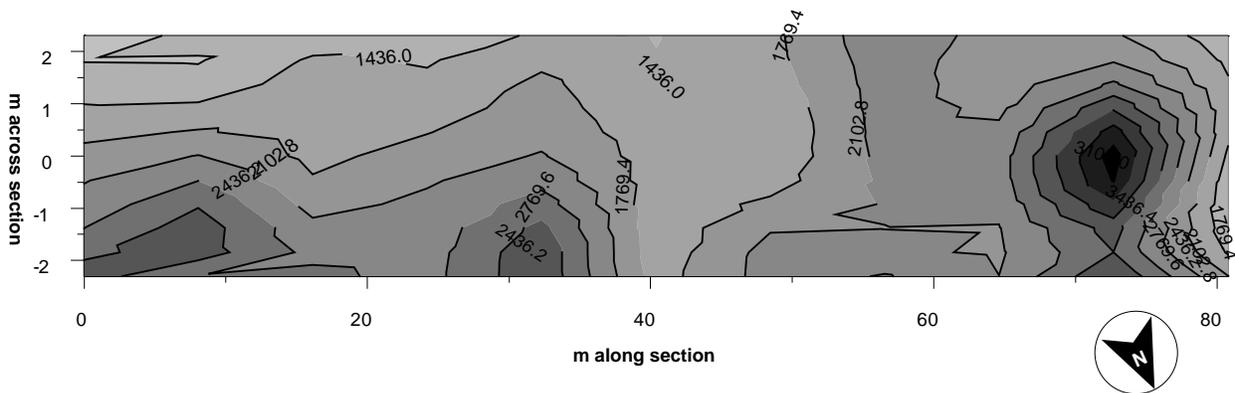
Figure 3.18: Distribution of asphalt concrete moduli along the pavement section.

Distribution of the asphalt concrete moduli along the pavement section is shown in Figure 3.18. Darker areas indicate higher modulus values. The distribution corresponds with the location of the segregated areas along the section and will be used when analyzing the performance of the six sub-sections subjected to HVS loading.

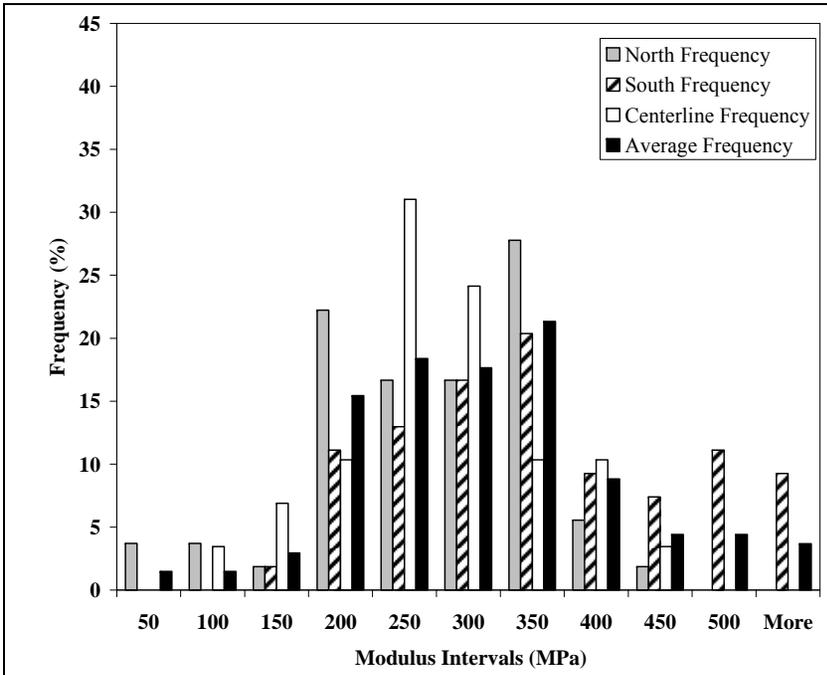
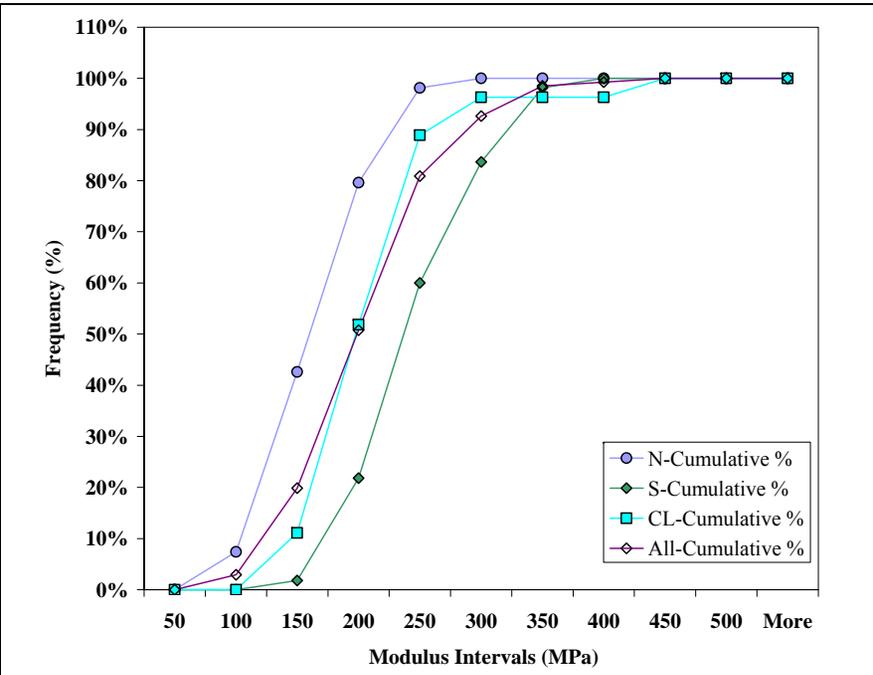
Figures 3.19 and 3.20 show the relative frequency and cumulative histogram, respectively of aggregate base moduli along the pavement section obtained from backcalculation of the FWD data. Results suggest that the first area may consist of two populations of moduli with values of approximately 250 MPa and 350 MPa, with the high modulus values on the northbound lane between stations 0.0 m and 30 m. Figure 3.21 shows the distribution of aggregate base modulus along the pavement section. In the figure, darker color indicates higher aggregate base modulus.

Figure 3.19: Relative frequency of base layer modulus.

Figure 3.20: Cumulative histogram of base layer modulus.

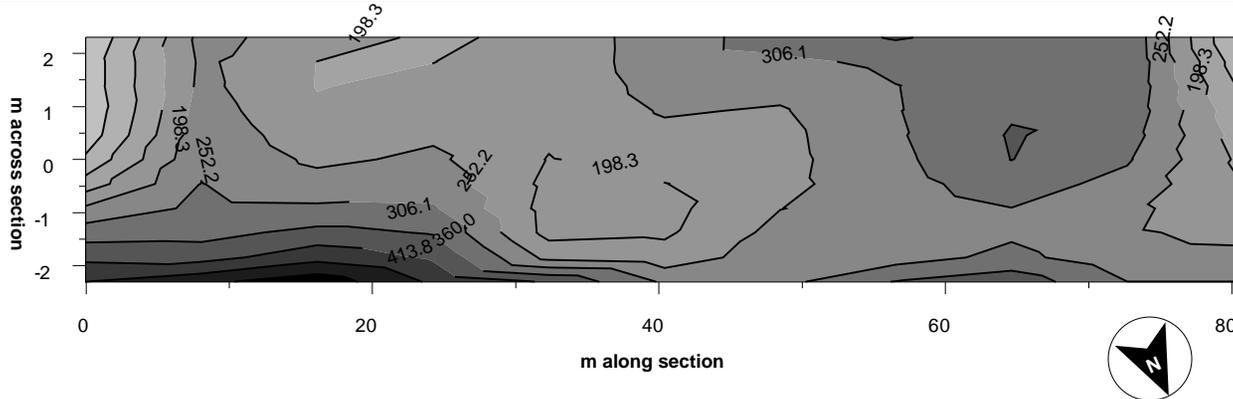
Figure 3.21: Distribution of aggregate base moduli along pavement section.

A comparison of Figures 3.21 and 3.23 indicates that low aggregate base moduli and low subgrade moduli were observed in the same locations. Direct comparison of these two parameters (Figure 3.24) indicates that, after construction, the modulus of the aggregate base was related to that of the subgrade. This observation is particularly important for aggregate base construction because a stiffer subgrade provides a compaction platform that promotes higher base densities.

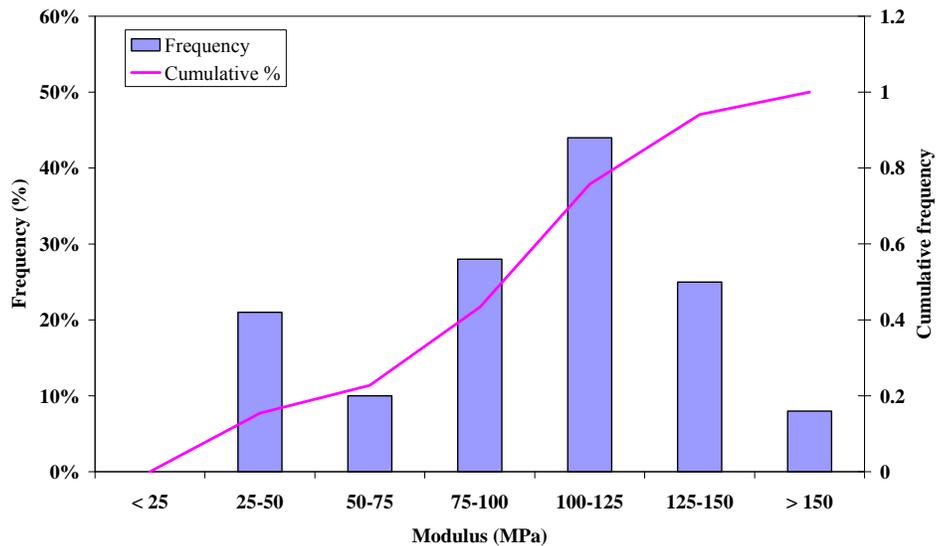
Figure 3.22: Relative frequency and cumulative histogram of subgrade modulus.

The average modulus of the subgrade was 98 MPa with a standard deviation of 37 MPa. Relative frequency and cumulative histogram are shown in Figure 3.22, while Figure 3.23 shows the distribution of subgrade modulus along the pavement section. In the figure, darker color indicates higher modulus. A weak subgrade (lower modulus) was observed between Stations 20 m and 50 m in the southbound lane (test lines 1.3 and 2.3 m). While the reason for the low subgrade modulus in this area is not clear, based on observations during construction the subgrade in this area was compacted at high moisture content (to the right of the line of optimum). Compaction in this moisture region induces dispersed particle orientation in this type of soil. This, in turn, results in higher resilient deformations (low resilient modulus) than if compaction occurs to the left of the line of optimum (lower moisture content).

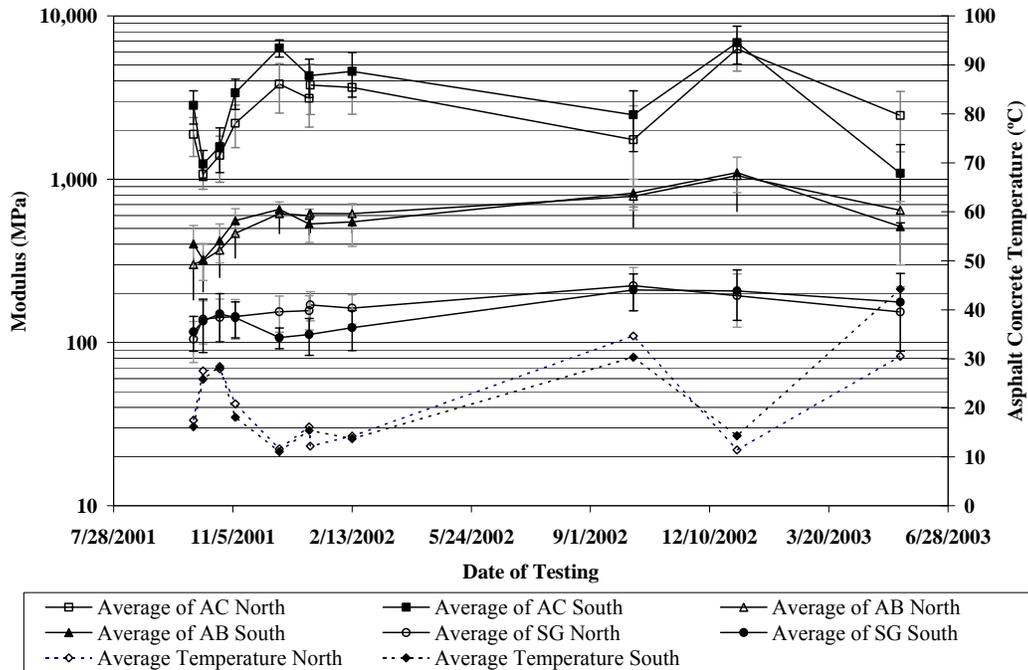
Figure 3.26: Summary of back-calculated moduli for pavement section.

Moduli were calculated from FWD deflections using the computer program ELMOD 5.0 (7). A non-linear subgrade and no bedrock were assumed in the back-calculations. Results of the back-calculations are summarized in Figure 3.26 for average layer moduli along the north and south lanes. Y-bar errors indicate one standard deviation from the average value.

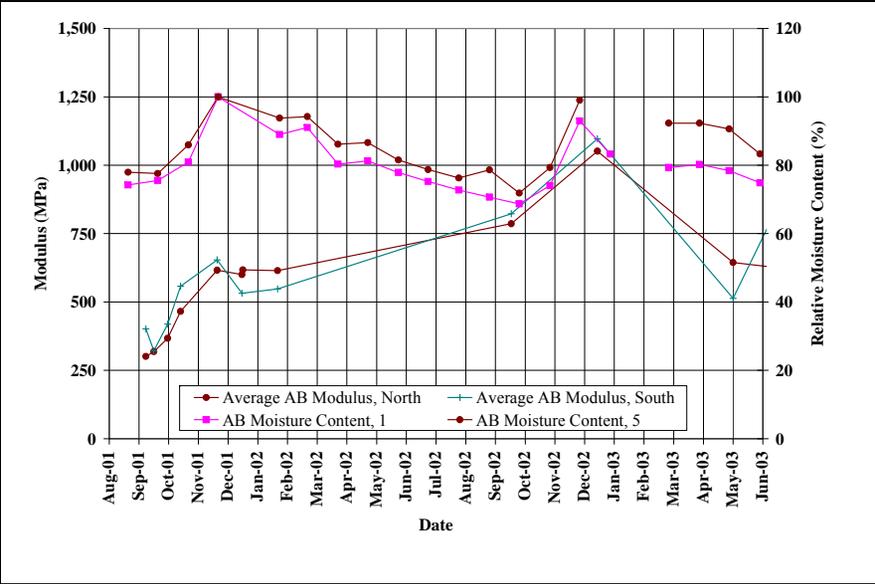
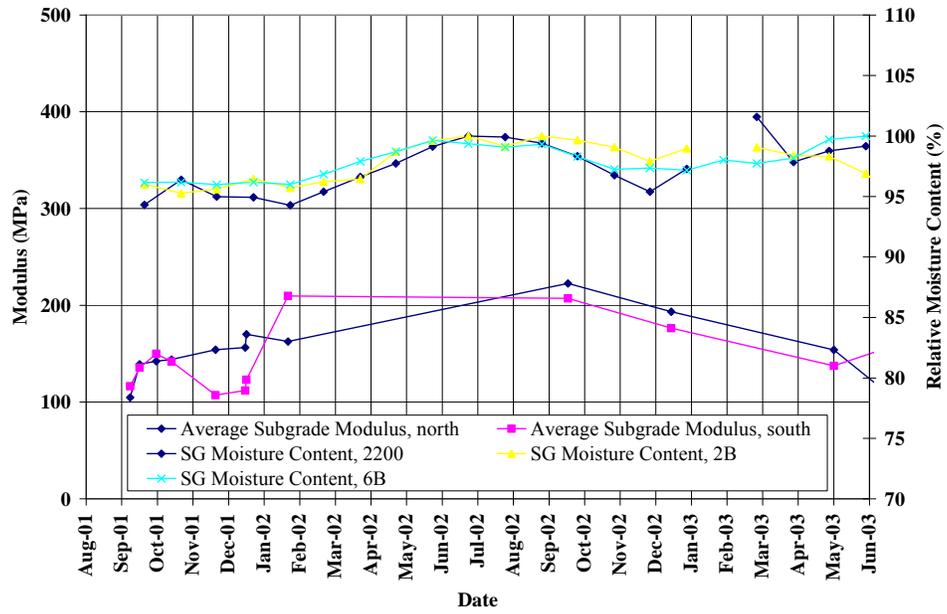
Figures 3.34 and 35 indicate variations of base, subgrade modulus, and moisture content with time. The effect of moisture content on the aggregate base somewhat contradicts experience for the period of data collected. Figure 3.34 shows an increase in moisture content in the aggregate base and is associated with an increase in the aggregate base modulus; usually a decrease in stiffness with increase in water content is expected. As discussed earlier, factors such as asphalt concrete modulus variations could have a more significant effect on the aggregate base modulus than moisture content. Figure 3.35 shows a decrease in subgrade moisture content and modulus during the months of May and June 2003. This pattern is expected because fine grained soils are affected significantly by moisture content.

Figure 3.34: Variation of modulus with time as a function of moisture content for aggregate base.

Figure 3.35: Variation of modulus with time as a function of moisture content for subgrade.

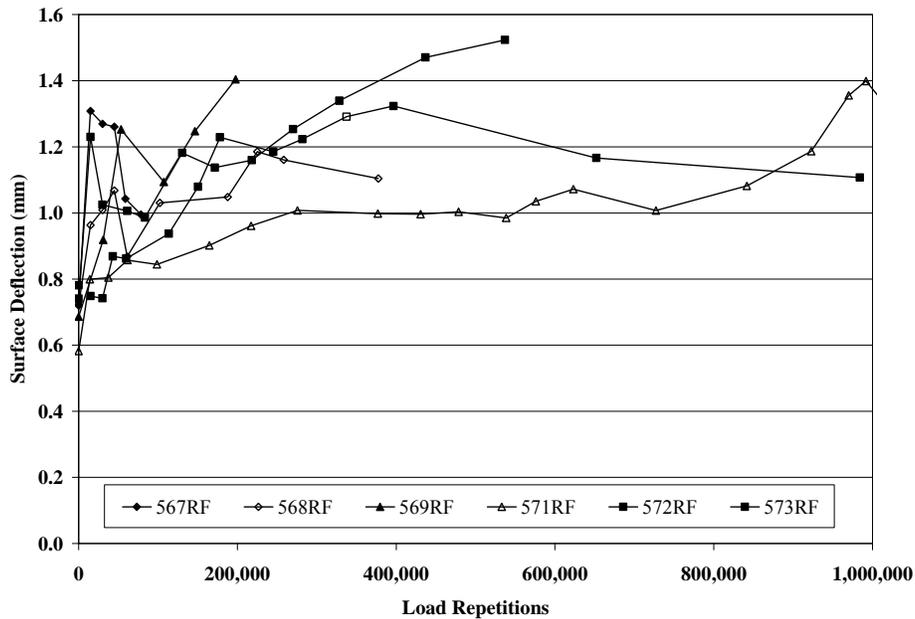
Figure 4.4: RSD surface deflections.

Average surface deflections for each HVS test section measured with the RSD under a slow moving 60 kN wheel are presented in Figure 4.4. Surface deflection generally increased with increasing number of load repetitions, as expected. Change in deflection with load repetitions was reduced for some sections. For example, for Sections 571RF and 573RF, the deflections remain relatively constant in the range 200,000 to about 800,000 repetitions.

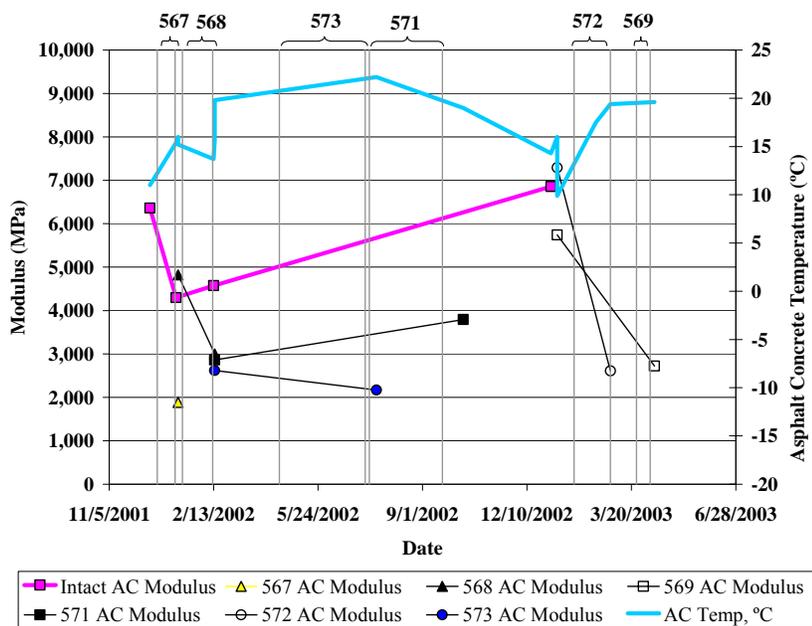
Figure 4.5: Backcalculated asphalt concrete moduli for HVS sections.

Figure 4.5 shows a clear reduction in asphalt concrete modulus after HVS testing on Sections 567RF, 568RF, 569RF, and 572RF, while Section 573RF shows a slight reduction and Section 571RF a slight increase in modulus. The moduli change on the latter two sections is explained by the large temperature difference between the FWD tests conducted after HVS testing and those conducted before HVS testing. Data interpretation accounted for these variations. Asphalt concrete modulus values were in the range of 4,000 to 7,000 MPa before HVS testing, depending on temperature, and between 2,000 MPa and 4,000 MPa after HVS testing.

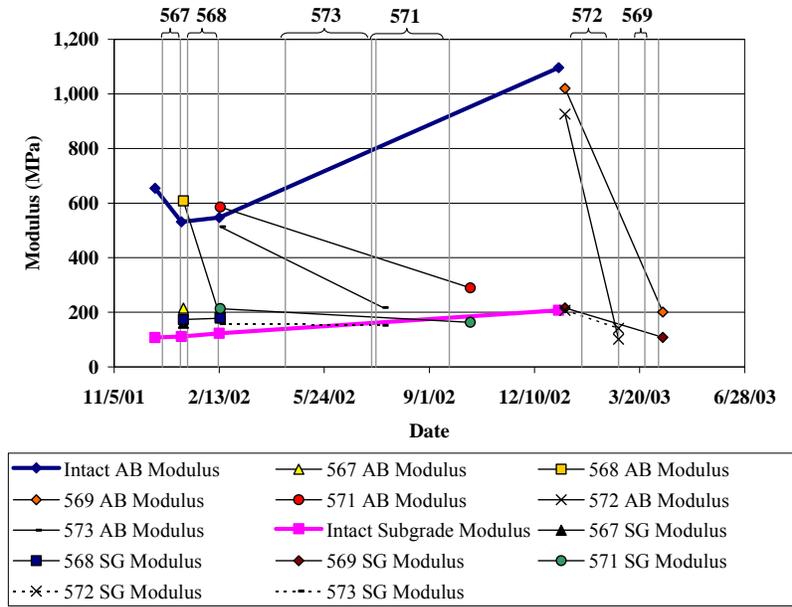
Figure 4.6: Backcalculated aggregate base and subgrade moduli for HVS sections.

Modulus values for the aggregate base are shown in Figure 4.6. The data show a clear reduction in aggregate base modulus over time for all sections. Values were in the range of 500 MPa to 1,100 MPa before HVS testing and between 100 MPa and 300 MPa after HVS testing. The agreement between intact modulus and modulus before HVS testing for each of the sections appeared reasonable.

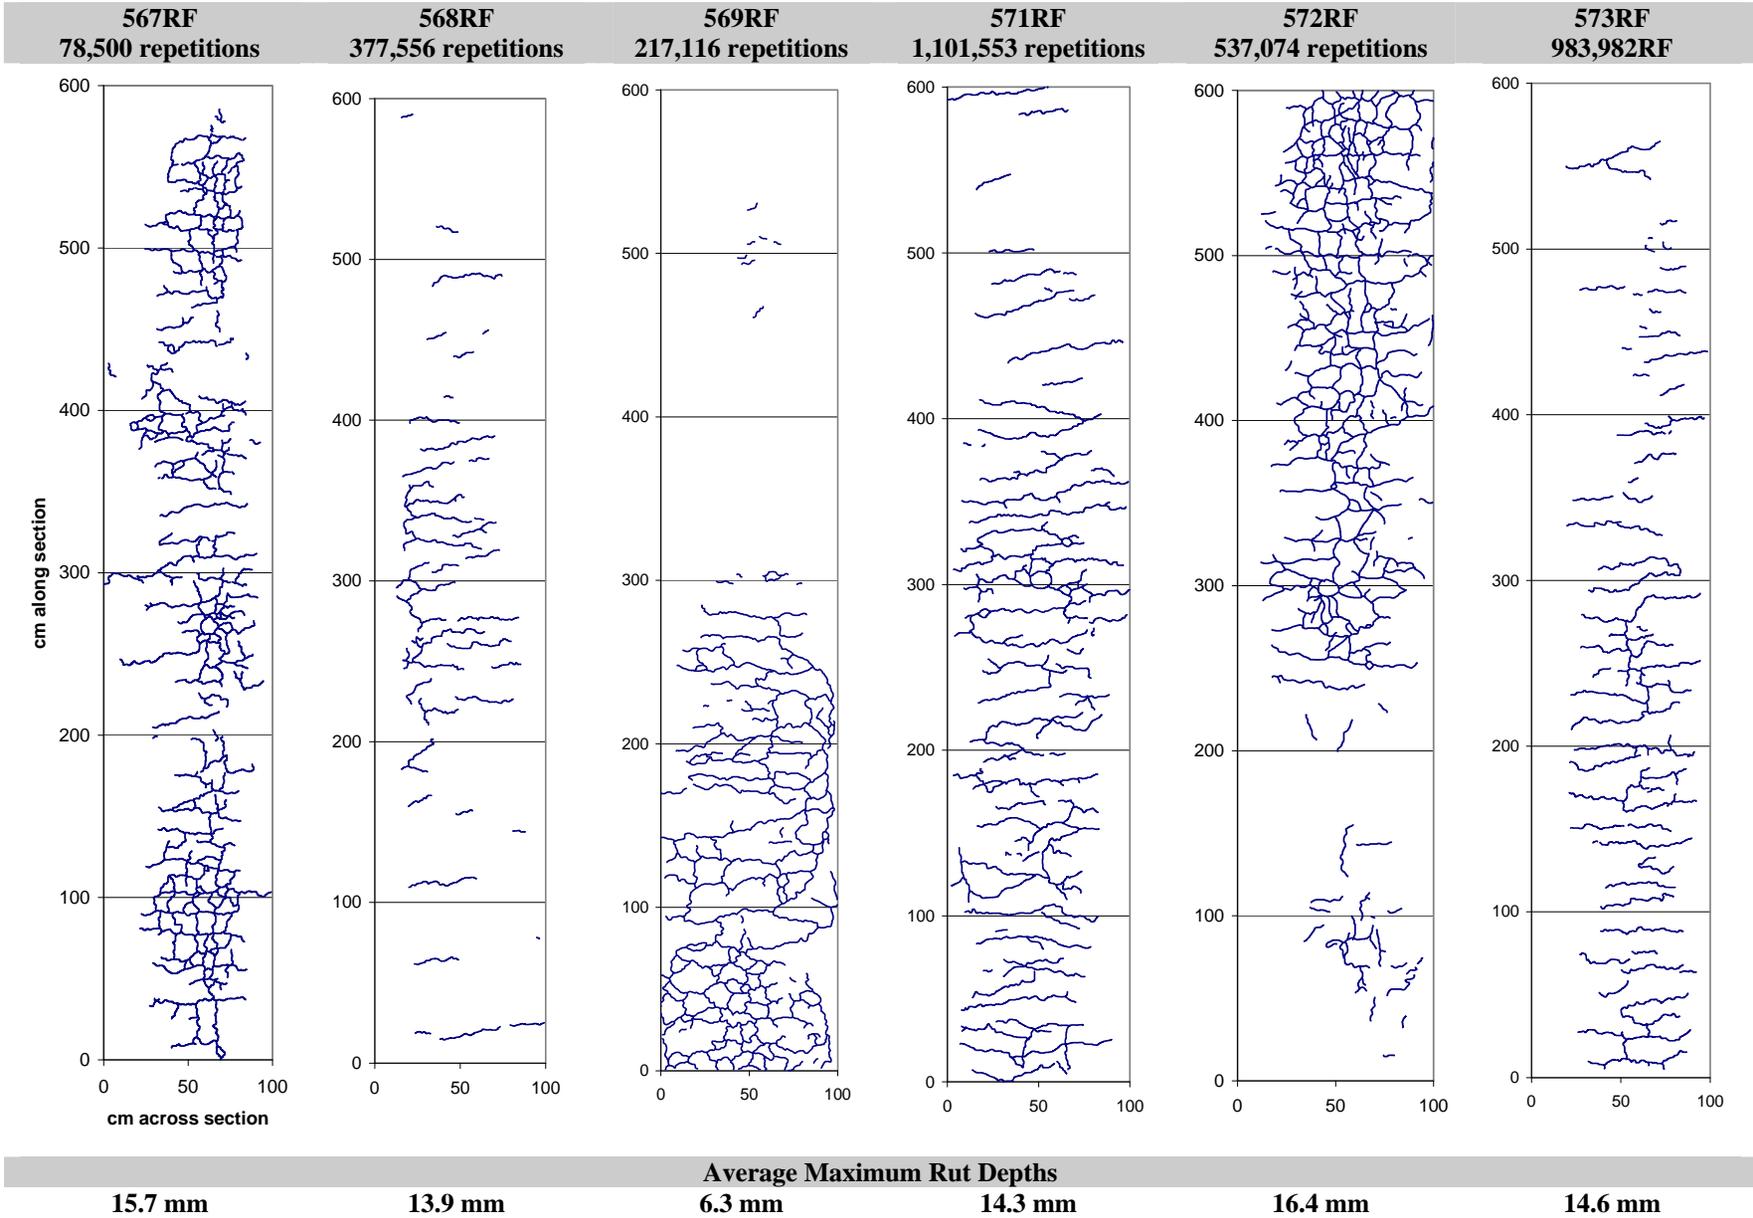
Figure 4.8: Cracking patterns and rut depths on Sections 567RF through 573RF after HVS testing.

The type of crack pattern observed could be associated with the condition of the aggregate base and subgrade layers and was similar to patterns in surface rutting and surface deflection data. Sections 571RF and 573RF were tested during a dry summer season. A weaker foundation typically produces more alligator cracking as seen in the remaining test sections except for Section 568RF.

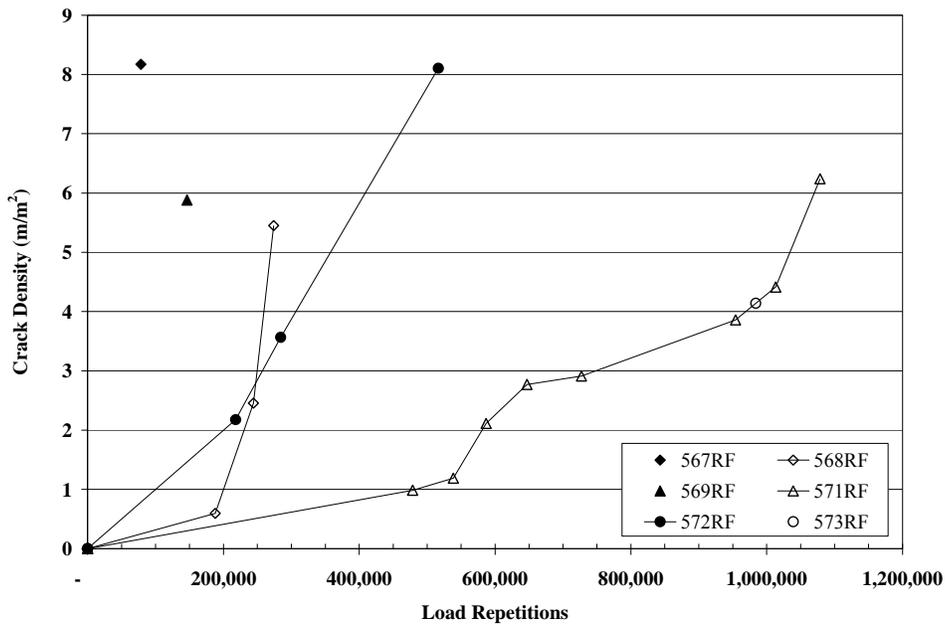
Figure 4.9: Summary of surface cracking performance.

Figure 4.9 summarizes surface cracking measurements with number of load applications for each HVS test. Testing was continued beyond the 2.5 m/m² crack density failure criterion because the rut limit had not been reached and additional data were desired for developing and calibrating performance models. Only one crack density point is shown for Sections 567RF, 569RF, and 573RF. The data show much lower crack density on Sections 571RF and 573RF than on the other sections. This observation is consistent with the drier aggregate base and subgrade when Sections 571RF and 573RF were tested. The effects of aggregate base and subgrade moisture conditions on the performance of the test sections conform to accepted pavement theory and practice.

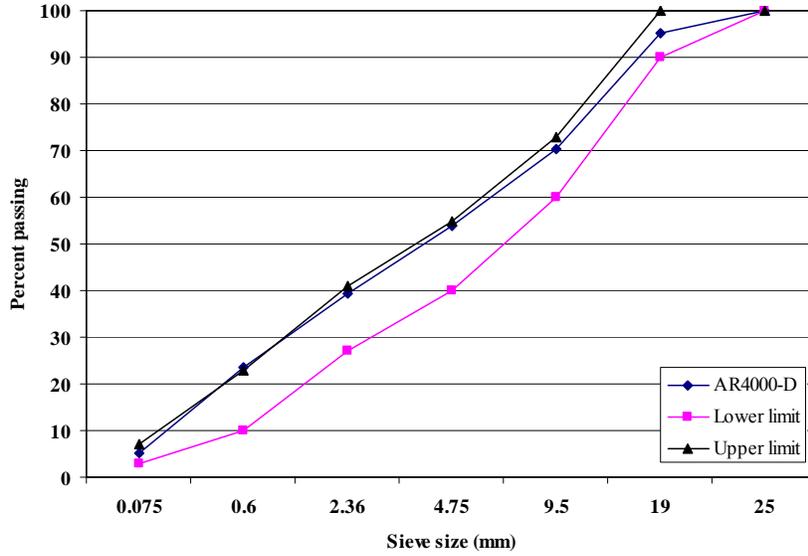
Figure 5.4: Gradation for AR4000-D overlay.

- AR4000-D: Material passing the 0.6 mm (#30), 2.36 mm (#8), and 4.75 mm (#4) sieves was on the upper envelope limit (Figure 5.4).
- RAC-G: Material passing the 0.3 mm (#50), 0.6 mm (#30), and 2.36 mm (#8) sieves was on the upper envelope limit (Figure 5.5).
- MB4-G: Material passing the 6.35 mm (1/4 in) and 9.5 mm (3/8 in) sieves was on the lower envelope limit (Figure 5.5).
- MB15-G: Material passing the 6.35 mm (1/4 in), 9.5 mm (3/8 mm), 12.5 mm (1/2 in), and 19.0 mm (3/4 in) sieves was on the lower envelope limit (Figure 5.5).
- MAC15-G: Material passing the 0.6 mm (#30), 9.5 mm (3/8 in), 12.5 mm (1/2 in), and 19.0 mm (3/4 in) sieves was on the upper envelope limit, while material passing the 2.36 mm (#8), 4.75 mm (#4), and 6.35 mm (1/4 in) sieves was outside the upper limit (Figure 5.5).

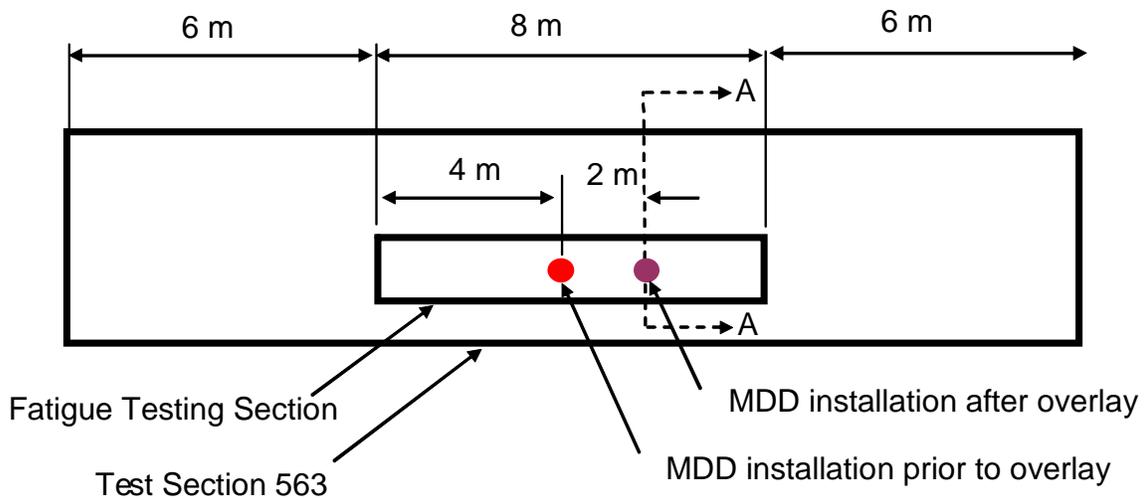
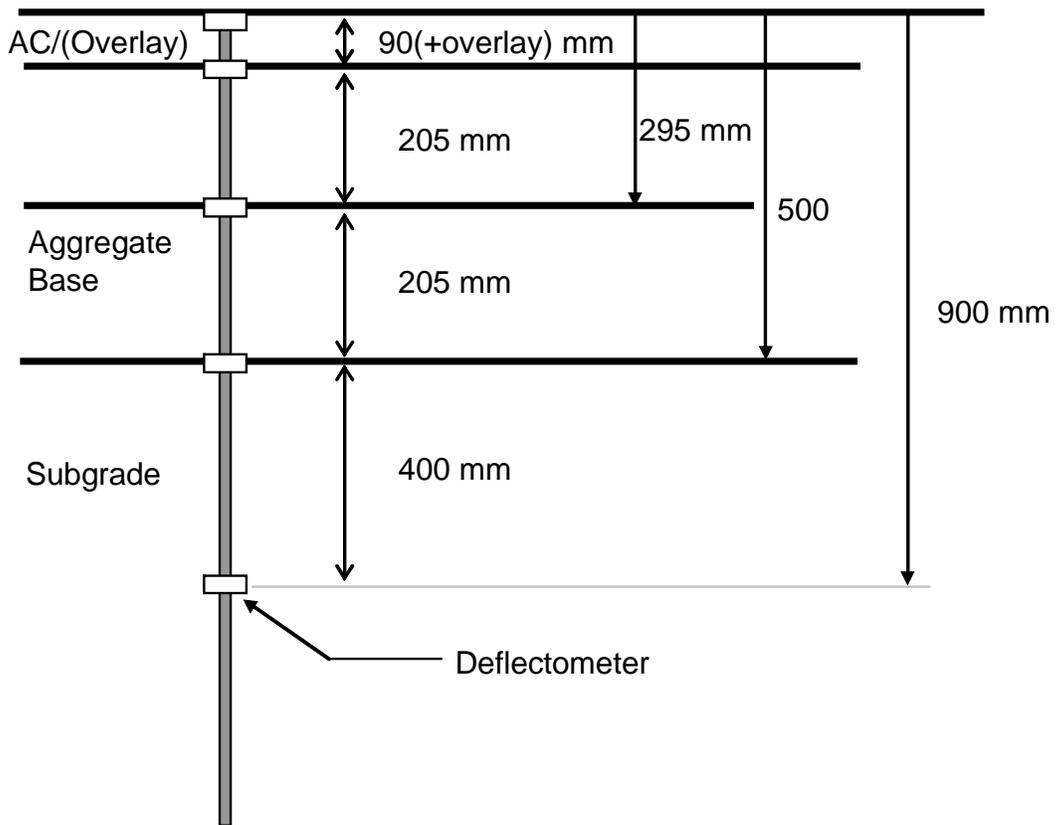
Figure B1. Multi-Depth Deflectometer (MDD) placement.

Plan View.

Section A-A.

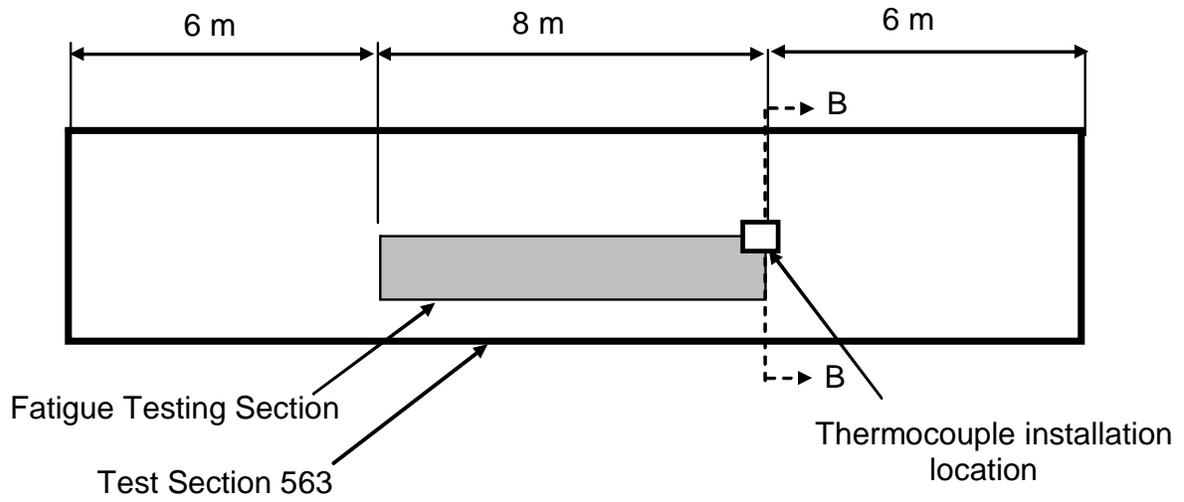
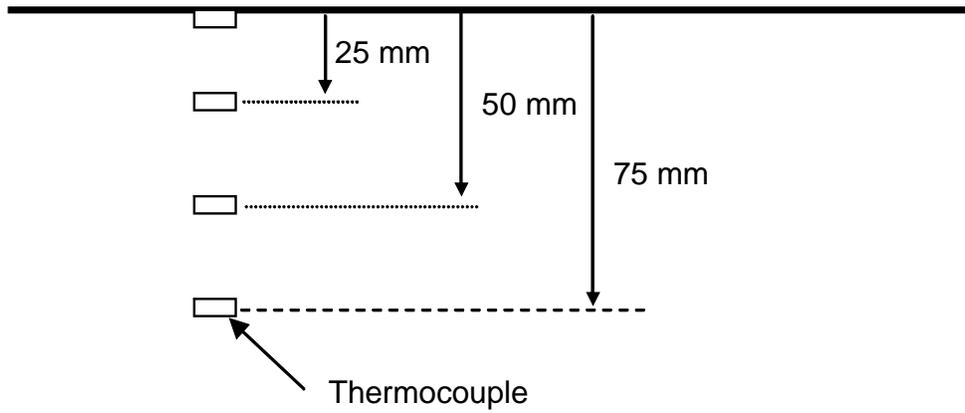
Figure B2. Thermocouple placement.

Plan View

Section B-B.
