Reflective Cracking Study: First-Level Report on the HVS Rutting Experiment

Partnered Pavement Research Program (PPRC) Contract Strategic Plan Element 4.10:
Development of Improved Rehabilitation Designs for Reflective Cracking

California Department of Transportation
Division of Research and Innovation
Office of Roadway Research

University of California
Pavement Research Center
UC Davis, UC Berkeley

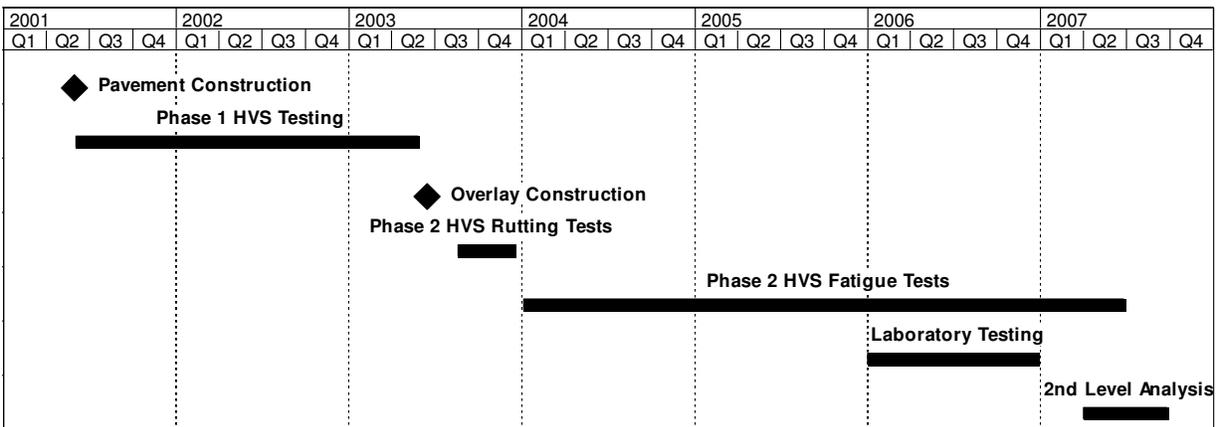
Figure 1.1: Timeline for the Reflective Cracking Study.

An overview of the project timeline is shown in Figure 1.1.

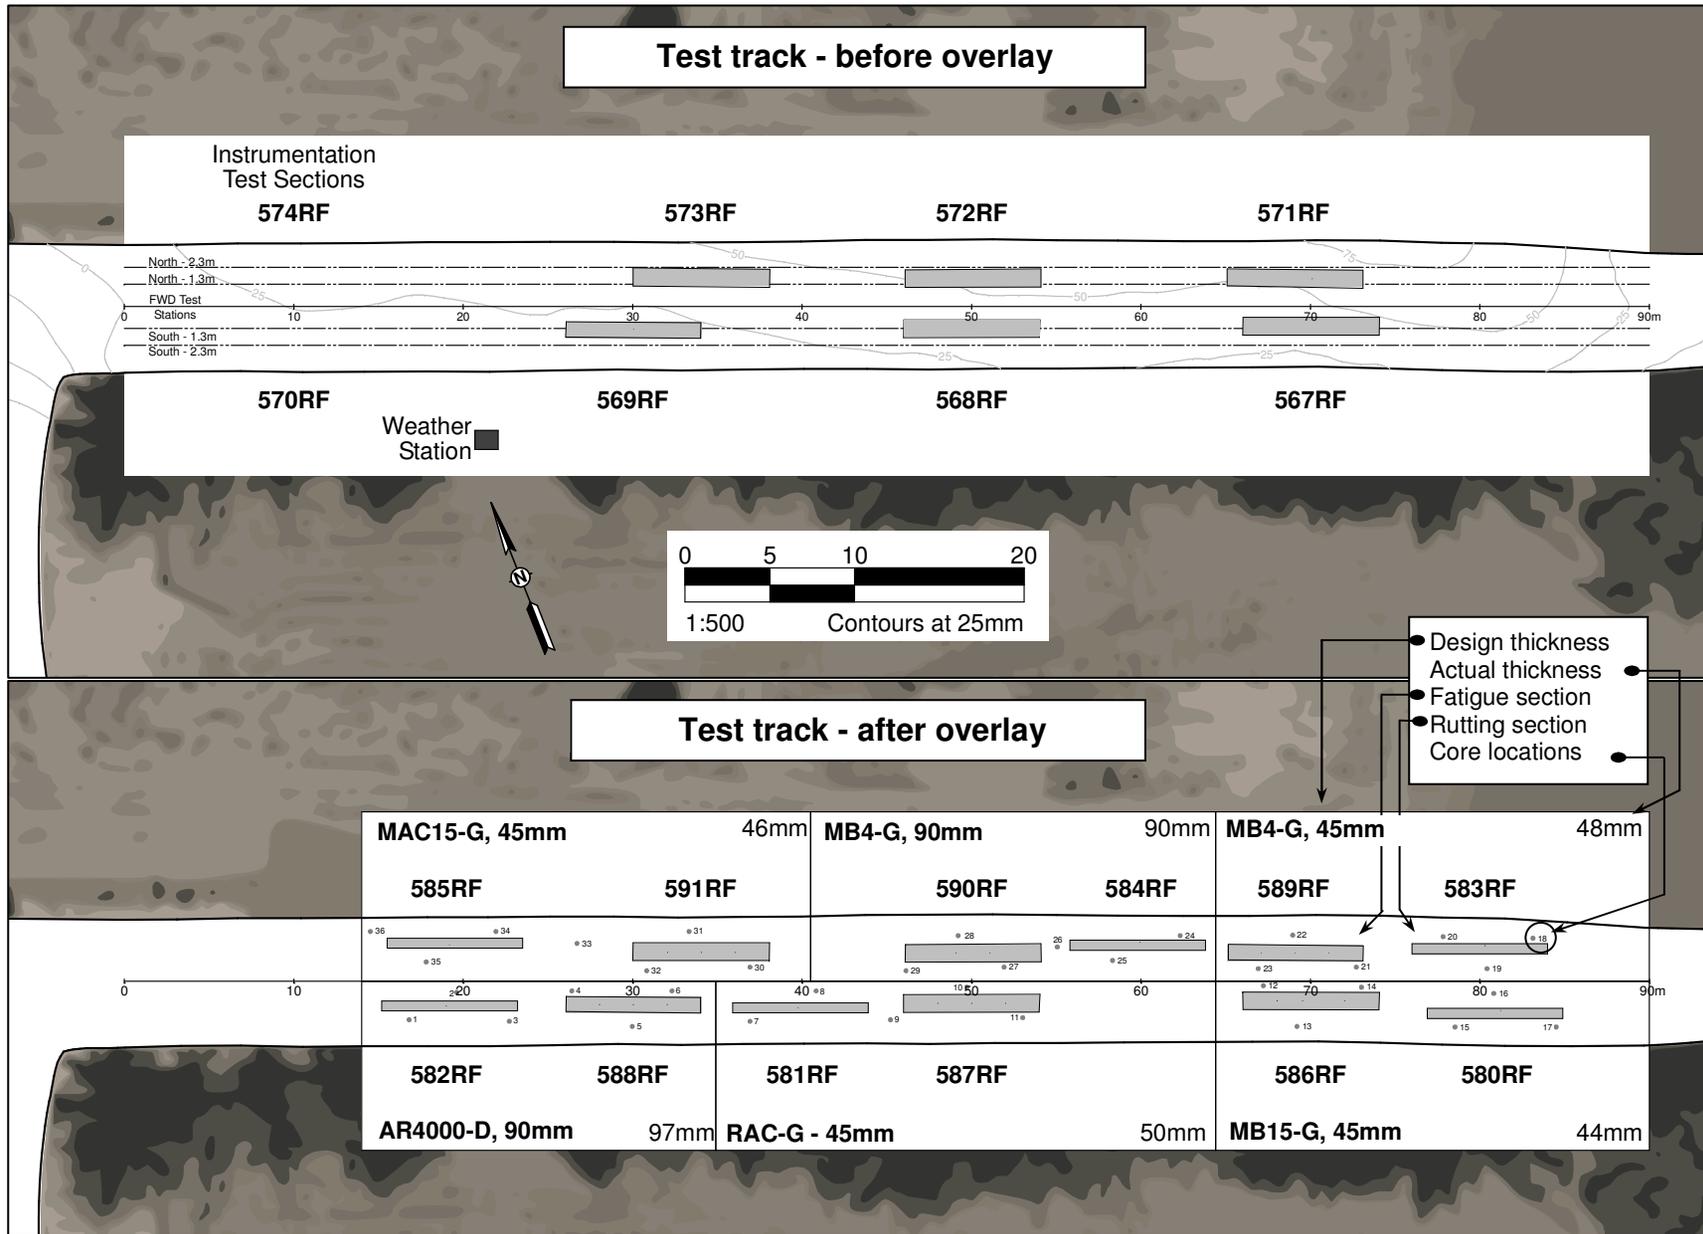
Figure 2.1: Layout of Reflective Cracking Study project.

These sections and the corresponding Phase 2 reflective cracking test sections (Sections 586RF through 591RF), tested after completion of the rutting study, are shown in Figure 2.1. The reflective cracking study is discussed in separate first-level analysis reports (3-8).

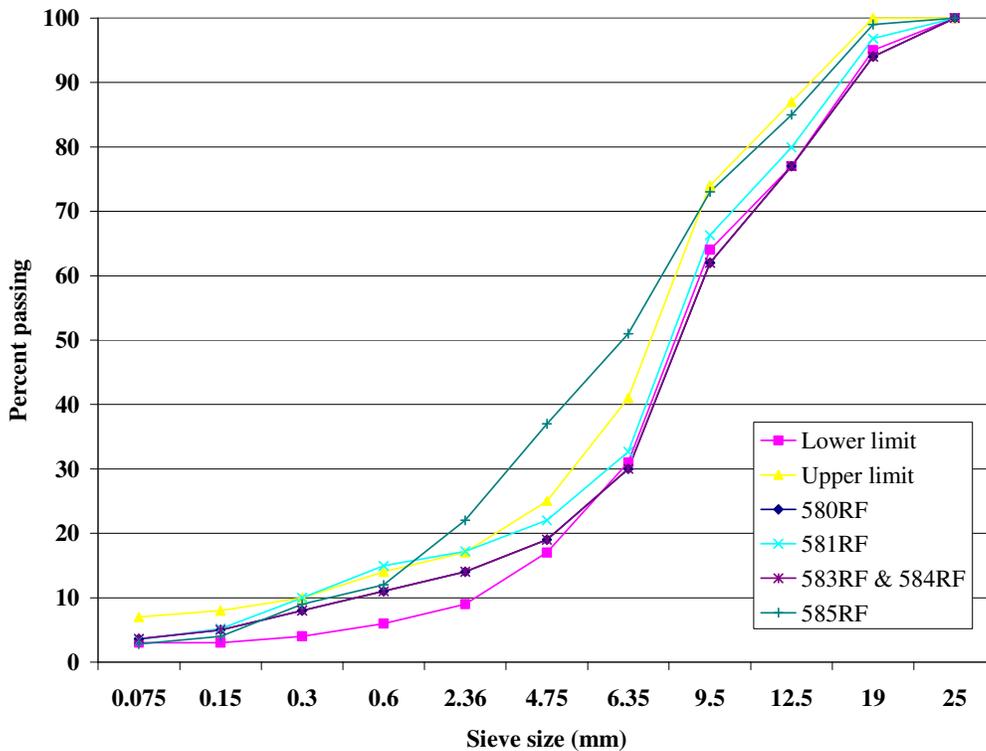
Figure 2.4: Gradation for modified binder overlays.

The aggregate gradations for the AR4000-D and modified binders generally met Caltrans specifications for 19.0 mm (3/4 inch) maximum size course and gap gradations respectively, with specifics for each section detailed below. Gradations are illustrated in Figures 2.4 (modified binders) and 2.5 (AR4000-D).

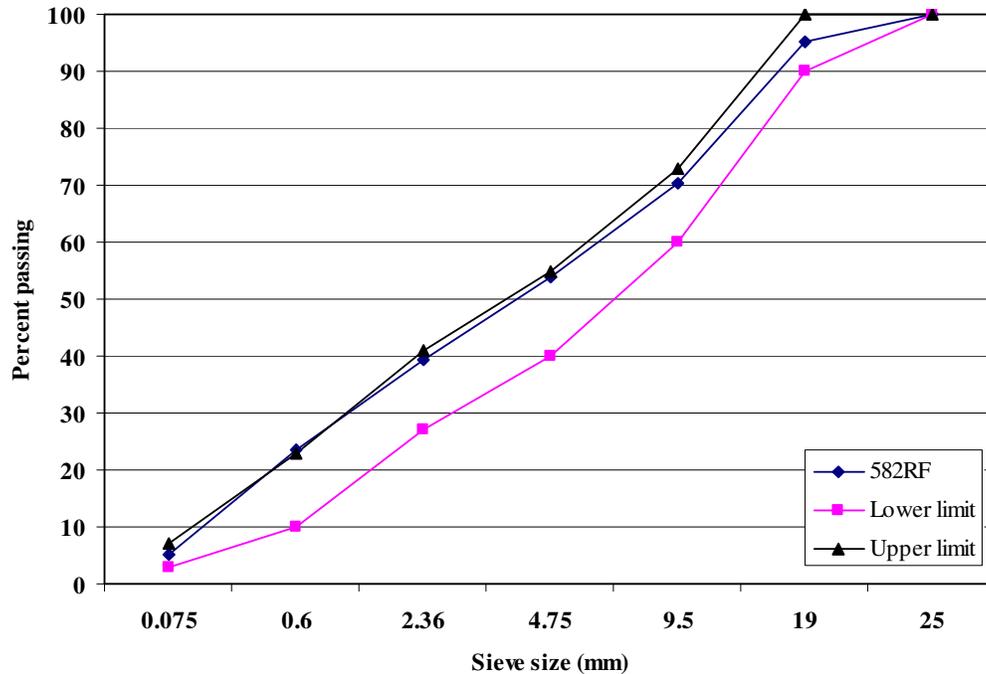
Figure 2.5: Gradation for AR4000-D overlay.

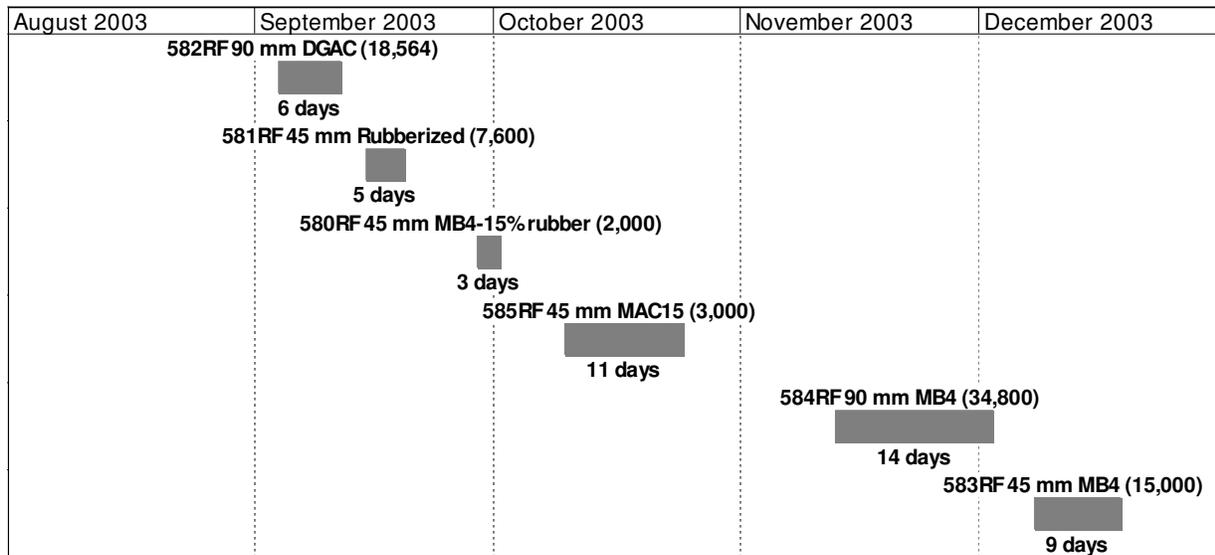
Figure 2.6: Trafficking schedule for the HVS rutting tests.

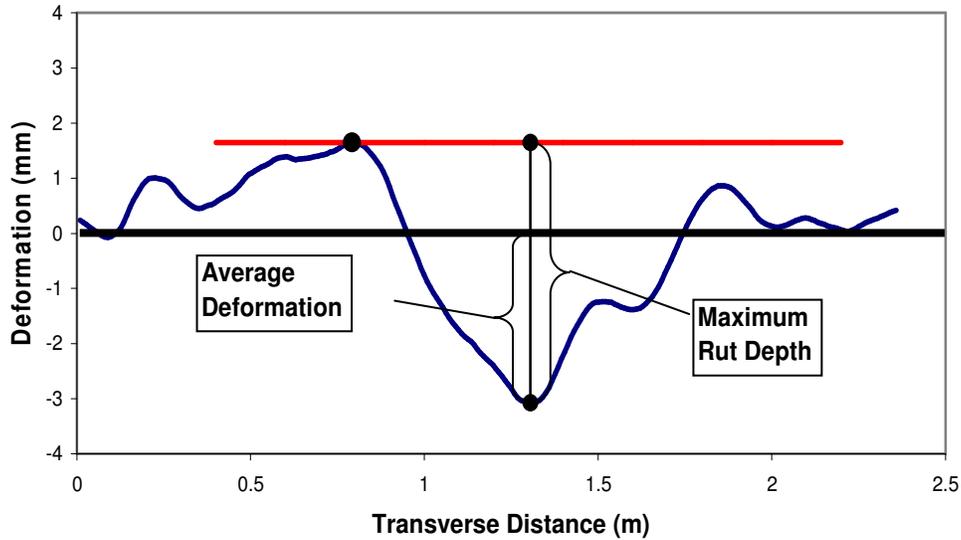
Figure 3.1: Illustration of maximum rut depth and average deformation of a leveled profile.

- Average maximum rut depth (average of the maximum rut depth at each measuring station)
- Average deformation
- Location and magnitude of the maximum rut depth, and
- Rate of rut development.

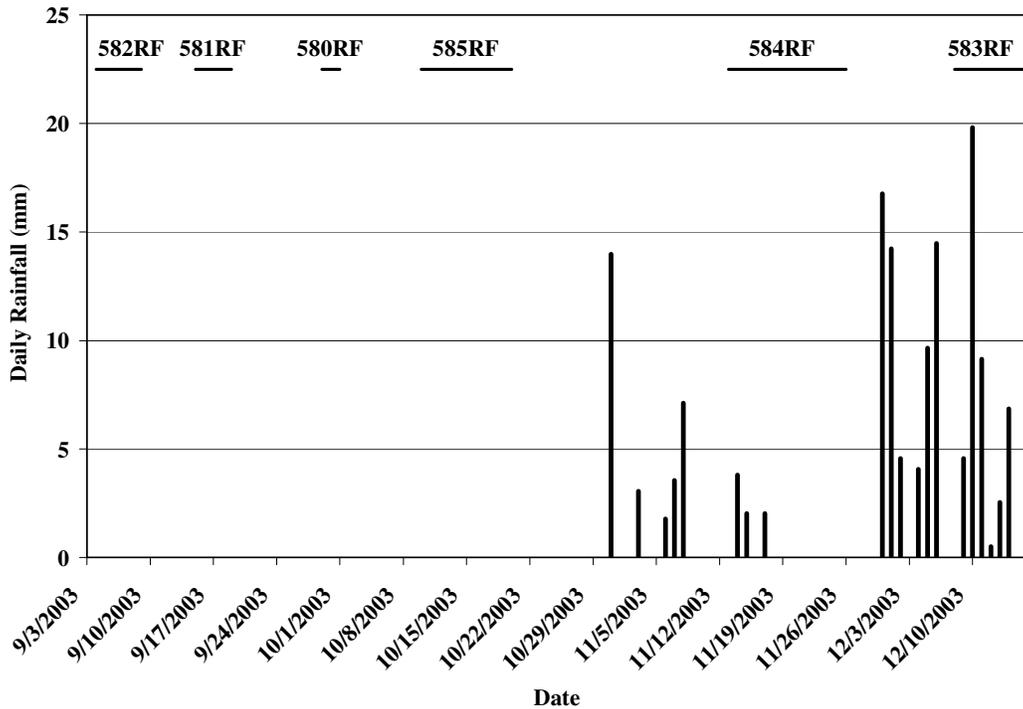
Figure 3.2: Measured rainfall at the Richmond Field Station during the HVS testing.

Figure 3. shows the monthly rainfall data from September 2003 to December 2003 as adapted from the weather station at the Richmond Field Station HVS site. The first four tests (582RF, 581RF, 580RF, and 585RF) were completed in dry conditions. During tests on Sections 583RF and 584RF, 144 mm (5.75 in) of rain was recorded.

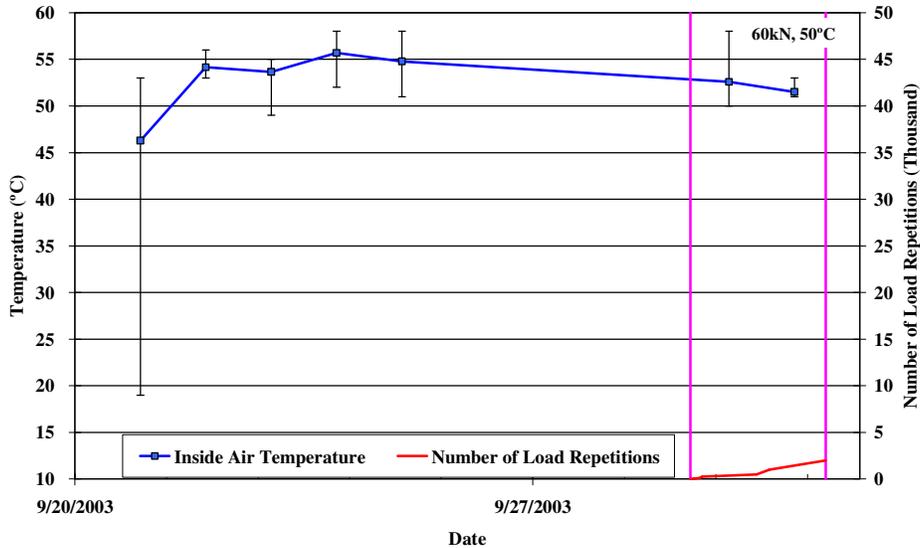
Figure 3.3: 580RF: Daily average air temperatures inside the temperature control chamber.

temperatures recorded in the temperature control unit, calculated from the hourly temperatures recorded during HVS operation, are shown in Figure 3.3. Vertical errors bars on each point on the graph show daily temperature range.

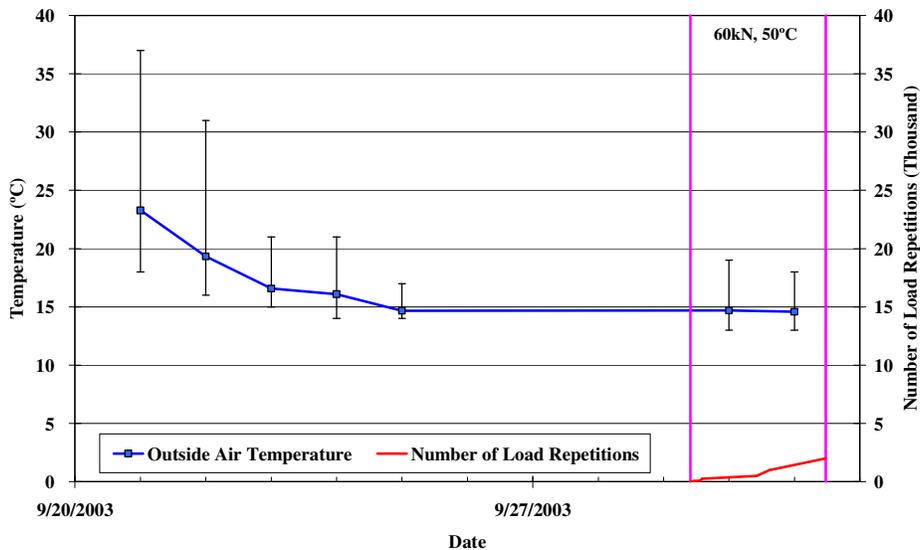
Figure 3.4: 580RF: Daily average air temperatures outside the temperature control chamber.

Outside air temperatures ranged from 13°C to 19°C with an average of 14.5°C and are summarized in Figure 3.4. Vertical error bars on each point on the graph show daily temperature range.

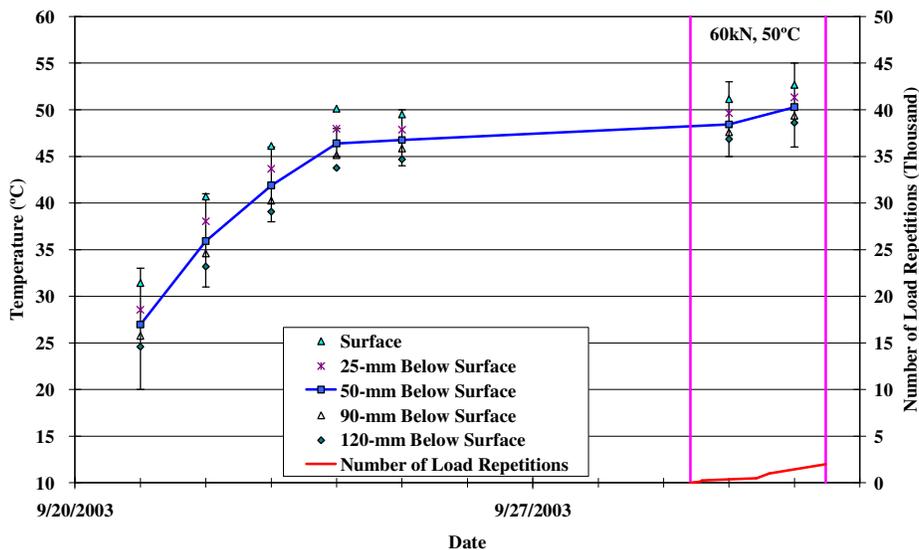
Figure 3.5: 580RF: Daily average temperatures at pavement surface and various depths.

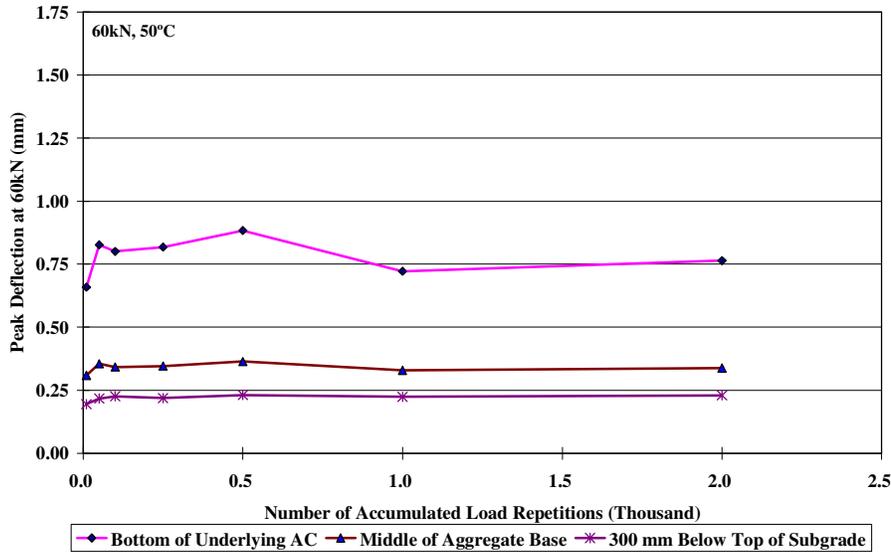
Figure 3.6: 580RF: Elastic deflections at MDD8 with 60 kN test load.

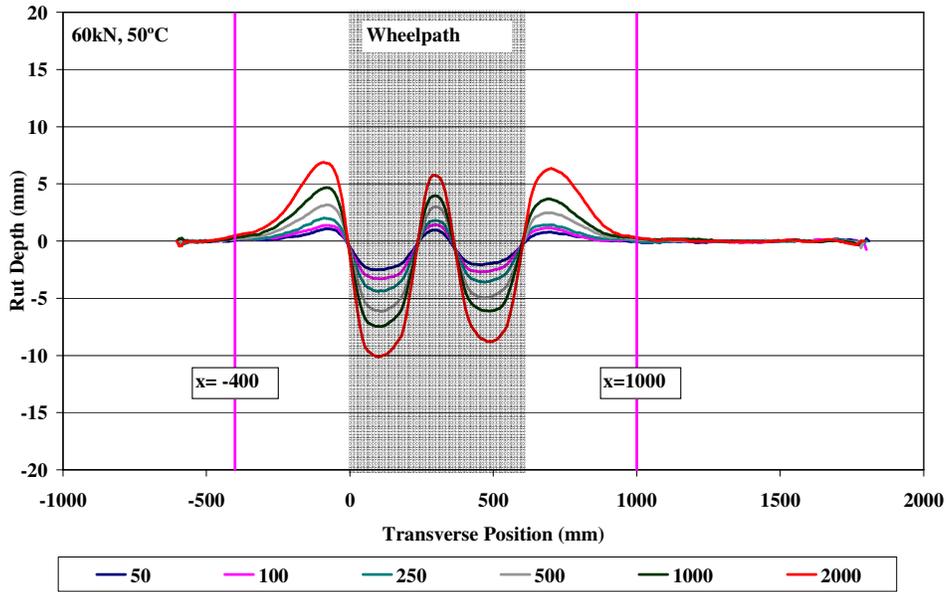
Figure 3.7: 580RF: Profilometer cross section at various load repetitions.

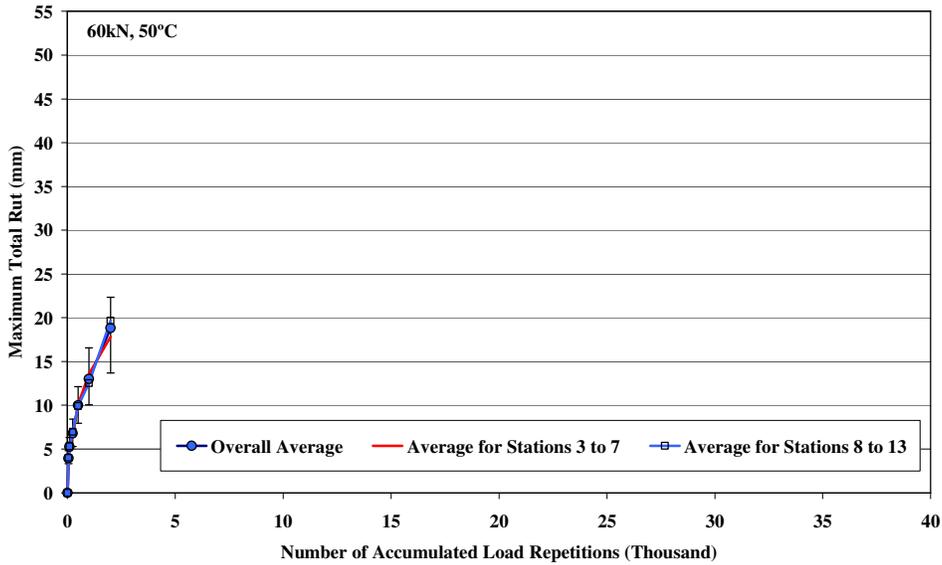
Figure 3.8: 580RF: Average maximum rut.

maximum rut depth and the average deformation were 18.8 mm and 7.1 mm, respectively. The maximum rut depth measured on the section was 22.3 mm. Rut development was rapid with the failure criteria of an average of 12.5 mm total rut depth reached after 914 load repetitions.

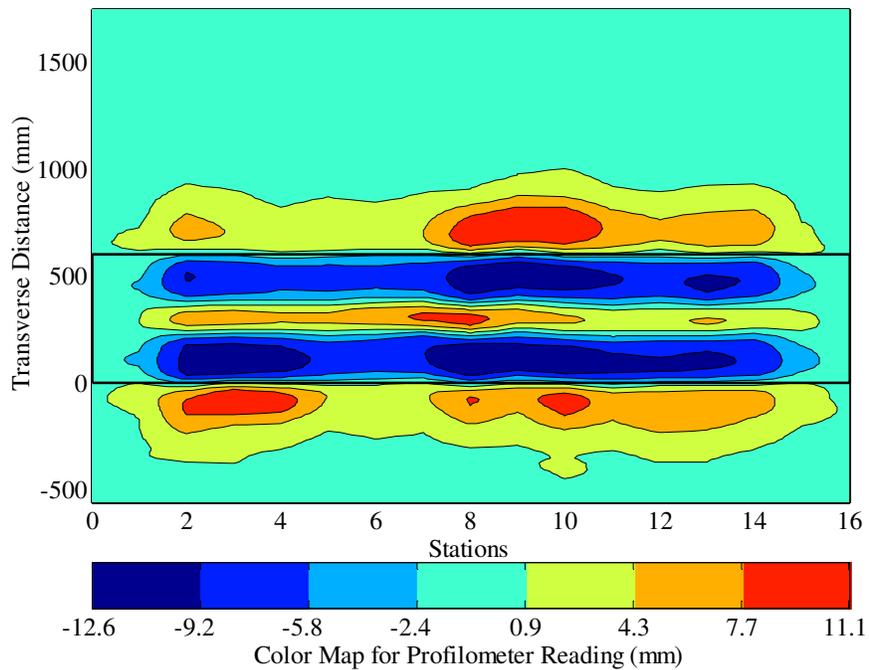
Figure 3.10: 580RF: Contour plot of permanent surface deformation after 2,000 repetitions.

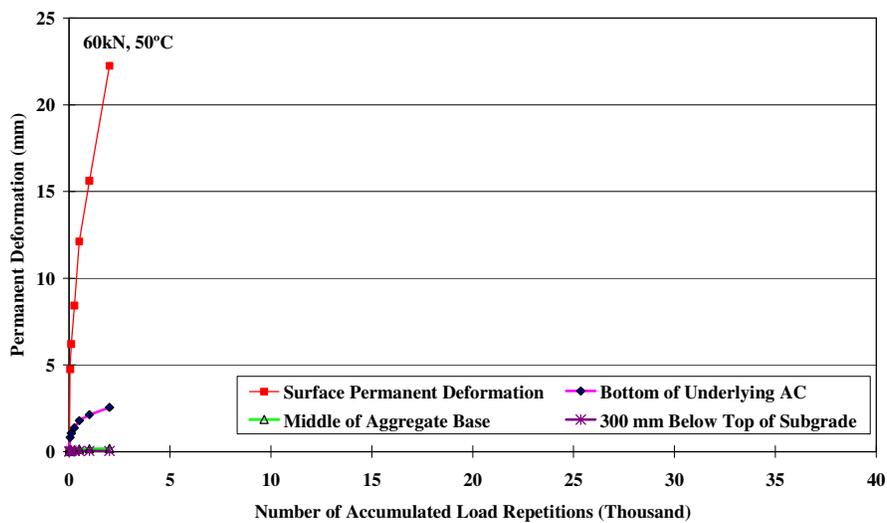
Figure 3.11: 580RF: Permanent in-depth deformation at MDD8.

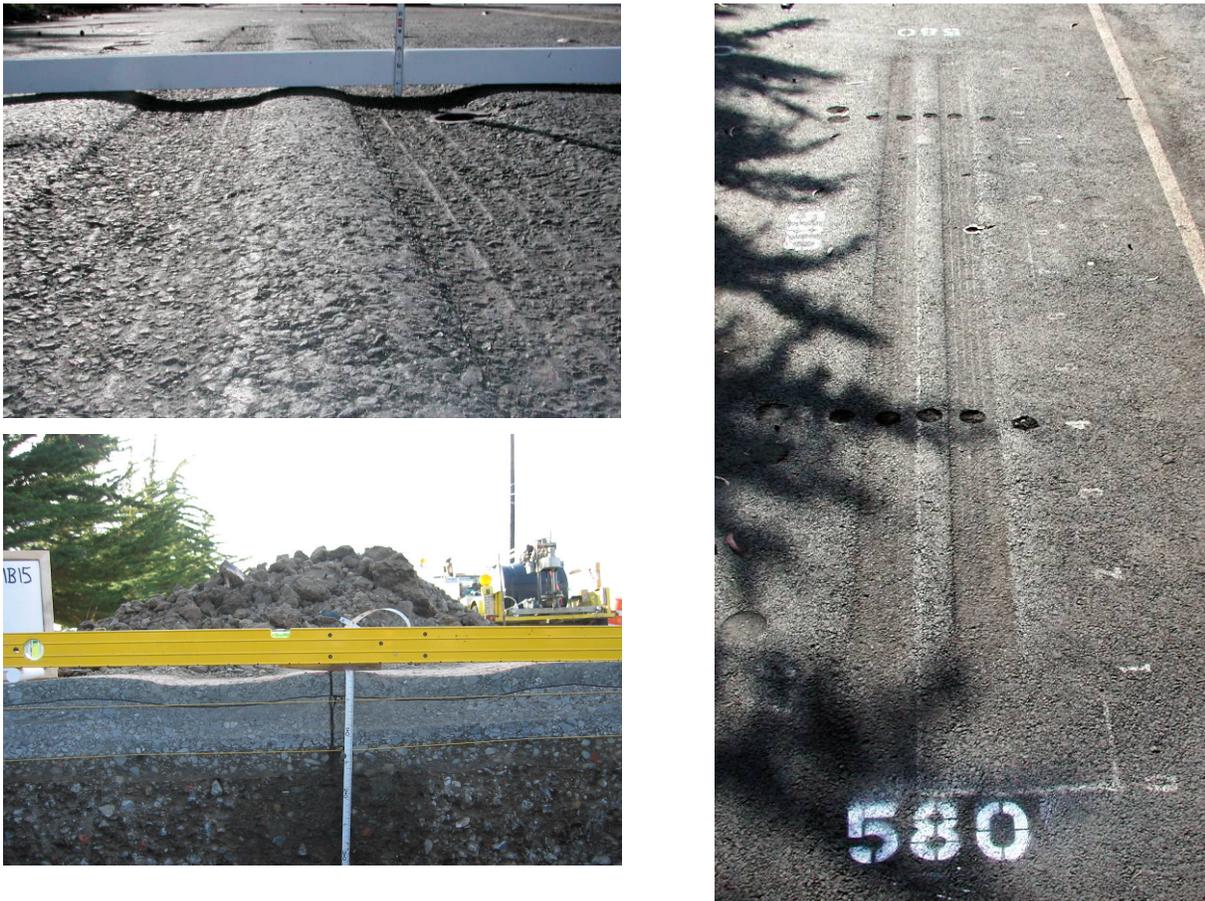
Figure 3.13: 580RF: Section photographs at the end of the test.

Apart from rutting, no other distress was recorded on the section. Figure 3.13 shows photographs taken of the surface at the end of the test.

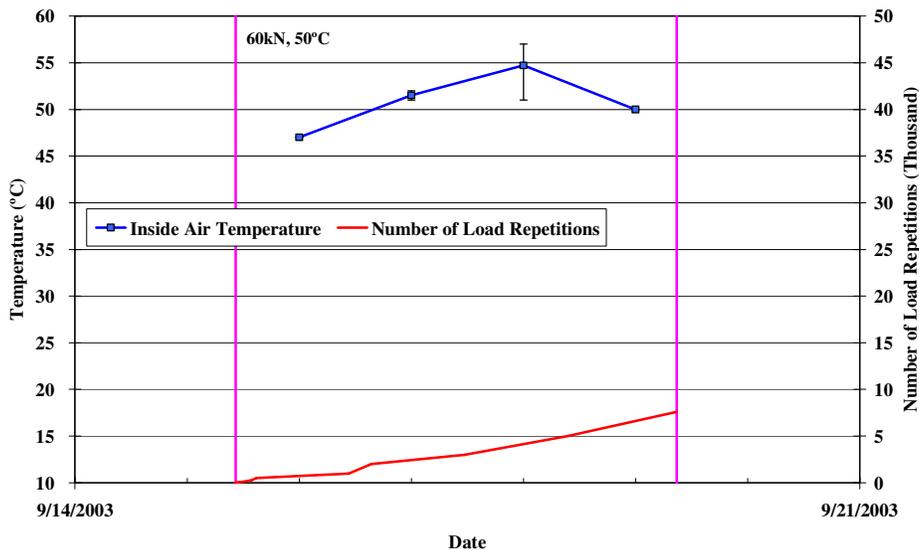
Figure 3.14: 581RF: Daily average air temperatures inside the temperature control chamber.

Air temperatures inside the temperature control chamber ranged from 51°C to 57°C, with an average of 53°C and standard deviation of 3.2°C. Air temperatures were adjusted to maintain a pavement temperature of 50°C±4°C. The daily average air temperatures recorded in the temperature control unit, calculated from the hourly temperatures recorded during HVS operation, are shown in Figure 3.14. Vertical errors bars show daily temperature range.

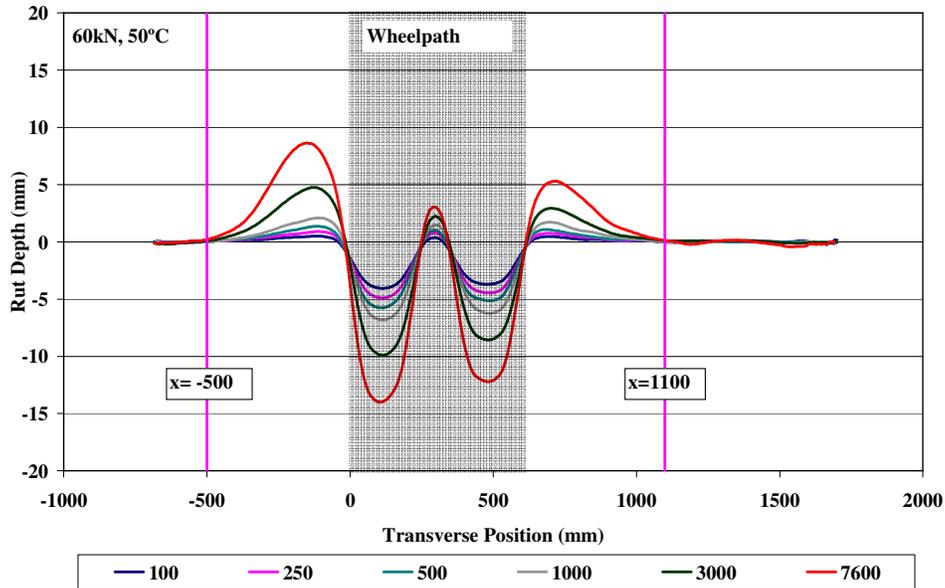
Figure 3.18: 581RF: Profilometer cross section at various load repetitions.

Figure 3.18 shows the average transverse cross section measured with the Laser Profilometer at various stages of the test and clearly indicates the increase in rutting and deformation over the duration of the test.

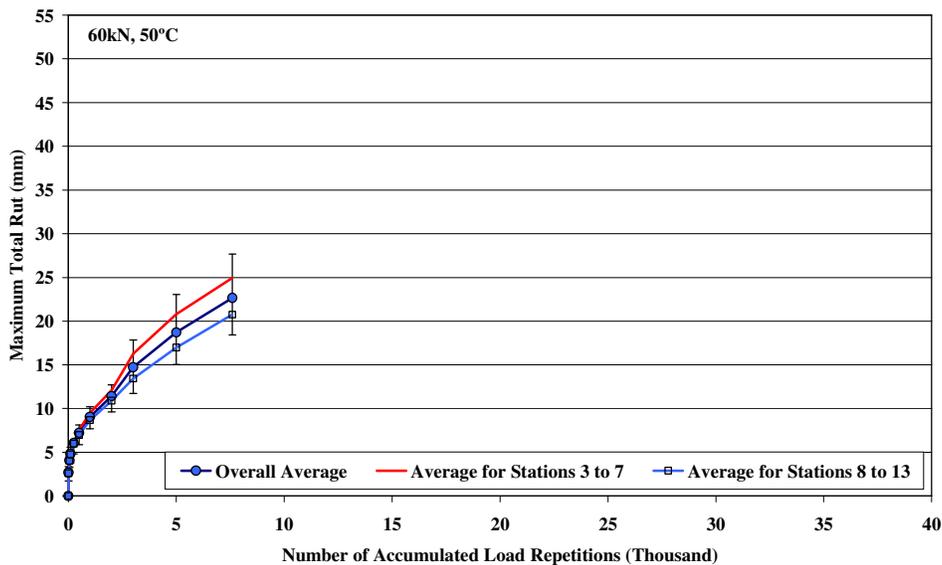
Figure 3.19: 581RF: Average maximum rut.

Figures 3.19 and 3.20 show the development of permanent deformation (average maximum rut and average deformation, respectively) with load repetitions as determined by the Laser Profilometer for the test section, with an embedment phase only apparent at the beginning of the experiment. Error bars on the average reading indicate variation along the length of the section. Figure 3.21 shows a contour plot of the pavement surface at the end of the test (7,600 repetitions). After completion of trafficking, the average maximum rut depth and the average deformation were 22.7 mm and 10.3 mm, respectively. The maximum rut depth measured on the section was 27.6 mm. Rut development was rapid with the failure criteria of an average of 12.5 mm total rut depth reached after 2,324 load repetitions.

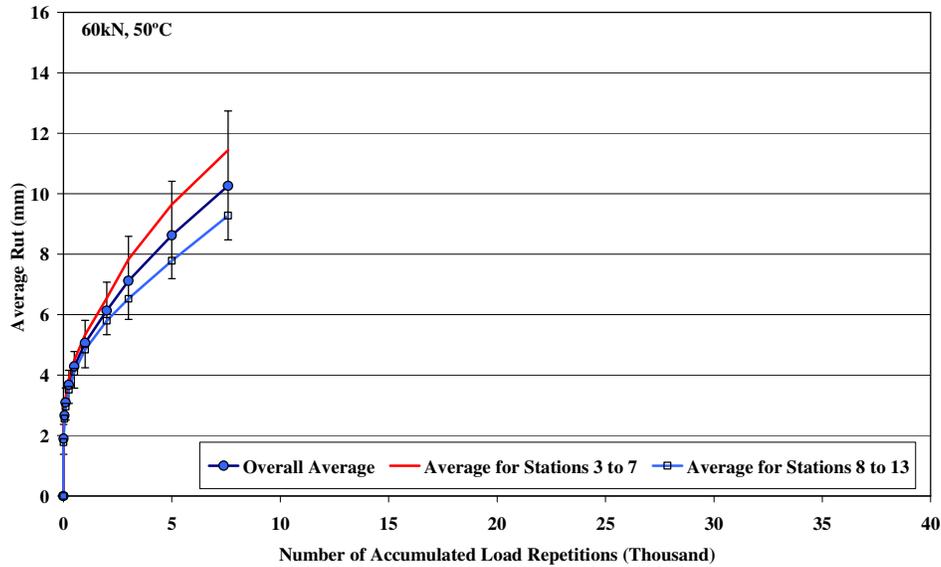
Figure 3.20: 581RF: Average deformation.

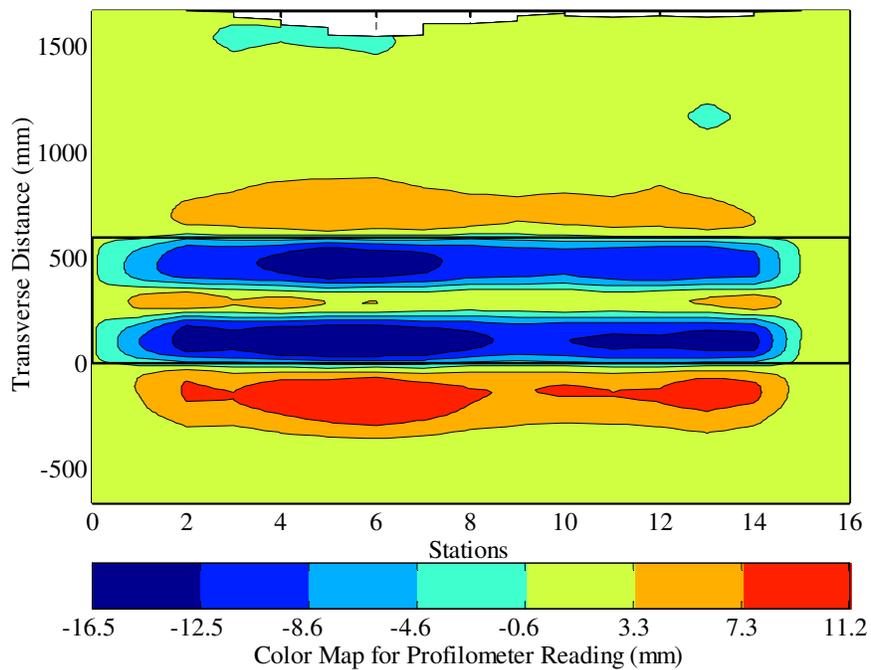
Figure 3.21: 581RF: Contour plot of permanent deformation after 7,600 repetitions.

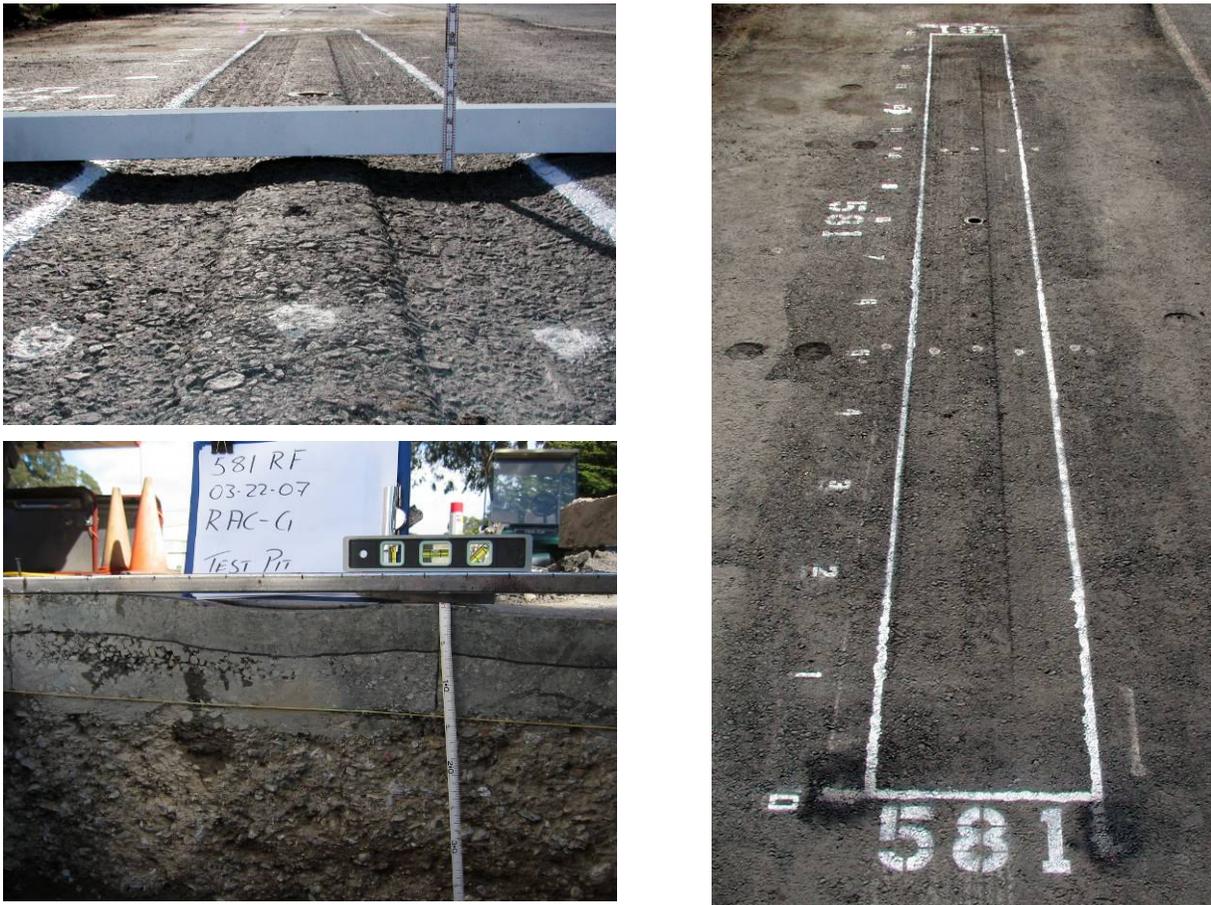
Figure 3.24: 581RF: Section photographs at the end of the test.

Apart from rutting, no other distress was recorded on the section. Figure 3.24 shows photographs taken of the surface at the end of the test.

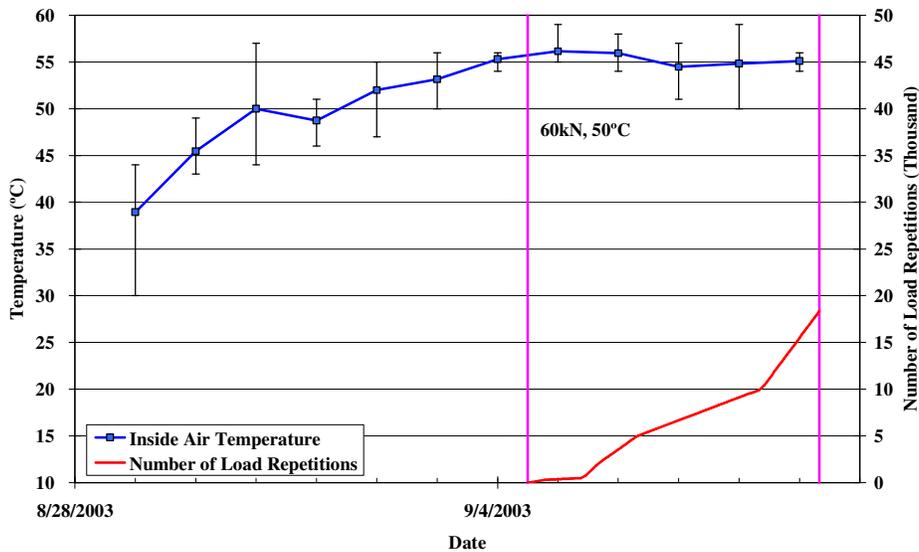
Figure 3.25: 582RF: Daily average air temperatures inside the temperature control chamber.

The daily average air temperatures recorded in the temperature control unit, calculated from the hourly temperatures recorded during HVS operation, are shown in Figure 3.25. Vertical errors bars on each point on the graph show daily temperature range.

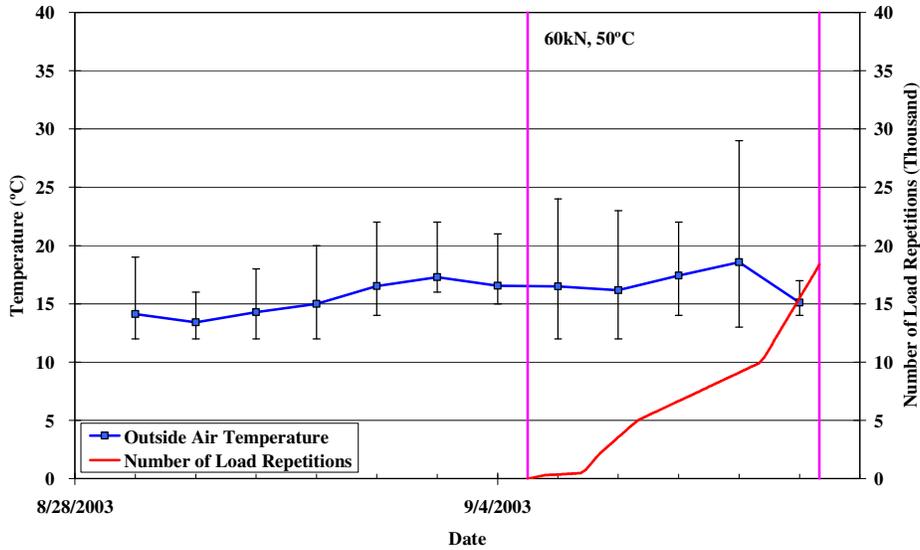
Figure 3.26: 582RF: Daily average air temperatures outside the temperature control chamber.

Outside air temperatures ranged from 12°C to 29°C with an average of 17.1°C and are summarized in Figure 3.26. Vertical error bars on each point on the graph show daily temperature range.

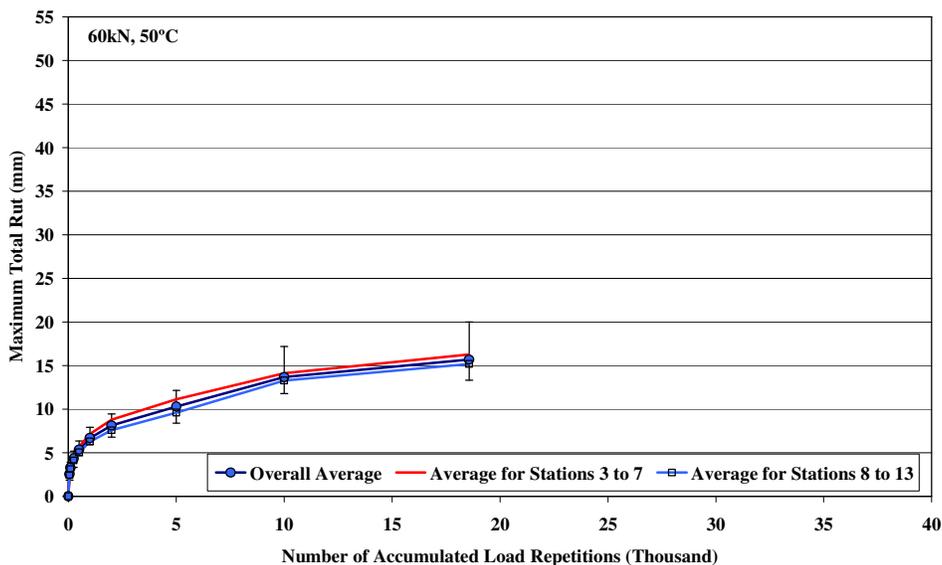
Figure 3.30: 582RF: Average maximum rut.

Figures 3.30 and 3.31 show the development of permanent deformation (average maximum rut and average deformation, respectively) with load repetitions as determined by the Laser Profilometer for the test section, with an embedment phase only apparent at the beginning of the experiment. Error bars on the average reading indicate variation along the length of the section. Figure 3.32 shows a contour plot of the pavement surface at the end of the test (18,564 repetitions). After completion of trafficking, the average maximum rut depth and the average deformation were 15.6 mm and 8.1 mm, respectively. The maximum rut depth measured on the section was 20.0 mm. Rut development was rapid with the failure criteria of an average of 12.5 mm total rut depth reached after 8,266 load repetitions.

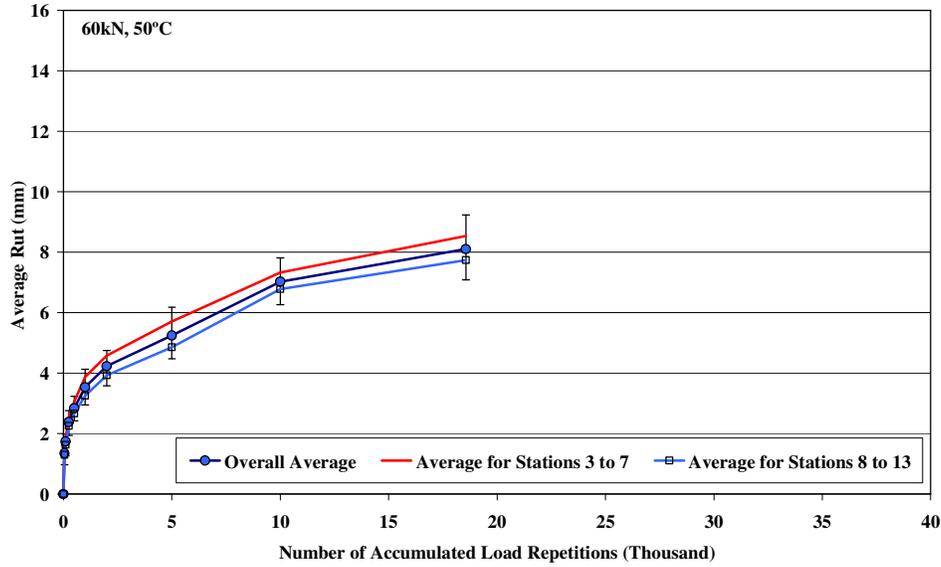
Figure 3.31: 582RF: Average deformation.

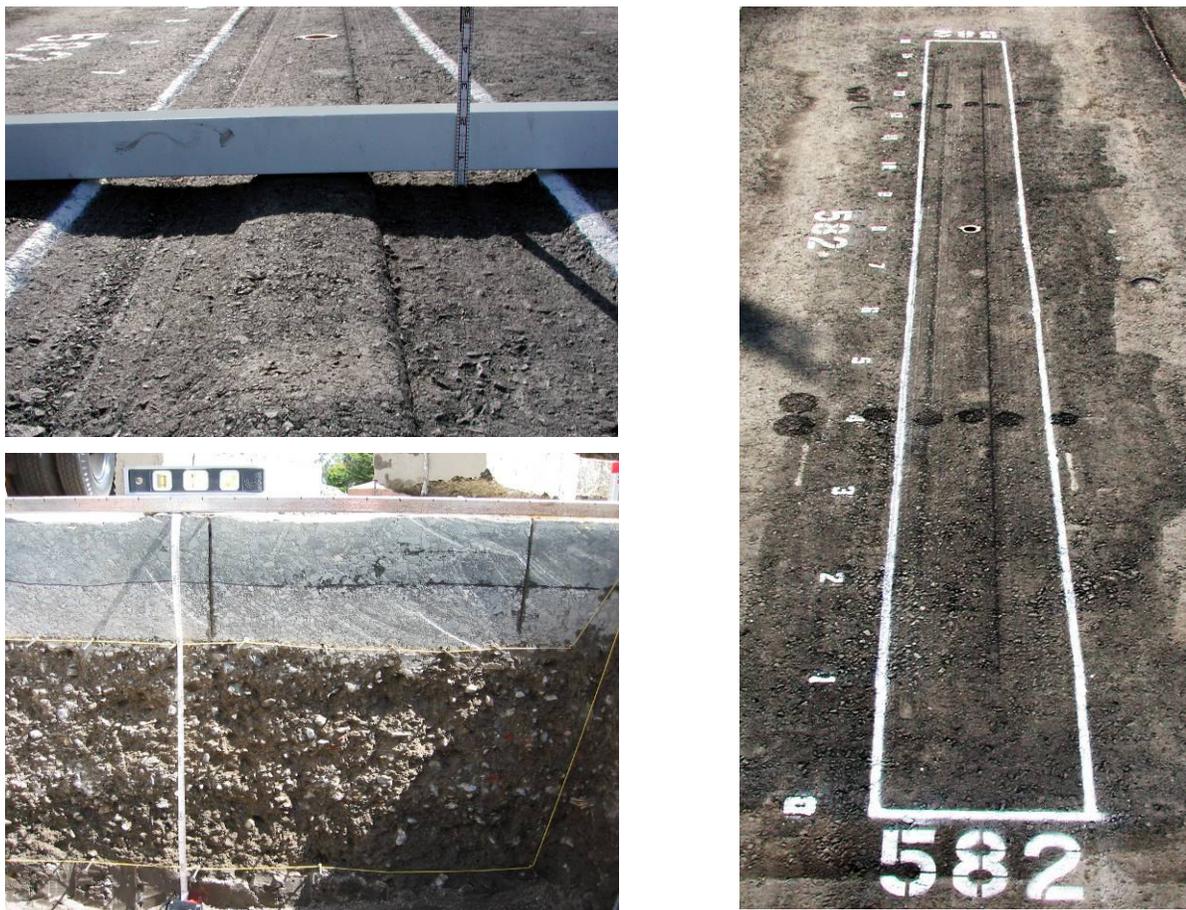
Figure 3.35: 582RF: Section photographs at the end of the test.

Apart from rutting, no other distress was recorded on the section. Figure 3.35 shows photographs taken of the surface at the end of the test.

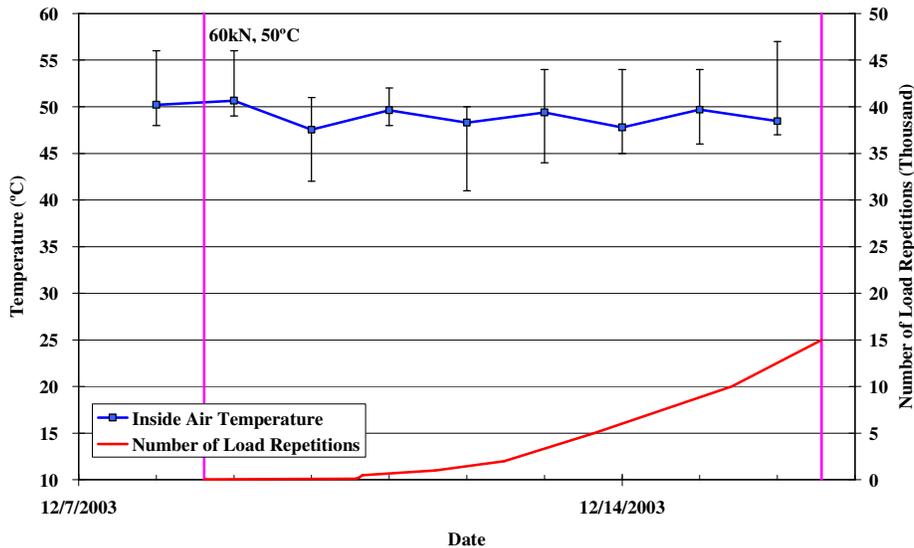
Figure 3.36: 583RF: Daily average air temperatures inside the temperature control chamber.

Air temperatures inside the temperature control chamber ranged from 41°C to 57°C, with an average of 49°C and a standard deviation of 3.9°C. Air temperatures were adjusted to maintain a pavement temperature of 50°C±4°C. The daily average air temperatures recorded in the temperature control unit, calculated from the hourly temperatures recorded during HVS operation, are shown in Figure 3.36. Vertical error bars on each point on the graph show daily temperature range.

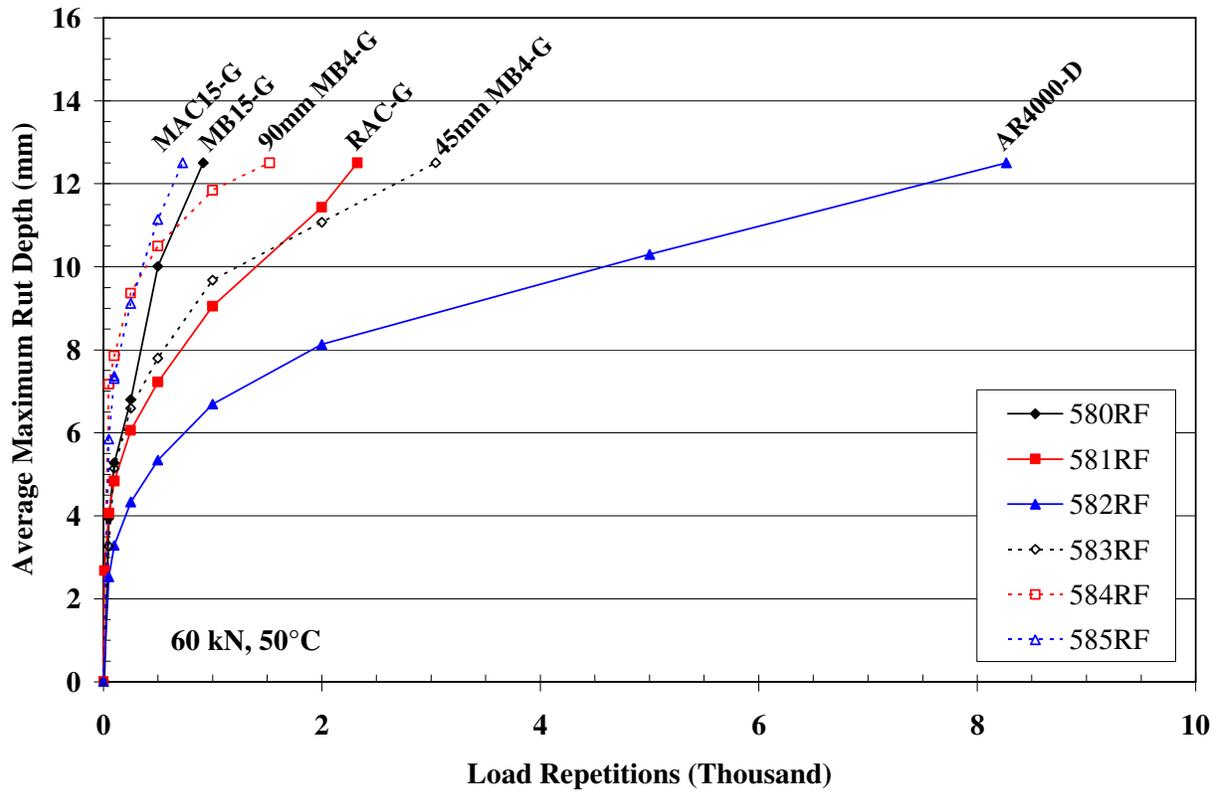
Figure 4.1: Progression of average maximum rut depth to 12.5 mm (0.5 in) failure criteria.
