Reflective Cracking Study: First-level Report on HVS Testing on Section 587RF — 45 mm RAC-G Overlay

Authors:
R. Wu, D. Jones and J. Harvey

University of California
Pavement Research Center
UC Davis, UC Berkeley

Prepared for: Caltrans	FHWA No: CA091073G	Date: January 2007
Contract No: 65A0172	Client Reference No: SPE 4.10	Status: Stage 6, Approved Version

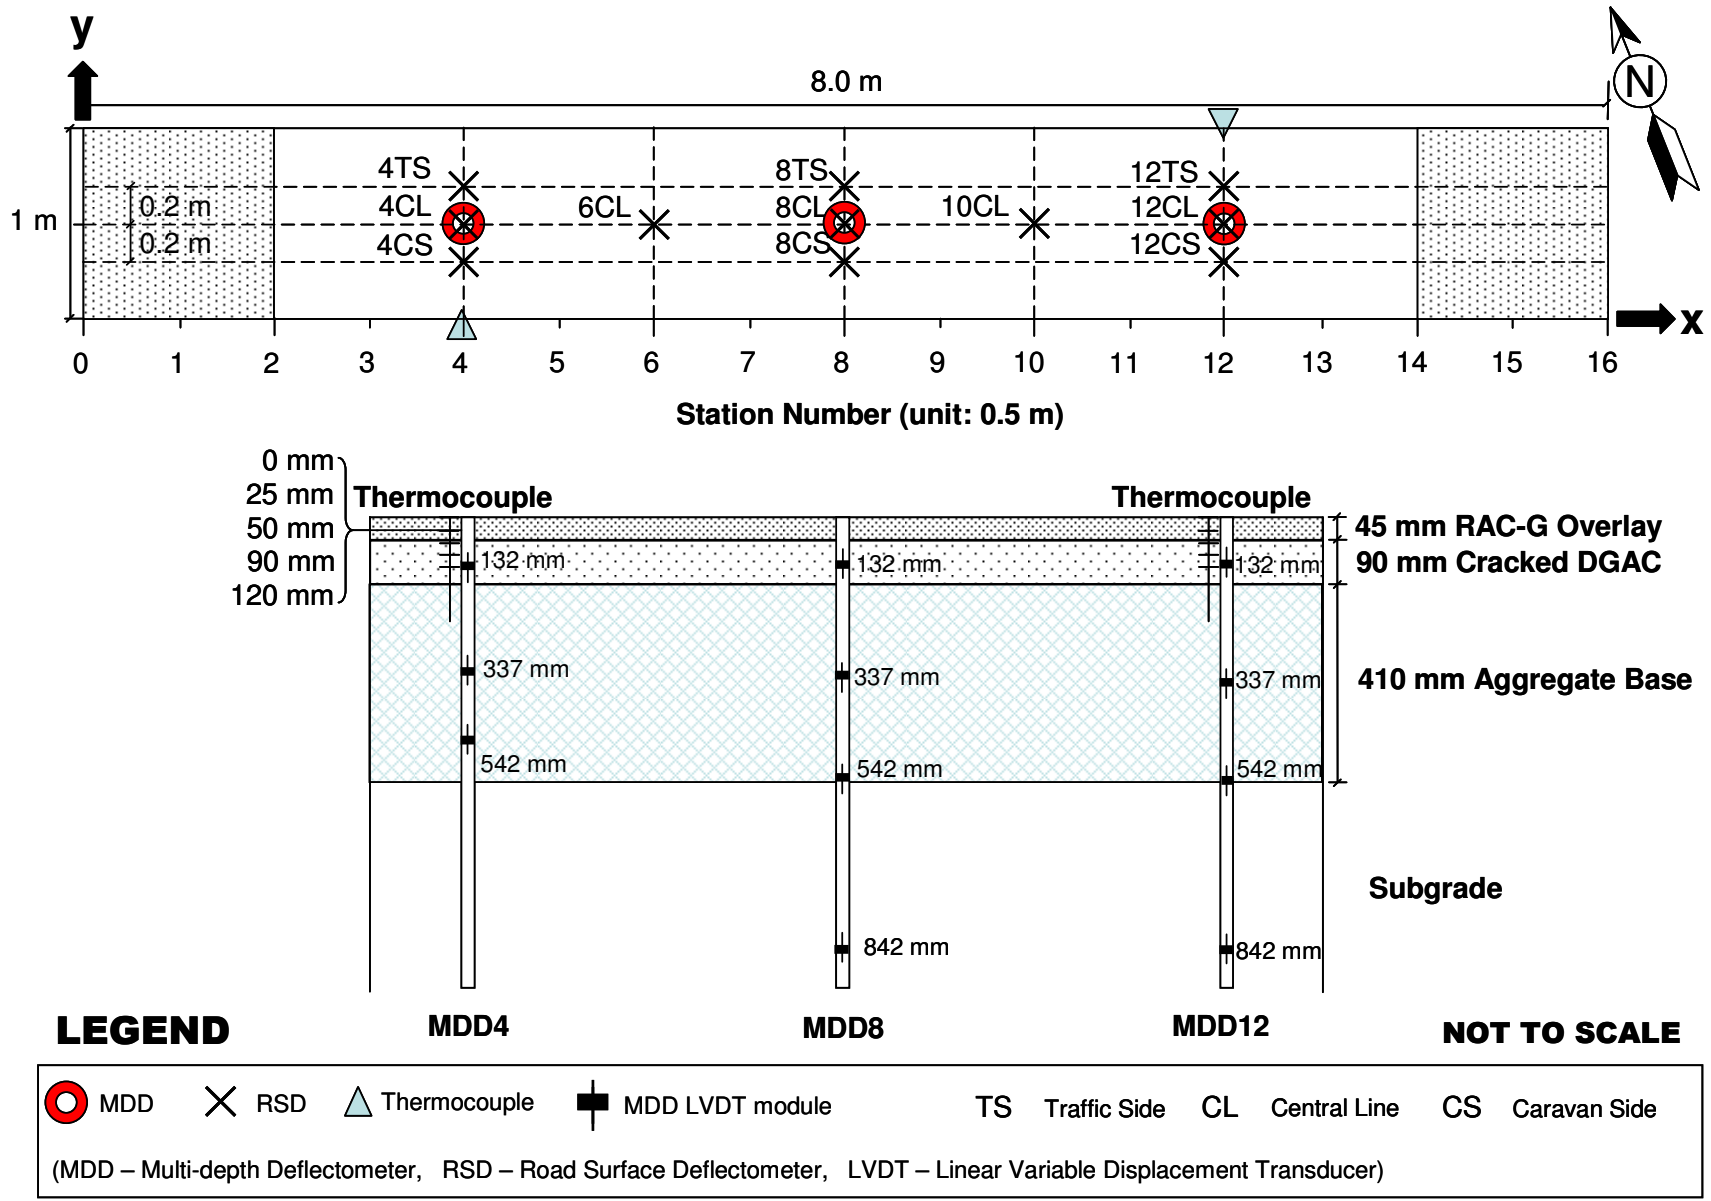
Figure 2.2: Section 587RF layout and location of instruments.

The test section layout for Section 591RF is shown in Figure 2.2. Station numbers refer to fixed points on the test section and are used for measurements and as a reference for discussing performance.

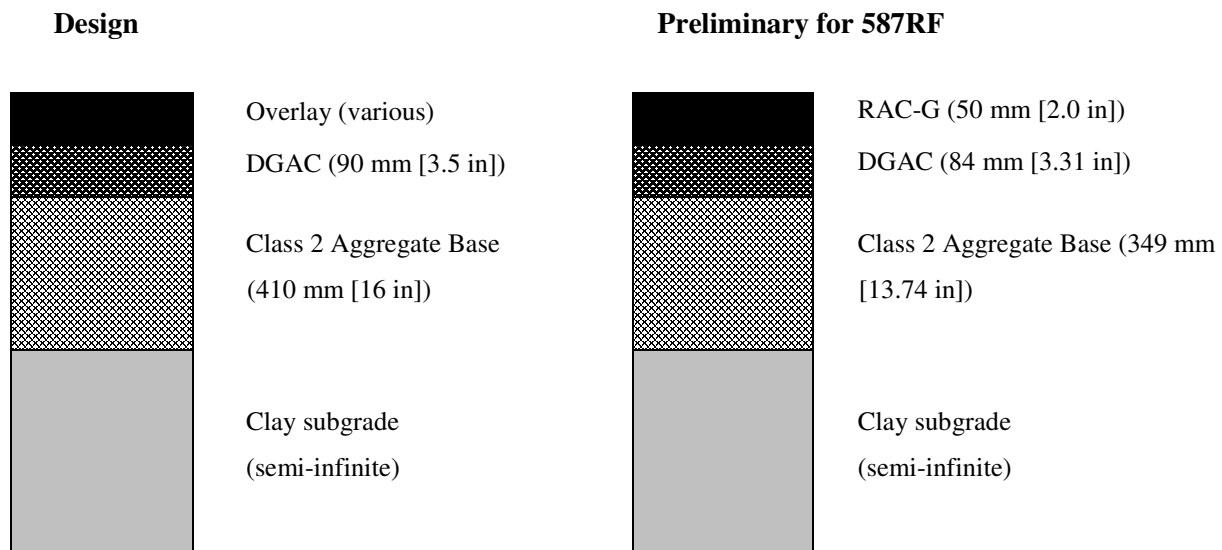
Figure 2.2: Pavement design for the Reflective Cracking Study test track
(Design and preliminary actual for 587RF)

The pavement for the first phase of HVS trafficking was designed according to the Caltrans Highway Design Manual Chapter 600 using the computer program *NEWCON90*. Design thickness was based on a tested subgrade R-value of 5 and a Traffic Index of 7 (~121,000 ESALs) (3). The pavement design for the test road and the preliminary as-built pavement structure for Section 587RF (determined from cores removed from the edge of the section) are illustrated in Figure 2.3.

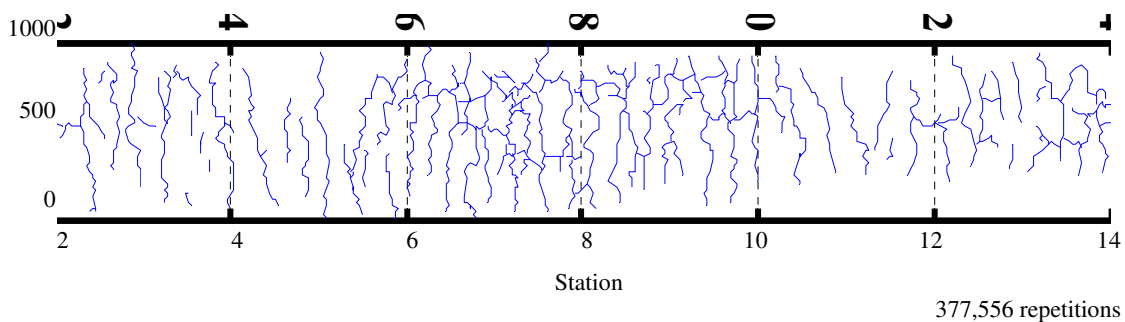
Figure 2.3: Cracking pattern on Section 568RF after Phase I HVS testing.

Trafficking of the underlying Section 568RF took place between January 14, 2002, and February 12, 2002, during which 377,556 repetitions were applied. Figure 2.3 presents the final cracking pattern after testing. Cracking was mostly transverse. Total crack length was 41.72 m (136.88 ft) and crack density was 5.96 m/m² (1.82 ft/ft²).

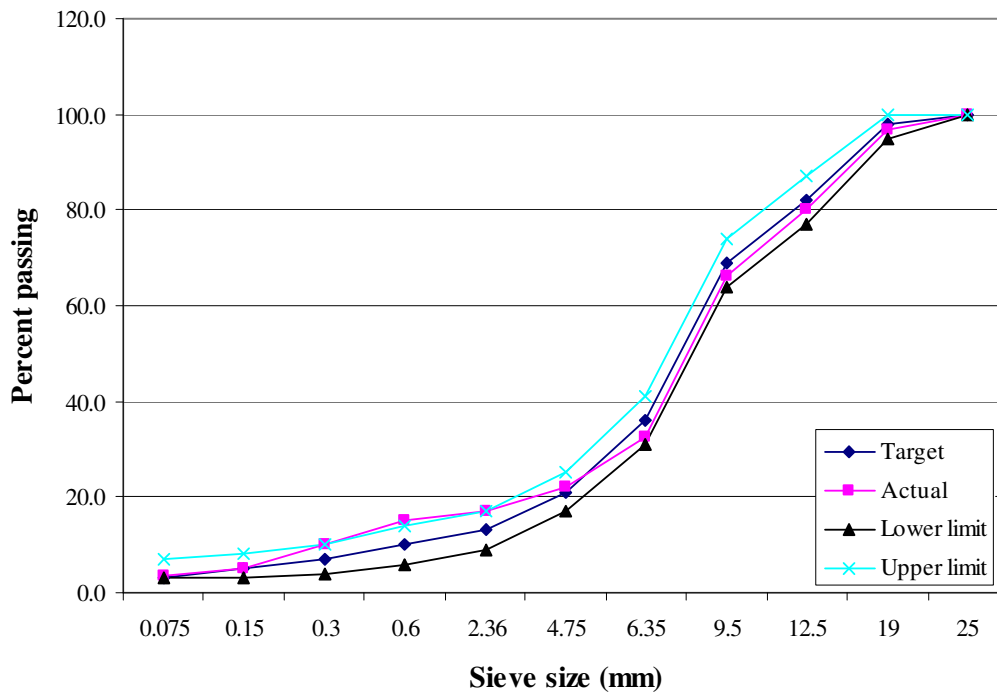
Figure 2.4: Actual vs. target gradation for RAC-G overlay.

Laboratory testing was carried out by Caltrans and UCPRC on samples collected during construction to determine actual binder properties, binder content, aggregate gradation, and air-void content. The RAC-G binder met the Caltrans binder specification, based on testing performed by Caltrans. The ignition-extracted binder content, corrected for aggregate ignition, showed an average value of 8.49 percent, marginally higher than the design binder content of 8.0 percent. The aggregate gradation met Caltrans specifications for a 19.0 mm (3/4 inch) maximum size gap gradation, with material passing the 0.3 mm (#50), 0.6 mm (#30) and 2.36 mm (#8) sieves on the limit for fine gradation. Gradation is illustrated in Figure 2.4. The preliminary as-built air-void content was 8.8 percent with a standard deviation of 1.3 percent, based on cores taken outside of the HVS sections. Final air-void contents will be determined from trenching and coring to be performed after trafficking of all sections.

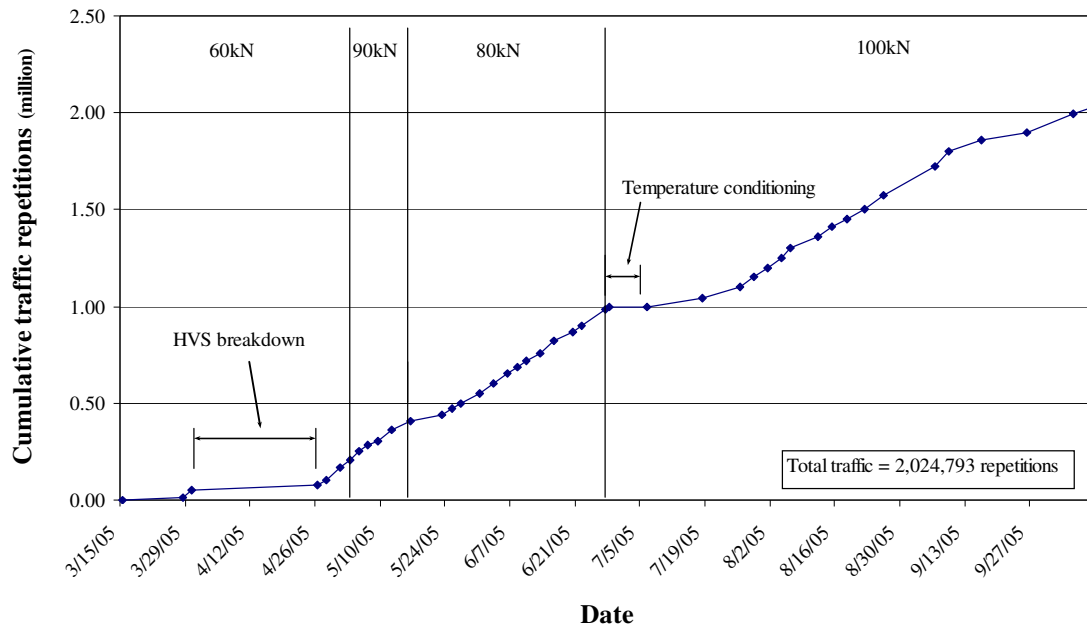
Figure 2.5: Cumulative traffic applications and loading history.

This loading equates to approximately 66 million equivalent standard axles, using the Caltrans conversion of $(\text{axle load}/18000)^{4.2}$, which in turn equates to a Traffic Index of 15.

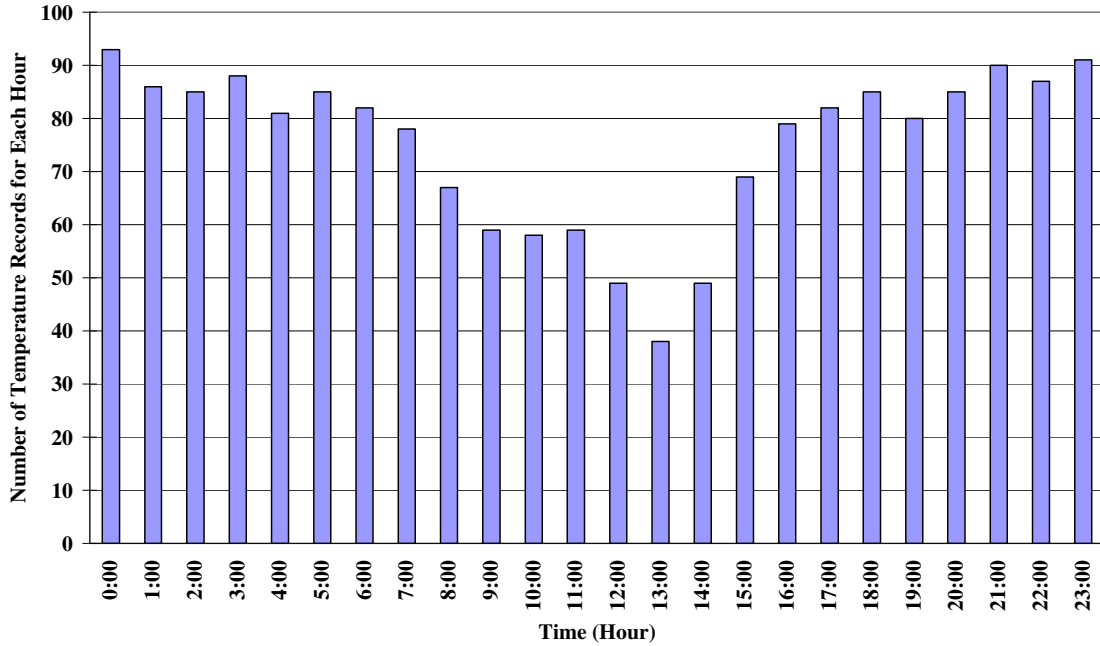
Figure 3.1: Frequencies of recorded temperatures.

- Zero to one million repetitions: mean of 19.8°C with a standard deviation of 1.9°C.
- One million to end of test: mean of 16.1°C with a standard deviation of 2.3°C.

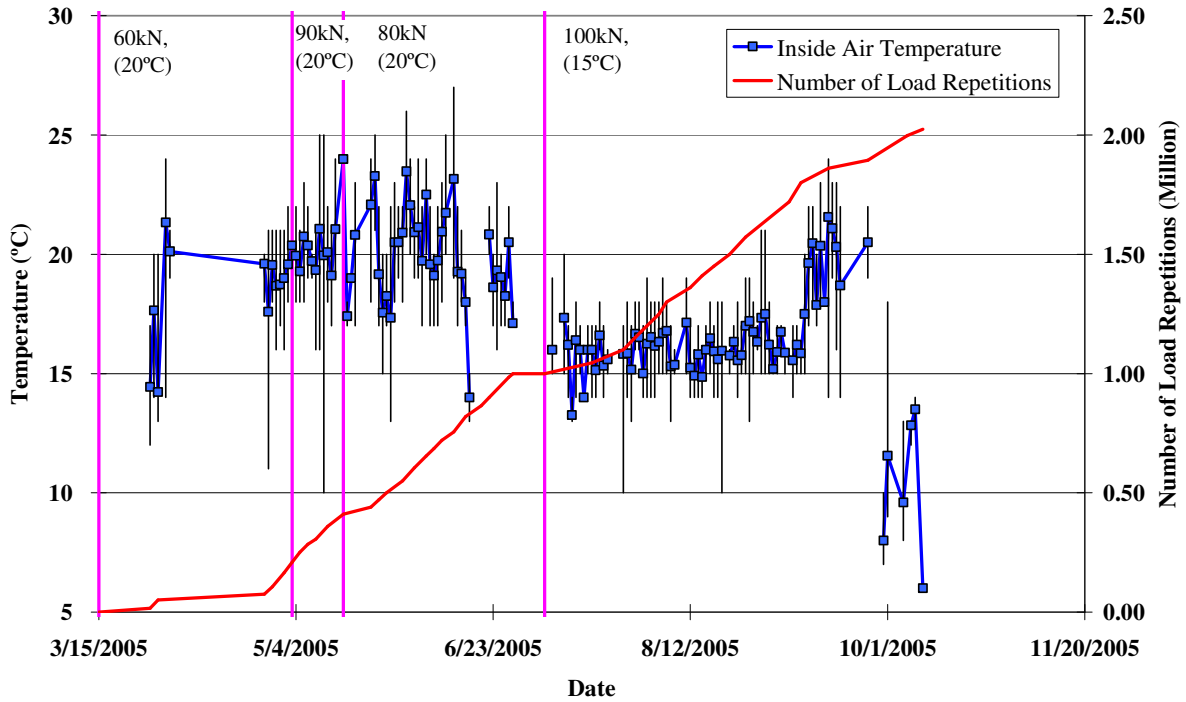
Figure 3.2: Daily average air temperatures inside the temperature control chamber.

The daily average temperatures recorded in the temperature control unit, calculated from the hourly temperatures recorded during HVS operation, are shown in Figure 3.2. Vertical errors bars on each point on the graph show daily temperature range.

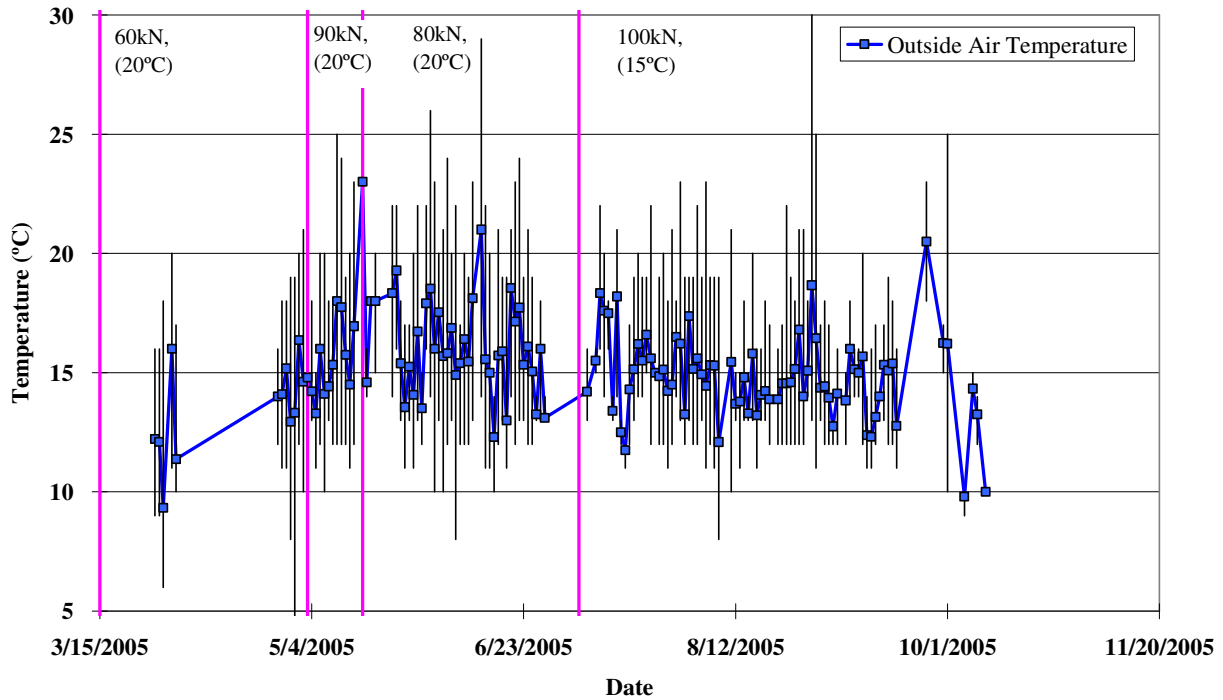
Figure 3.3: Daily average air temperatures outside the temperature control chamber.

Outside air temperatures ranged from 9.3°C to 23.0°C with an average of 15.1 C and are summarized in Figure 3.3. Vertical error bars on each point on the graph show daily temperature range.

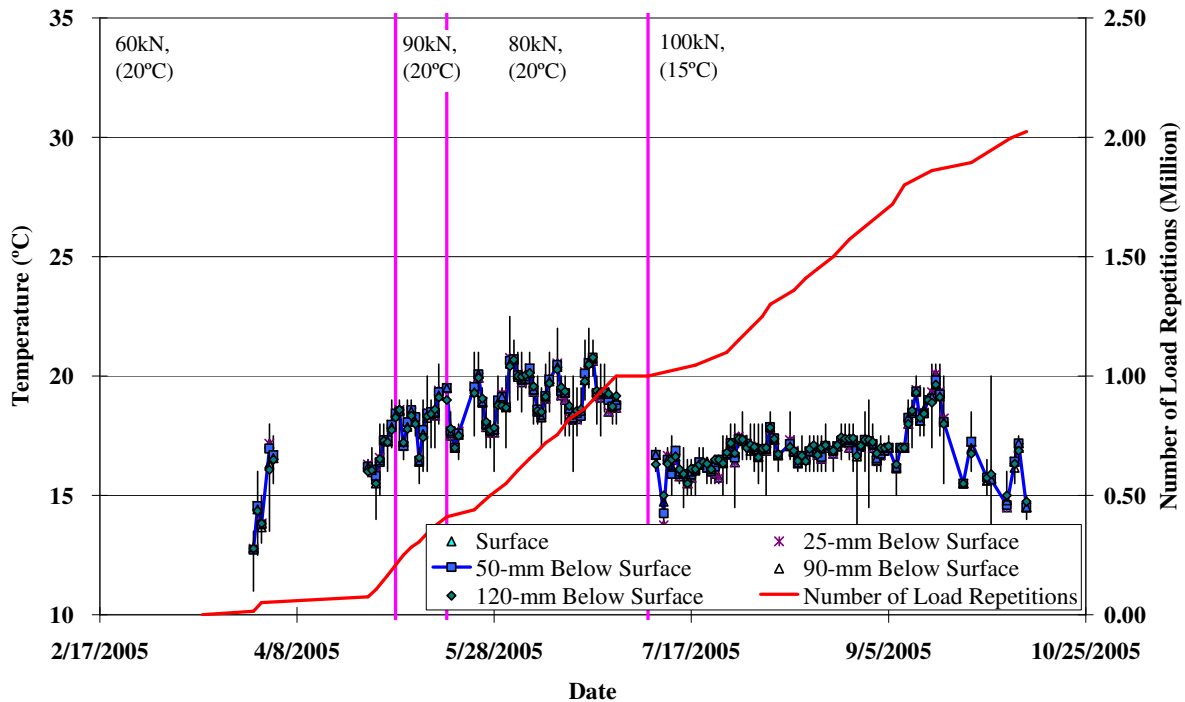
Figure 3.4: Daily average temperatures at pavement surface and various depths.

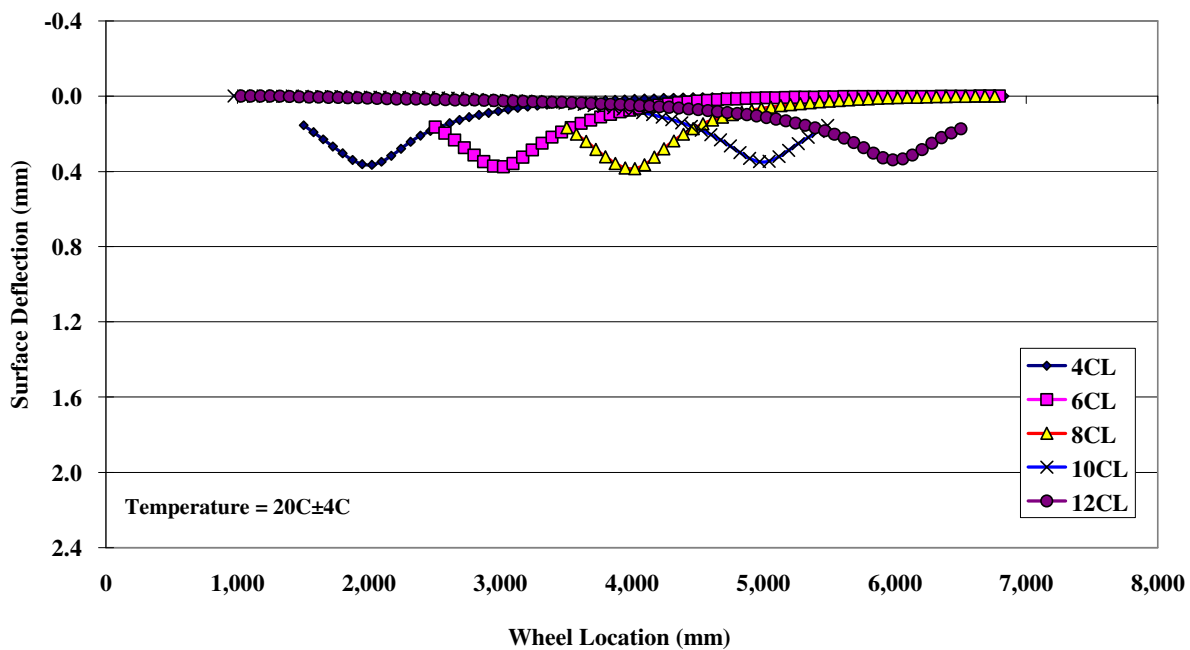
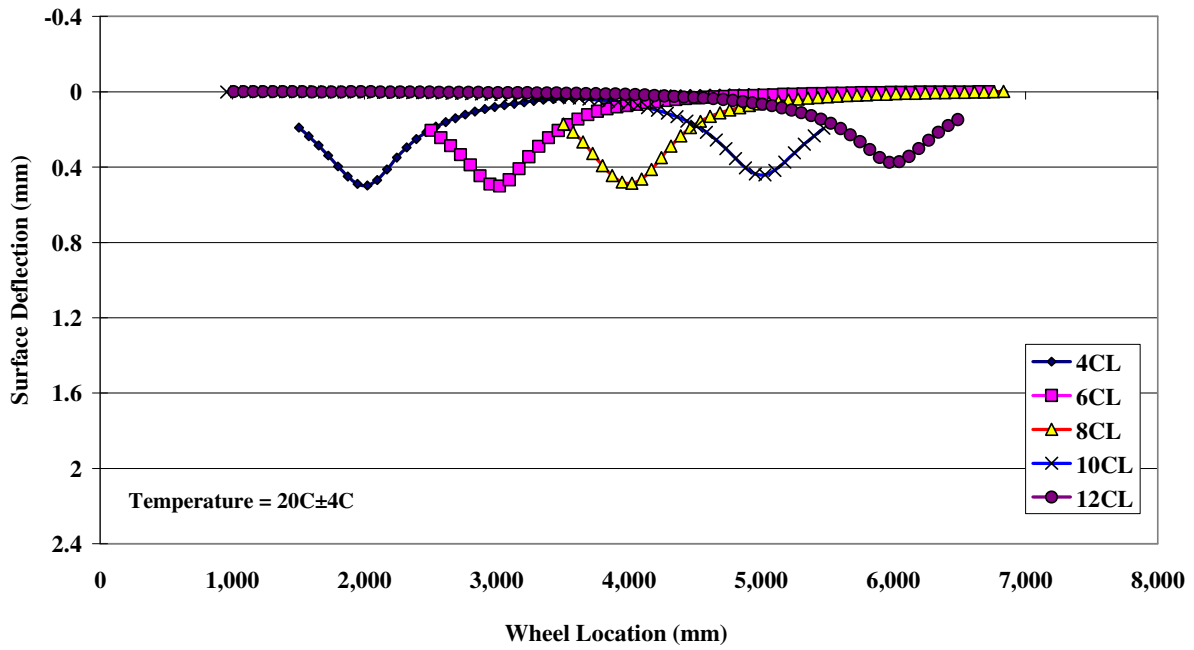
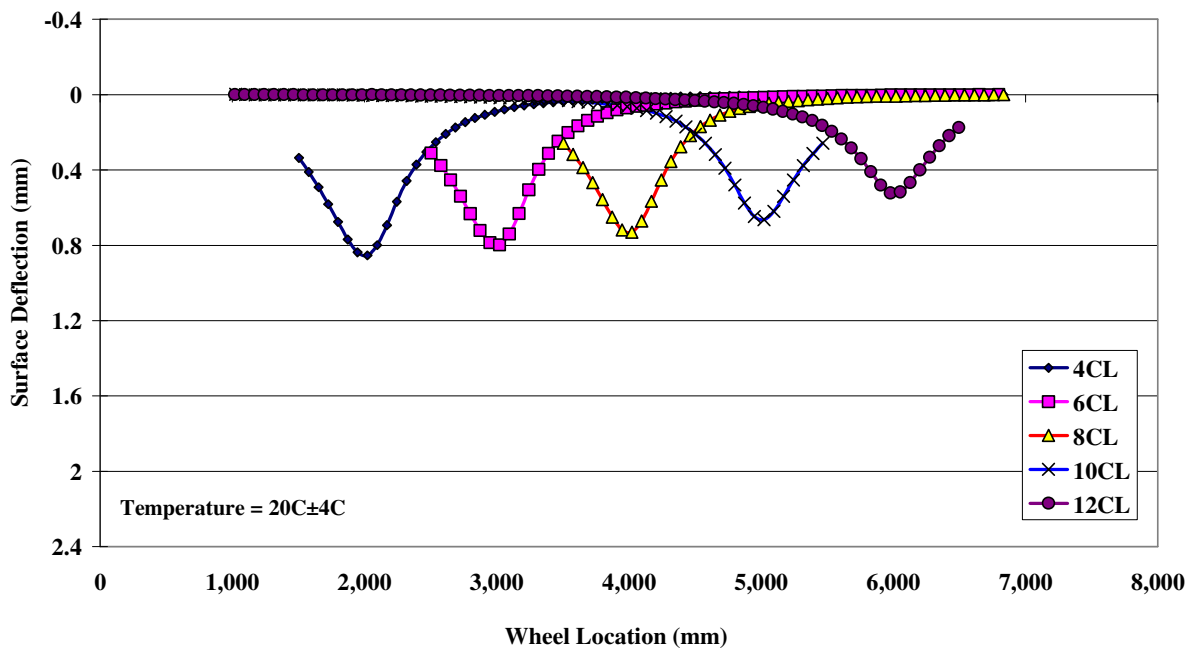
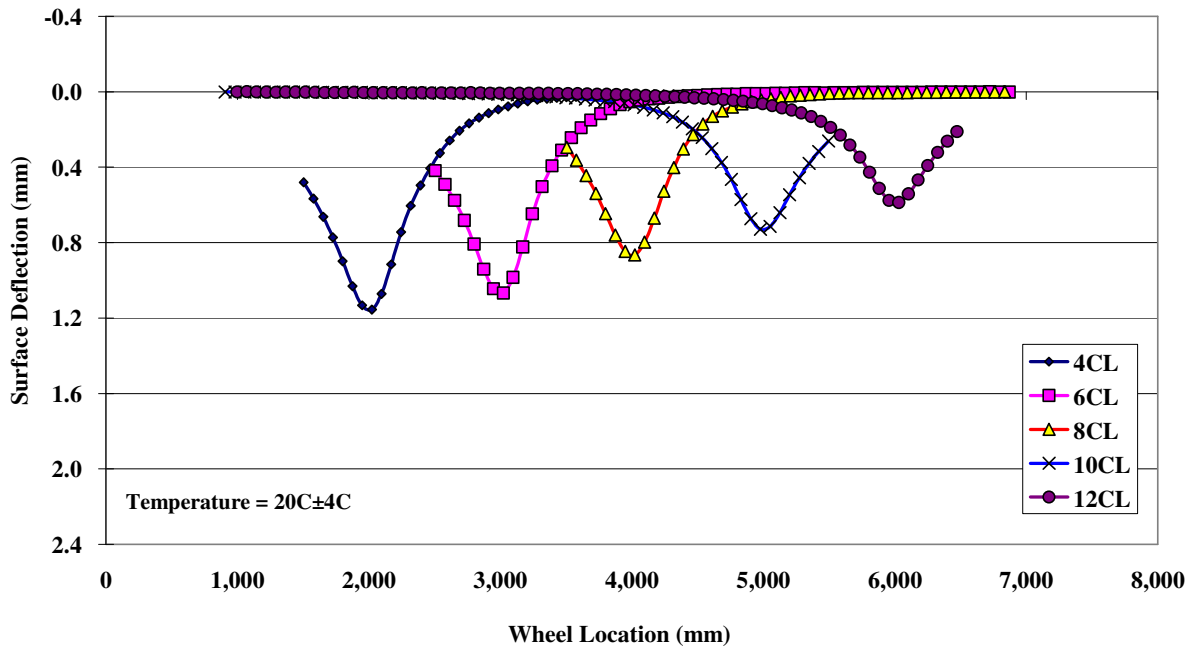
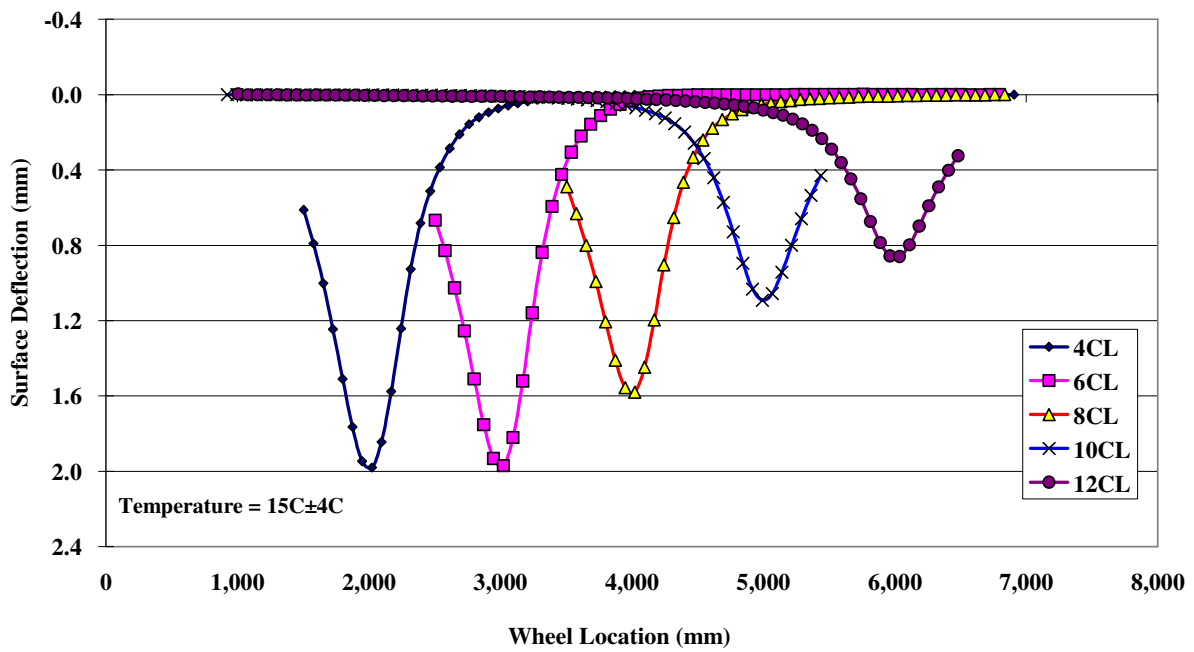
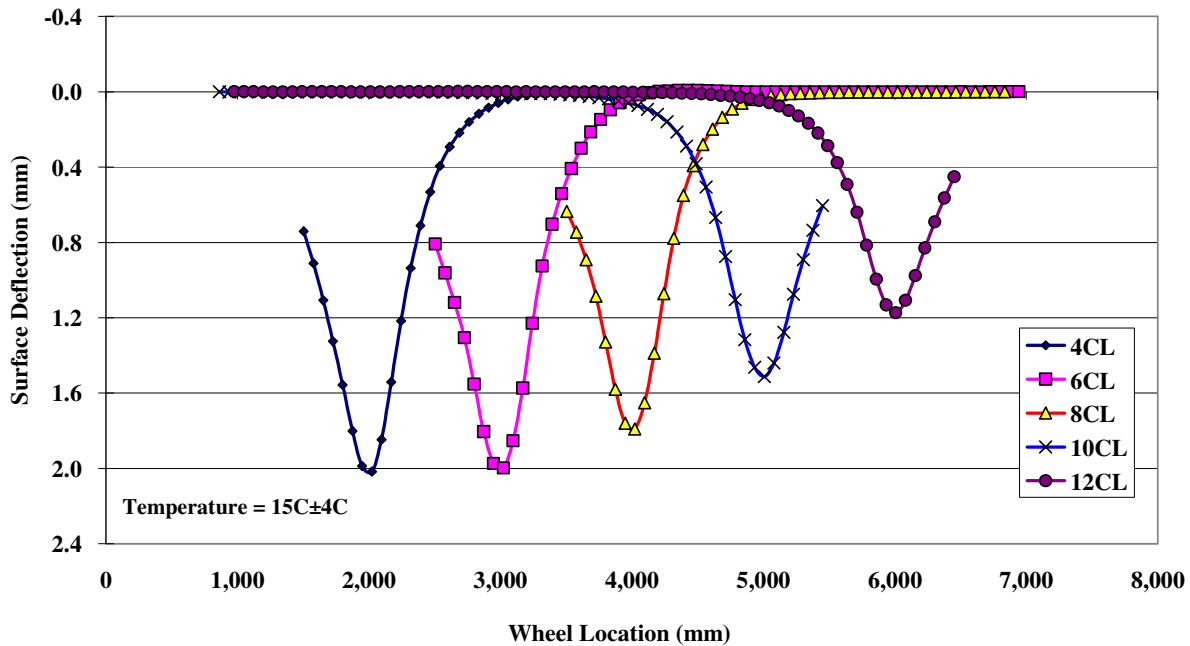
Figure 3.6: RSD deflections at CL locations with 60 kN test load at test start.

Figure 3.7: RSD deflections at CL locations with 60 kN test load after 208,896 repetitions.

Figure 3.8: RSD deflections at CL locations with 60 kN test load after 410,255 repetitions.

Figure 3.9: RSD deflections at CL locations with 60 kN test load after 1,000,000 repetitions.

Figure 3.10: RSD deflections at CL locations with 60 kN test load after 1,500,000 repetitions.

Figure 3.11: RSD deflections at CL locations with 60 kN test load at test completion.

Deflections and damage rates both increased with increase in load. Figures 3.6 to 3.11 compare the deflection bowls at the same locations at test start, load change intervals, 1,500,000 repetitions and at test completion. The same scale is used on all figures, and the increasing deflection over time and with load is clearly evident. The higher deflections at points 4CL, 6CL, and 8CL over the cracked underlying DGAC are obvious.

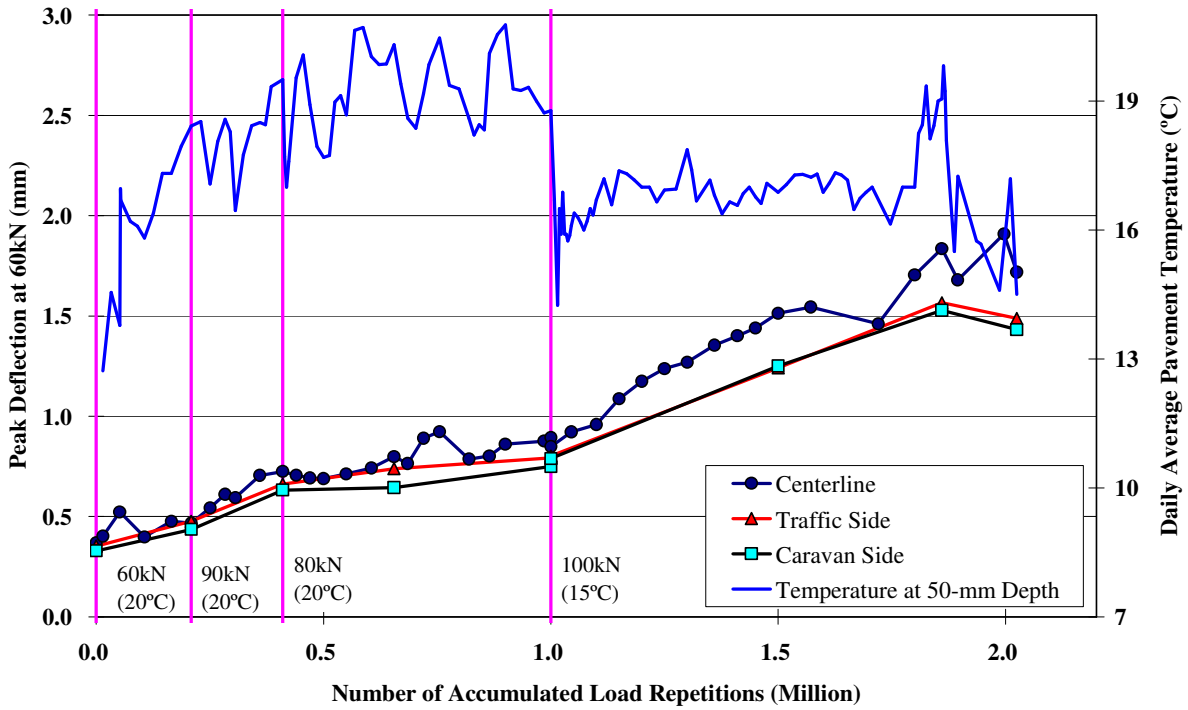
Figure 3.12: Average surface deflections with 60 kN test load (centerline and sides).

The average 60 kN RSD deflections at centerline and side locations (200 mm from centerline within the trafficked area) are illustrated in Figure 3.12. These deflections are mostly all within 0.2 mm of each other, although as expected the side deflections are less than those of the centerline. These results indicate that damage was somewhat greater in the vicinity of the centerline compared to the area away from the centerline where fewer repetitions are applied by the programmed wander of the HVS trafficking pattern.

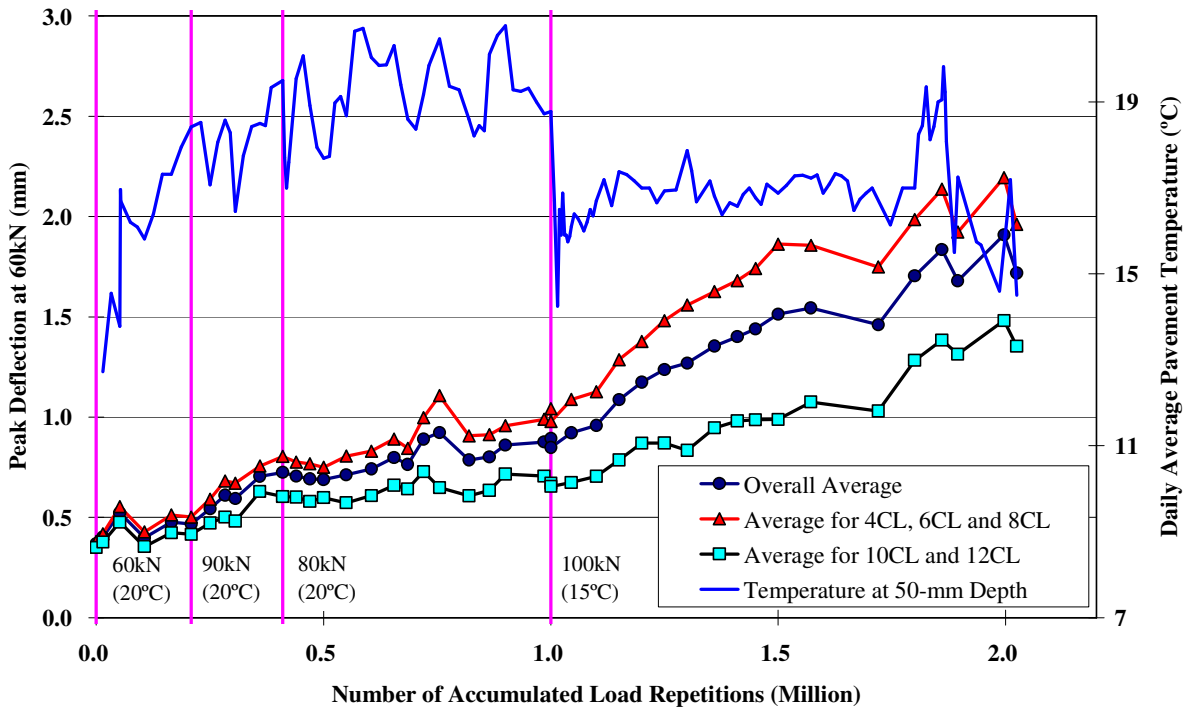
Figure 3.13: Average surface deflections with 60 kN test load (centerline and subsection).

Figure 3.13 shows the average 60 kN deflection at centerline as well as the averages for measurements taken at the end of the section with more severely cracked DGAC underneath (4CL, 6CL and 8CL) and the end with less severe cracking (10CL and 12CL). The difference in deflections is evident between the two ends. In Figures 3.12 and 3.13, some sensitivity of RSD deflection to temperature is evident, for example at approximately 100,000, 350,000, 750,000, the load change at 1,000,000, and at 1,750,000 repetitions. The influence of temperature on deflection will be discussed in the second-level analysis report. The sensitivity of the RSD to a load reduction is evident in the early phase of 80 kN loading.

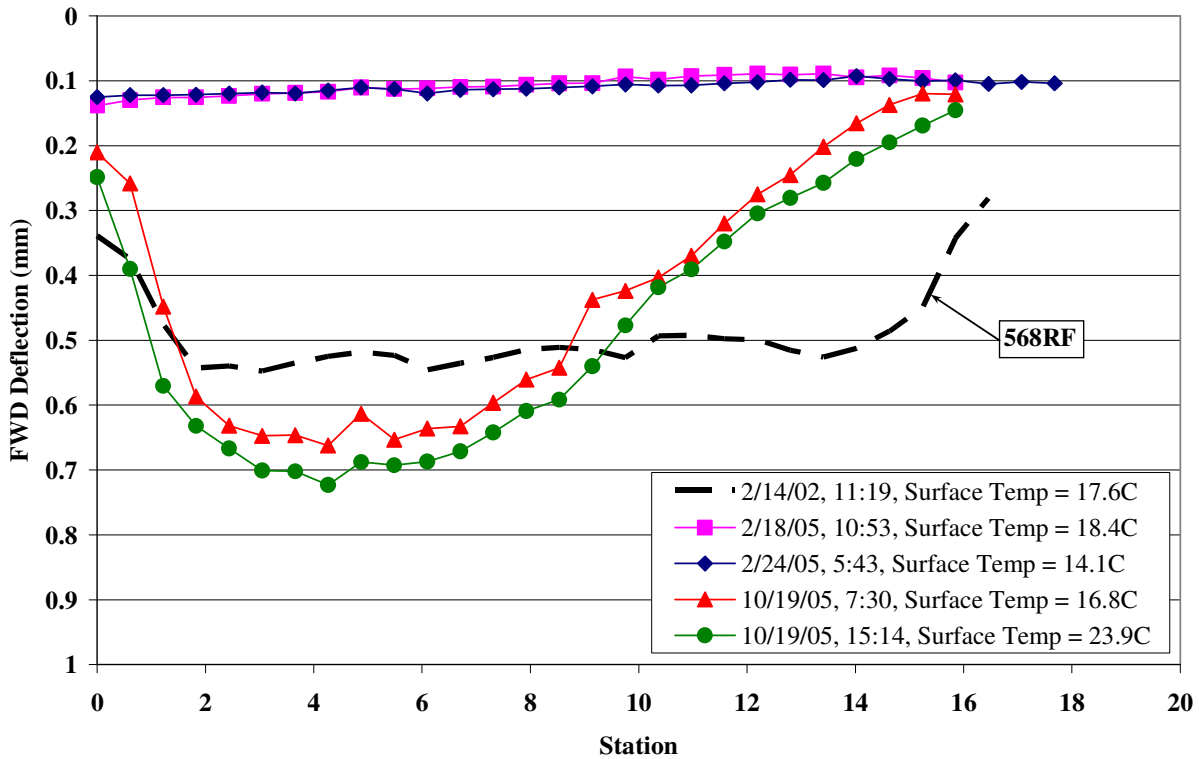
Figure 3.14: Composite pavement stiffness (FWD Sensor 1) on section centerline.

Figure 3.14 shows the effect of damage on the pavement over the course of the experiment. Deflection measured on Section 568RF prior to placing the overlay was relatively high, especially in the area of significant cracking. Placement of the overlay considerably reduced the deflection. However, considerable damage was again caused by the HVS trafficking, with higher damage recorded after the test on parts of the section (Stations 3 through 8) when compared to that after completion of testing on Section 568RF. The overlay provided some structural improvement over the area with less severe cracking (Stations 10 through 13). The figure also shows that deflections were influenced by temperature, with lower deflections measured in the morning (lower temperature) compared to those measured in the afternoon (higher temperature) at the end of the test.

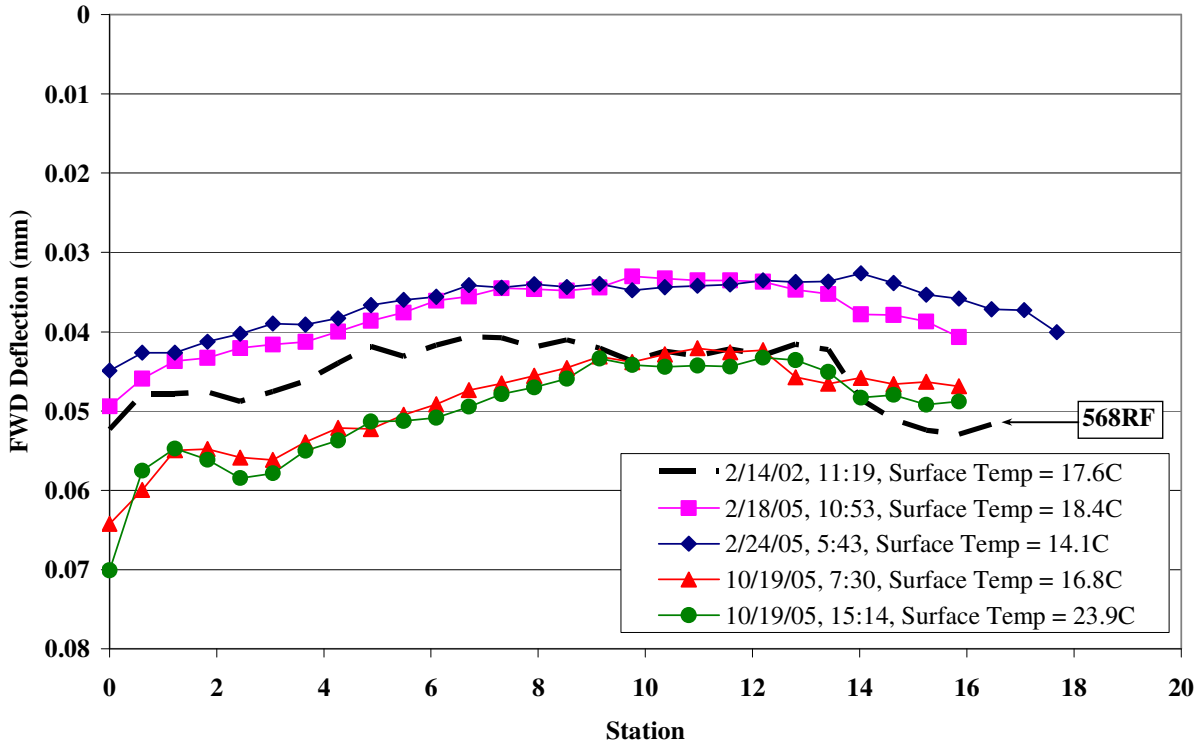
Figure 3.15: Subgrade pavement stiffness (FWD Sensor 6) on section centerline.

Figure 3.15 shows deflections in the subgrade before and after the test. These measurements indicate that there was no significant change (0.02 mm) during the course of the experiment, and that the overlay did not provide any significant structural improvement to the overall pavement structure in terms of protection of the subgrade. It appears that the subgrade was less stiff at the end of the section that had more cracking in the underlying DGAC (Stations 3 through 8). The slight increase in deflection on completion of the test could be attributed to moisture in the subgrade and/or increased deflections in the upper layers.

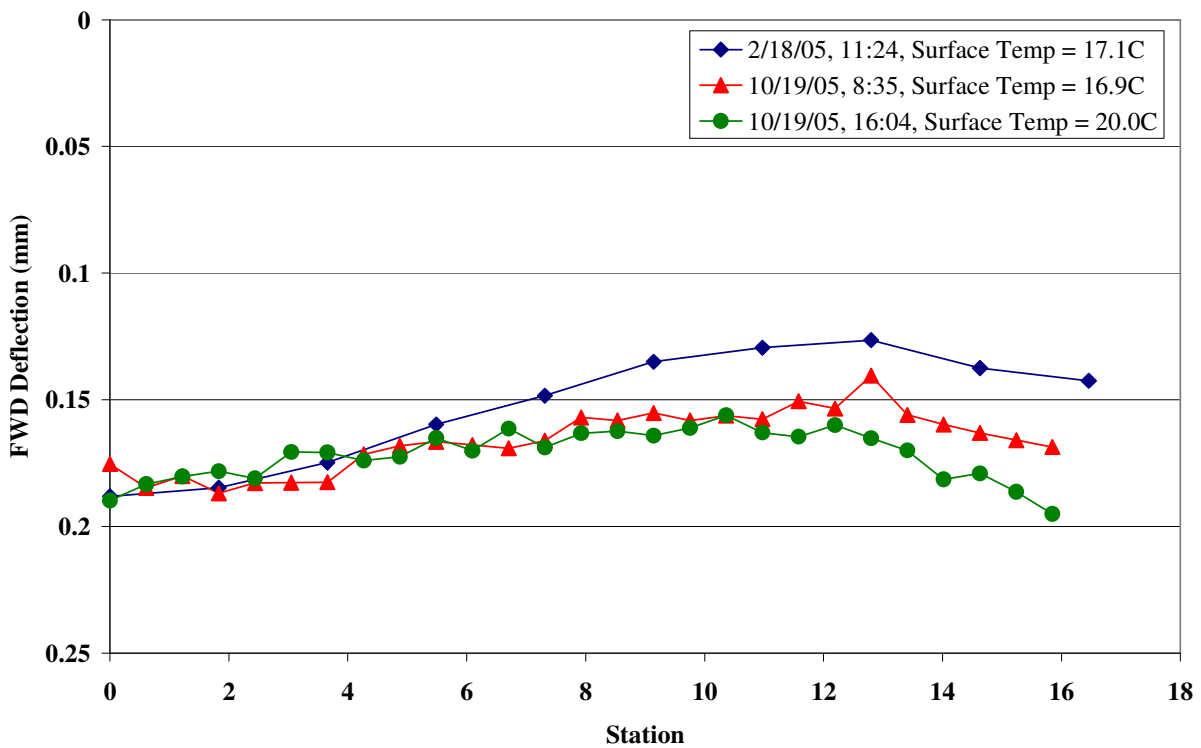
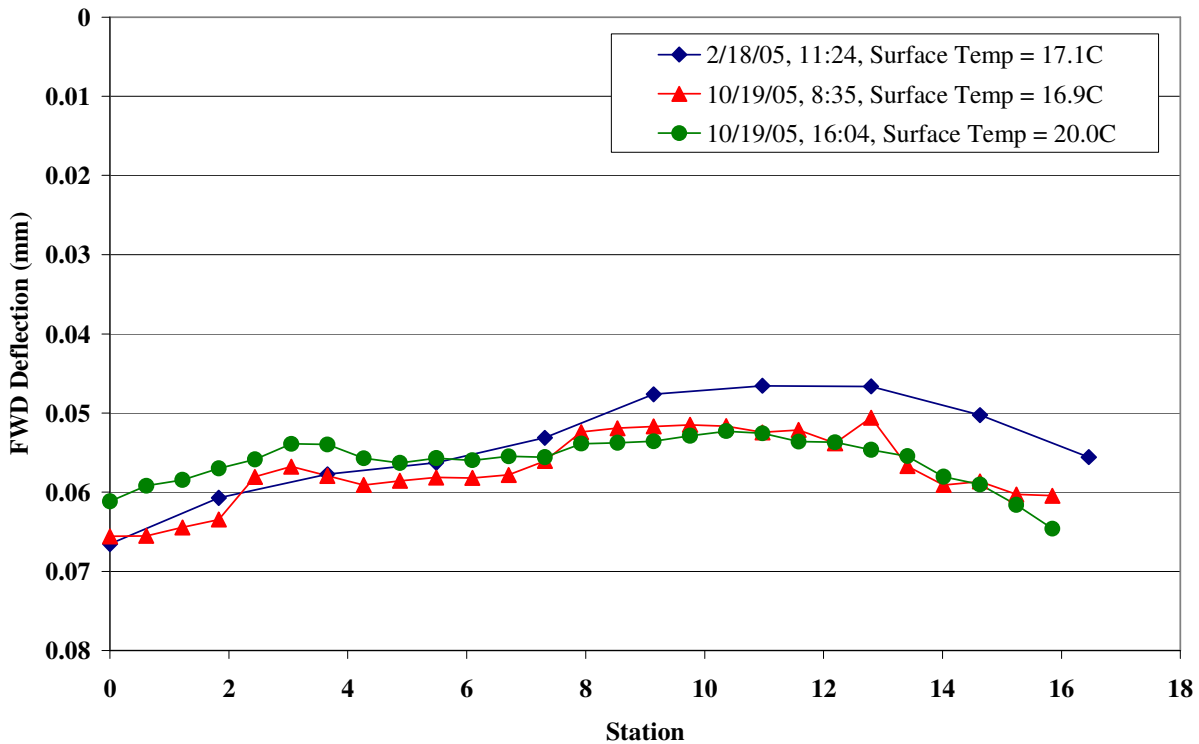
Figure 3.16: Composite pavement stiffness (FWD Sensor 1) outside trafficked area.

Figure 3.17: Subgrade pavement stiffness (FWD Sensor 6) outside trafficked area.

Figures 3.16 and 3.17 show FWD deflections taken along the side of the HVS test section but outside the trafficked area (i.e., the area tested did not have traffic damage). These figures can be used to understand the influence of environmental conditions on the performance of the section. The figures show very little change over the course of the experiment. The temperature difference between the two measurements was only 3.1°C and hence little influence of this parameter on deflection was noted.

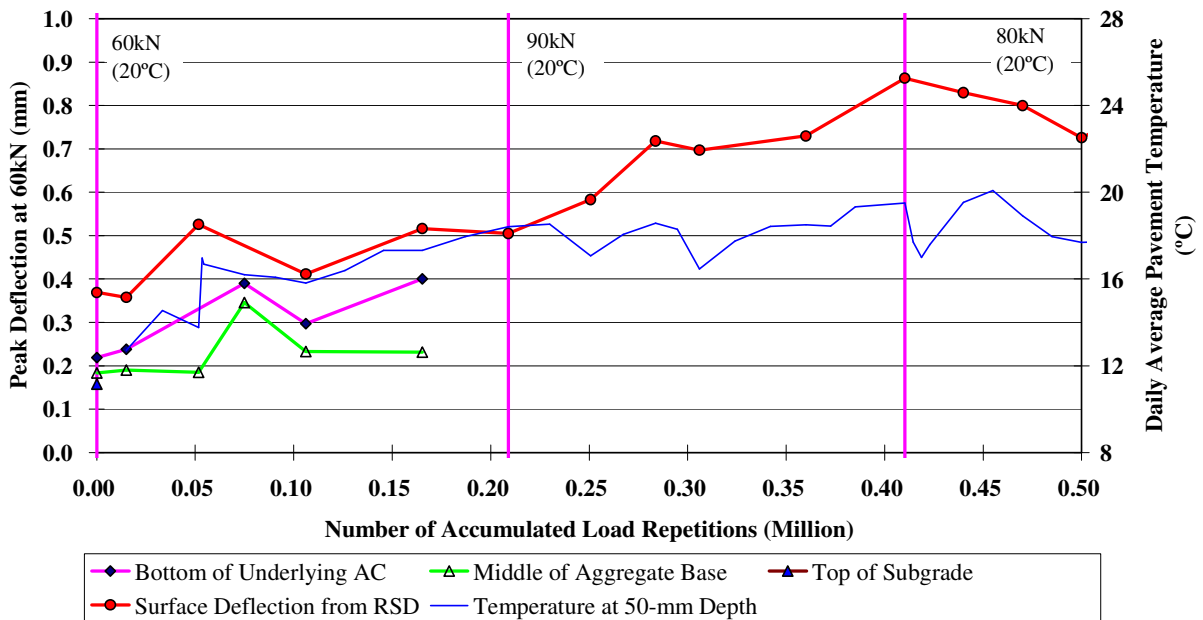
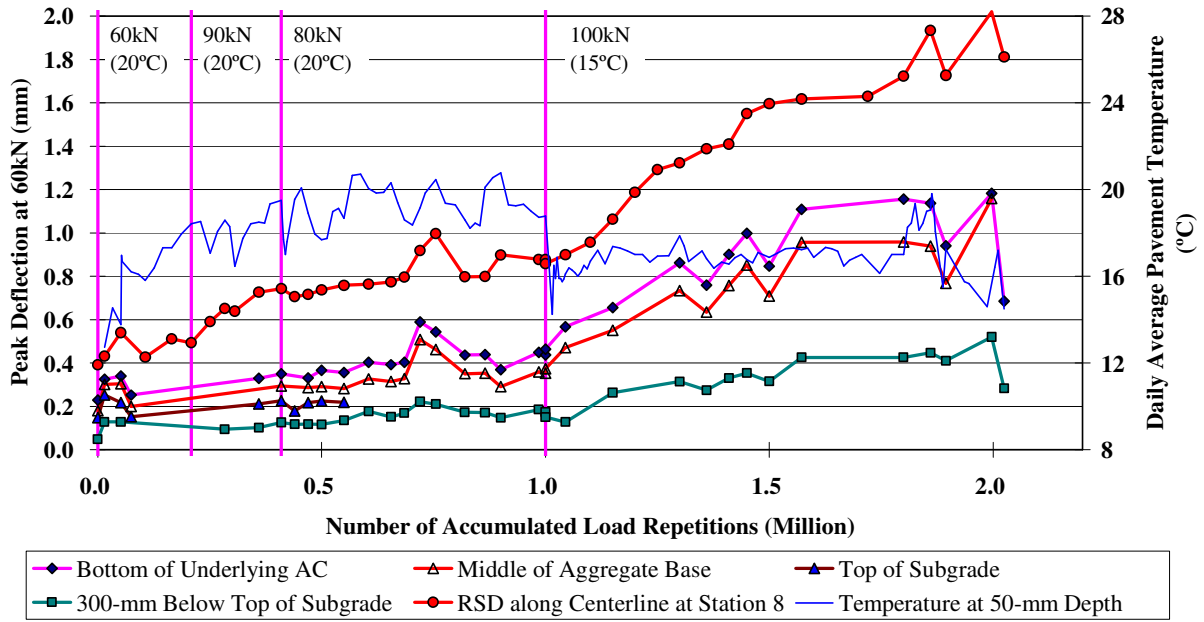
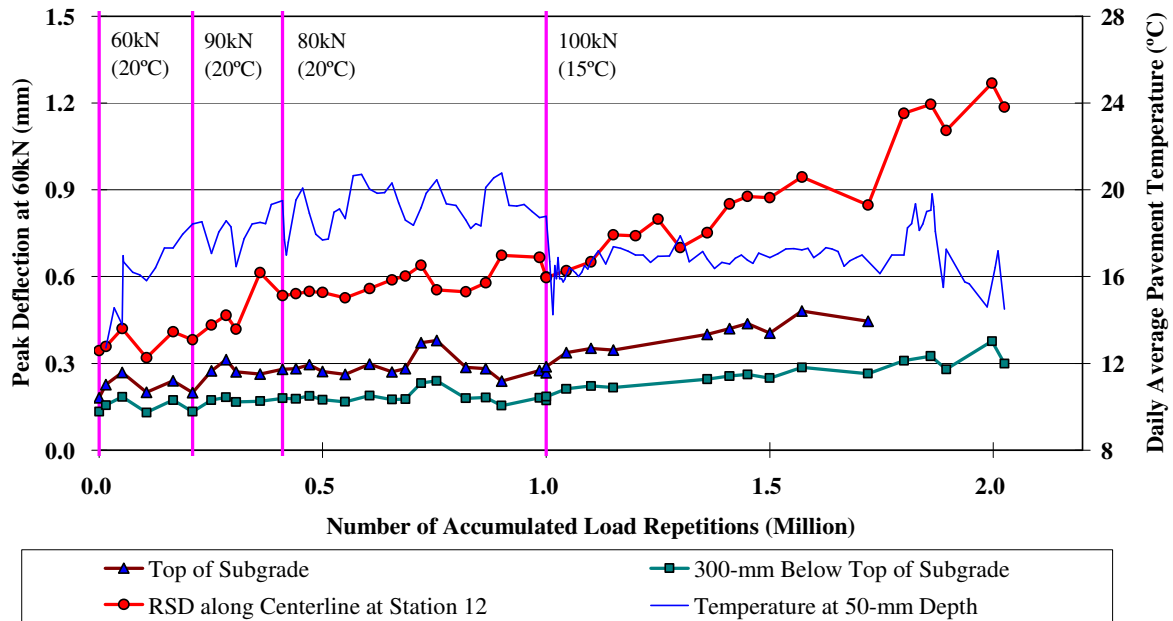
Figure 3.18: Elastic deflections at MDD4 with 60 kN test load.

Figure 3.19: Elastic deflections at MDD8 with 60 kN test load.

Figure 3.20: Elastic deflections at MDD12 with 60 kN test load.

Depth (mm)	Layer	Elastic Deflection at 60 kN (microns)		
		Before Trafficking	After Trafficking	Ratio of Final/Initial
MDD4				
0	Surface (from RSD)	370	2,250	6.08
132	Bottom of cracked DGAC	220	N/A	-
337	Middle of aggregate base	180	N/A	-
542	Bottom of aggregate base	160	N/A	-
847	300 mm below top of subgrade	N/A	N/A	-
MDD8				
0	Surface (from RSD)	390	2,020	5.12
132	Bottom of cracked DGAC	230	1180	5.13
337	Middle of aggregate base	180	N/A	-
542	Bottom of aggregate base	150	1180	7.87
847	300 mm below top of subgrade	50	520	10.4
MDD12				
0	Surface (from RSD)	340	1,270	3.74
132	Bottom of cracked DGAC	N/A	N/A	-
337	Middle of aggregate base	180	N/A	-
542	Bottom of aggregate base	130	N/A	-
847	300 mm below top of subgrade	N/A	380	-

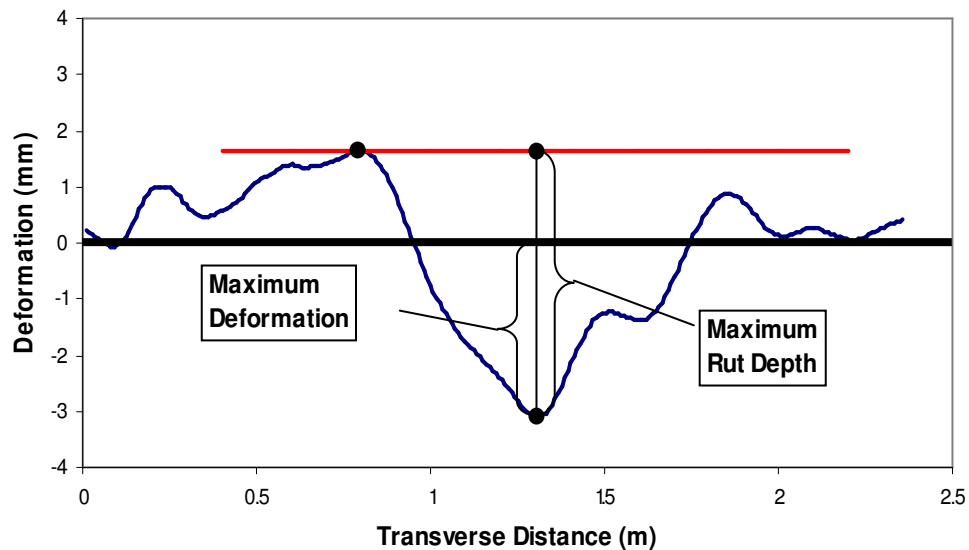
Figure 3.21: Illustration of maximum rut depth and maximum deformation of a leveled profile.

Deformation and rutting on HVS tests are usually analyzed using two definitions, namely maximum rut depth and maximum deformation (4), as illustrated in Figure 3.21. The Laser Profilometer is used to measure these distresses and provides sufficient information to evaluate the evolution of permanent surface deformation of the entire test section at various loading stages.
