Reflective Cracking Study: First-level Report on HVS Testing on Section 587RF — 45 mm RAC-G Overlay

Authors:
R. Wu, D. Jones and J. Harvey

University of California
Pavement Research Center
UC Davis, UC Berkeley

Prepared for: Caltrans	FHWA No: CA091073G	Date: January 2007
Contract No: 65A0172	Client Reference No: SPE 4.10	Status: Stage 6, Approved Version

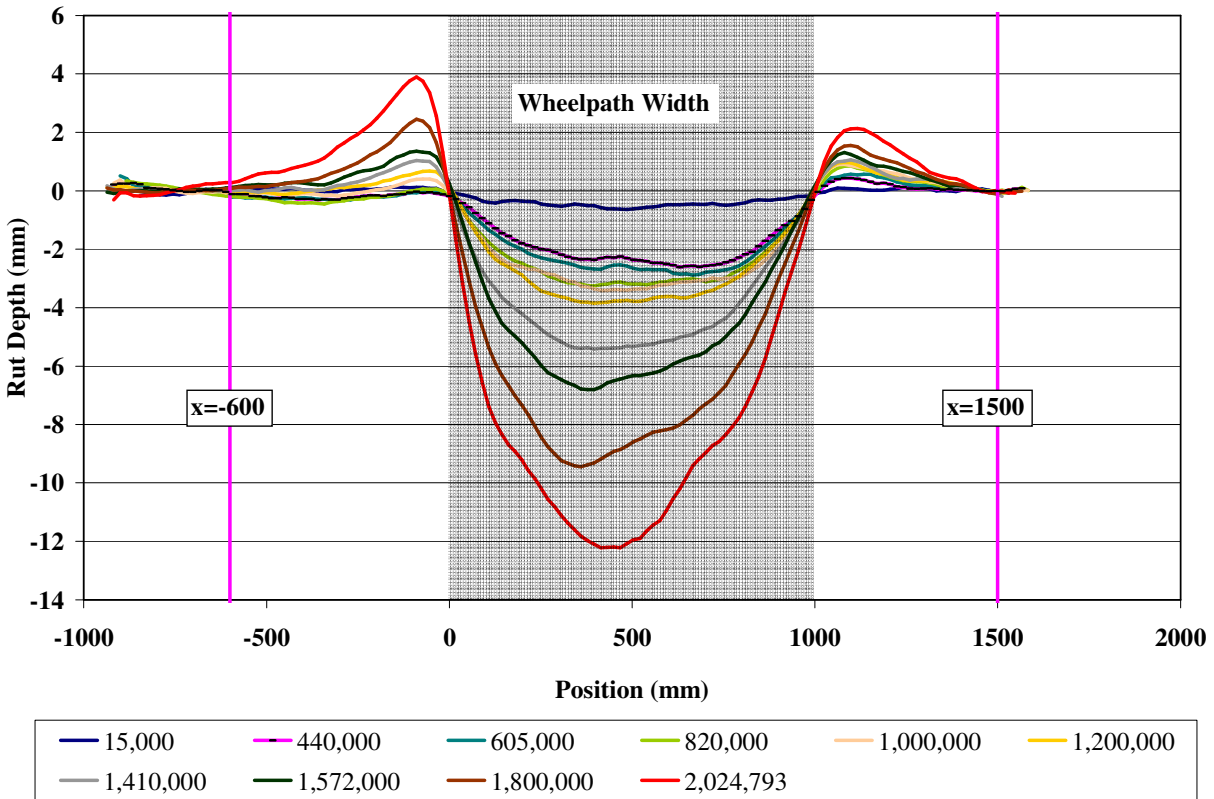
Figure 3.22: Profilometer cross section at various load repetitions.

Figure 3.22 shows the average transverse cross section measured with the Profilometer at various stages of the test. This plot clearly shows the increase in rutting and deformation over the duration of the test.

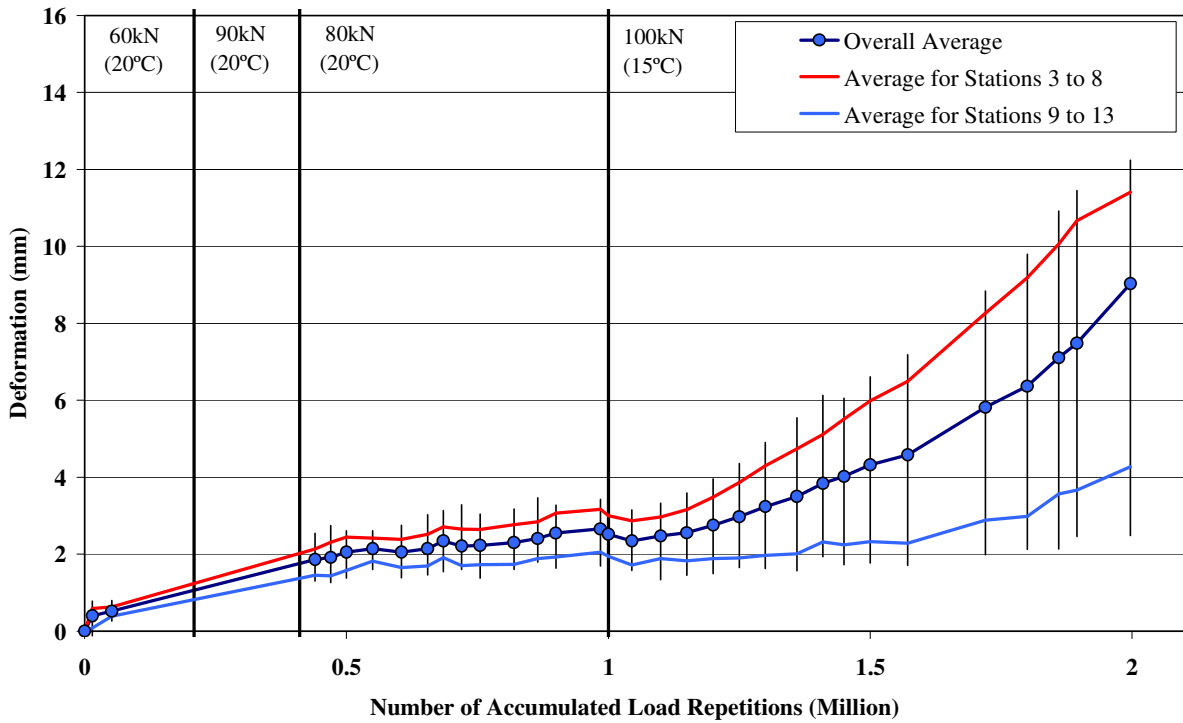
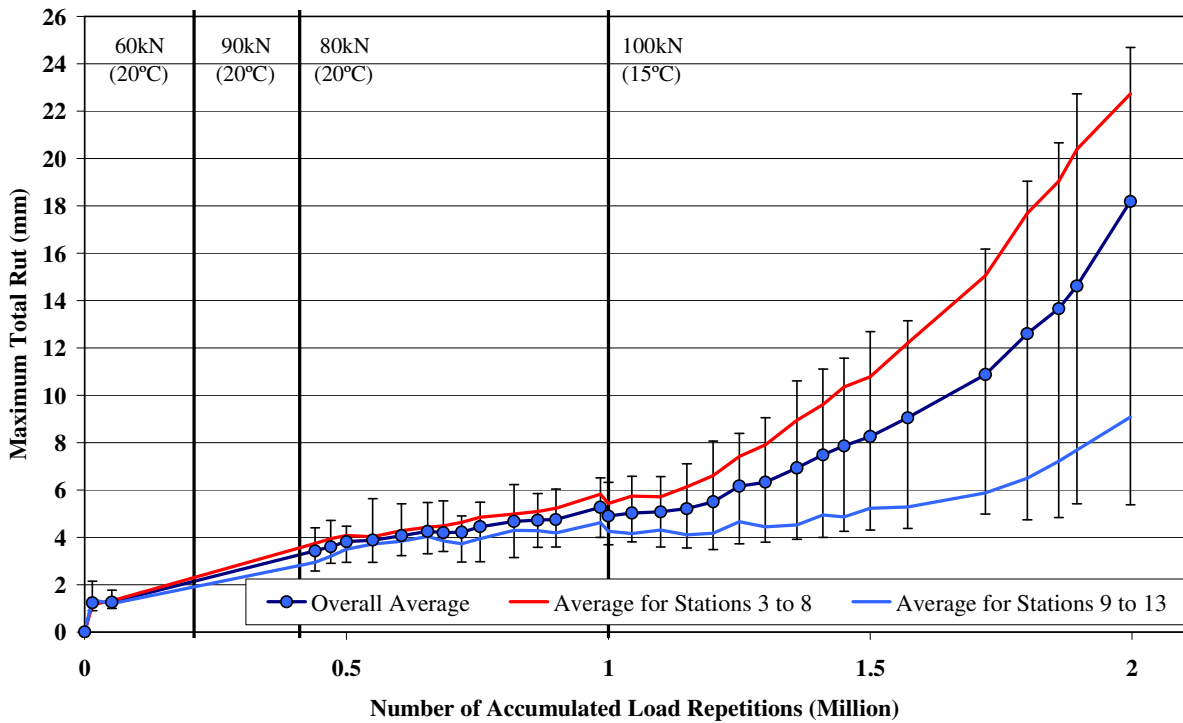
Figure 3.23: Average maximum deformation determined from Laser Profilometer data.

Figure 3.24: Average maximum rut determined from Laser Profilometer data.

During HVS testing, rutting usually occurs at a high rate initially and then typically diminishes as trafficking progresses until reaching a steady state. If the load level is subsequently increased, the pavement will normally undergo another phase of rapid rutting development until a steady phase for that new load level is reached. This initial phase is referred to as the “embedment” phase. Figures 3.23 and 3.24 show the development of permanent deformation (maximum deformation and maximum rut, respectively) with load repetitions as determined by the Laser Profilometer for the test section with an embedment phase only apparent at the beginning of the experiment. Rut development is relatively constant until the 100 kN load change, after which it increases at a much higher rate. Error bars on the average reading indicate variation along the length of the section. The figures also show average maximum deformation and average maximum rut for Stations 3 to 8 and 9 to 13. Stations 3 to 8 are over the end of the section where the underlying DGAC was significantly cracked, while Stations 9 to 13 are over the end with less severe cracking. The figures show that deformation and rut are considerably higher over the significantly cracked section.

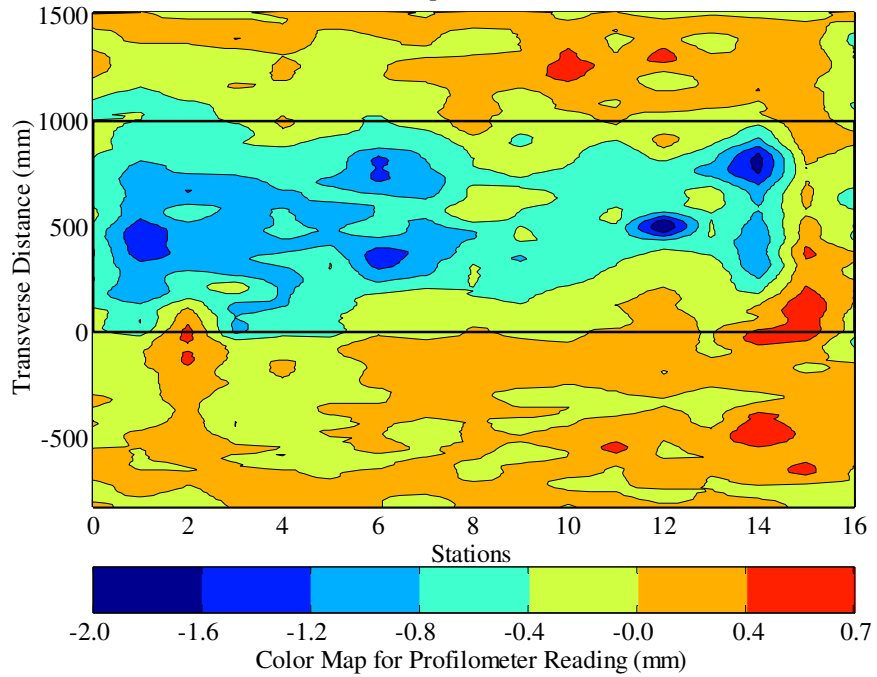
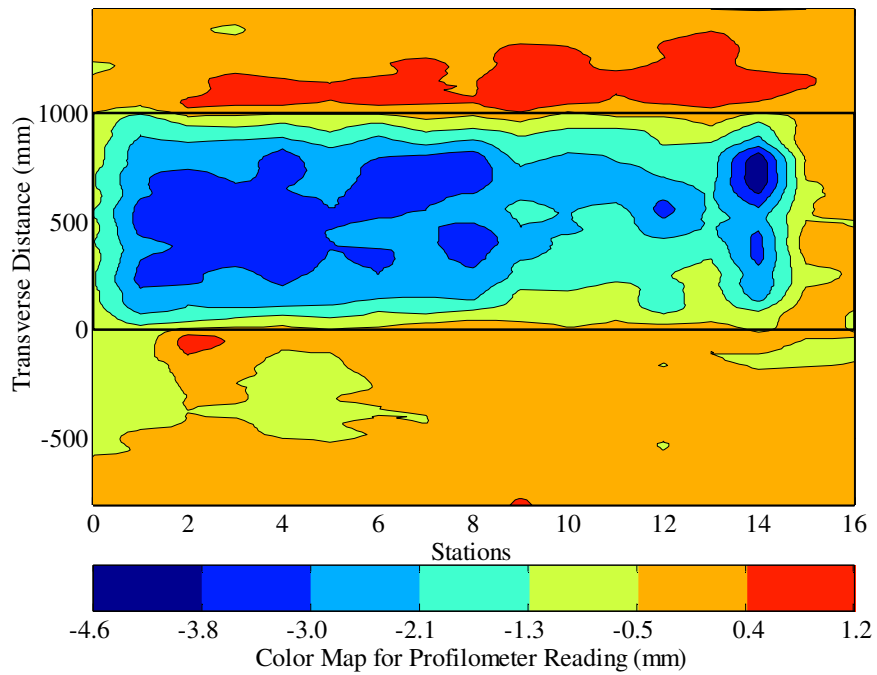
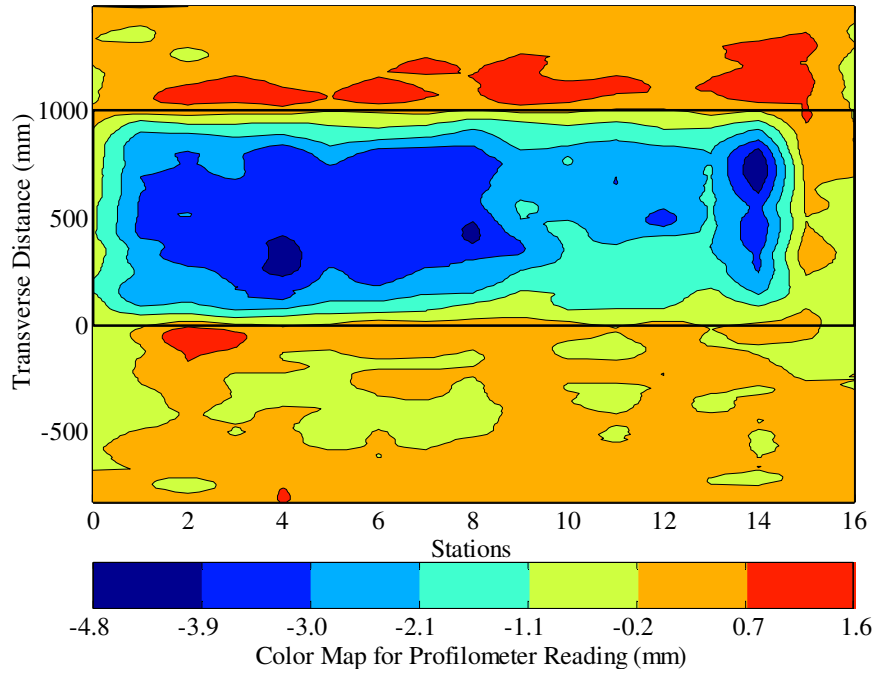
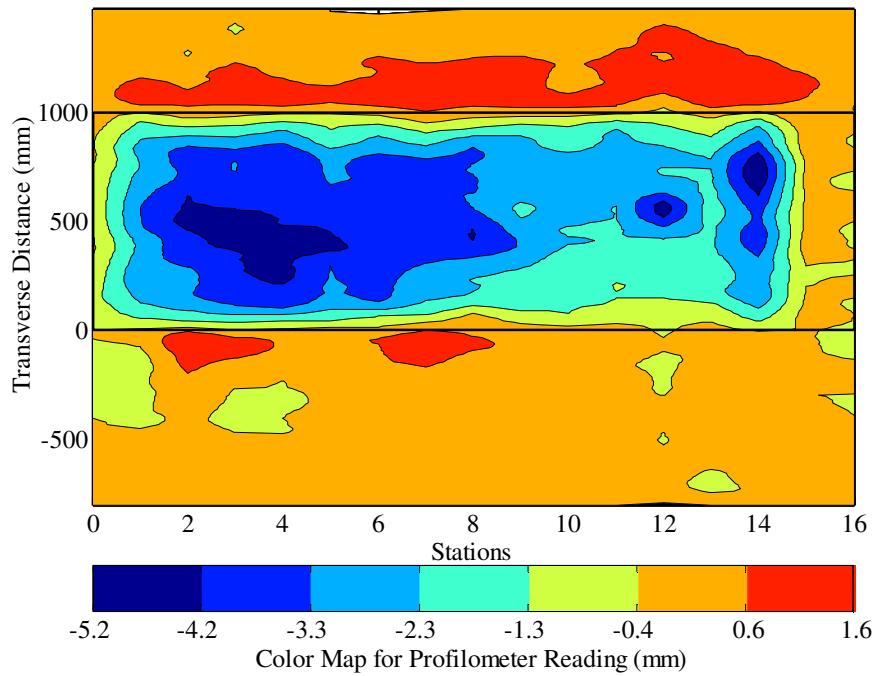
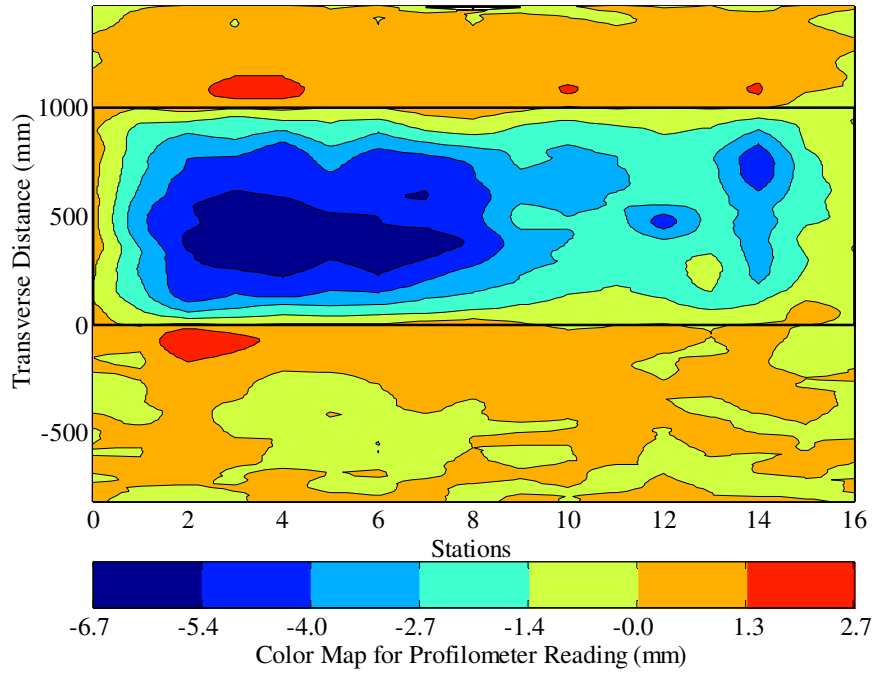
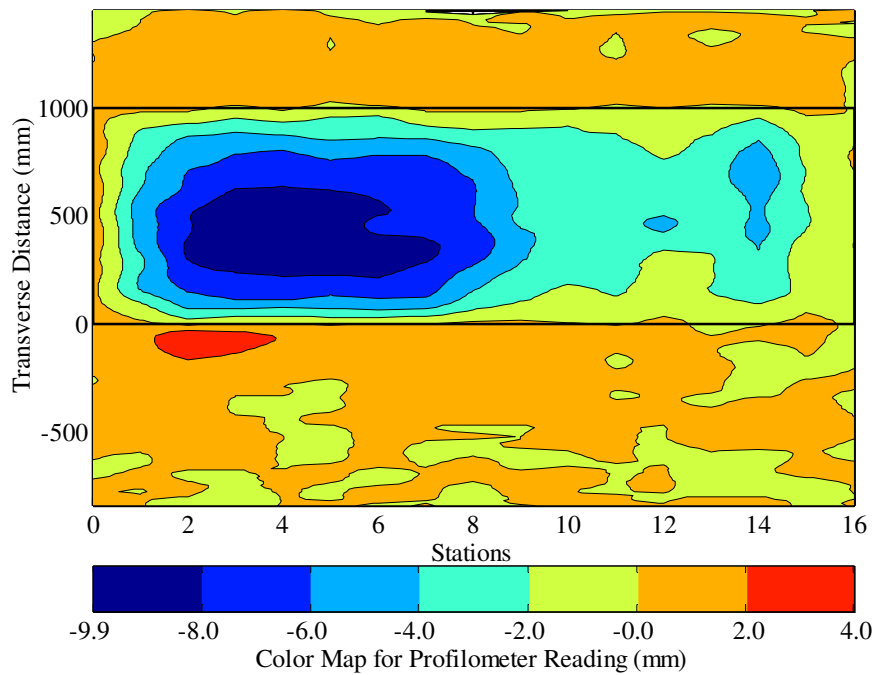
Figure 3.25: Contour plot of permanent deformation after 50,000 repetitions.

Figure 3.26: Contour plot of permanent deformation after 500,000 repetitions.

Figure 3.27: Contour plot of permanent deformation after 760,000 repetitions.

Figure 3.28: Contour plot of permanent deformation after 1,000,000 repetitions.

Figure 3.29: Contour plot of permanent deformation after 1,250,000 repetitions.

Figure 3.30: Contour plot of permanent deformation after 1,500,000 repetitions.

Figure 3.25 shows a contour plot of the pavement surface after 50,000 repetitions, when the initial embedment phase had steadied. Figures 3.26 through 3.31 show contour plots of the rutting progression on the surface from 500,000 repetitions up to test completion. The increase in rutting after the 100 kN load change is clearly evident in Figure 3.29 when compared to Figure 3.28.

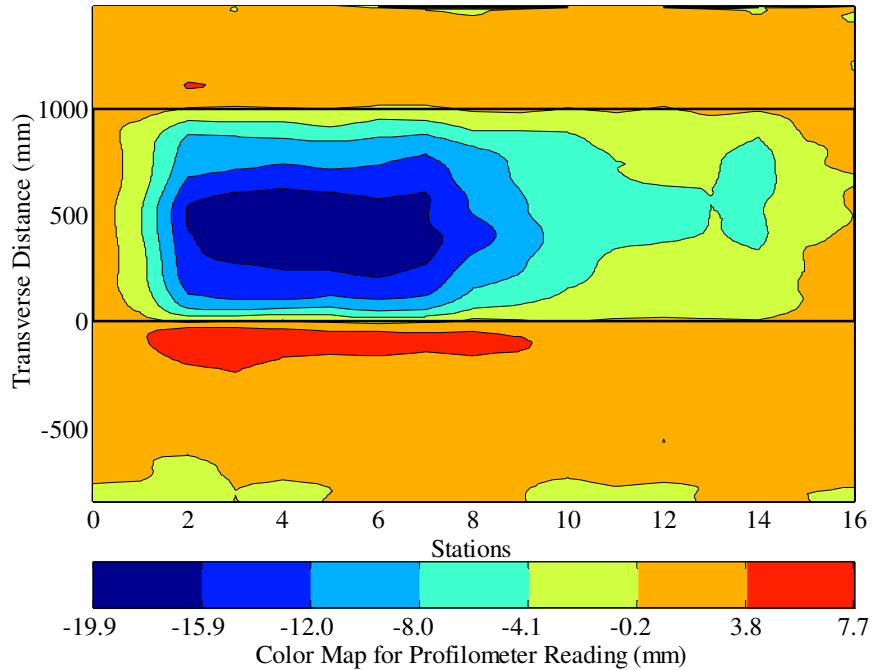
Figure 3.31: Contour plot of permanent deformation after 2,024,793 repetitions.

After completion of trafficking (2.02 million load repetitions), the average maximum deformation and the average maximum rut depth were 12.1 and 16.1 mm, respectively. The maximum rut depth measured on the section was 26.3 mm. Testing was halted after the average maximum rut depth had exceeded 12.5 mm, in line with the failure criteria determined for the experiment. The final surface rutting pattern of the overlay generally corresponds with the fatigue cracking pattern of the cracked DGAC layer as shown in Figure 3.32, with the deepest rut occurring on that half of the section with the highest density of cracking in the underlying layer.

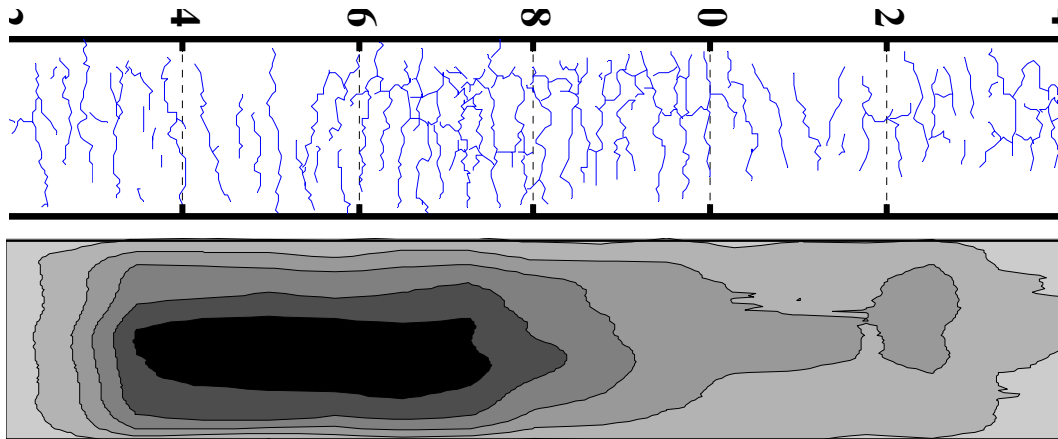
Figure 3.32: Comparison of cracking pattern from Phase 1 and rutting in Phase 2.

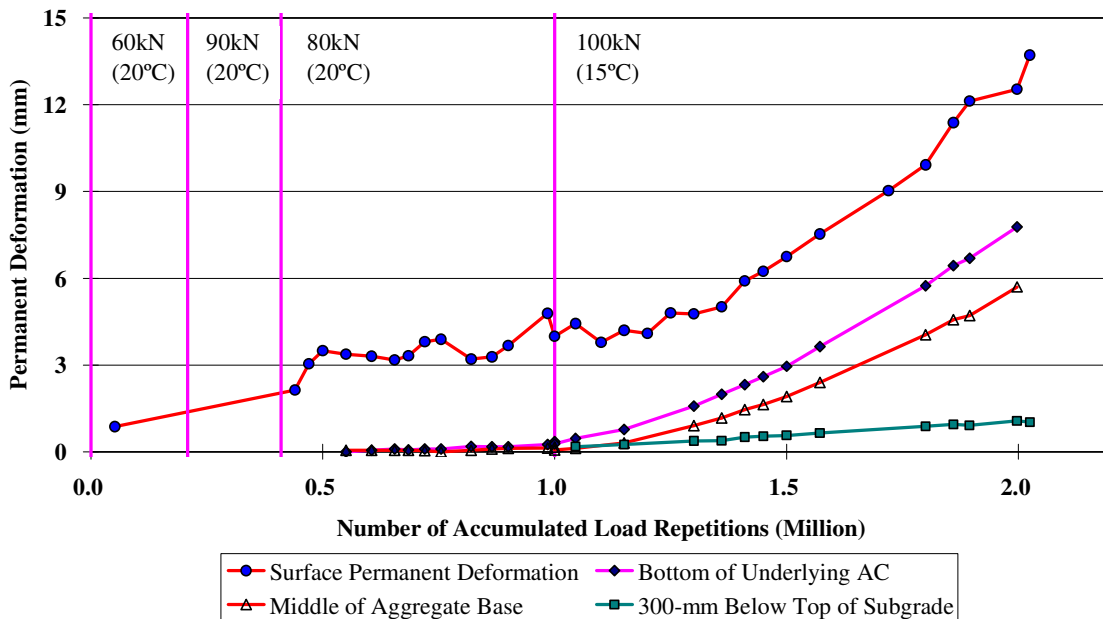
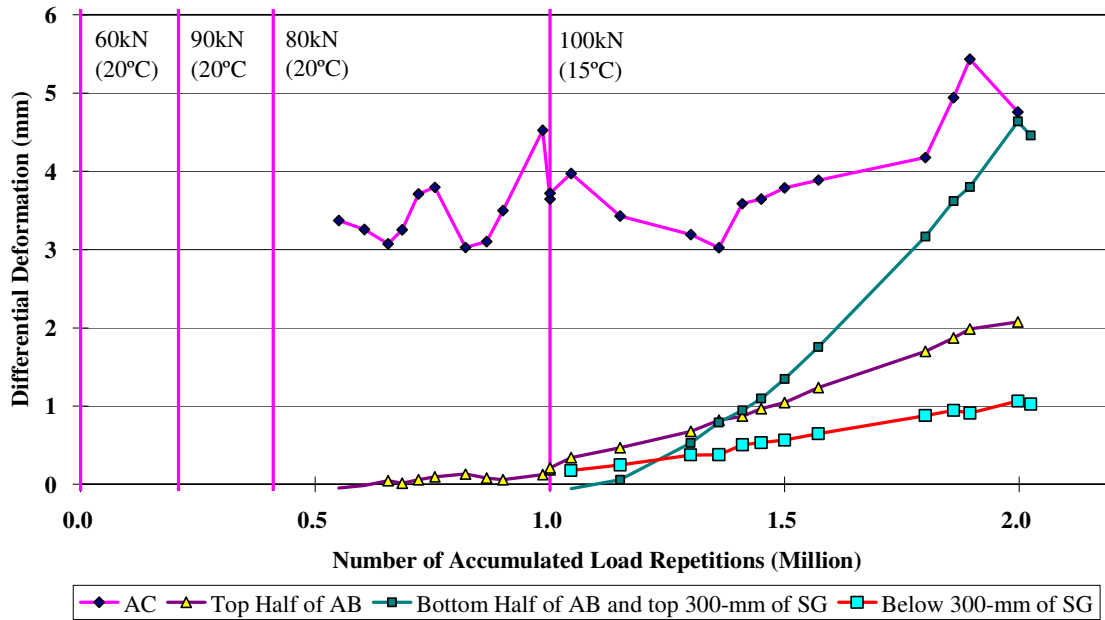
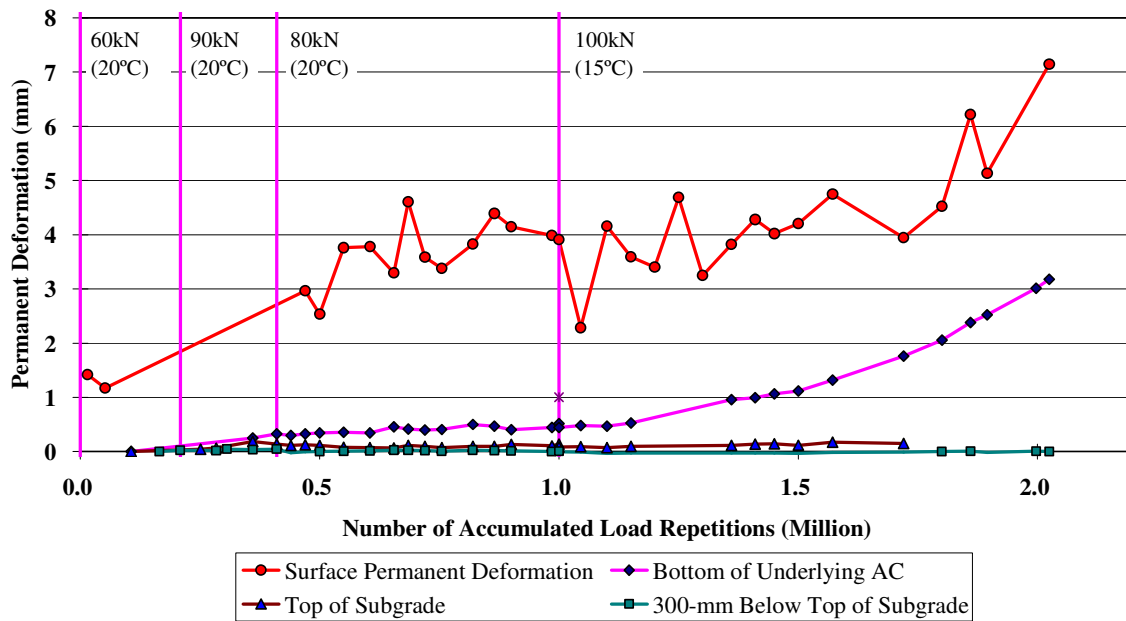
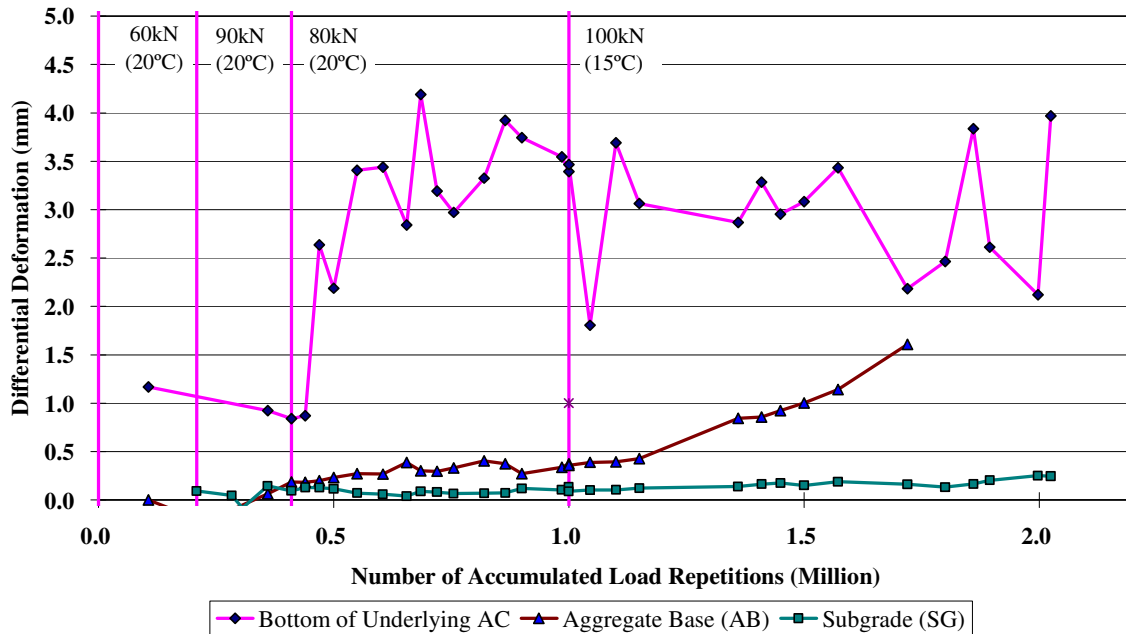
Figure 3.33: In-depth permanent deformation at MDD8.

Figure 3.34: In-depth differential deformation at MDD8.

Figure 3.35: In-depth permanent deformation at MDD12.

Figure 3.36: In-depth differential deformation at MDD12.

Layer	Thickness (mm)	Vertical Permanent Deformation (mm)		Percentage Total Deformation (%)	
		MDD8	MDD12	MDD8	MDD12
After 1,000,000 load repetitions					
Surface (Profilometer)	-	3.7	3.5	86	88
Bottom of cracked DGAC	135	0.3	0.4	7	10
Upper aggregate base	205	0.2	Not measured	5	Not determined
Lower aggregate base	205	0.1	0.1	2	2
Subgrade to anchor	2,158	Not measured	Not measured	Not determined	Not determined
Total (AC+base)	3,000	0.6	Not determined	100	100
After 2,024,793 load repetitions (test completion)					
Surface (Profilometer)	-	6.0	3.6	29	49
Bottom of cracked DGAC	135	7.7	3.8	38	51
Upper aggregate base	205	5.7	Not measured	28	Not determined
Lower aggregate base	205	1.0	0.0	5	0
Subgrade to anchor	2,158	Not measured	Not measured	Not determined	Not determined
Total (AC+base)	3,000	14.4	Not determined	100	100

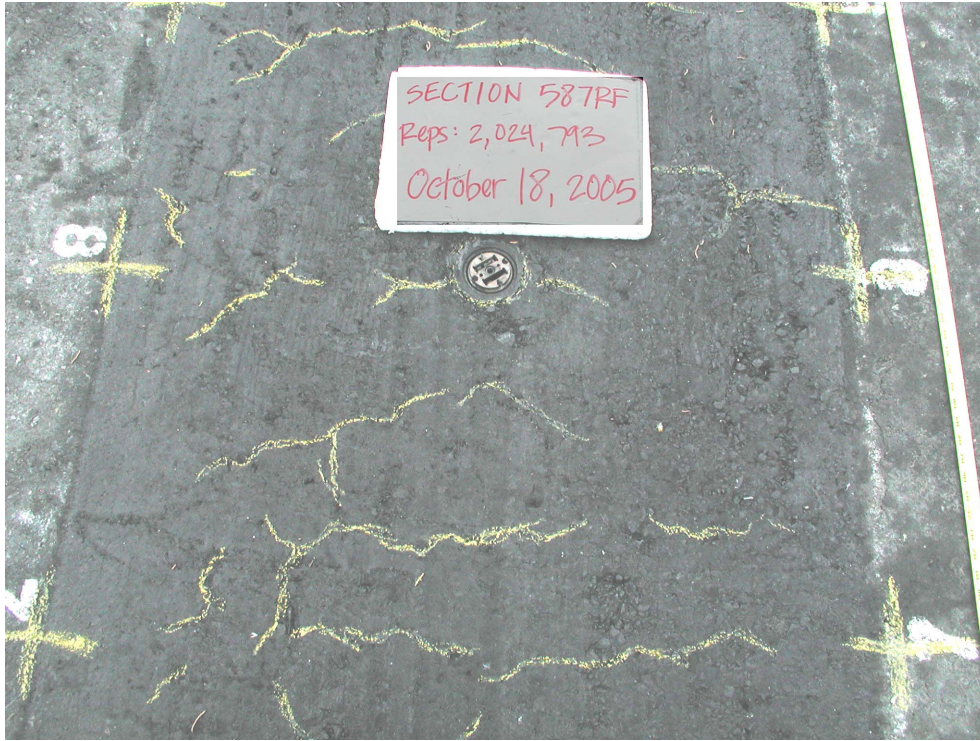
Figure 3.37: Surface cracks marked with crayon between Stations 7 and 8 at end of test.

the failure criterion of 2.5 m/m^2 set for the experiment, reached after approximately 1.9 million repetitions. Figure 3.37 shows the last photograph taken of the surface between Stations 7 and 8.

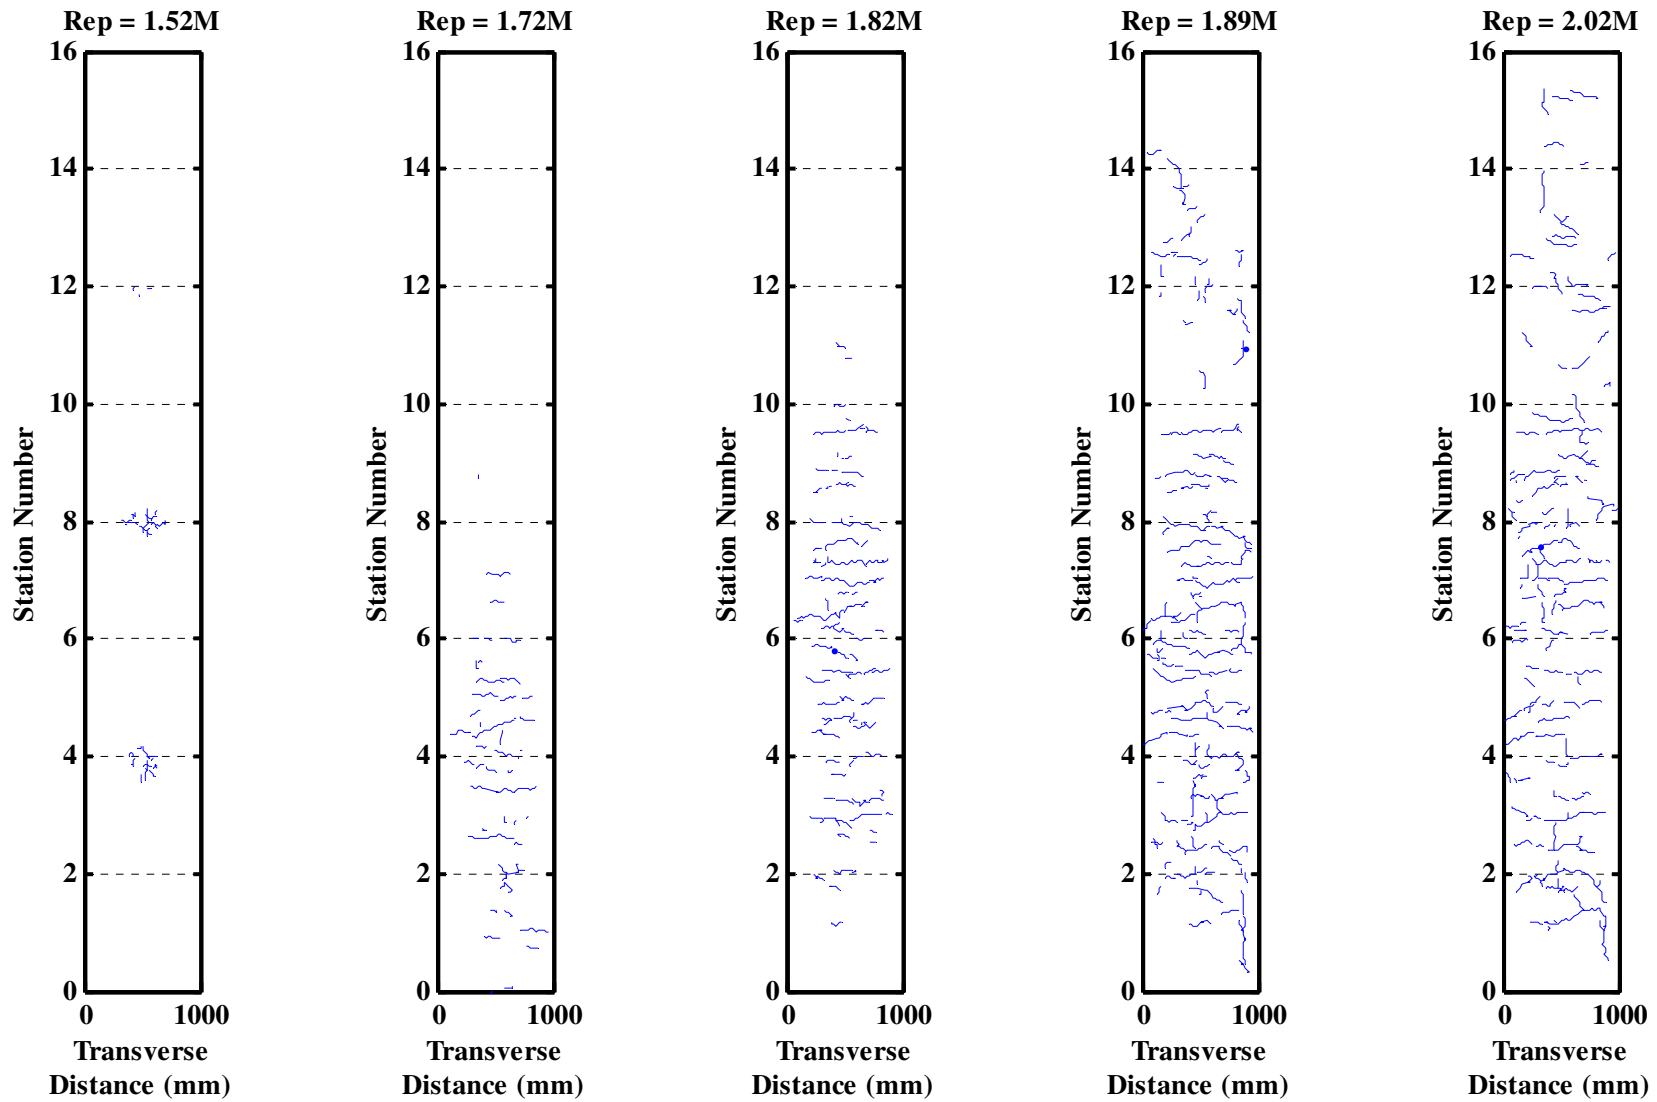
Figure 3.38: Crack development between 1.52 million repetitions and test completion.

Figure 3.38 illustrates the sequence of surface crack patterns at various load applications. In some instances, cracks marked in one inspection did not appear in the following inspection. This is attributed to the difficulty of identifying the very thin cracks on the dark asphalt concrete surface and to the accumulation of rubber on the surface during trafficking. Despite this, the data collected is considered to provide a satisfactory representation of surface cracking development.

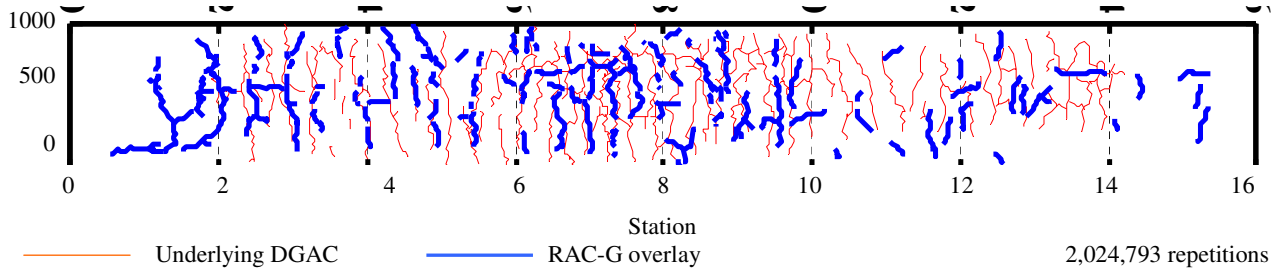
Figure 3.39: Cracking pattern comparison between underlying layer and overlay.

Figure 3.39 compares the cracking on Section 587RF with that on the underlying Section 568RF. The cracks do not match exactly, but provide an indication of reflection from the underlying layer. The areas of severe cracking in the underlying layer are matched in the overlay, specifically between Stations 6 and 10.

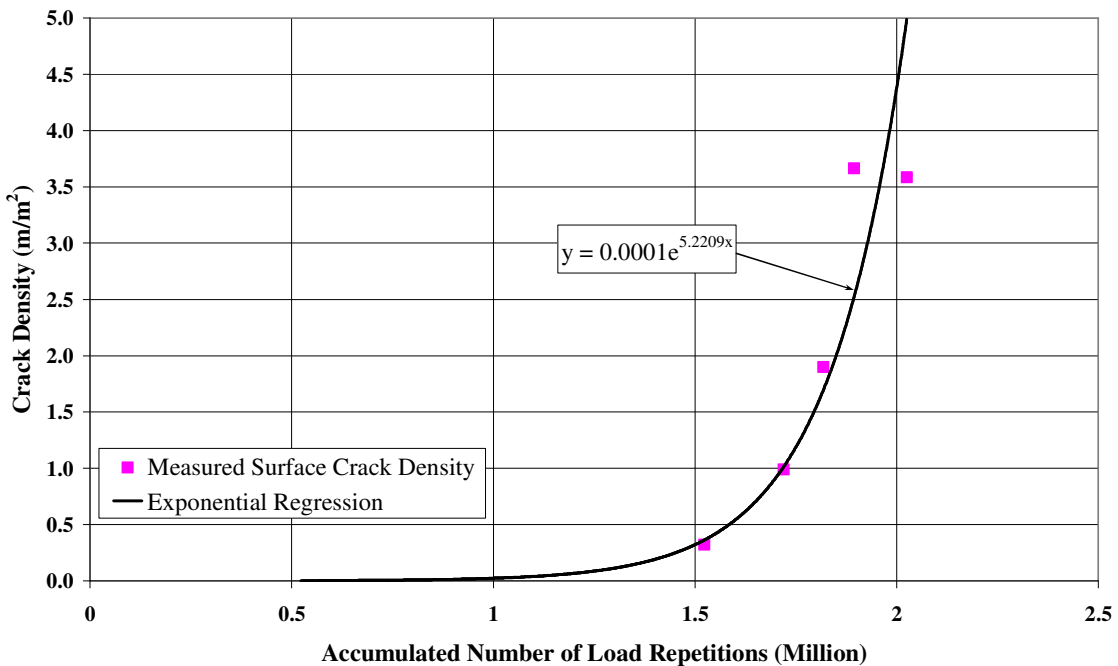
Figure 3.40: Crack accumulation with trafficking.

Further analysis of the cracks indicated that the crack accumulation history can be fitted reasonably well with the following exponential function (Figure 3.40):

Where: CD is the crack density in m/m^2
 N is the number of accumulated load repetitions in millions.
