Reflective Cracking Study: Summary Report

Partnered Pavement Research Program (PPRC) Contract Strategic Plan Element 4.10:
Development of Improved Rehabilitation Designs for Reflective Cracking

California Department of Transportation
Division of Research and Innovation
Office of Roadway Research

University of California
Pavement Research Center
UC Davis, UC Berkeley

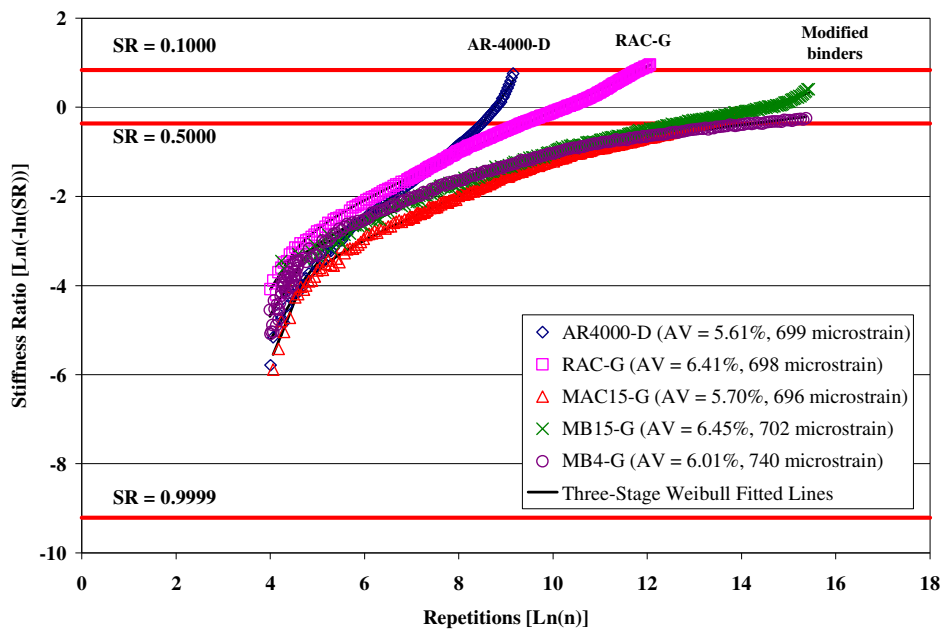
Figure 6.1: Typical Weibull curves for Reflective Cracking Study mixes.
20°C and 700 microstrain.

The fitting of flexural controlled-deformation fatigue test results with a three-stage Weibull equation appeared promising. The three-stage Weibull equation is flexible and sufficiently precise to accommodate most fatigue damage curve shapes, while adequately characterizing fatigue performance in terms of the entire damage process. Conventional two-point fatigue life modeling considers only initial (50th load repetitions) and end (50 percent stiffness reduction) points and neglects the fatigue damage process. For mixes using modified binders, the traditional parameter of 50 Percent Loss of Initial Stiffness does not capture the improved crack propagation resistance of rubber- and polymer-modified mixes that occurs after this point (Figure 6.1). In addition, test duration to reach 50 percent stiffness reduction is very long and thus not feasible. Hence, to accurately characterize the fatigue performance of these mixes, understanding the fatigue damage process is important.
