Research Report – UCD-ITS-RR-11-22

Quiet Pavement Research: Bridge Deck Tire Noise Report

June 2011

Abstract: This report presents the results of tire noise research performed on bridge decks. This work is part of a project that has looked into tire noise on concrete pavements and bridge decks. The objectives of the project are: (a) to identify relationships between tire/pavement noise and variables observed in concrete pavement and bridge decks, (b) to determine trends in noise levels versus age for concrete pavement and bridge decks, and (c) to develop recommendations on surface textures to minimize tire/pavement noise.

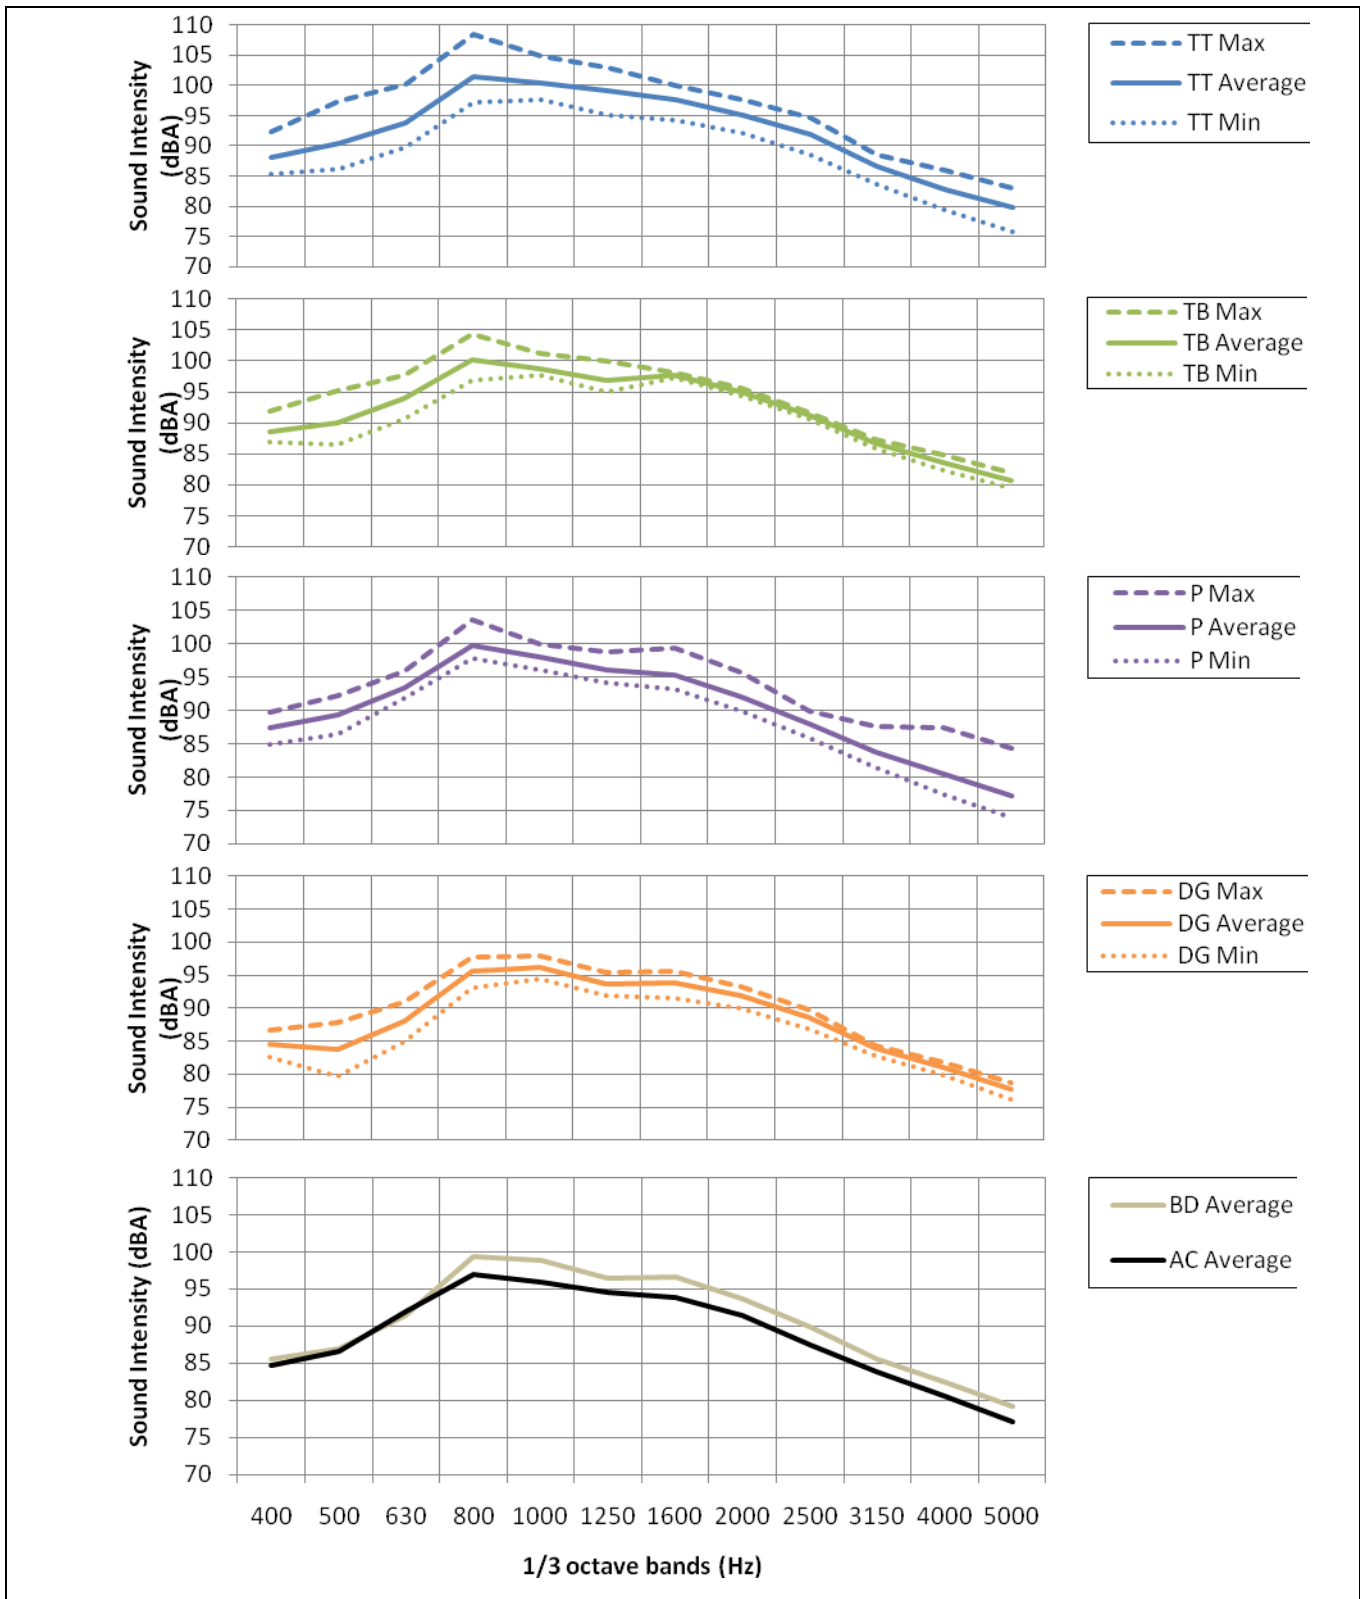
Figure 3.11: Comparison of OBSI spectral content of bridge decks with different surface types.

(Note: TT is transversely tined, TB is transversely broomed, P is polyester overlay, DG is diamond ground, BD is burlap drag, and AC is hot-mix asphalt [asphalt concrete].)

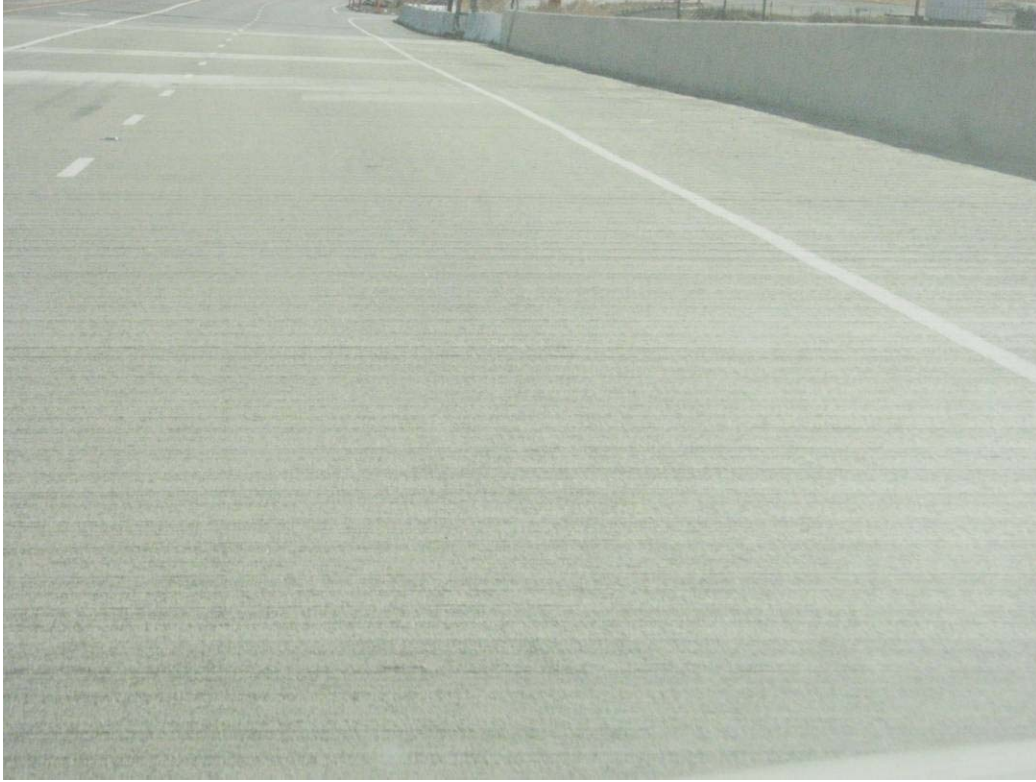
Figure 4.42: OBSI Surface and diamond-ground segments near joints on Section QP-124.1.

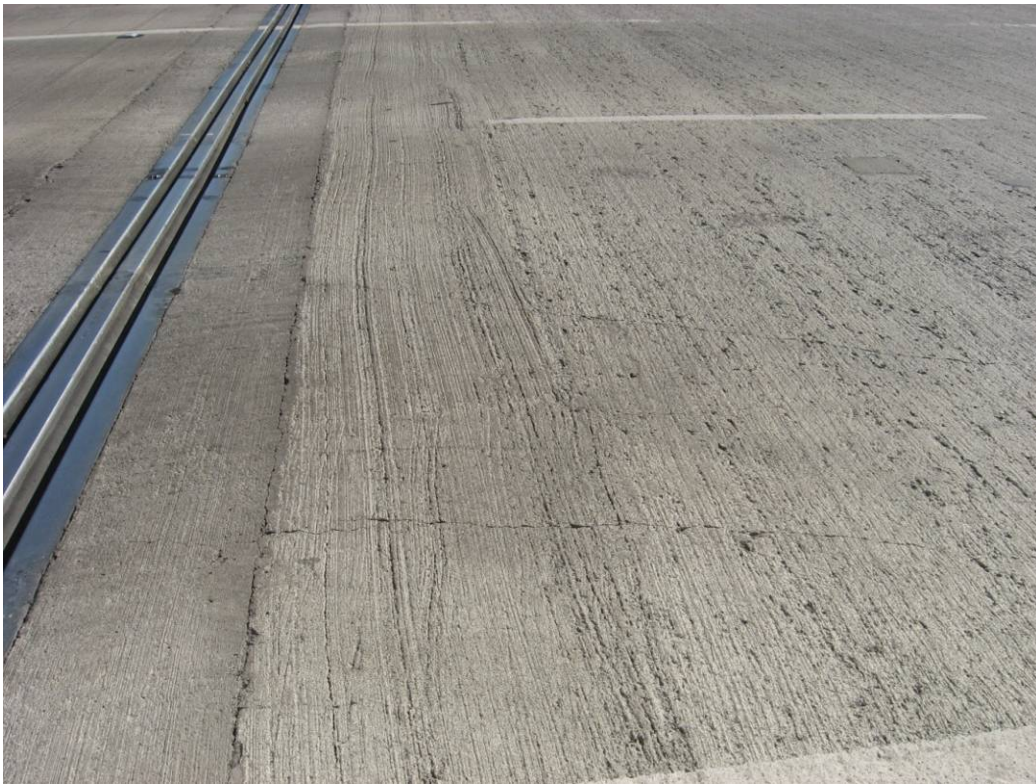
Figure 4.43: Detail of surface and joint on Section QP-124.1.
