**PERFORMANCE OF DRAINED AND UNDRAINED  
FLEXIBLE PAVEMENT STRUCTURES UNDER WET  
CONDITIONS TEST DATA FROM ACCELERATED  
PAVEMENT TEST SECTION 543-DRAINED**

**UCD-ITS-RR-04-6**

**Performance of Drained and Undrained Flexible Pavement  
Structures under Wet Conditions**

**Test Data from Accelerated Pavement Test Section 543-Drained**

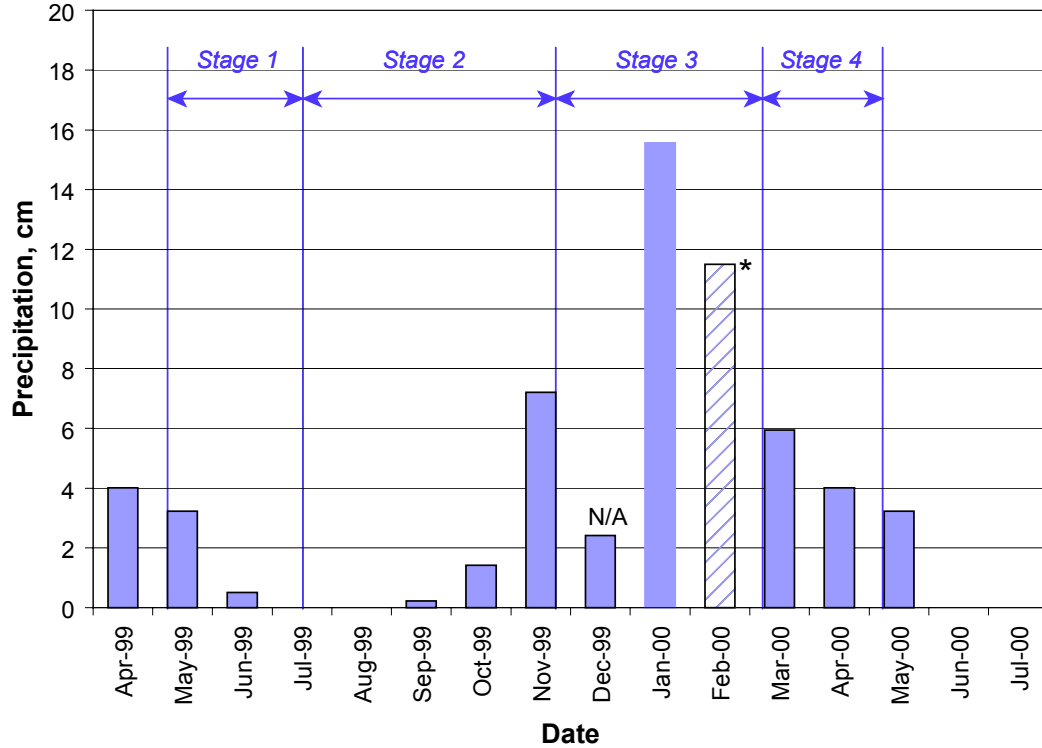
**Figure 6. Average monthly rainfall during testing of Section 543.**

\* Note: Data was not available for Richmond, California weather station for the month of February 2000. Data shown here for February 2000 is from nearby National Climate Data Center weather station in Berkeley, California.

Figure 6 shows average monthly rainfall data collected at the National Weather Service weather station in Richmond, California. Figures 7 and 8 show average volumetric moisture contents for the aggregate base, subbase, and subgrade materials obtained using a hydro-probe test device. Depths of moisture content measurements are summarized in Table 5.

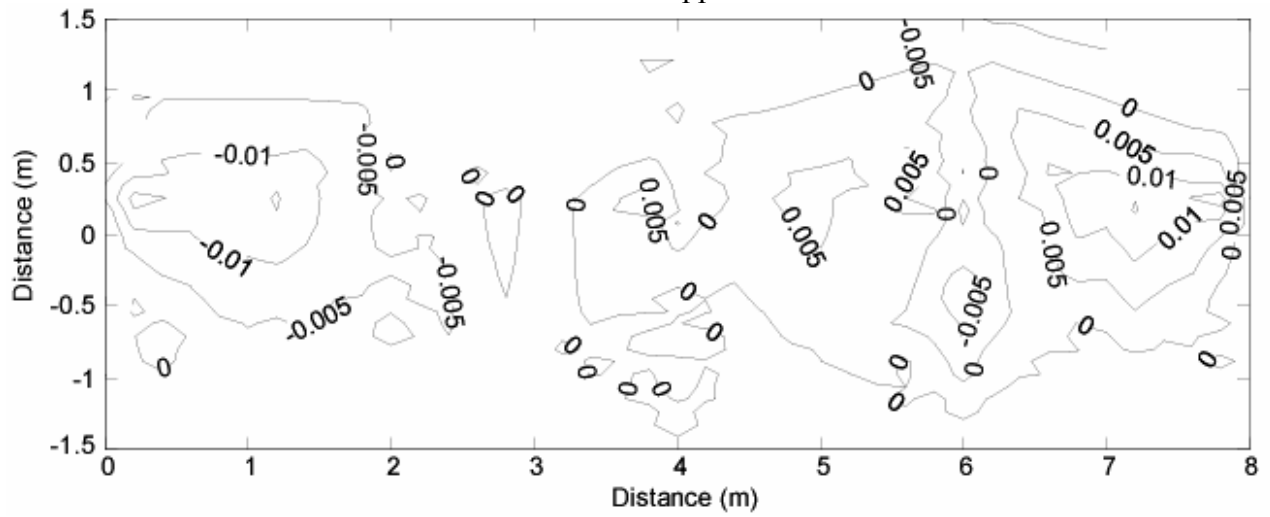
217k HVS load applications

514k HVS load applications

1,197k HVS load applications

Figure 35 shows the reduction of bound layer thickness across the section. In this figure, the GPR data contours follow trends obtained using the profilometer. However, the GPR surveys overestimate the reduction in layer thickness. According to the GPR surveys, the thickness reductions were about twice the magnitude of those measured with the profilometer. Based on the forensic activities, reduction in bound layer thickness was mostly due to the change in characteristics of the ATPB layer in the trafficked areas. This overestimation by the GPR surveys may be due to the contamination of the ATPB with fine material from the aggregate base, which produces about the same GPR image as the aggregate base.

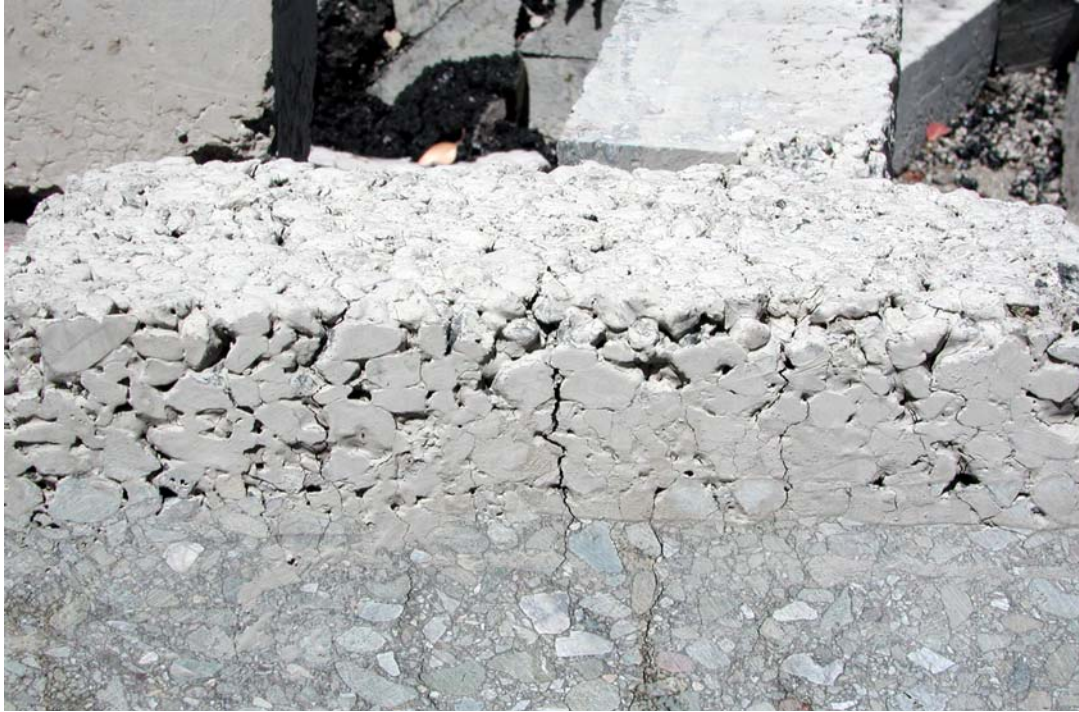
**Figure 40a. Fines-clogged ATPB slab from Section 543.**

Note: Sample is a slab shown upside-down (ATPB at top of image).

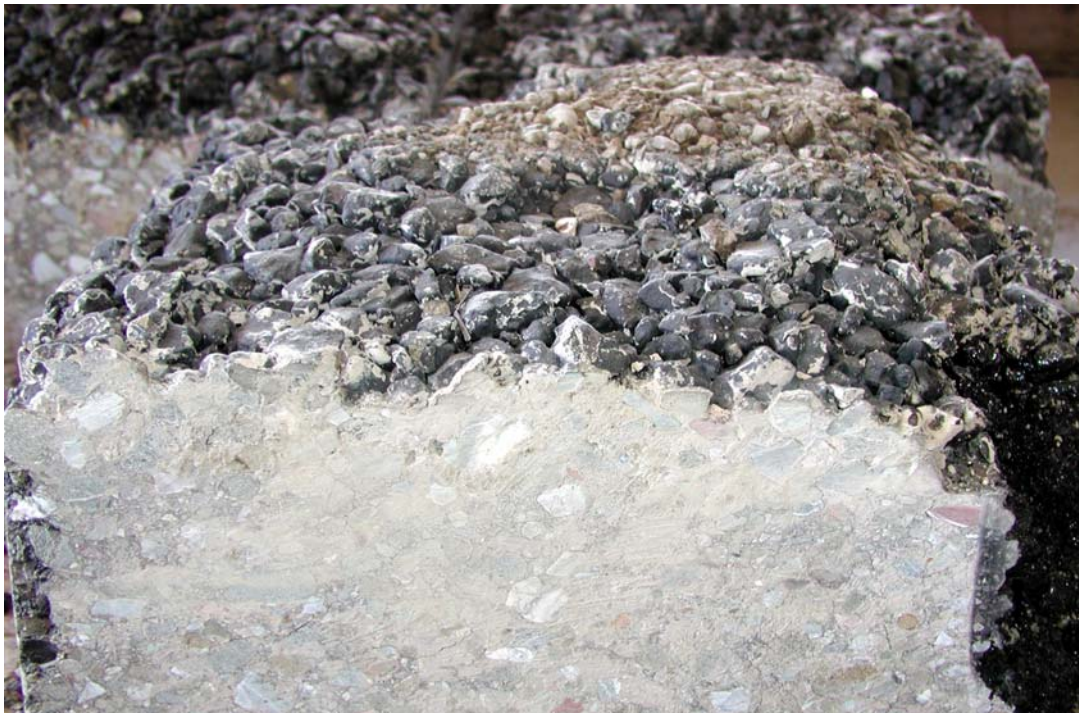
**Figure 40b. ATPB slab from another HVS test section demonstrating appearance of ATPB without fines infiltration.**

Note: Sample is shown upside-down (ATPB at top of image).

**Figure 40. ATPB with and without fines infiltration.**

Figure 40 shows the significant contamination of the ATPB near its interface with the aggregate base with fine silt material. It should be noted that the aggregate base had been primed prior to the placing of the ATPB. The results of this test suggest that it would be desirable to place a filter fabric on top of the untreated base prior to placing the ATPB to preclude upward migration of fines when the drainage system is not effective.
