Research Report – UCD-ITS-RR-09-64

# Re-Cementation of Crushed Material in Pavement Bases

**Authors:**  
L. Chai, C. L. Monismith,  
and J. Harvey

<b>DOCUMENT RETRIEVAL PAGE</b>		<b>Technical Memorandum No.:</b> UCPRC-TM-2009-04			
<b>Title:</b> Re-cementation of Crushed Material in Pavement Bases					
<b>Authors:</b> L. Chai, C. L. Monismith, and J. Harvey					
<b>Caltrans Technical Lead and Reviewer:</b> D. Maskey					
<b>Prepared for:</b> California Department of Transportation Division of Research and Innovation Office of Roadway Research		<b>FHWA No.:</b> CA131890A	<b>Date Work Submitted:</b> March 30, 2010	<b>Memorandum Date:</b> October 2009	
<b>Strategic Plan Element No:</b> 3.1.4		<b>Status:</b> Stage 6, final version		<b>Version No:</b> 1	
<p><b>Abstract:</b> When recycled crushed concrete and crushed cement-treated materials have been used in pavement bases and subbases, increases in stiffness have been observed. This stiffness increase has been attributed to re-cementation of these materials. To evaluate this phenomenon, four projects that used these recycled materials and for which data are available have been studied. Two of the projects are pavements that had been

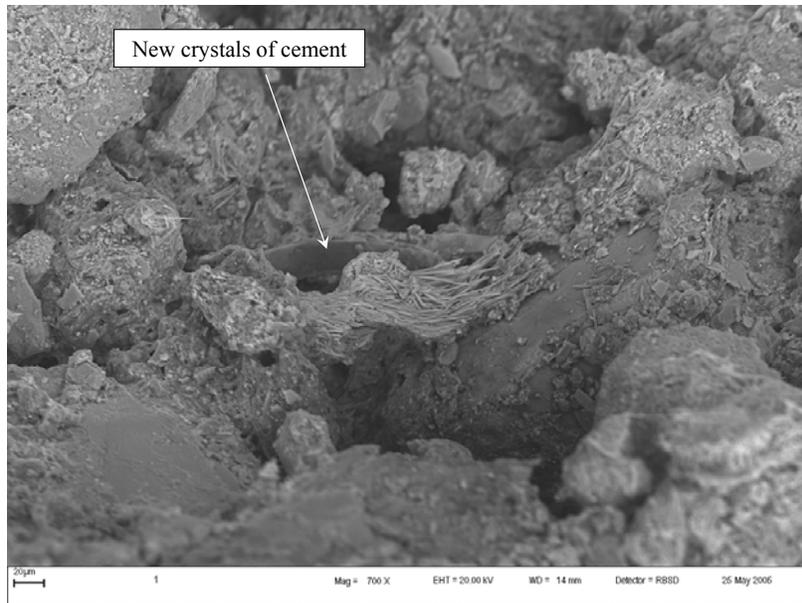
**Figure 2.1: New crystals of cement reaction products (10).**

Re-cementation is a process that occurs when materials such as crushed concrete and cement-treated soils are mixed with water and other granular materials to improve compactability, and compacted as base and subbase layers in pavement structures. Previously unhydrated cement particles will be exposed to water allowing additional hydration to continue in the compacted material over a long period of time. Figure 2.1 shows an example of new crystals of cement reaction products formed from the re-cementation process. That material shown is from an asphalt emulsion-stabilized base made with in-place recycled cement-treated base with 4 percent cement that was originally built in the late 1960s and later recycled with the emulsion in 1974 because it had failed by block cracking from shrinkage of the cemented base. The sample shown was freshly taken from the pavement 30 years later in 2005, but it shows evidence of ongoing formation of new cementitious material, in addition to evidence of older cementitious material apparently dating back to the original construction. Evidence was also found in the base of unhydrated cement even 35-plus years after the original mixing of the cement and 30 years after its being recycled with emulsion. The evidence that this is a new re-cementation product is its shape and the presence of unhydrated cement in the face of the base layer when the pit was opened in 2005.

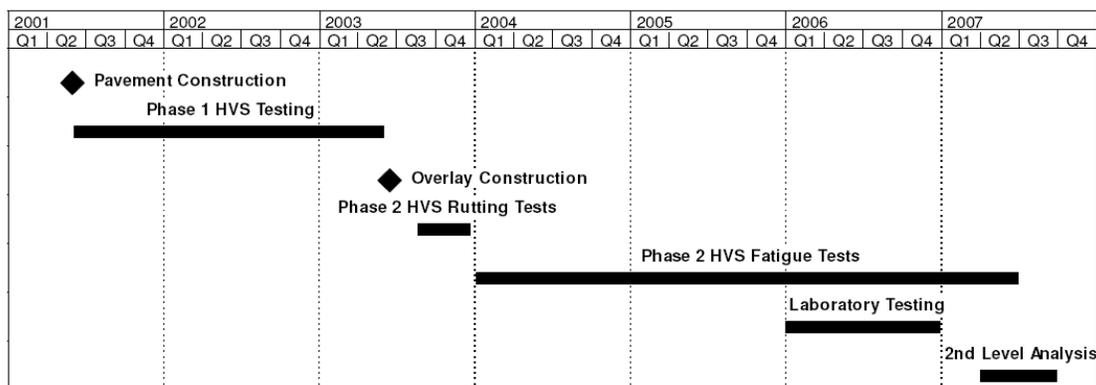
Figure 3.1: Reflective Cracking Study schedule. (5)

The test track was constructed in September 2001 according to Caltrans practice. Figure 3.1 illustrates the schedule for the test plan followed in the project. Figure 3.1 shows that the program involved (1) construction of a new pavement section, (2) cracking the HMA layer of this pavement using an HVS to produce cracked sections for overlays (Phase One), (3) overlay construction, and, (4) HVS testing of the various overlay sections (Phase Two).

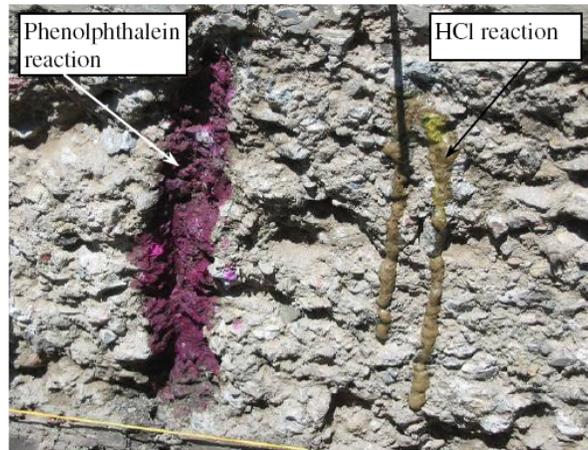
**Figure 3.2: 580RF phenolphthalein and hydrochloric acid reaction on base material.**

Re-cementation of the base material was visible. A cement odor was present and strong effervescence was noted when dilute hydrochloric acid was sprayed onto the base material, indicating the presence of old cement (Figure 3.2). When phenolphthalein was sprayed onto the base material, the sprayed area turned red, signifying a pH greater than 10, which is indicative of uncarbonated cemented material (Figure 3.2).

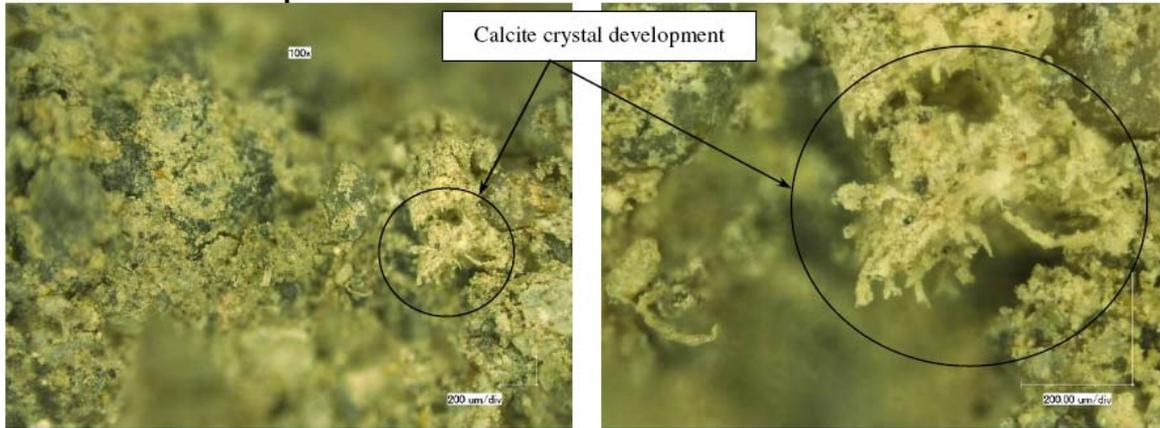
**Figure 3.3: Optical microscope view ( $\pm 100\times$ ) of calcite crystal development associated with cracks.**

**Figure 3.4: Optical microscope view ( $\pm 200\times$ ) of calcite crystal development associated with cracks.**

Figure 3.3 (optical microscope at  $\pm 100\times$  magnification) and Figure 3.4 (optical microscope at  $\pm 200\times$  magnification) show the presence of calcite crystals associated with the cracking in the carbonated sample, none of which were evident in the uncarbonated material. The well-crystallized nature of the material is indicative of recent formation (during the week before examination). There was also a conspicuous absence of calcium hydroxide, indicating severe carbonation.

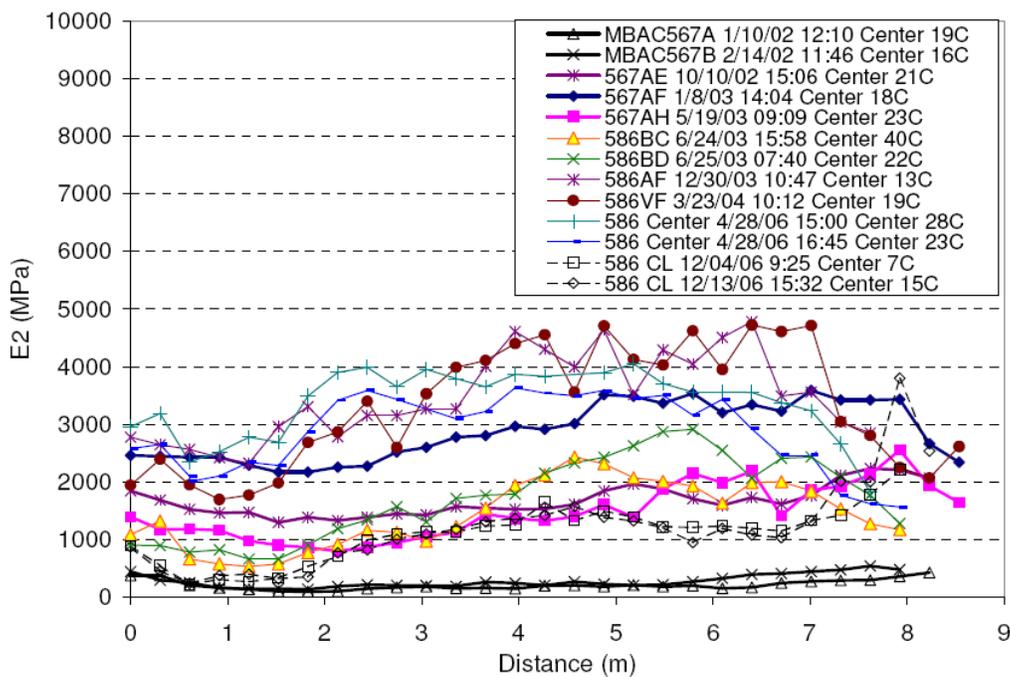
**Figure 3.5: Moduli of aggregate base from FWD measurements over a period of about five years; Sections 567RF/586RF (center of wheelpath).**

Very little time passed between the initial construction and the initial HVS testing on Section 567/586RF, and during that period no FWD tests were conducted. Backcalculations show that the moduli of the base changed between 1,000 and 4,000 MPa (145,000 and 580,000 psi) during the approximately five years that passed between the initial and the second HVS trafficking; Figure 3.5 and Figure 3.6 show that changes especially occurred during the first two years. During this time there was almost no truck traffic and only light car traffic. This would indicate that while some of the stiffness increase is likely due to curing (drying out causing suction) of the base, much of the stiffness gain should be attributed to re-cementation of the recycled concrete aggregate particles used in the base material (12). Most virgin Class 2 bases have stiffnesses that generally do not exceed 500 MPa (73,000 psi), while this base material had stiffnesses that were 2 to 8 times higher than most virgin Class 2 AB materials.

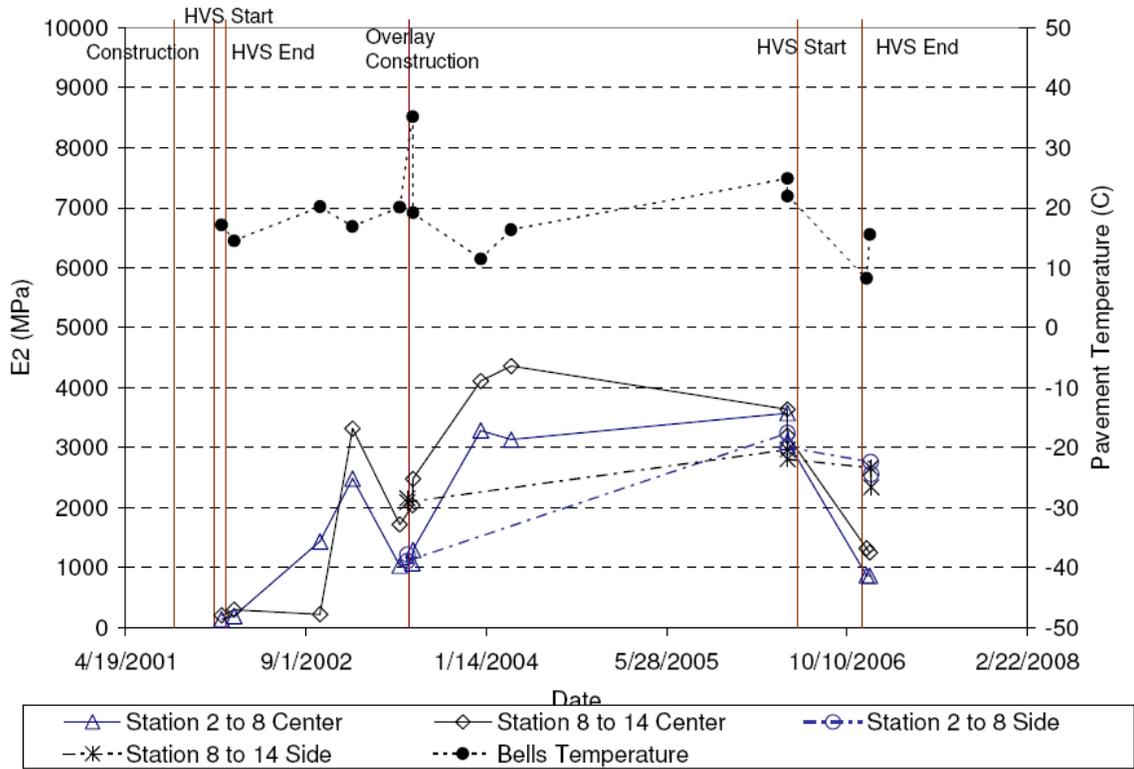
Figure 3.6: Moduli of aggregate base from FWD measurements versus time for Sections 567RF/586RF.

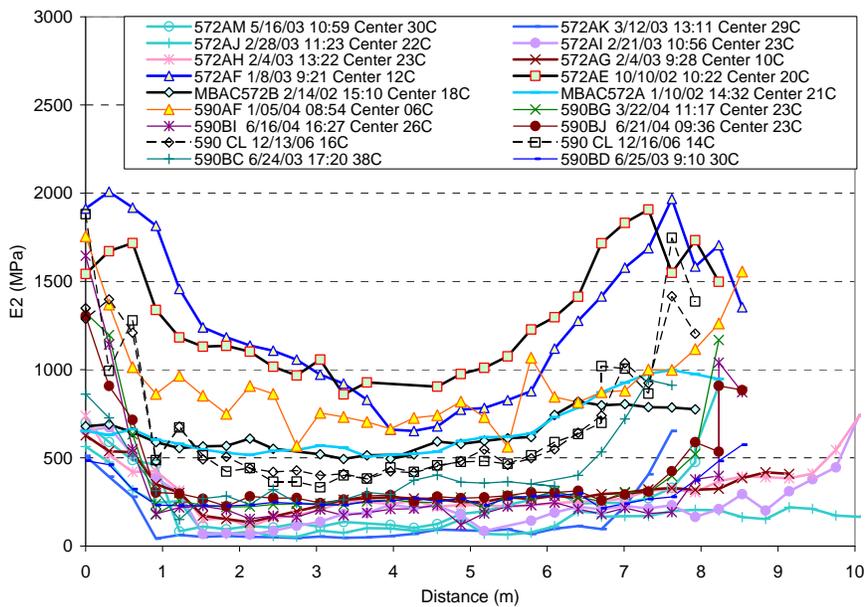
Figure 3.7: Modulus of aggregate base from FWD on Sections 572RF/590RF (center of wheelpath).

A similar trend can be seen for Section 572/590RF which was constructed at the same time with materials from the same source (Figure 3.7 and Figure 3.8). Section 572/590RF had approximately 18 months of light traffic between initial construction and initial HVS trafficking, another year between the two HVS tests, and another two years between measurements after the second HVS trafficking. It can be seen in Figure 3.8 that in the 18 months after initial construction the stiffness increased to approximately 1,000 MPa (145,000 psi). The very heavy loading of HVS trafficking then reduced the stiffness to approximately 150 MPa (22,000 psi), after which it increased over the next year to approximately 750 MPa (108,000 psi). The second round of heavy loading from the HVS brought the stiffness down to about 250 MPa (36,000 psi), which then increased over the next two years to about 500 MPa (73,000 psi).

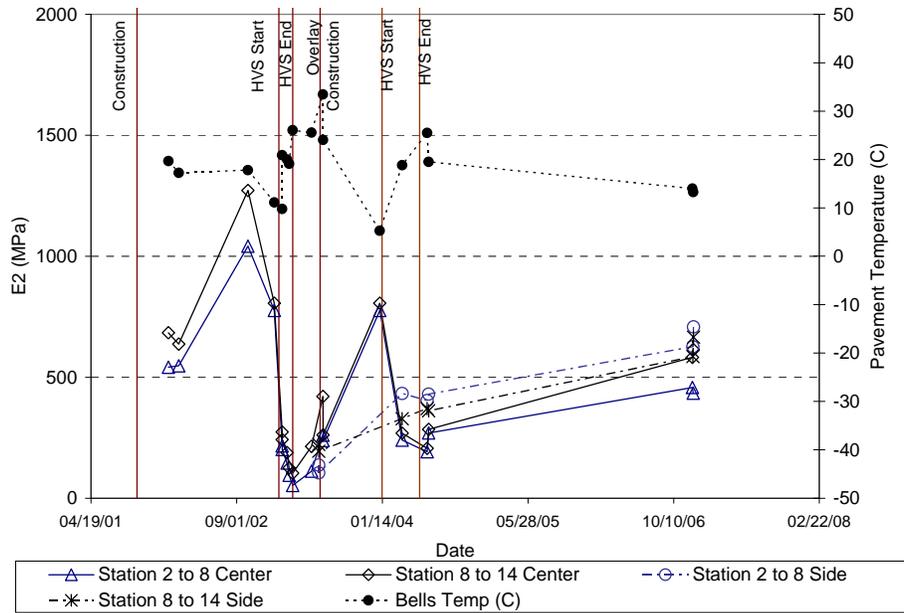
**Figure 3.8: Modulus of aggregate base from FWD versus time on Section 572RF/590RF.**

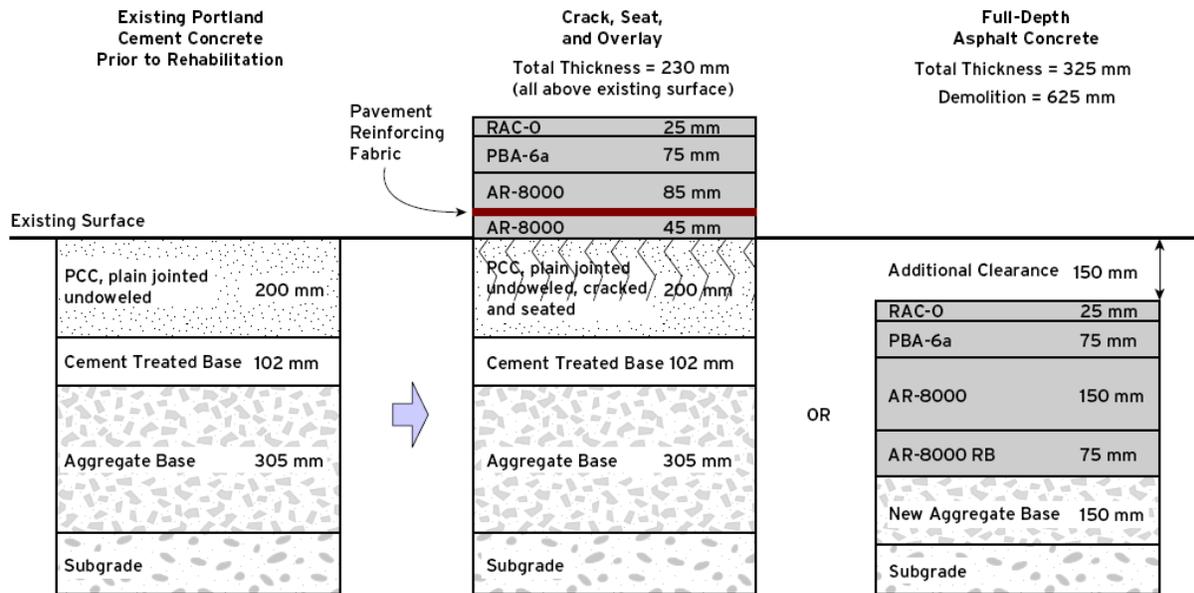
**Figure 3.9: Illustration of I-710 rehabilitation strategies.**

The Interstate 710 freeway is a heavily trafficked route in Southern California which carries traffic into and out of the ports of Long Beach and Los Angeles. The original jointed plain concrete pavement structure was built in 1955, and consisted of 200 mm (8 in.) of portland cement concrete, 100 mm (4 in.) of cement-treated base, 100 mm (4 in.) of aggregate base, and, 200 mm (8 in.) of imported subbase material (9). Due to vertical clearance limitations, two different types of pavement cross section were selected for the rehabilitation in 2002: full-depth asphalt concrete on aggregate base under the overcrossings; and crack, seat, and asphalt concrete overlay (CSOL) on the sections where vertical clearance was not a problem. Figure 3.9 illustrates the rehabilitation methods used. The new aggregate base shown under the full-depth sections was manufactured by the contractor from various sources of concrete pavement slabs from the Port of Long Beach. These slabs were crushed to meet Caltrans Class 2 AB specifications, and then placed as Class 2 AB before paving asphalt over the top. As part of the post-construction monitoring of this initial project using this type of design, the pavement was evaluated for five years.

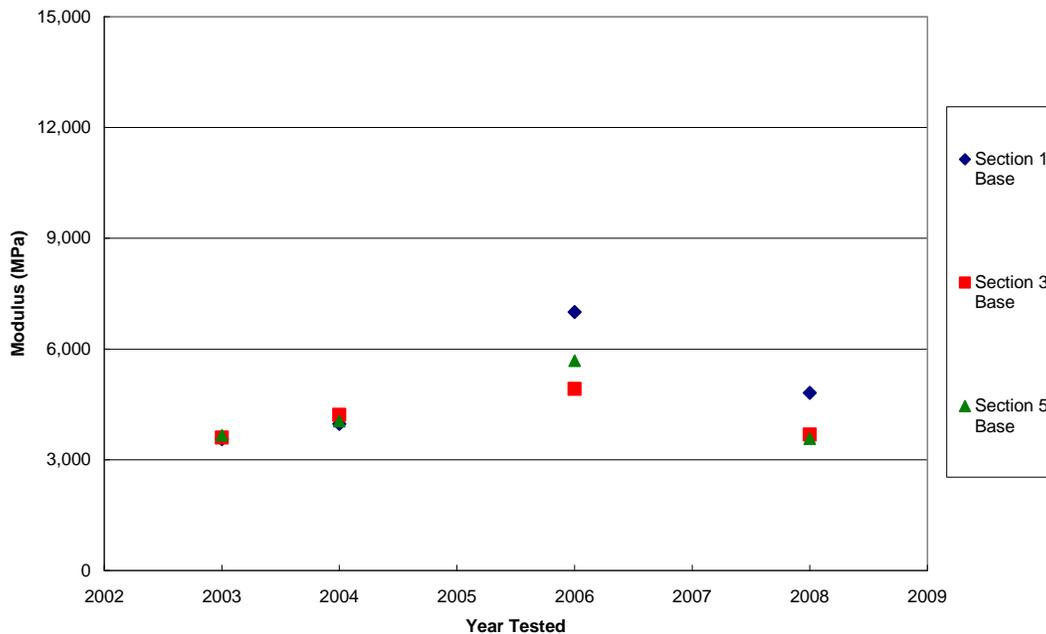
**Figure 3.10: I-710 Northbound Lane 1 full-depth sections—layer moduli with time.**

Figure 3.10 through Figure 3.12 show the backcalculated base moduli for the three full-depth sections. Average moduli values for the crushed concrete base section in the full-depth sections were of the order of 4,000 MPa (580,000 psi) with a range of about 1,200 MPa to 7,000 MPa (174,000 to 1,016,000 psi). These values are higher than observed values for conventional crushed aggregate base material. It is suspected that significant cementing must have taken place in the base layer to account for the high levels determined through backcalculation even though no cores were obtained that could be used for strength measurement or to provide evidence of cementation in a laboratory study. Nevertheless, although the computed values might not precisely represent the in-situ characteristics of the material, increased stiffness was evident.

It is apparent from these results that over the five-year period of evaluation after construction the stiffness of the base did not decrease significantly, while it did decrease to values typical of aggregate base with no cementation under the HVS loading. The wheel loads on the I-710 pavement do not include many loads over the legal limit,

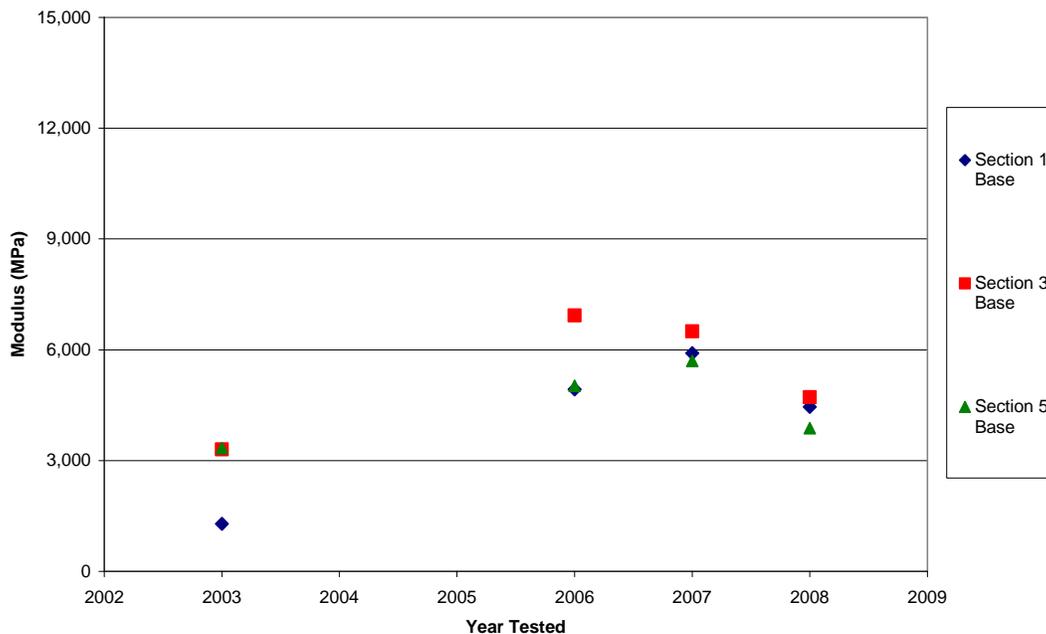
**Figure 3.11: I-710 Northbound Lane 2 full-depth sections—layer moduli with time.**

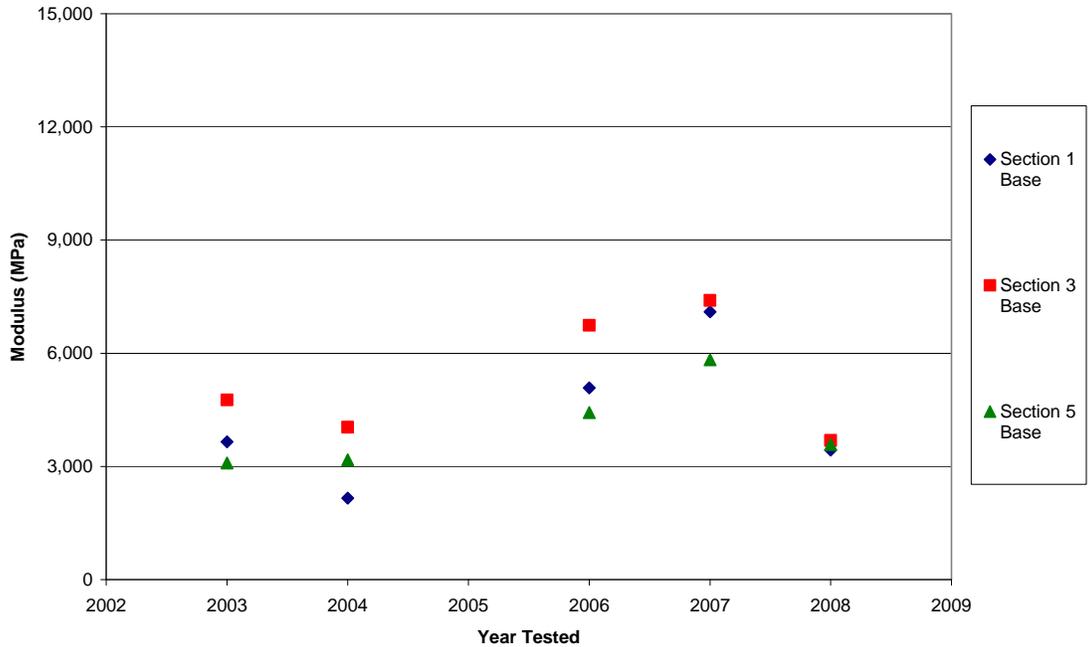
**Figure 3.12: I-710 Northbound Lane 3 full-depth sections—layer moduli with time.**

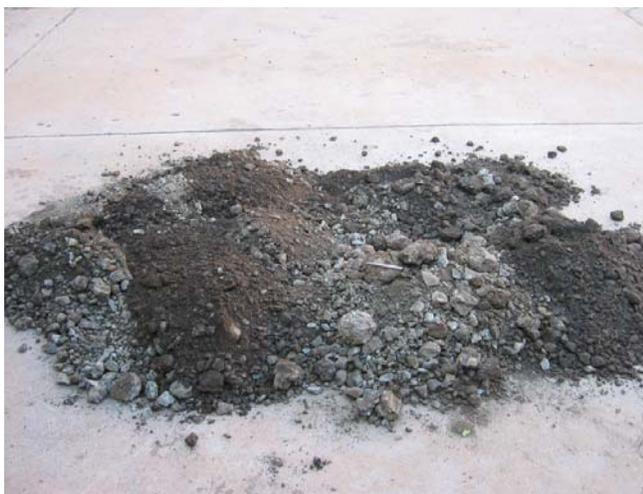
**Figure 3.13: Base course material from test pit.  
(Note large cemented lumps.)**

In Figure 3.13, lumps of cemented base from the original road were noted. Freshly exposed faces reacted to phenolphthalein turning a dark red color, indicating the presence of cement (Figure 3.14). A reaction was also obtained when hydrochloric acid was sprayed onto the material, indicating the presence of carbonate.

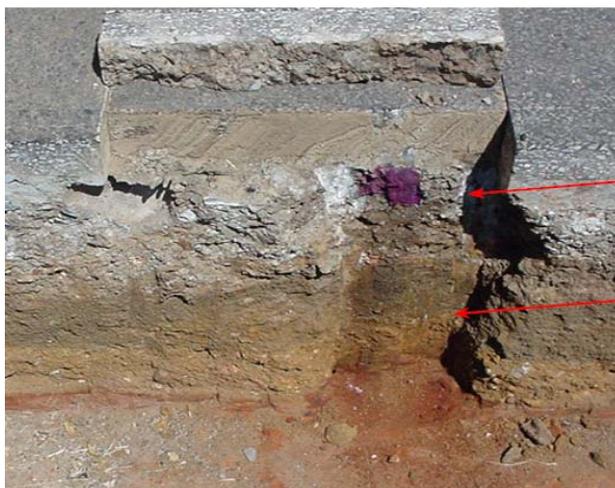
**Figure 3.14: Phenolphthalein reaction on base.**

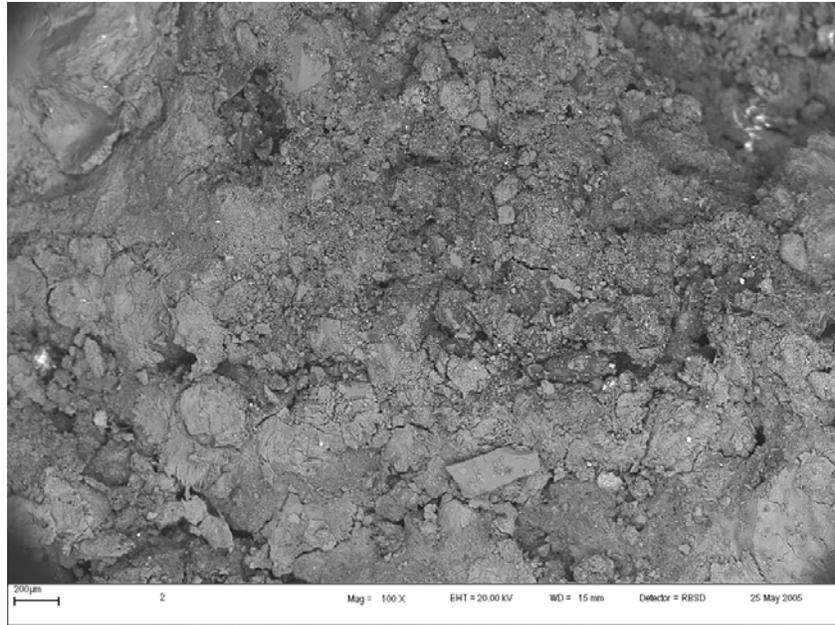
**Figure 3.15: Example of carbonated specimen cracking (shown in the lower part of the photograph).**

Figure 3.15 and Figure 3.16 show a typical result of carbonation where the development of calcite (calcium carbonate,  $\text{CaCO}_3$ ) from lime (calcium hydroxide,  $\text{Ca}(\text{OH})_2$ ) in the material results in expansion and cracking. This cracking was seen previously in a range of different carbonated materials. The highly crystallized nature of the material is indicative of recent formation. There is also a conspicuous absence of calcium hydroxide, indicating severe carbonation.

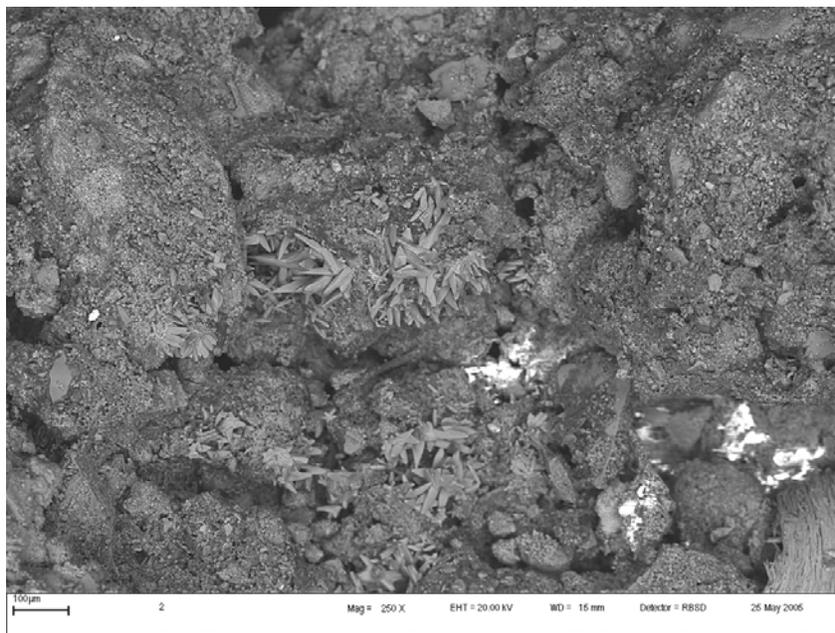
**Figure 3.16: Development of young calcite crystals associated with cracks.  
(Note ettringite crystals in the bottom right corner).**

Well-formed fibrous ettringite is also clearly visible in Figure 3.16 (strawlike [wispy] crystals in the bottom right corner), which indicates that cement was present in the matrix after construction, the former apparently generated during breakdown of the highly cemented pre-existing base.

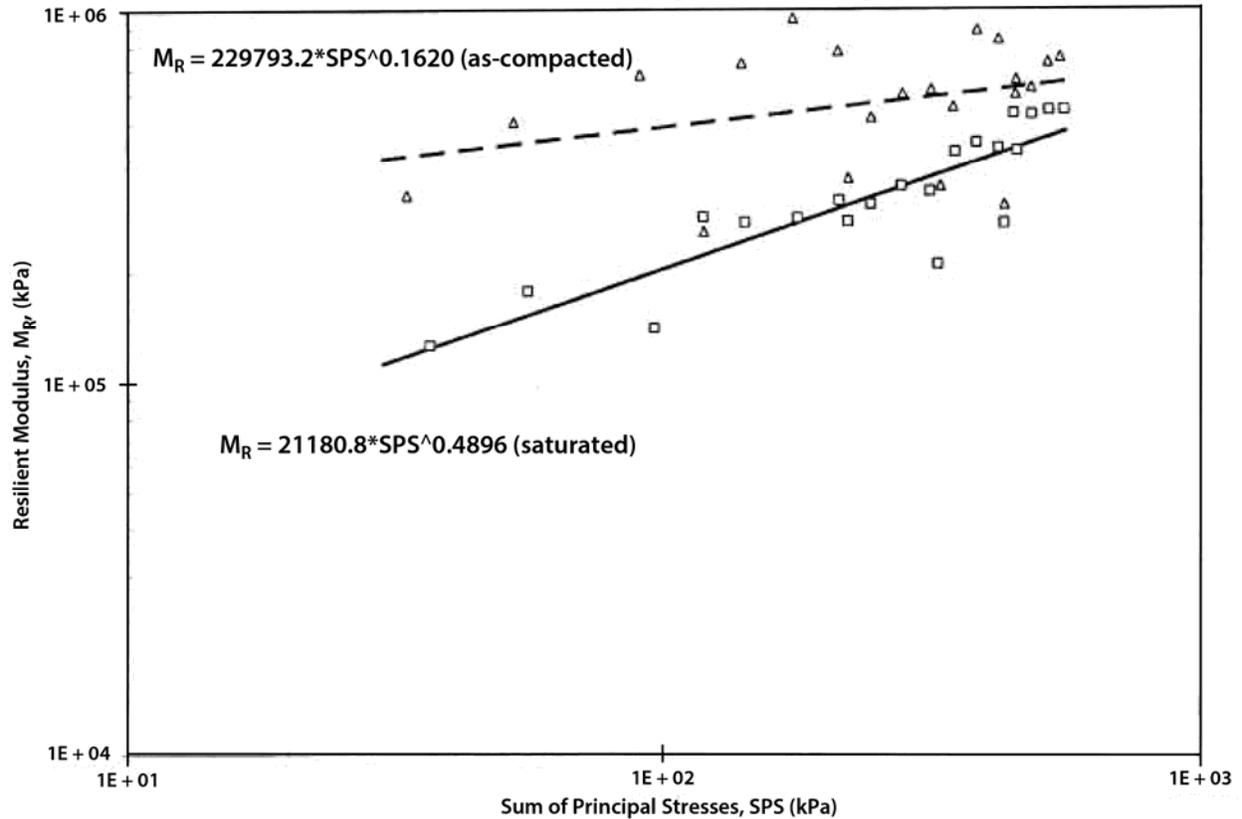
**Figure 3.17: Laboratory resilient modulus test results for aggregate base.**

Results of the initial laboratory resilient modulus testing on the aggregate base are shown in Figure 3.17. It can be seen that the stiffness is between about 300 and 500 MPa (44,000 and 73,000 psi) depending on the confining stress in the as-compacted moisture condition, which is the expected range for high quality uncemented aggregate base. FWD testing performed across the 1,000 ft-long test pavement just after construction in 1995 showed stiffnesses that averaged 285 MPa (41,000 psi) with a standard deviation 73 MPa (11,000 psi), again well within the range of expected values for uncemented aggregate base.

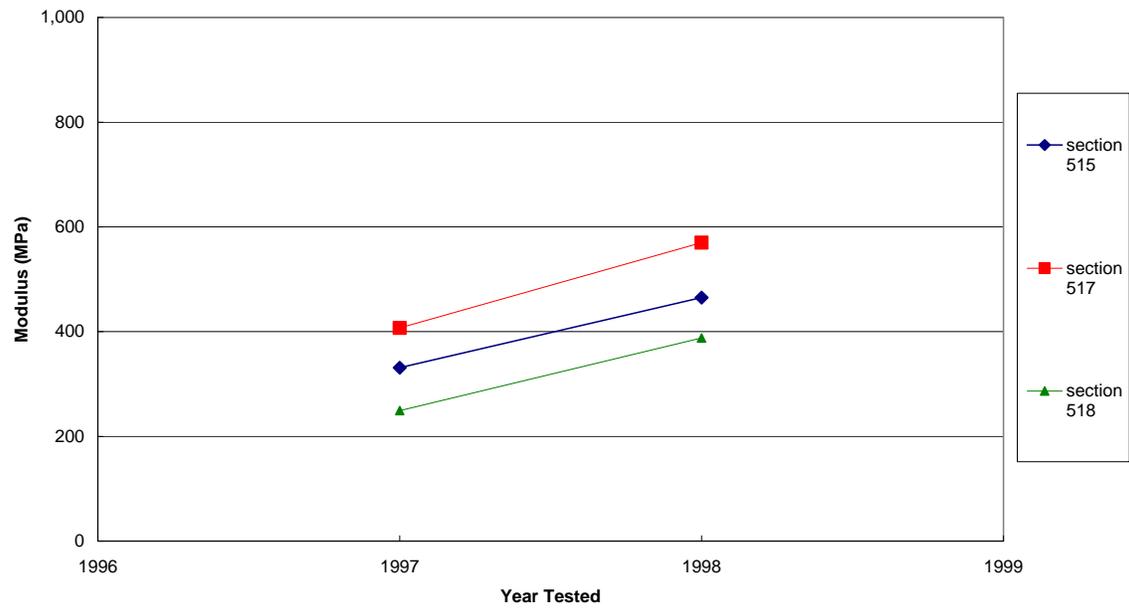
**Figure 3.18: Backcalculated moduli from FWD deflections.**

FWD testing and backcalculations performed in 1997 and 1998 showed some increase after 1995 on areas that were not subjected to any trafficking from the HVS, as shown in Figure 3.18, with stiffness ranging between 250 and 400 MPa (36,000 and 58,000 psi). For each of three sections examined (RF 515, 517, and 518), the computed stiffness moduli of the granular base layers increased again with time between 1997 and 1998 as seen in Figure 3.18. This increase was about 45 percent for each section over the year.
