Research Report – UCD-ITS-RR-14-26

Full-Depth Recycling Study: Test Track Construction and First Level Analysis of Phase 1 HVS and Laboratory Testing

Partnered Pavement Research Center (PPRC) Contract Strategic Plan Element 4.36: Recycling of Rubberized HMA in RAP and FDR Projects

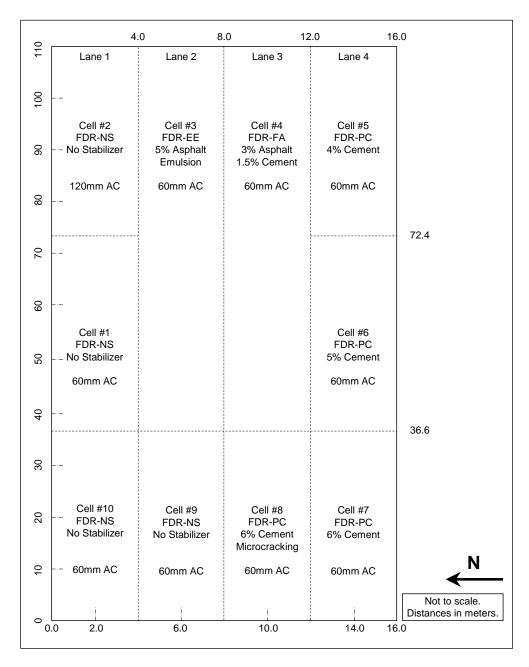
Figure 3.2: Planned test track layout.

The planned FDR test track layout is shown in Figure 3.2. All test track measurements and locations discussed in this report are based on this layout.

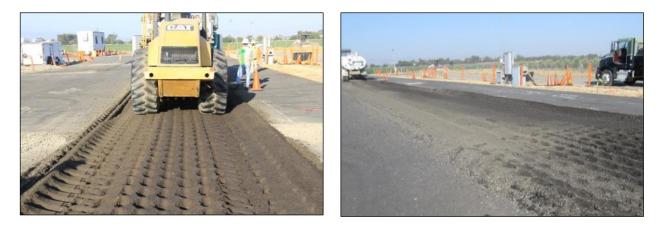
The FDR-EE lane was compacted following the same sequence as that described for the FDR-NS lane. During compaction with the padfoot roller, the strip down the left side of the lane where no binder had been applied (Figure 3.17) was clearly visible. After completion of rolling with the smooth drum roller, the areas with excess fluid content in the recycled material in the first half of the lane was clearly visible in the form of puddles on the surface (Figure 3.18 and Figure 3.19). Excavation of the pulverized material in the adjacent FDR-FA lane clearly showed the high moisture content in the FDR-EE layer after compaction (Figure 3.20). Subsequent passes with the smooth drum roller caused additional water puddles to appear on the test track surface.

Figure 3.17: FDR-EE: Compaction with padfoot roller. (Note untreated areas and emulsion adhering to tire).

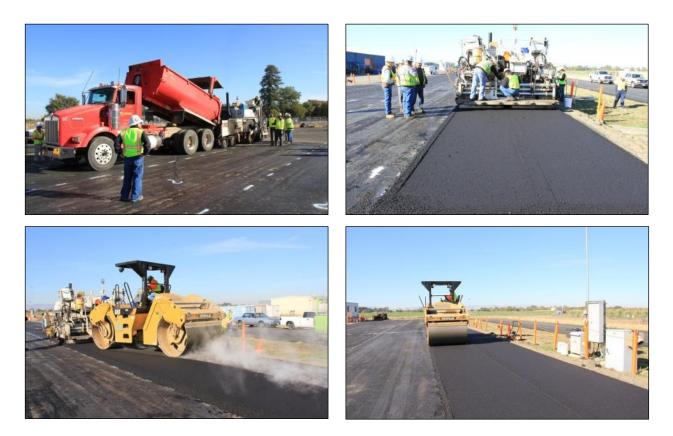
Mix was transported using end-dump trucks. Paving was carried out in a west-east direction and followed conventional procedures (Figure 3.37). Work started in Lane #1, followed by Lanes #2, #3, and #4. The second lift on Lane #1 (Cell #2) was placed after completion of the first lift on the other lanes. A breakdown roller closely followed the paver, applying about four passes. A single pass was made with an intermediate rubber-tired roller, followed by another four passes with a finish roller. Compaction of the lower lift appeared to be consistent and no problems were noted (Figure 3.38). On the second lift placed in Cell #2, the mix appeared tender and some shearing was noted (Figure 3.39) in the vicinity of the instrumentation cables (discussed in Section 4.4).

Figure 3.37: Asphalt concrete placement.

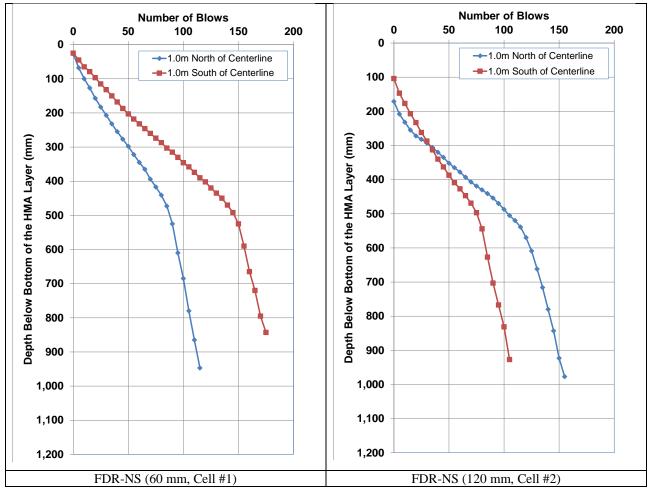
- FDR-NS: Tests were done on both the 60 mm and 120 mm thick asphalt concrete sections. Only one distinct change was noted in the penetration rate. This was at approximately 20 in. (500 mm) below the bottom of the asphalt concrete layer, corresponding to the interface between the original base and the subgrade. This indicates that the recycled base and old aggregate base layer had similar mechanical properties. The combined as-built thickness was comparable to the 22.5 in. (570 mm) design thickness.
- FDR-EE, FDR-FA, and FDR-PC: Measurements were consistent with those taken on the FDR-NS sections, with a distinct change between the base and subgrade at approximately 20 in. (500 mm) below the bottom of the asphalt concrete layer.

Figure 3.41: Unbound layer DCP penetration curves for unstabilized sections.

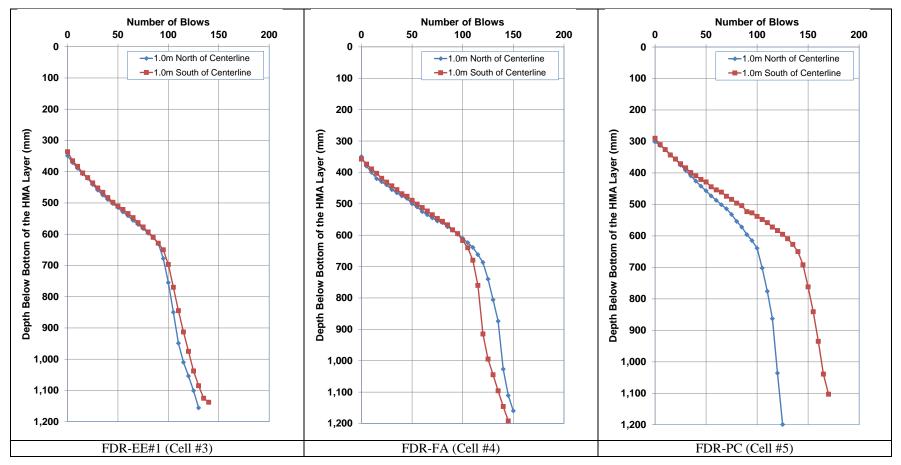
Figure 3.42: Unbound layer DCP penetration curves for stabilized sections.

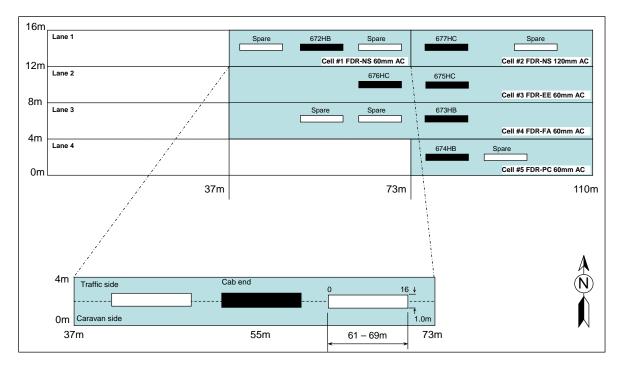
- Section 672HB: FDR-NS (60 mm asphalt concrete)
- Section 673HB: FDR-FA
- Section 674HB: FDR-PC
- Section 675HC: FDR-EE (test #1)
- Section 676HC: FDR-EE (test #2)
- Section 677HC: FDR-NS (120 mm asphalt concrete)

Figure 4.1: Test track layout.

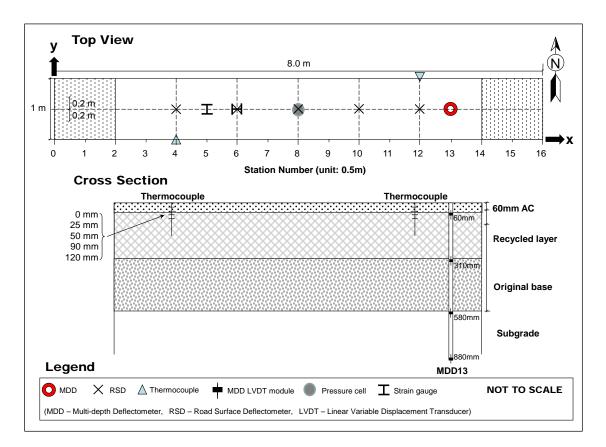
An HVS test section is 26.2 ft (8.0 m) long and 3.3 ft (1.0 m) wide. A schematic in Figure 4.2 shows an HVS test section along with the stationing and coordinate system. Station numbers (0 to 16) refer to fixed points on the test section and are used for measurements and as a reference for discussing performance. Stations are placed at 1.6 ft (0.5 m) increments. A sensor installed at the center of the test section would have an *x*-coordinate of 4,000 mm and a *y*-coordinate of 500 mm.

Figure 4.2: Schematic of an HVS test section.

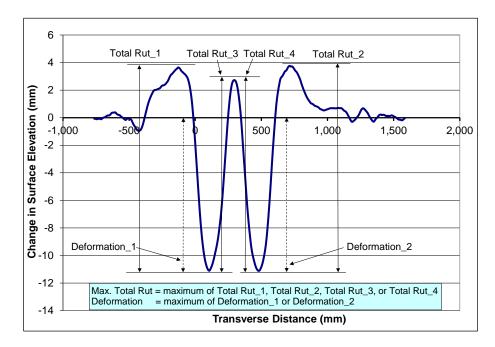
Figure 4.6: Illustration of maximum rut depth and deformation for a leveled profile.

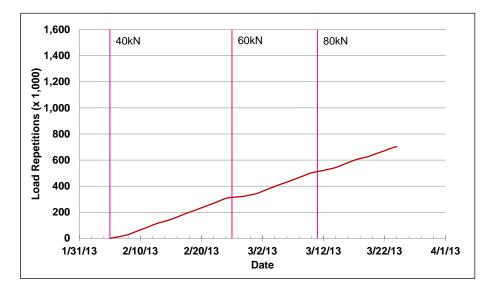
Loading commenced with a 40 kN (9,000 lb) half-axle load on February 5, 2013, and ended with an 80 kN (18,000 lb) load on March 24, 2013. A total of 713,000 load repetitions were applied and 49 datasets were collected. Load was increased from 40 kN to 60 kN (13,500 lb) and then to 80 kN (18,000 lb) after 315,000 and 515,000 load repetitions, respectively. No breakdowns occurred during testing on this section. The HVS loading history for Section 672HB is shown in Figure 5.2.

Figure 5.2: 672HB: HVS loading history.

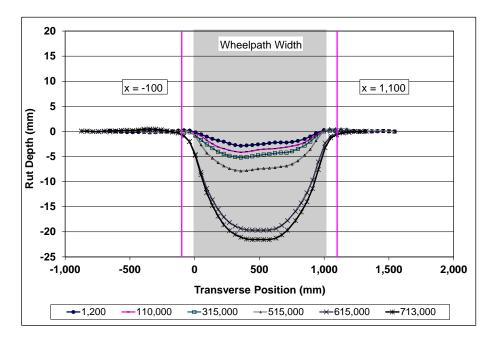
Figure 5.6 shows the average transverse cross section measured with the laser profilometer at various stages of the test. This plot clearly shows the increase in rutting and deformation over time. Figure 5.7 shows the development of permanent deformation (average maximum total rut and average deformation) with load repetitions. The two plots show that most of the deformation was in the form of a depression (i.e., deformation was below the zero elevation point at the surface [Figure 4.6]) rather than upward and outward displacement of the material above the zero elevation point.

Figure 5.6: 672HB: Profilometer cross section at various load repetitions.

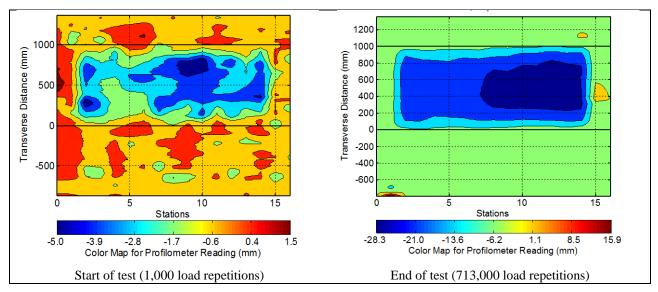
Figure 5.8 shows contour plots of the pavement surface at the start and end of the test (713,000 load repetitions) that also indicate the deeper rut at one end of the section. Terminal rut (12.5 mm [0.5 in.]) was reached after approximately 320,000 load repetitions. However, testing was continued for approximately 400,000 additional load repetitions to further assess rutting trends at the higher loads.

Figure 5.8: 672HB: Contour plots of permanent surface deformation. (Note different scales in legends.)

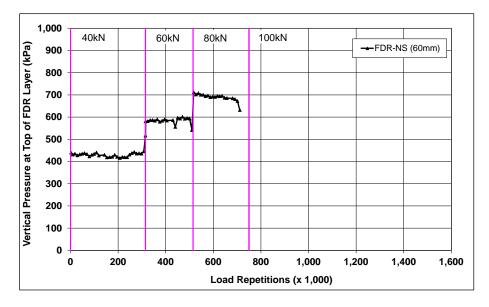
Figure 5.11 shows the traffic-induced vertical pressure at the top of the recycled base layer. Pressure readings were stable, but sensitive to load change, for the duration of the test. Increases in recorded pressures occurred after the load changes, as expected. The reason for the decrease in pressure at the end of the test is unclear, but it is assumed that either the instrumentation was damaged or support conditions under the pressure cell changed.

Figure 5.11: 672HB: Vertical pressure at the top of the recycled layer.

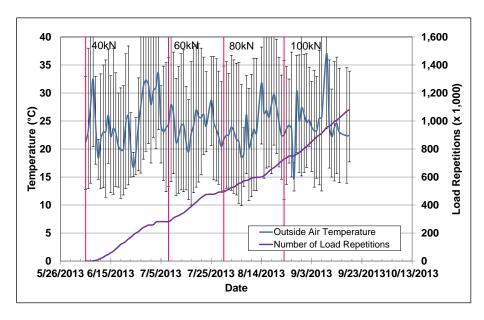
Daily average outside air temperatures are summarized in Figure 5.18. Vertical error bars on each point on the graph show the daily temperature range. Temperatures ranged from 10°C to 47°C (50°F to 117°F) during the course of HVS testing, with a daily average of 24°C (75°F), an average minimum of 15°C (59°F), and an average maximum of 36°C (97°F).

Figure 5.18: 677HC: Daily average air temperatures outside the environmental chamber.

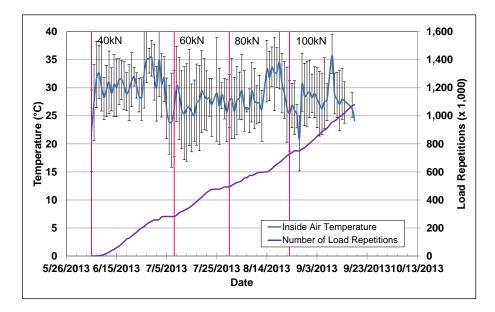
During the test, air temperatures inside the temperature control chamber ranged from 14° C to 61° C (57° F to 142° F) with an average of 29° C (84° F) and a standard deviation of 2.9° C (5.2° F). Air temperature was adjusted to maintain a pavement temperature of 30° C $\pm 4^{\circ}$ C (86° F $\pm 7^{\circ}$ F) at a pavement depth of 50 mm (2.0 in.). The recorded pavement temperatures discussed in Section 5.4.3 indicate that the inside air temperatures were adjusted appropriately to maintain the required pavement temperature. The daily average air temperatures recorded in the environmental chamber, calculated from the hourly temperatures recorded during HVS operation, are shown in Figure 5.19. Vertical error bars on each point on the graph show the daily temperature range.

Figure 5.19: 677HC: Daily average air temperatures inside the environmental chamber.

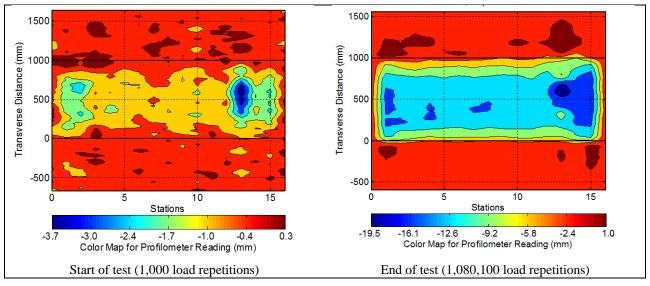
After completion of trafficking, the average maximum total rut depth and the average deformation were 14.3 mm (0.56 in.) and 12.8 mm (0.50 in.), respectively. The maximum rut depth measured on the section was 19.4 mm (0.76 in.), recorded at Station 13.

Figure 5.23: 677HC: Contour plots of permanent surface deformation. (Note different scales in legends.)

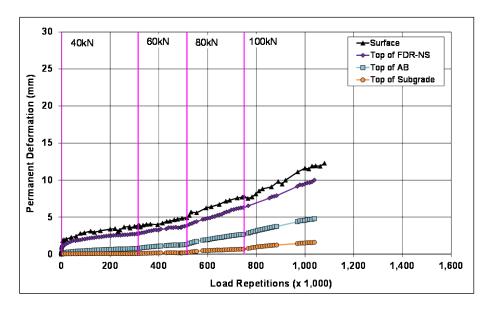
Permanent deformation in the underlying layers, recorded with a multi-depth deflectometer (MDD) at Station 13 and compared to the surface layer laser profilometer measurements, is shown in Figure 5.24.

Figure 5.24: 677HC: Permanent deformation in the underlying layers.

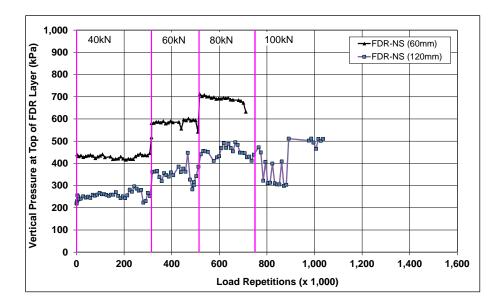
Figure 5.26 shows a comparison of traffic-induced vertical pressure at the top of the recycled base layer for the FDR-NS (120 mm) and FDR-NS (60 mm) sections. Pressure readings were lower on the FDR-NS (120 mm) section, as expected. Pressure readings were also sensitive to load changes. Measurements were erratic toward the end of the test after the load change to 100 kN. The reason for this is unclear, but it is assumed that either the instrumentation was damaged or support conditions under the pressure cell changed.

Figure 5.26: 677HC: Vertical pressure at the top of the recycled layer.

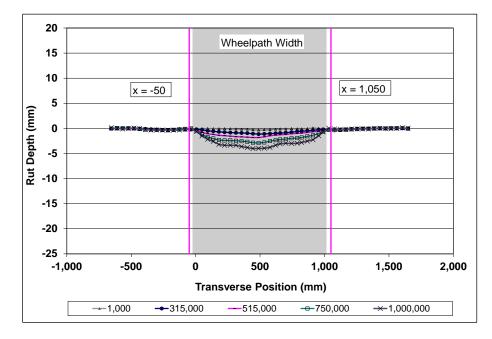
Figure 5.36 shows the average transverse cross section measured with the laser profilometer at various stages of the test and illustrates the increase in rutting and deformation over time. Figure 5.37 shows the development of permanent deformation (average maximum rut and average deformation) with load repetitions for the test section. The results for the FDR-NS (60 mm) section are shown for comparison. The two plots show that most of the deformation was in the form of a depression rather than upward and outward displacement of the material above the zero elevation point.

Figure 5.36: 673HB: Profilometer cross section at various load repetitions.

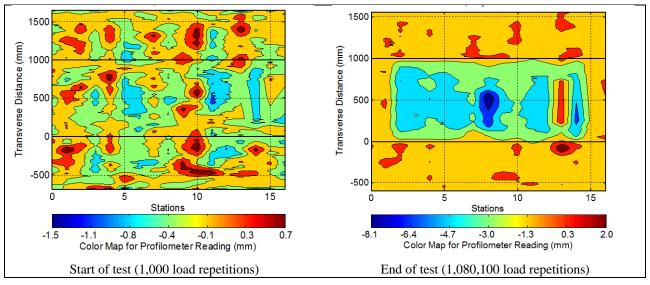
Figure 5.38 shows contour plots of the pavement surface at the start and end of the test (1,000,000 load repetitions). The plot shows the relative uniformity of the rut depth over the length of the section. The small area of distress at Station 8 was attributed to some mechanical damage on the surface and not to rutting (see Section 5.5.11). After completion of trafficking, the average maximum rut depth and the average deformation were 5.0 mm (0.20 in.) and 4.1 mm (0.16 in.), respectively. The maximum total rut depth measured on the section was 8.2 mm (0.32 in.), recorded at Station 8 in the area of mechanical damage on the surface.

Figure 5.38: 673HB: Contour plots of permanent surface deformation. (Note different scales in legends.)

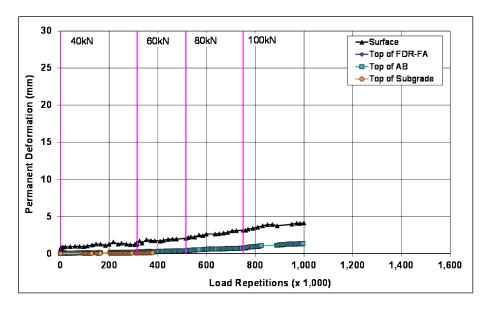
Permanent deformation in the underlying layers, recorded with a multi-depth deflectometer (MDD) at Station 13 and compared to the surface layer laser profilometer measurements is shown in Figure 5.39.

Figure 5.39: 673HB: Permanent deformation in the underlying layers.

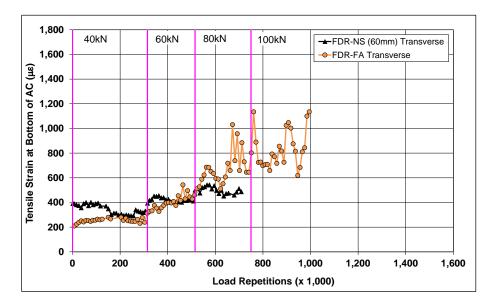
Figure 5.40 shows the peak traffic-induced transverse tensile strain at the bottom of the asphalt concrete layer. The strain gauge installed to measure longitudinal strain was damaged during placement of the asphalt concrete surfacing and therefore no readings were obtained. Transverse strain measurements from the FDR-NS (60 mm) section are included in the figure for comparison. Trends in the transverse strains measured on the FDR-FA section differed from those measured on the FDR-NS sections. Initial transverse strains were significantly lower than those recorded on the unstabilized section, but they showed a relatively sharp increase in the first 50,000 load repetitions attributable to initial breakdown of the portland cement bonds. The strains stabilized thereafter at similar levels to those recorded on the FDR-NS (60 mm) section for the remainder of the 40 kN wheel load trafficking. The increase in strain immediately after the load change was not as sharp as that recorded on the FDR-NS section, but it continued to increase for the remainder of the test suggesting further weakening of the structure (probably attributed to microcracking in the recycled base) caused by trafficking. Variability in the strain measurements recorded in the latter part of the test was attributed to a combination of temperature changes and their effect on microcracks under the strain gauge. No surface distresses associated with the increase in strain measurements in the recycled layer were noted during the course of the study.

Figure 5.40: 673HB: Tensile strain at the bottom of the asphalt concrete layer.

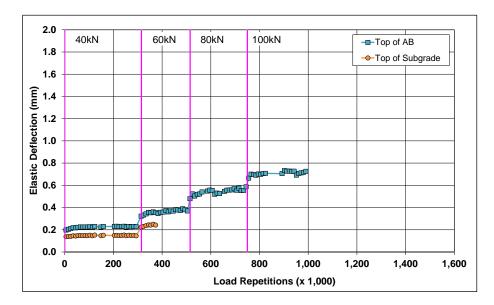
Figure 5.43 shows the history of in-depth elastic deflections, measured by the LVDTs at the top of the existing aggregate base and top of the subgrade in the multi-depth deflectometer in the FDR-FA section. The LVDT at the top of the recycled layer failed early in the experiment and no data is available for this location. The readings are consistent with the surface deflections measured with the RSD, and those recorded on the FDR-NS (60 mm) section. However, the deflections measured were lower than those recorded on the unstabilized sections, as expected due to the higher stiffnesses associated with the stabilized recycled layer. Deflections increased with increased load, as expected, but stabilized after each embedment phase with increasing number of load repetitions, which suggests continued stiffening/densification during HVS trafficking and the absence of any distress in the recycled layer.

Figure 5.43: 673HB: Elastic deflection in the underlying layers.

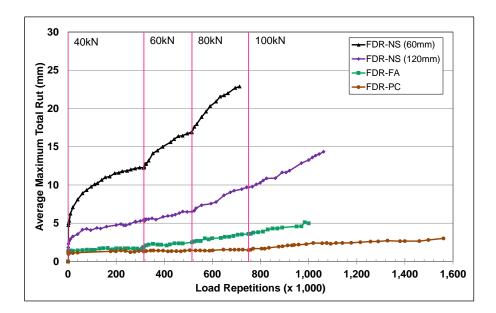
Figure 5.95: Comparison of average maximum rut.

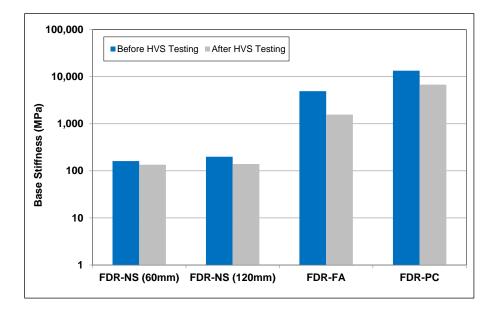
Figure 5.96: Comparison of backcalculated stiffness before and after testing.
