Research Report – UCD-ITS-RR-16-19

Results from Visual Inspection and Laboratory Testing  
for ASR in Existing Concrete Cores from Bridges and  
Pavements in California

Partnered Pavement Research Center (PPRC) Strategic Plan Project Task 3.34:  
Improved Screening Tests for ASR

California Department of Transportation  
Division of Research, Innovation and System Information  
and Materials Engineering and Testing Services, Office of  
Structural Materials

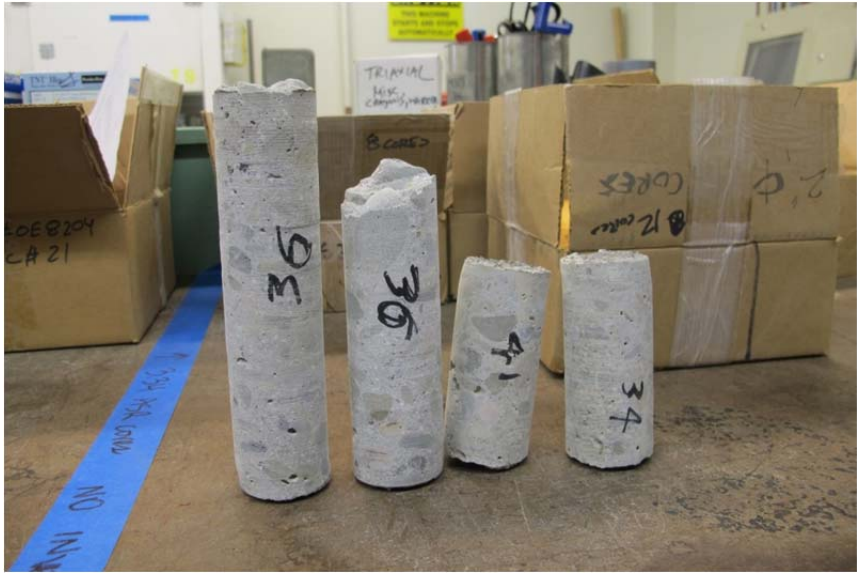
Figure 2.2: Bridge cores; cores equal to or longer than 3 inches were used for ASR visual inspection.

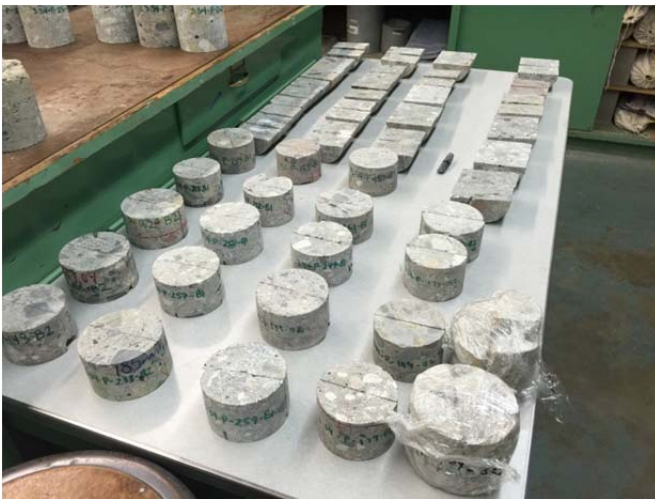
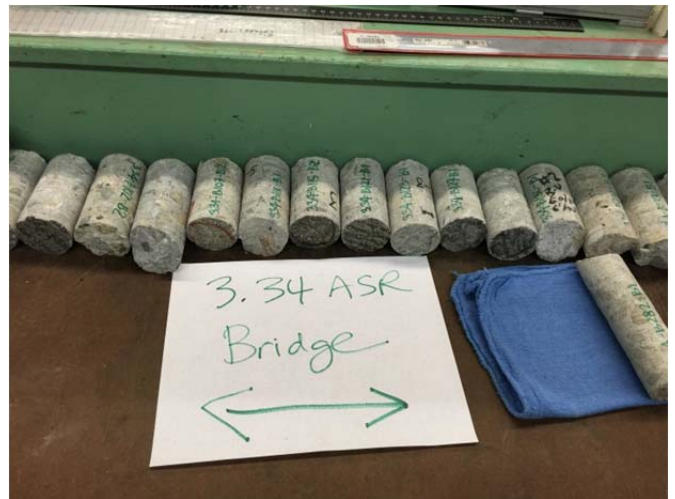
**Figure 2.9: Concrete cores for visual inspection.**

All the pavement cores used for CTE testing had been cut to a length of 6 inches (152 mm), but the pavement cores and bridge cores from the GPR study were of varying lengths. For this study, bridge cores that were equal to or longer than 3 inches were cut vertically into two parts for the ASR visual inspection (Figure 2.8 and Figure 2.9).

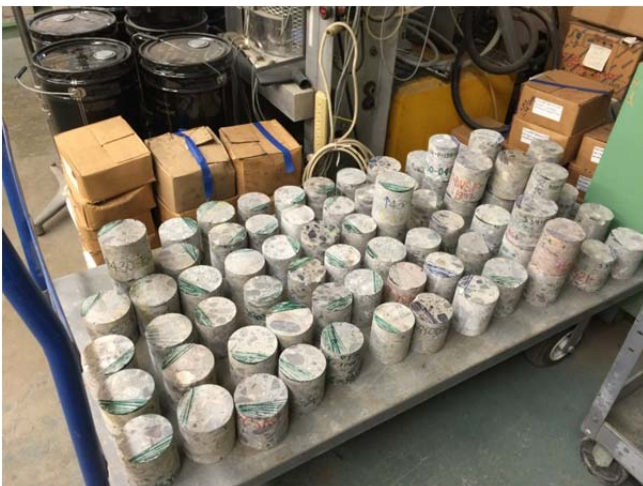
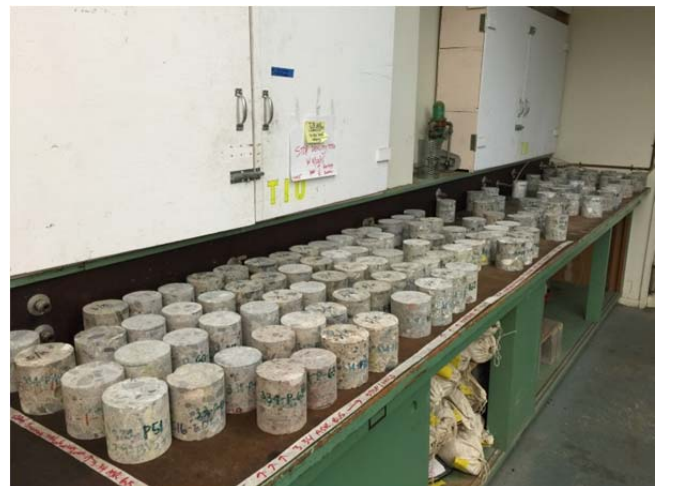
**Figure 2.10: Concrete pavement cores after cutting and leveling for strength testing.**

Pavement core pieces cut for strength testing were ground to ensure that the top and bottom surfaces were parallel to each other and perpendicular to the core sides (Figure 2.10). All the bridge cores were too small for strength testing.

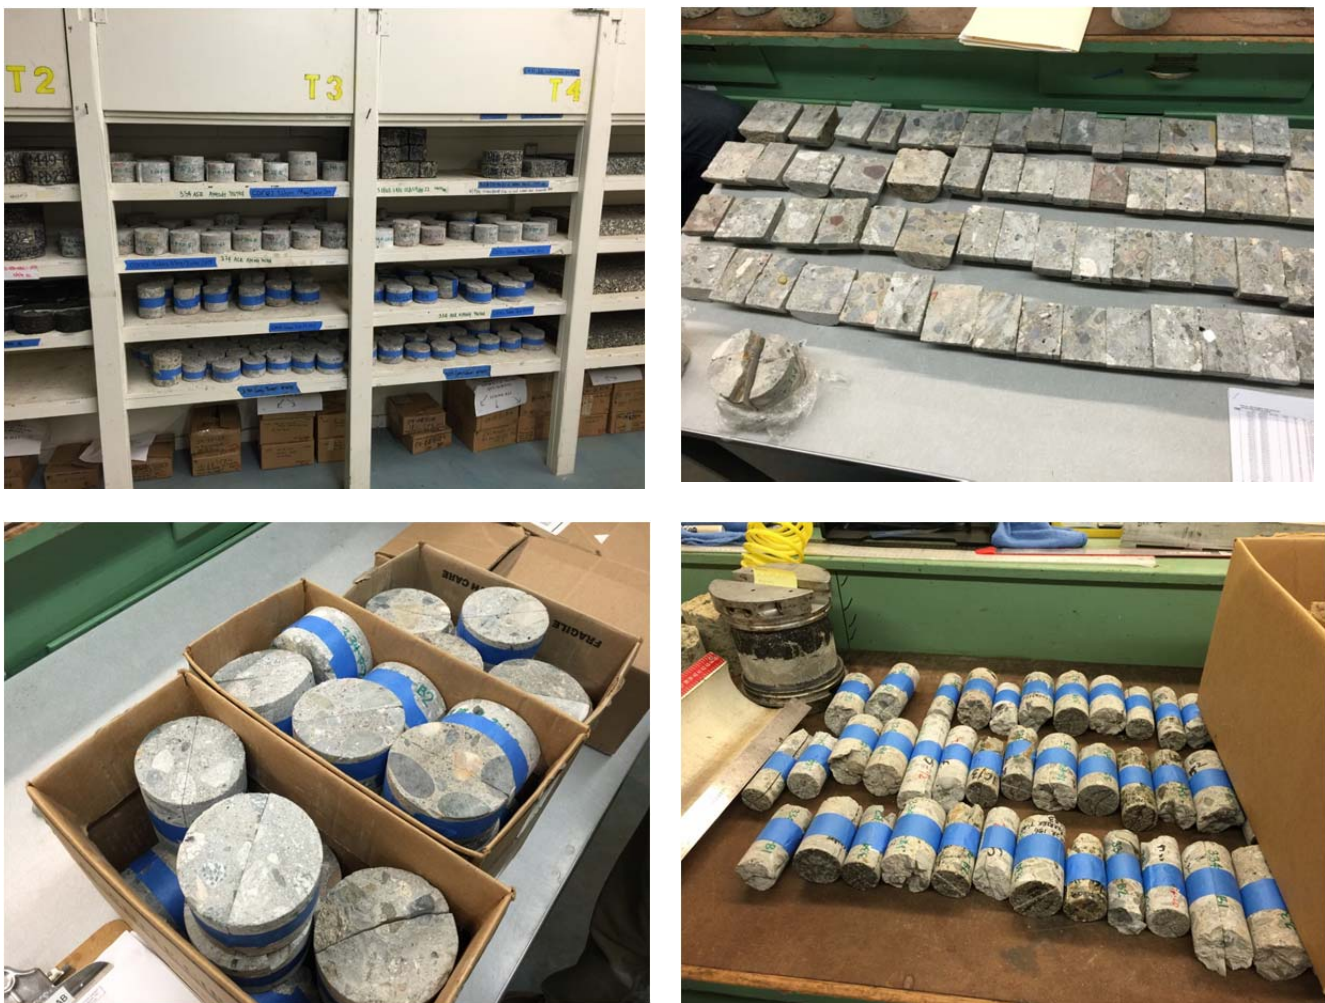
Figure 3.1: Pavement and bridge cores after cutting for visual inspection.

A total of 259 pavement core samples (multiple pieces for most pavement cores) and 80 bridge core samples (Figure 3.1) were visually inspected by the primary petrographer.

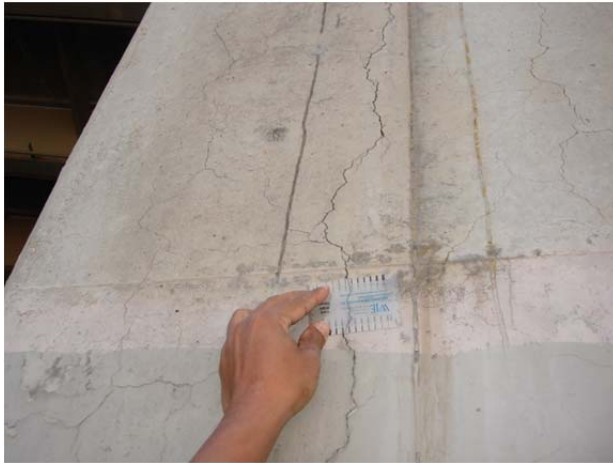
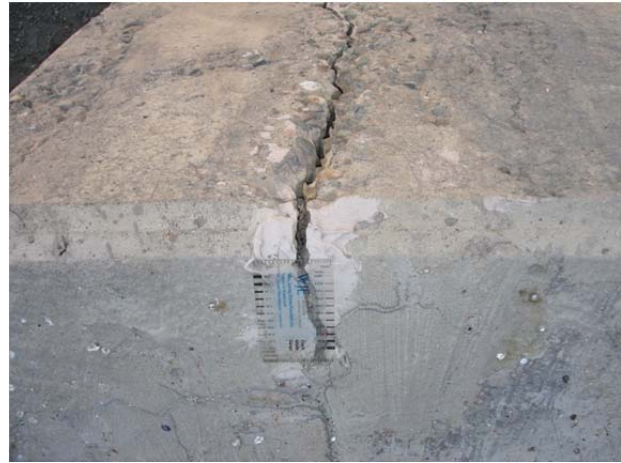
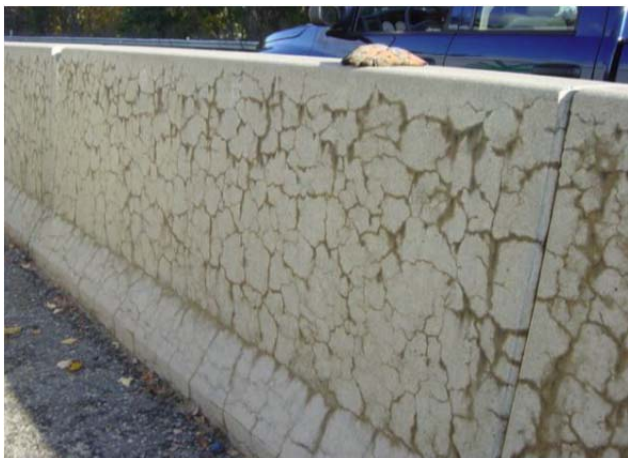
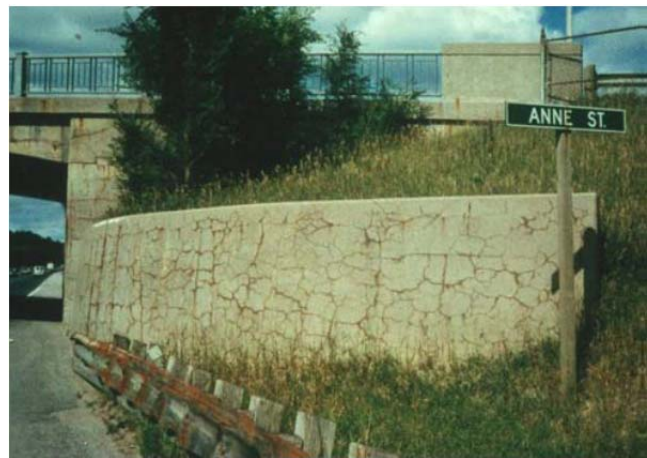
**Figure A.2: Example photos showing some of the common petrographic features of ASR.**

gel, and voids lined or filled with gel. Each feature should be given a weighing factor based on its association to ASR. Photos in Figure A.2 show some of the common petrographic features of ASR. The weighted features should be summed and normalized to the area examined, which will give a Damage Rating Index (DRI) value for the core slice. Additional information should be gathered regarding the presence of reacted aggregate (but not showing signs of distress), the presence of secondary mineral deposits other than ASR gel, and the physical characteristics of the concrete, such as consolidation and segregation.

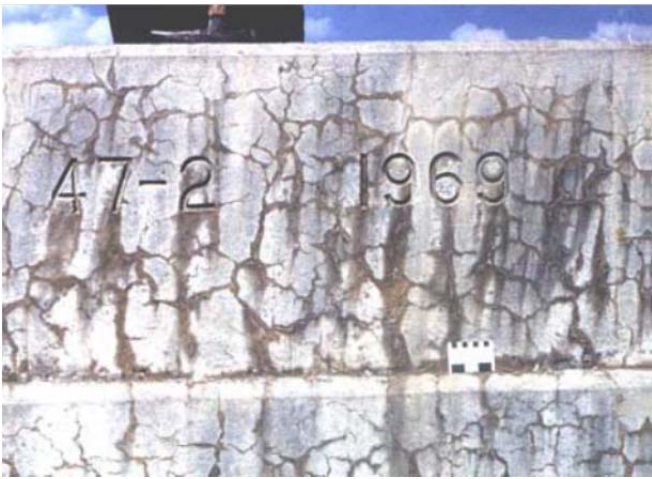
**Figure A.2: Example photos showing some of the common petrographic features of ASR (*cont'd*).**

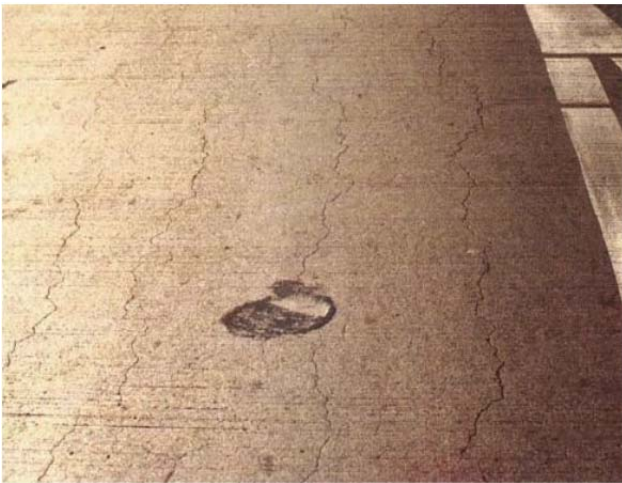
**Figure A.2. Example photos showing some of the common petrographic features of ASR (cont'd).**  
(Some of the photos are from the reference: Thomas, M.D.A., B. Fournier, and K.J. Folliard. *Alkali-aggregate Reactivity (AAR) Facts Book*. No. FHWA-HIF-13-019. 2013.)
