# Reflective Cracking Study: HVS Test Section Forensic Investigation

Partnered Pavement Research Program (PPRC) Contract Strategic Plan Element 4.10:  
Development of Improved Rehabilitation Designs for Reflective Cracking

California Department of Transportation  
Division of Research and Innovation  
Office of Roadway Research

University of California  
Pavement Research Center  
UC Davis, UC Berkeley

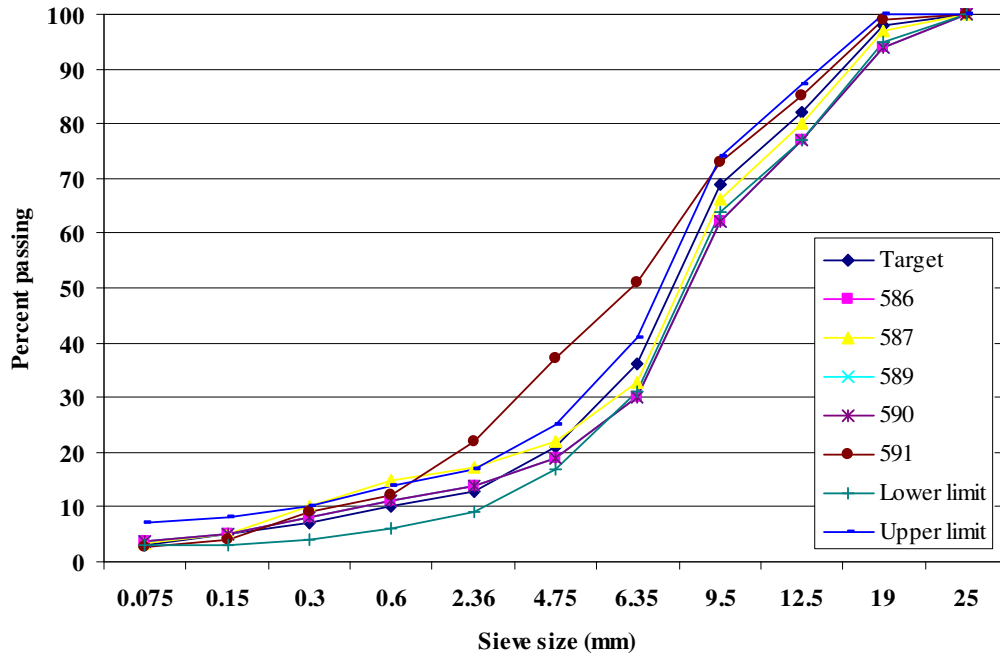
Figure 2.6: Gradation for modified binder overlays.

- 580RF and 586RF: Material passing the 6.35 mm (1/4 in), 9.5 mm (3/8 mm), 12.5 mm (1/2 in) and 19.0 mm (3/4 in) sieves was on the lower envelope limit (Figure 2.6).

- 585RF and 591RF: Material passing the 0.6 mm (#30), 9.5 mm (3/8 in), 12.5 mm (1/2 in) and 19.0 mm (3/4 in) sieves was on the upper envelope limit, while material passing the 2.36 mm (#8), 4.75 mm (#4) and 6.35 mm (1/4 in) sieves was outside the upper limit (Figure 2.6).

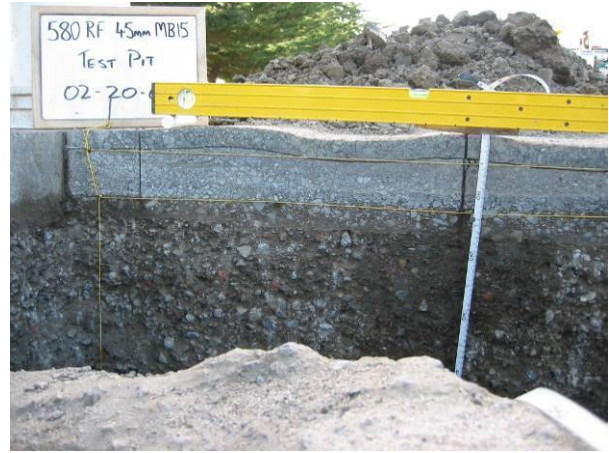
**Figure 3.3: 580RF test pit profile. (1)**

- Some densification (approximately 3 to 4 mm) was noted in the overlay in the trafficked area. Most of the rutting occurred in the underlying DGAC layer (Figure 3.3). No rutting was noted in the base and subgrade. Some displacement was recorded on either side of the trafficked area.

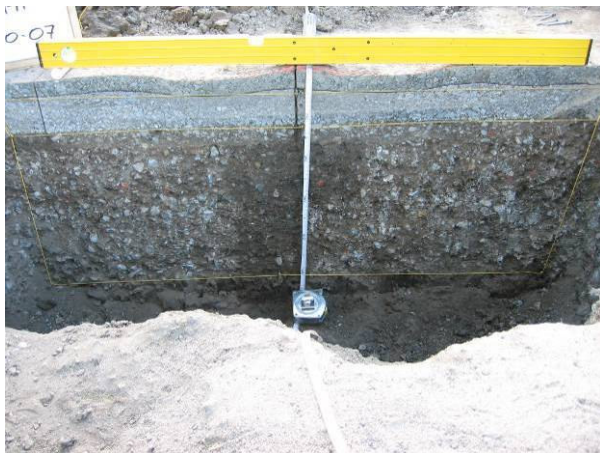
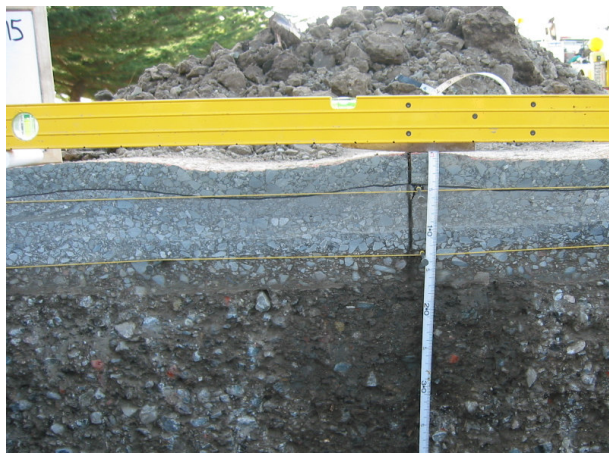
- The base under the trafficked area was thinner than the design (average 387 mm), but met the design requirements (410 mm) on the shoulder side of the section. The base material was dark grey-brown and consisted primarily of non-plastic recycled construction rubble, which included various types of natural aggregate (including andesite, granite, quartz, and quartzite pebbles) and small quantities of glass, fabric, and organic matter. The structure was generally homogenous. Grain size varied from fine to coarse with maximum particle size typically between 19 mm and 25 mm. Consistency was rated as hard in the top 70 mm, very hard between 70 mm and 250 mm, and firm to hard below as moisture content increased (Figures 3.4 and 3.5).

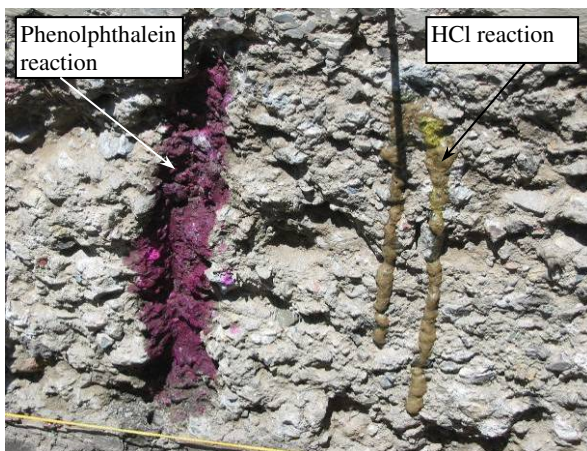
- Recementation of the base material was visibly apparent. A cement odor was present and strong effervescence was noted when dilute hydrochloric acid was sprayed onto the base material, indicating the presence of old cement (Figure 3.6). When phenolphthalein was sprayed onto the base material, the sprayed area turned red, signifying a pH greater than 10, which is indicative of uncarbonated cemented material (Figures 3.6 and 3.7). These tests, together with the DCP measurements discussed in Section 3.6 indicate some recementation of the recycled concrete base material occurred after construction. This is discussed in more detail in Section 3.7.

**Figure 3.6: 580RF phenolphthalein and hydrochloric acid reaction on base material.**

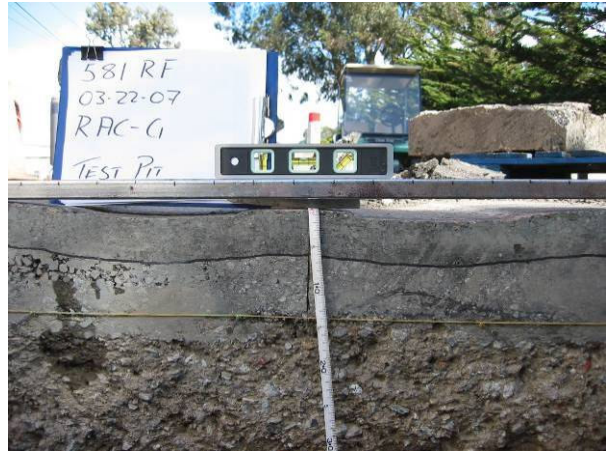
**Figure 3.9: 581RF test pit profile (1).**

- Some densification (approximately 2 to 3 mm) was noted in the overlay in the trafficked area. Most of the rutting occurred in the DGAC layer (Figure 3.9). No rutting was recorded in the base and subgrade. Some displacement was recorded on either side of the trafficked area.

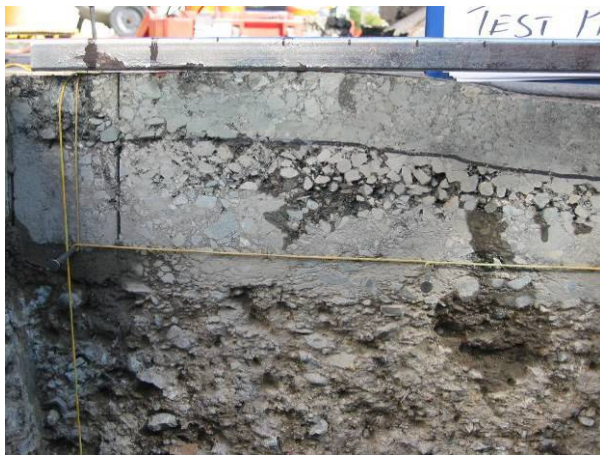
- The overlay was well bonded to the DGAC in the trafficked area, but some debonding was noted on the edge of the pit. Poor bonding was also noted between the two lifts in the DGAC in some areas. Water from the saw cutting operation was still clearly visible in these poorly bonded areas after the rest of the profile had dried (Figure 3.10). The DGAC was well bonded to the aggregate base.

- Some segregation was noted in the DGAC layer on the traffic side of the section (Figure 3.10). Apart from this and the rutting, no other distresses were noted in the asphalt layers.

**Figure 3.10: 581RF segregation in DGAC layer.**

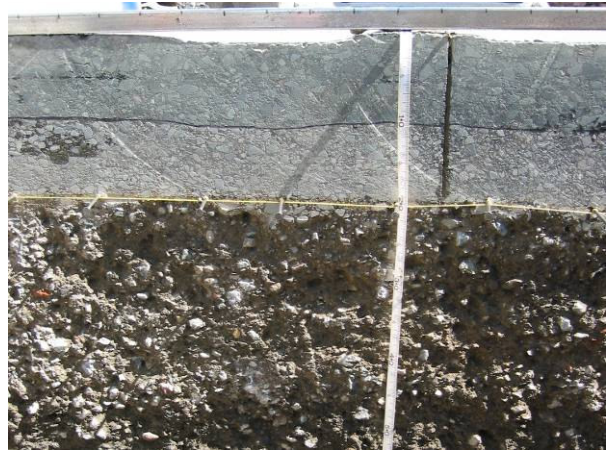
**Figure 3.15: 582RF test pit profile (1).**

- The average thicknesses of the overlay (101 mm) and underlying DGAC (97 mm) were greater than the design.
- Rutting was noted in both the overlay and the underlying layer (Figure 3.15). No rutting was noted in the base and subgrade. Slight displacement was recorded on either side of the trafficked area.

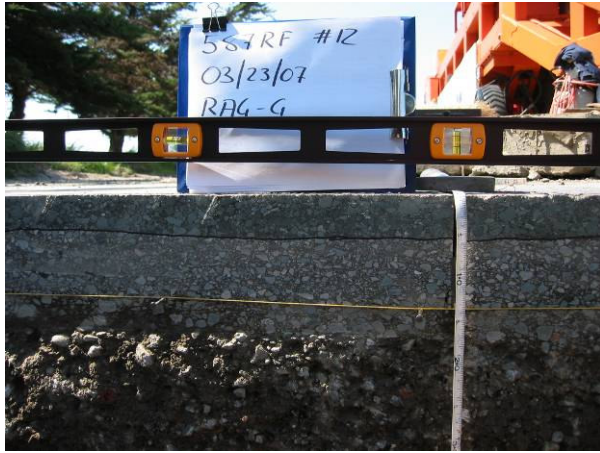
**Figure 3.36: 587RF#12 test pit profile.**

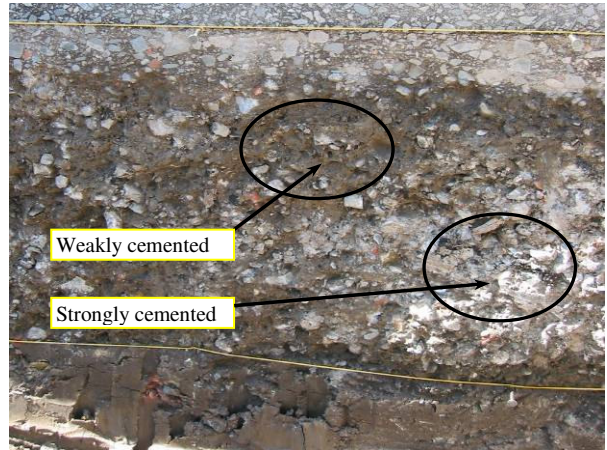
**Figure 3.41: 587RF#12 areas of strong and weak base cementation.**

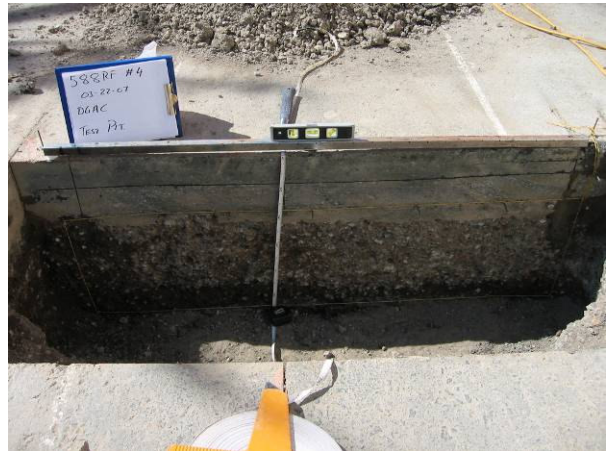
- Rutting was noted in both the overlay and the underlying layer (Figures 3.43 and 3.44). Some rutting was also measured at the top of the base in the test pit at Station 12. No rutting was observed in the subgrade. Displacement was recorded on either side of the trafficked area. The rut resulting from Phase 1 trafficking could not be clearly distinguished from that resulting from Phase 2 trafficking.

**Figure 3.43: 588RF#4 test pit profile.**

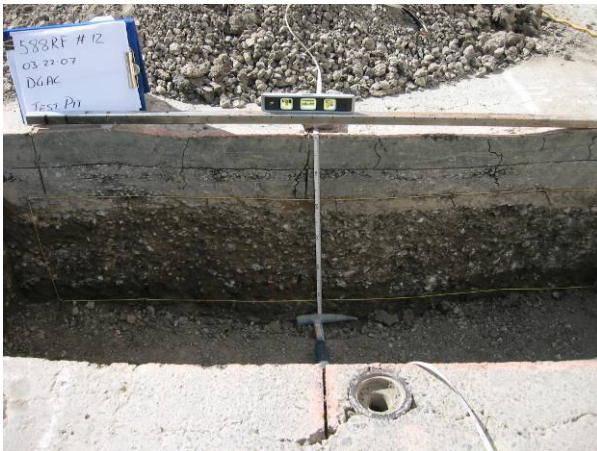
- Bottom-up cracking was noted in the underlying DGAC and in the overlay in both test pits. Some of the cracks originated at the bottom of the underlying DGAC and continued all the way to the surface (Figure 3.44), while some appeared to have stopped at the bond between the two lifts of the overlay. A few bottom-up cracks originating from the weak bond between the overlay and the underlying layer and between the overlay lifts were also noted (Figure 3.47). Some segregation was noted in the underlying DGAC layer (Figure 3.46).

**Figure 3.44: 588RF#12 test pit profile.**

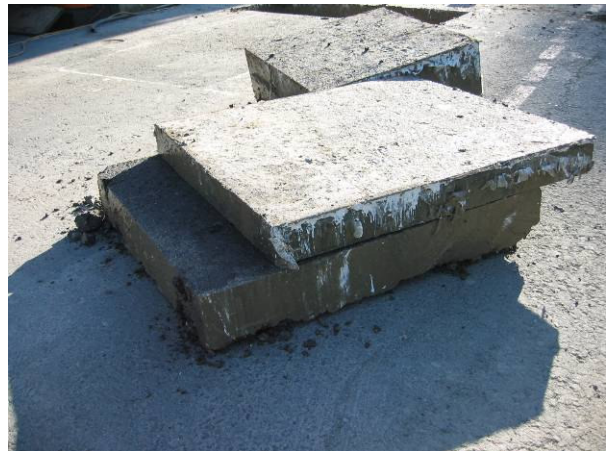
- The overlay was generally poorly bonded to the underlying layer (Figure 3.45). Bonding between lifts was also unsatisfactory (Figure 3.46). Water from the saw cutting operation was still clearly visible in these poorly bonded areas after the rest of the profile had dried. The DGAC was well bonded to the aggregate base.

**Figure 3.45: 588RF debonding between overlay and underlying layer.**

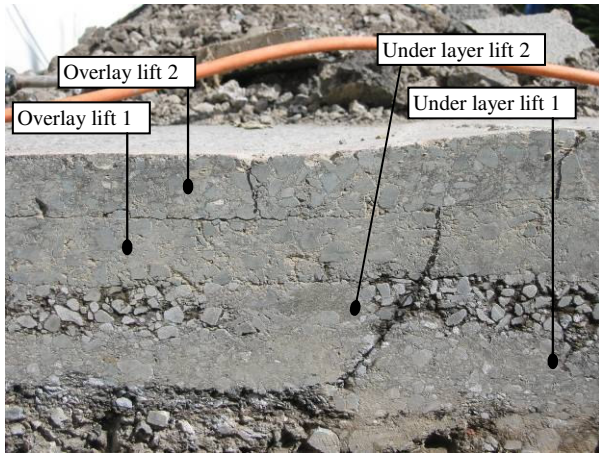
**Figure 3.46: 588RF poor bonding between layers.**

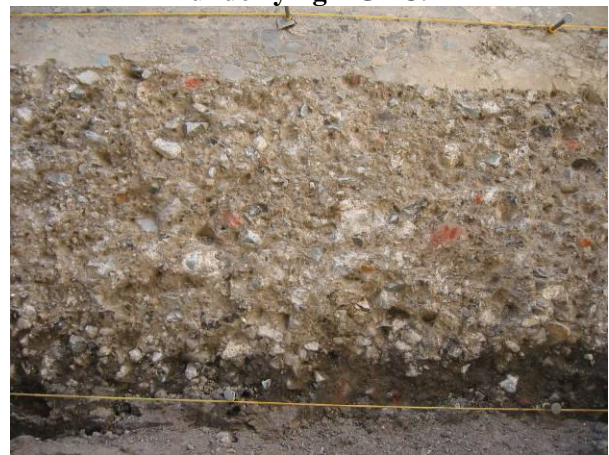
- Recementation of the base material was visibly apparent in both test pits, although bond strengths appeared weaker in the test pit at Station 12 (Figure 3.48) compared to the material at Station 4 (Figure 3.49). Relatively strong hydrochloric acid and phenolphthalein reactions were recorded in both test pits.

**Figure 3.49: 588RF#4 areas of strong base cementation.**

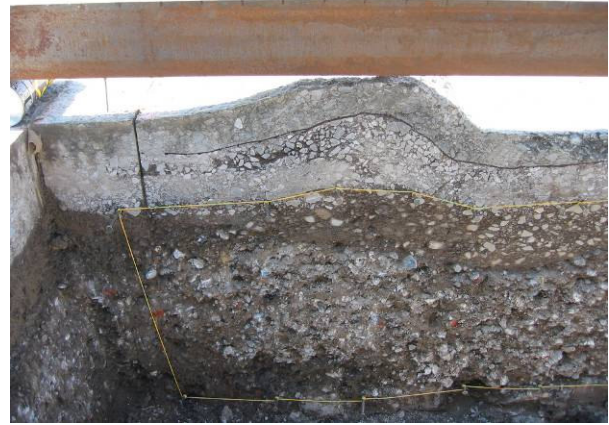
- The average thickness of the overlay generally equaled the design thickness, while the average thickness of the underlying DGAC was considerably less than the design (84 mm and 75 mm at Stations 4 and 12 respectively).
- Very little rutting/densification was evident in the overlay. Rutting in the underlying DGAC from the Phase 1 trafficking was noted in the Station 4 profile (Figure 3.51), but no rutting was noted in the base and subgrade on this profile. At Station 12, the severe rutting observed occurred predominantly in the underlying DGAC layer, with some rutting in the base and only minor densification in the overlay (Figure 3.52). No rutting was recorded in the subgrade. Severe displacement was recorded on either side of the trafficked area at the Station 12 test pit (Figure 3.53).
- The overlay was well bonded to the DGAC, which was well bonded to the aggregate base.

**Figure 3.53: 589RF#12 severe displacement on edge of rut.**

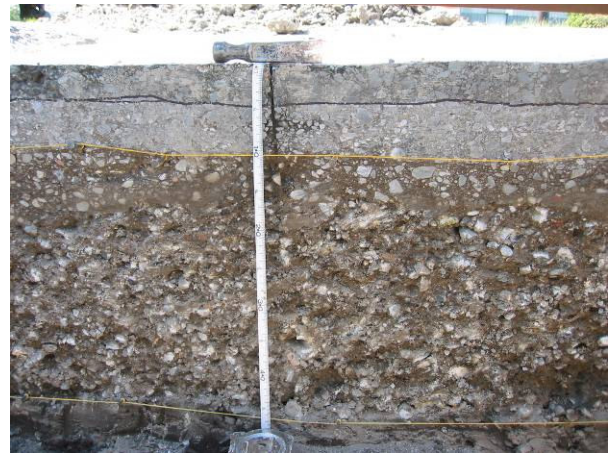
**Figure 3.55: 589RF#12 base material (coarser than other pits).**

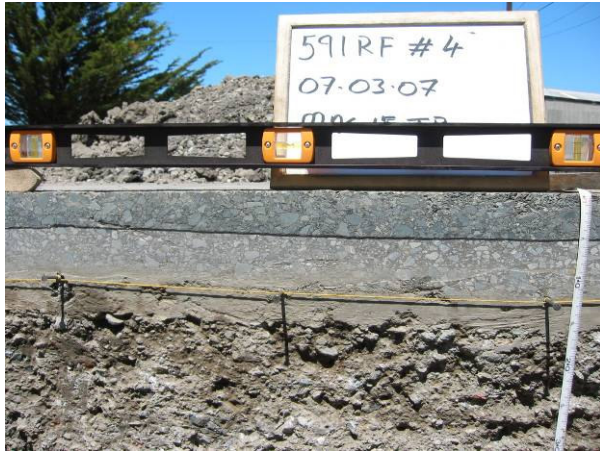
**Figure 3.64: 591RF#4 rutting from Phase 1 trafficking.**

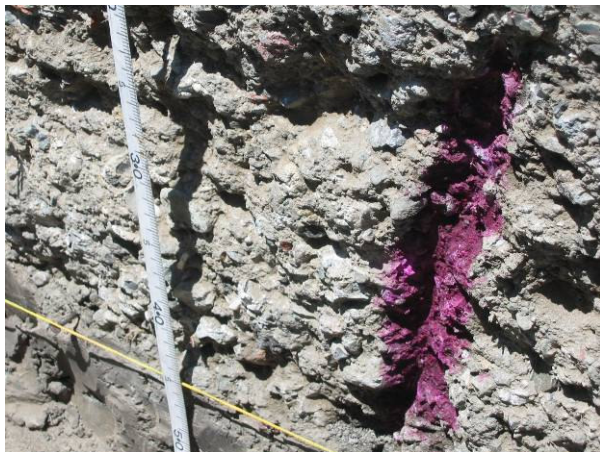
- Moisture content in the base was rated as moist.
- The layer definition between the base and subgrade was clear. Some punching of the base into the in situ material was noted (Figure 3.68).

**Figure 3.68: 591RF strongly cemented base.**

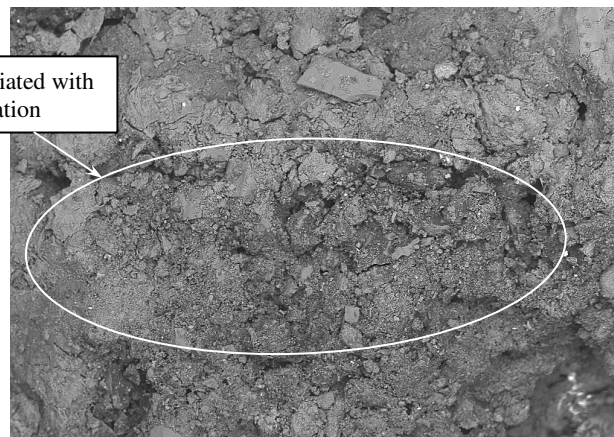
Sample 2 was exactly the same as Sample 1 except that the specimen was exposed to atmospheric carbon dioxide prior to preparation for the microscope studies. The overall effect is shown in Figure 3.80 (optical microscope at  $\pm 100\times$  magnification) and Figure 3.81 (SEM at  $\pm 55\times$  magnification), in which significant cracking is visible. This is the typical result of carbonation where the development of calcite (calcium carbonate,  $\text{CaCO}_3$ ) from lime (calcium hydroxide,  $\text{Ca}(\text{OH})_2$ ) in the material results in expansion and cracking of the material. Such cracking is unlikely to result from drying as it was not seen in the uncarbonated specimen, which was also dried, albeit under slightly different conditions. Figure 3.82 (optical microscope at  $\pm 100\times$  magnification), Figure 3.83 (optical microscope at  $\pm 200\times$  magnification), and Figure 3.84 (SEM at  $\pm 140\times$  magnification) show the presence of calcite crystals associated with the cracking in the carbonated sample, none of which were evident in the uncarbonated material. The well-crystallized nature of the material is indicative of recent formation (during the week before examination). There was also a conspicuous absence of calcium hydroxide, indicating severe carbonation.

**Figure 3.81: SEM view ( $\pm 55\times$ ) of Sample 2.**
