Research Report – UCD-ITS-RR-13-33

Warm-Mix Asphalt Study: Field Test Performance Evaluation

DOCUMENT RETRIEVAL PAGE		Technical Memorandum: UCPRC-TM-2013-08			
Title: Warm-Mix Asphalt Study: Field Test Performance Evaluation					
Authors: D. Jones					
Technical Leads: T. Joe Holland (Caltrans) and Nathan Gauff (CalRecycle)					
Prepared for: Caltrans and CalRecycle		FHWA No.: CA142385D	Work submitted: 04/05/2014		Date December 2013
Strategic Plan Element No.: 4.18		Status: Final		Version No.: 1	
Abstract:					
<p>A number of warm-mix asphalt test sections were constructed in California between 2007 and 2010 to assess long-term performance under selected traffic and climate conditions. A range of pavement designs were assessed, but the six projects evaluated in this report focused on open-graded friction courses with polymer-modified (PG 58-34) and rubber-modified (PG 64-16) binders (three projects each). The main purpose of these experiments was to monitor performance under actual conditions and to quantify any benefits associated with using warm-mix asphalt under specific situations, such as with long hauls, in cool and/or damp conditions, under trafficking by large agricultura

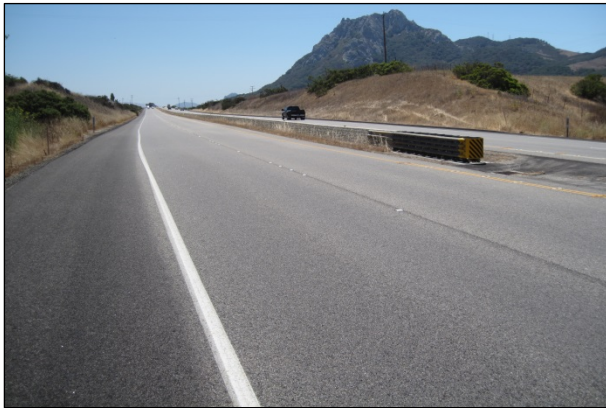
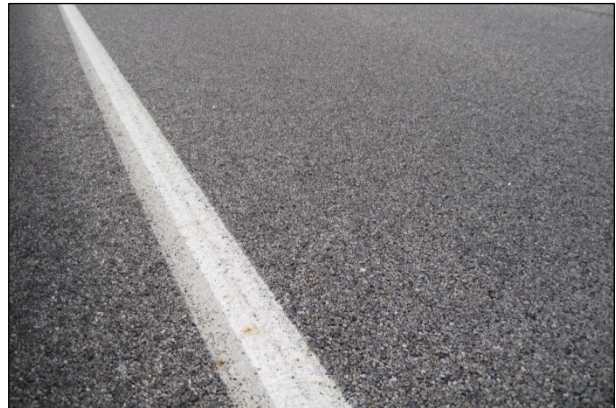
Figure 3.14: Morro Bay Sasobit, May 2012 (60 months), track marks no longer visible.

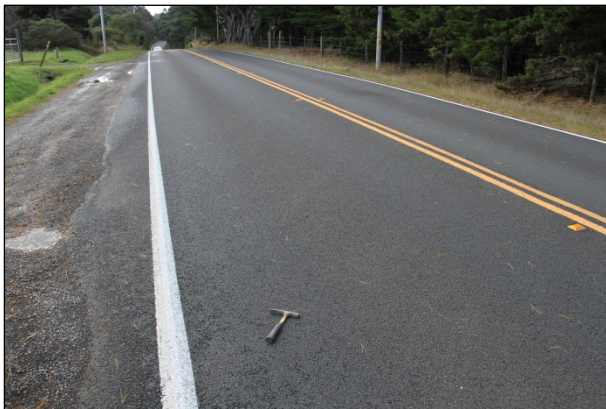
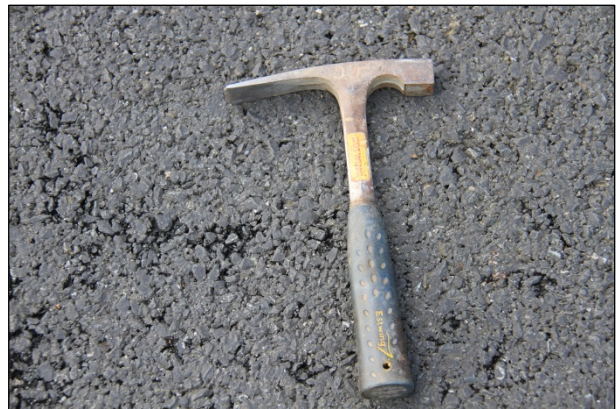
Figure 4.1: Point Arena Evotherm, December 2008 (3 months).

The Evotherm section resembled a typical open-graded friction course and was given an overall rating of “good.” No early stone loss was noted. Water was effectively draining through the friction course and out through the sides of the road. No other problems were observed.

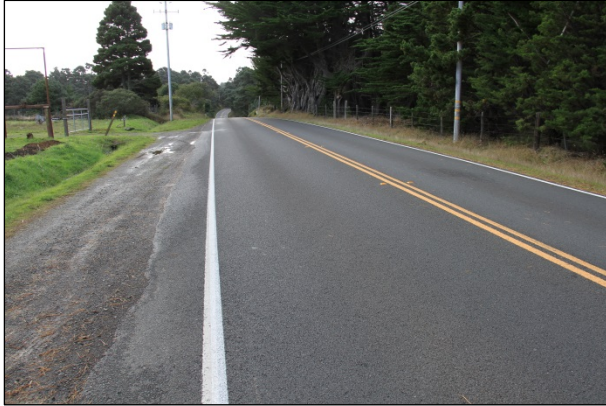
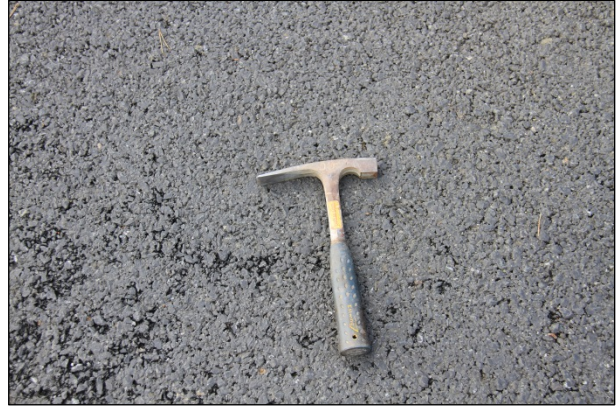
Figure 4.2: Point Arena Evotherm, November 2010 (23 months).

No deterioration compared to the December 2008 baseline measurements was noted on the sections after 23 months of traffic. The number and severity of the longitudinal cracks had not increased. Drainage through the OGFC was still effective.

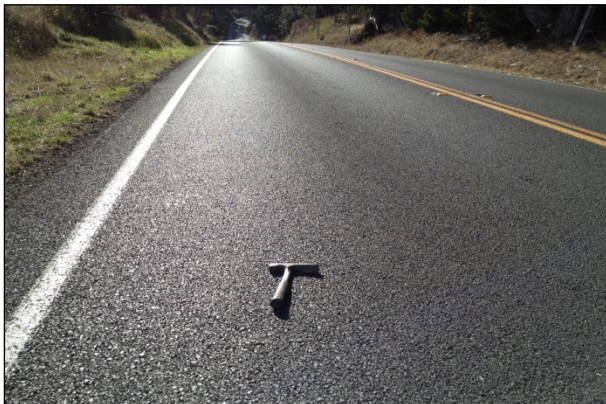
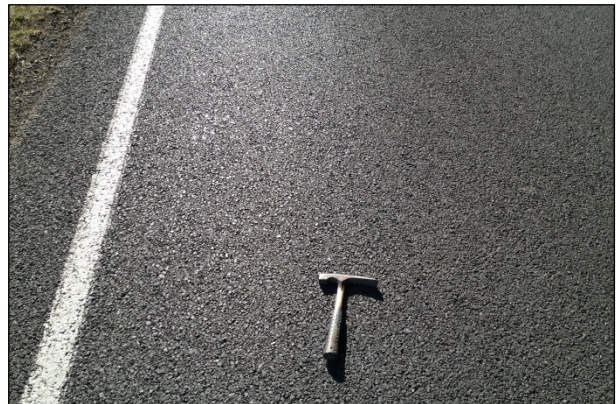
Figure 4.4: Point Arena Evotherm, December 2013 (54 months).

No deterioration compared to the December 2008 baseline measurements was noted on the sections after 54 months of traffic. The number and severity of the longitudinal cracks did not appear to have increased since the June 2012 visit. Drainage through the OGFC was still effective.

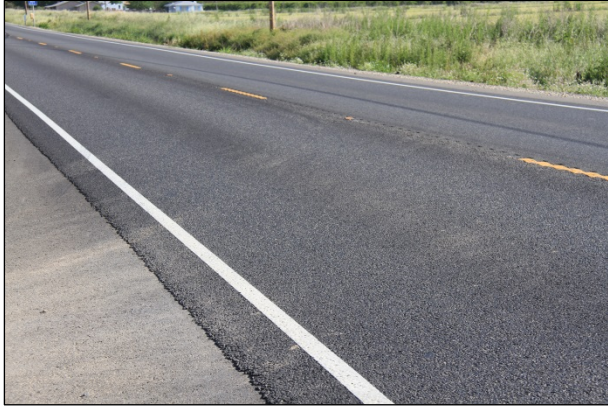
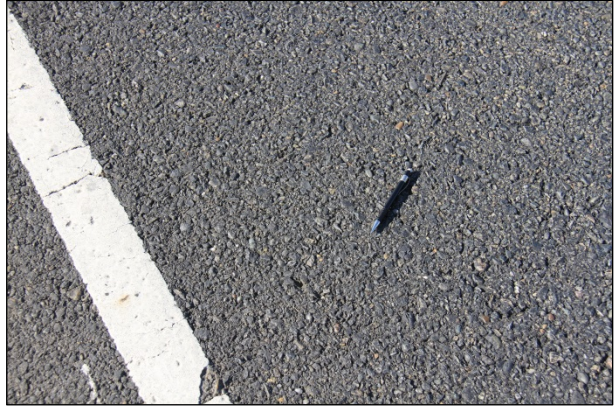
Figure 6.2: Marysville Evotherm, June 2011 (24 months).

No deterioration compared to the June 2009 baseline measurements was noted on the section after 24 months of traffic, indicating that frequent and aggressive turning movements by large agricultural equipment is unlikely to negatively influence warm-mix asphalt surfacings.

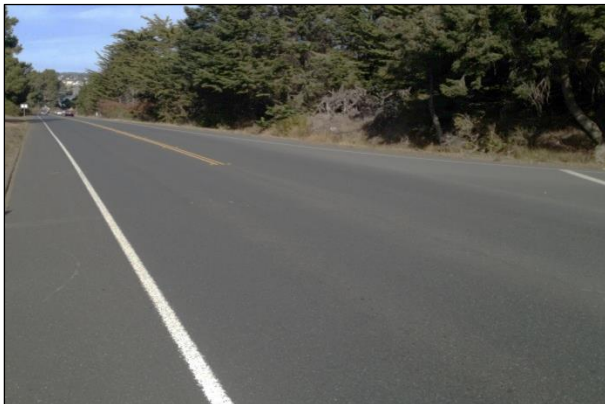
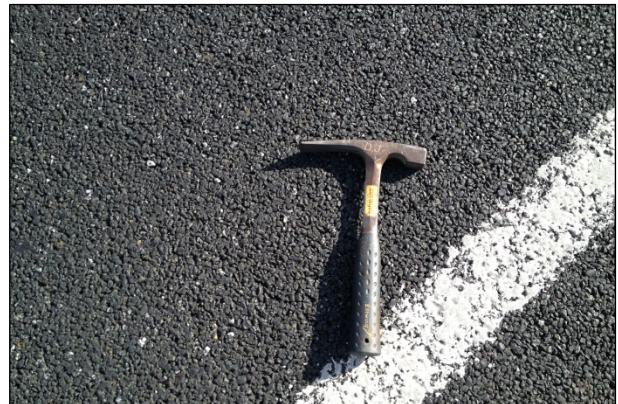
Figure 7.2: Mendocino Control, December 2013 (42 months).

No deterioration compared to the July 2010 baseline measurements was noted on the sections after 42 months of traffic. The raveling observed on the Advera section during the December 2012 visit had not deteriorated.

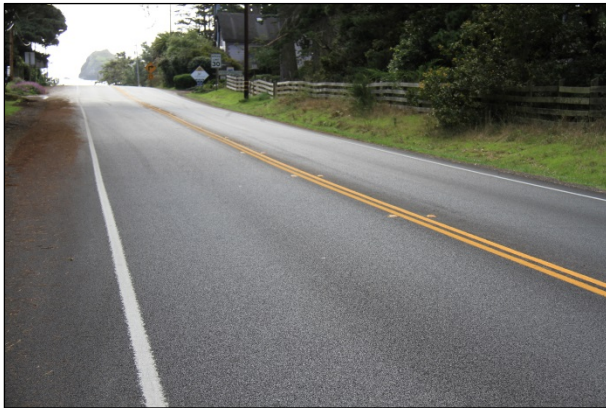
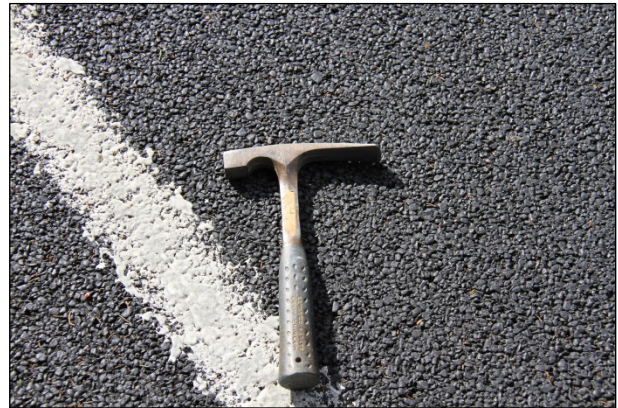
Figure 7.7: Mendocino Rediset, July 2010 (0 months).

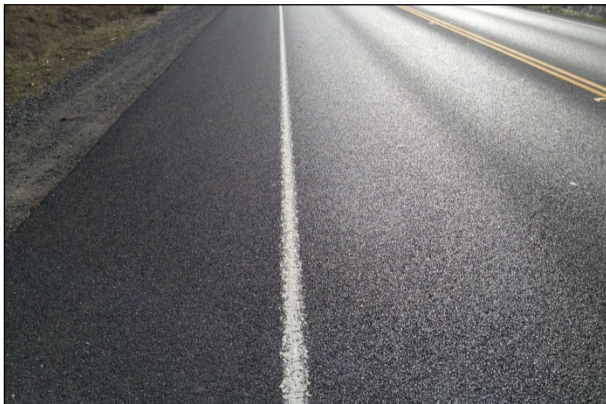
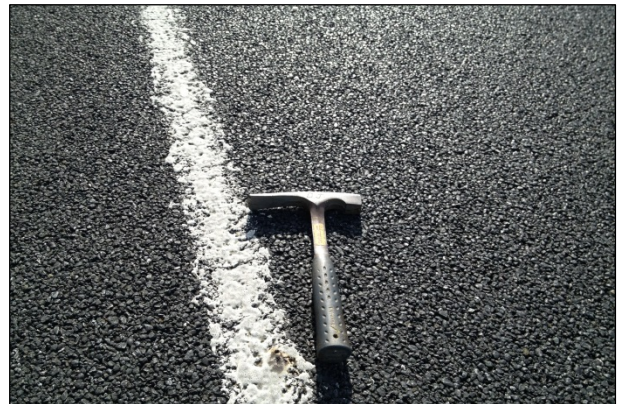
Figure 7.8: Mendocino Rediset, December 2013 (42 months).

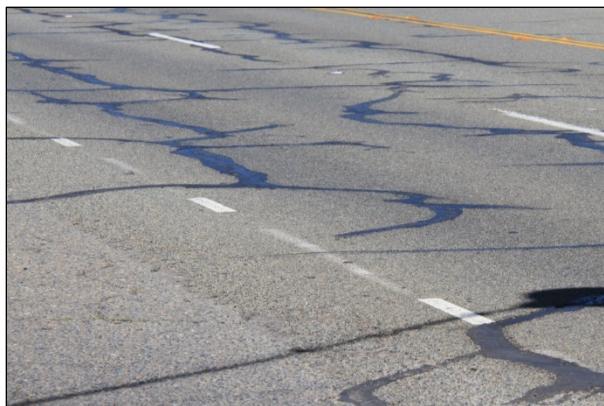
Figure 8.1: Auburn Evotherm, July 2010, one month prior to paving.
