**Report of Field Site Visit
District 3, Sacramento
Interstate 5, PM 17.2-17.9
RAC-O Overlay**

Work Conducted Under PPRC Strategic Plan Task 4.16

Technical Memorandum TM-UCB-PRC-2005-7

June 2005

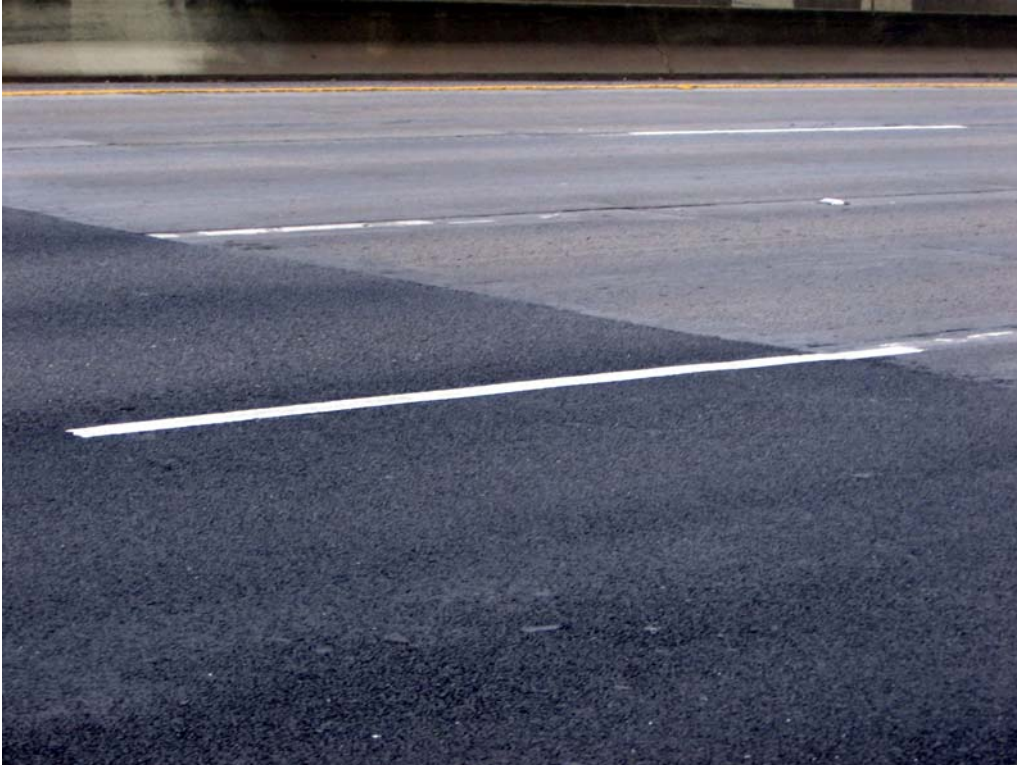
Figure 25. End of open graded section (northbound direction)

The end point of the condition survey was Station 61+00 northbound, where the open graded section ends. Figure 25 shows the end of the open graded section and the start of PCC section.
