# Quieter Pavement Research: Concrete Pavement Tire Noise

**Author:**  
E. Kohler and J. Harvey

Work Conducted as Part of Partnered Pavement Research Center Strategic Plan Element No. 4.22:  
Quiet Concrete Pavement Research

University of California  
Pavement Research Center  
Davis and Berkeley

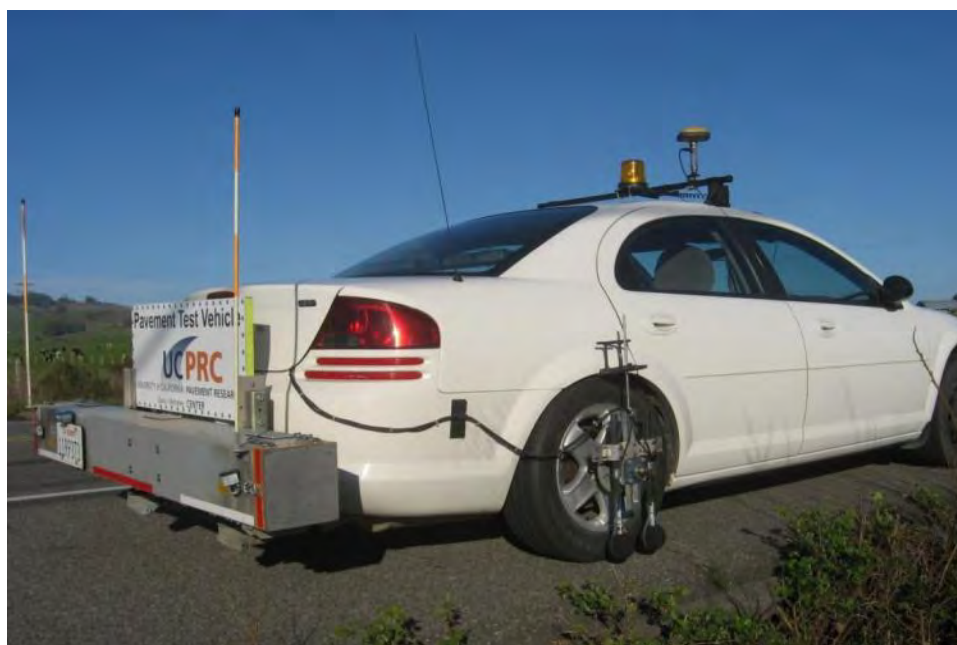
**Figure 2.1: Instrumented vehicle with on-board sound intensity probes and an inertial profilometer.**

In addition to the use of the OBSI method to measure tire/pavement noise, an inertial profilometer was used to measure International Roughness Index (IRI) and Mean Profile Depth (MPD), and visual observations were made of the surface texture type and condition of each test section. The measured IRI values and texture observations were collected at the same fixed short intervals used for OBSI measurement. The instrumented vehicle used in this project is shown in Figure 2.1.

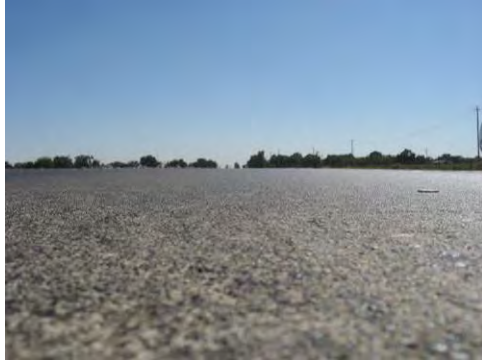
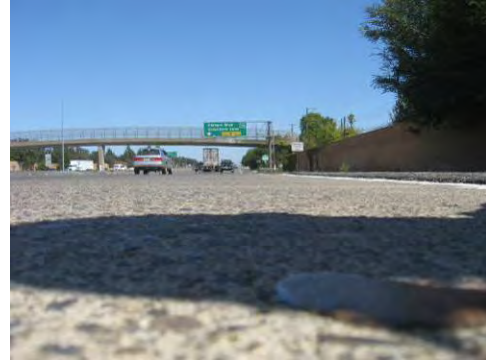
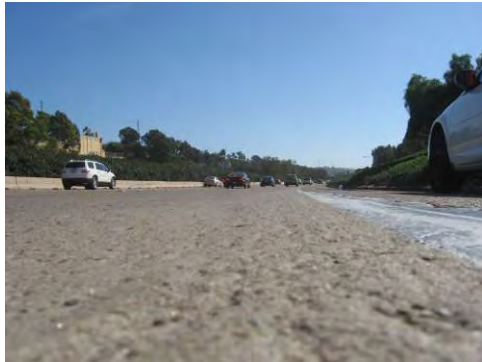
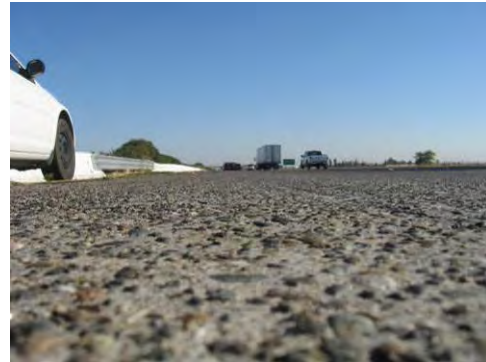
**QP-102.2 (103.0 dB[A])**

**QP-107.3 (103.7 dB[A])**

**QP-130.1 (107.3 dB[A])**

**QP-116.1 (107.8 dB[A])**

**Figure 4.1: Example photographs of burlap drag surfaces and their OBSI levels.**

The oldest concrete pavement sections evaluated in this study have burlap drag texture, with sections on Interstate 80 in Solano County having been in service for over 60 years according to the available records (QP-116). Due to their long service life, some of the sections in this category had pavements that showed no signs of applied surface texture, and were then categorized as *worn out* texture. Burlap drag sections are not constructed in California highways any more, which is why no “young” sections, other than one built for a field evaluation experiment, were included in the experiment. This young section, which was about five years old when first tested, yielded an OBSI level of about 102 dB(A). Other than the experimental section, all burlap drag sections were older than 30 years, and had OBSI levels ranging between 101 and 108 dB(A). These values indicate that the actions of traffic, often combined with rainfall, will tend to polish some concrete surfaces and remove positive texture (stones protruding from the surface) without damaging the paste around the stones. The same combination of traffic and environment will tend to ravel asphalt surfaces and cause loss of paste around the aggregates in some concrete surfaces, creating positive texture by leaving the stones protruding from the surface. The quieter sections seem to be, judging from the pictures, those with shallow texture, as shown in Figure 4.1. Therefore, a possible reason for variability of OBSI for the burlap drag sections is variation in the macrotexture caused by the protrusion of aggregates. A summary of the information for burlap drag sections is presented in Table 4.1.

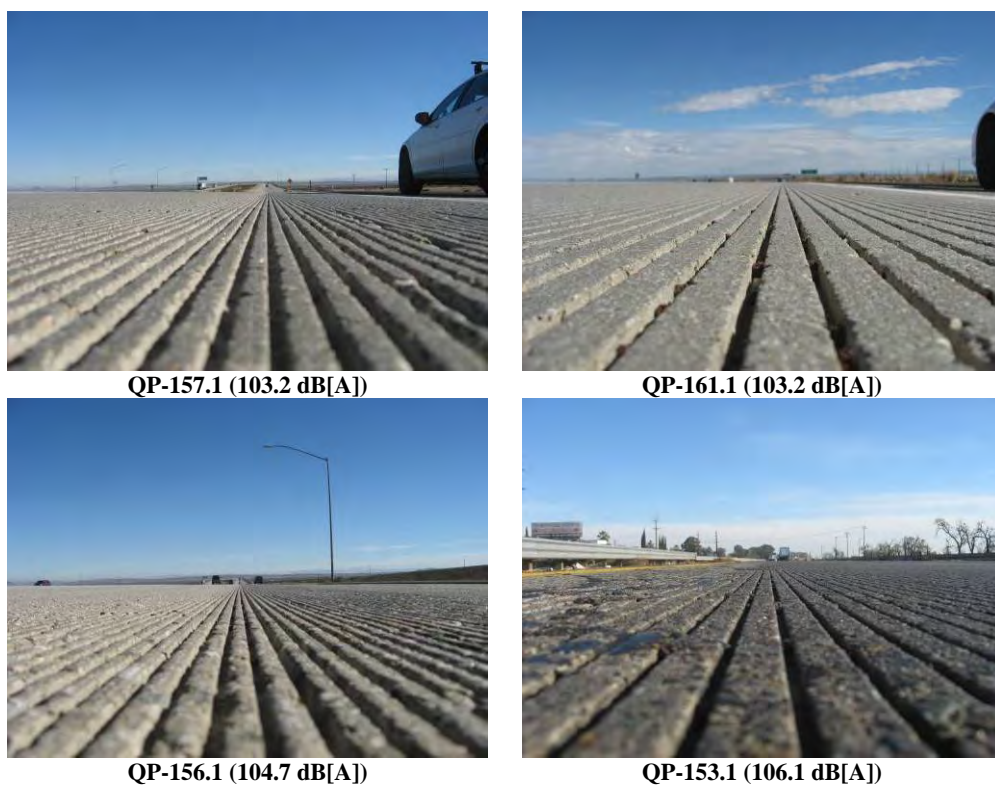
**Figure 4.3: Example photographs of diamond grooved surfaces and their OBSI levels.**

Prior to this testing, it was uncertain whether diamond grooving without diamond grinding had an effect on noise level because the grooves leave most of the contact area between the tire and the pavement unchanged, and therefore diamond grooving might not be as effective as diamond grinding for reducing the noise level on existing concrete pavements. However, based on this study’s results for 19 diamond grooved sections and 32 diamond ground sections (7 and 24 sections in Year 2, respectively), the two techniques appear to yield similar OBSI levels. Comparison of Figure 3.33 (diamond ground) and Figure 3.35 (diamond grooved) shows that experiment samples of both texture types have similar ages, with less than 15 years since their last resurfacing. It can also be seen from Table 2.1 that the DG and Gr sample sections are distributed across both passenger car and truck lanes and in both dry and wet parts of state, except for the very wet North Coast region. A summary of the information for diamond grooved sections is presented in Table 4.3. Photographs of example diamond grooved surfaces are shown in Figure 4.3.

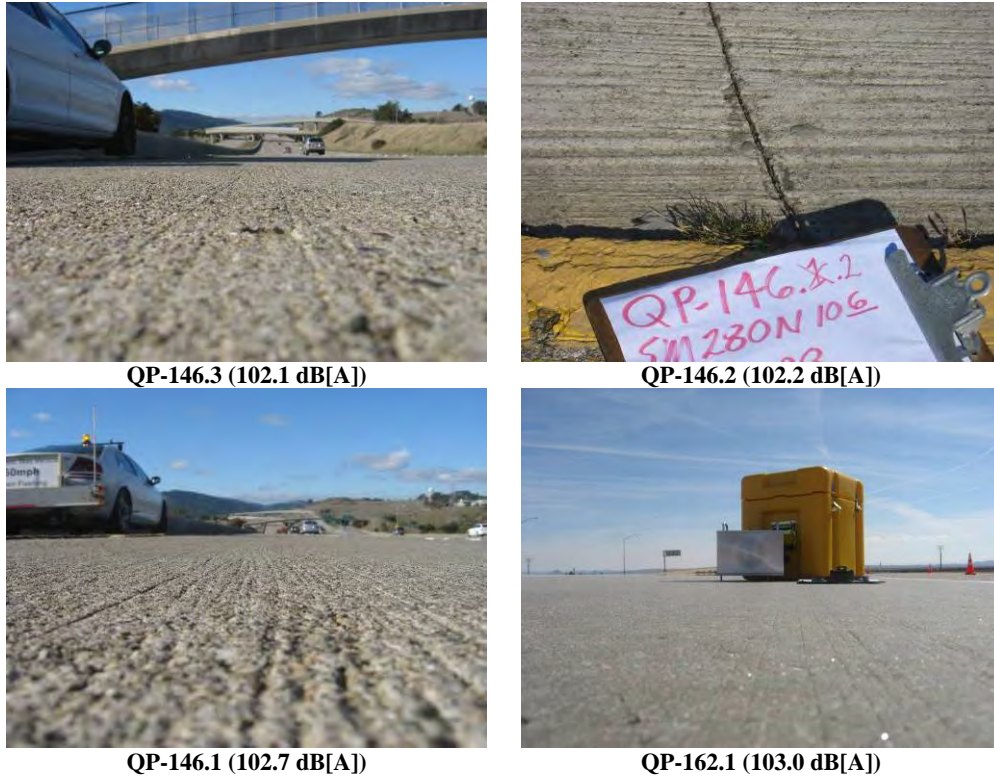
**Figure 4.4: Example photographs of longitudinally broomed surfaces and their OBSI levels.**

Longitudinally broomed pavement surface texture is uncommon on California highways. The difference between longitudinally broomed and burlap drag surface textures is only clear on surfaces that are not *worn out* (i.e., texture has not been worn off by traffic) and still show the striations caused by the texturing tool. The difference between the two techniques is less apparent in the case of *worn out* surfaces. In this study, the presence of striations of more than 1 or 2 mm depth (as evaluated subjectively from photographs) was considered reason to label a texture as longitudinally broomed. If only shallower striations or none were observed, then the section was labeled as having a burlap drag texture type. This resulted in a low number of longitudinally broomed sections, and affected the balance of the experimental factorial, complicating the interpretation of results. From a practical point of view, longitudinal brooming could be considered equivalent to a “heavy drag” texture. A summary of the information for longitudinally broomed sections is presented in Table 4.4. Photographs of example longitudinally broomed surfaces are shown in Figure 4.4.

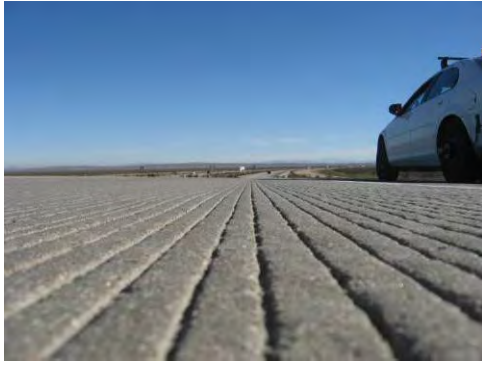
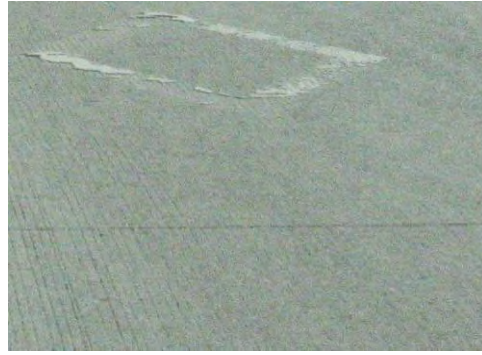
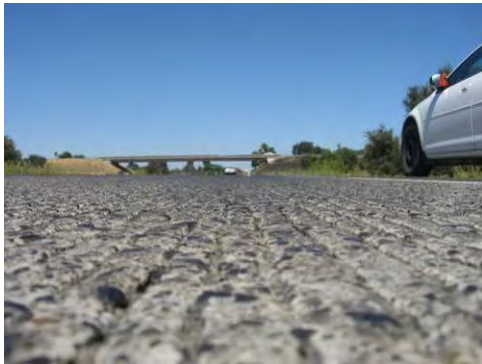
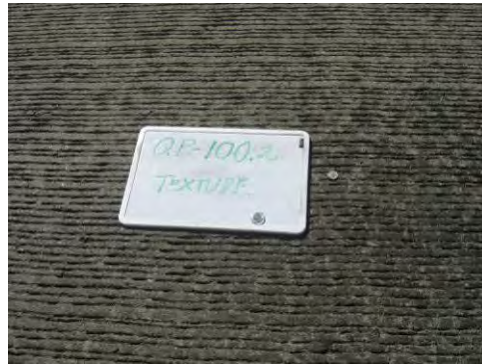
QP-158.1 (104.4 dB[A])

QP-127.3 (104.5 dB[A])

QP-101.1 (106.7 dB[A])

QP-100.2 (106.8 dB[A])

**Figure 4.5: Example photographs of longitudinally tined surfaces and their OBSI levels.**

Longitudinal tining is the texture type most commonly found on California highways. Sections tested in the study ranged in surface age from several months to 42 years. The interquartile range reveals that 50 percent of the sections of this texture type are expected to fall between 103.7 and 105.6 dB(A). This is interesting because the longitudinal grooves that result from the tining process vary widely in depth, spacing, the amount of material displaced that protrudes from the surface, and how straight they are (often they appear to be “waves” of different wavelengths, but in other cases they are perfectly straight). Four examples of longitudinally tined sections are shown in Figure 4.5. A summary of the information for longitudinally tined sections is presented in Table 4.5.

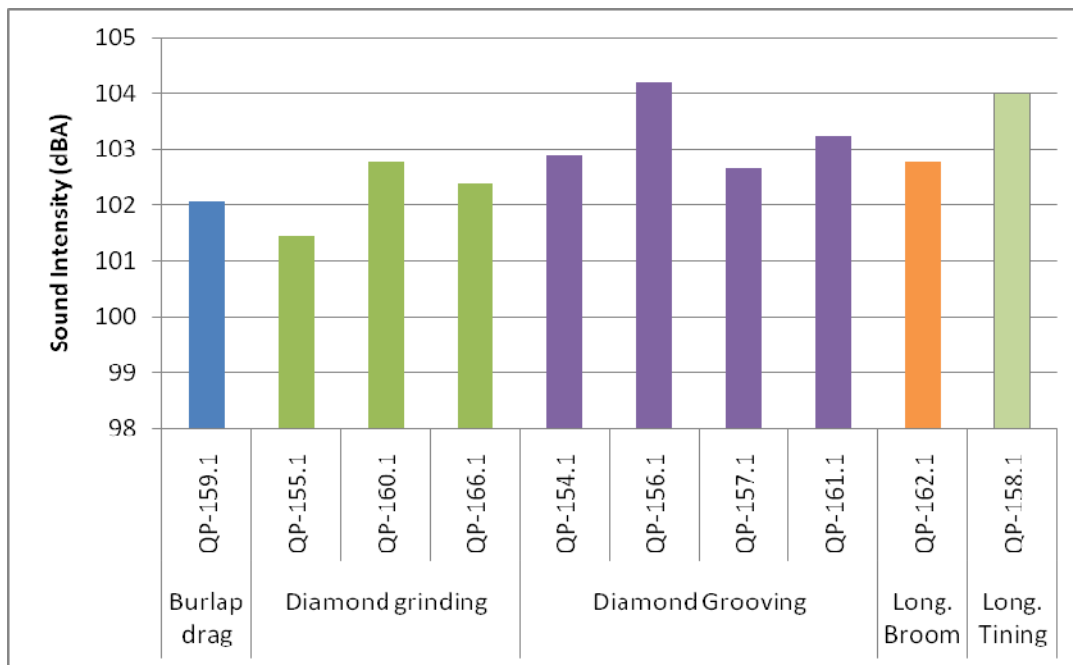
**Figure 4.6: Comparison of OBSI noise levels of concrete pavement textures in Mojave sections averaged over the two years of measurement.**

Table 4.6, Figure 4.6, and Figure 4.7 present the results of the pavement sections in the Mojave test site (Kern 58). The quietest sections were those with a diamond-ground surface. Figure 4.6 shows the results of the sections averaged across the two years while Figure 4.7 shows each year of measurement individually, ordered by the Year 1 OBSI measured value. The one-year change on the Mojave sections in the reported data for the corrected OBSI values ranges from 0 to 1.6 dB(A), averaging 0.7 db(A), which is greater than expected. It should be noted that the effects of the error term for the tire correction equation discussed in Chapter 2 is accentuated on a small sample such as the Mojave sections. In this case, since there are only two years of data the error term is large relative to the expected annual change (noise to signal ratio), and the error does not get averaged out well on a small sample. Additional years of data will be needed to clarify the rate of change of OBSI on these sections.

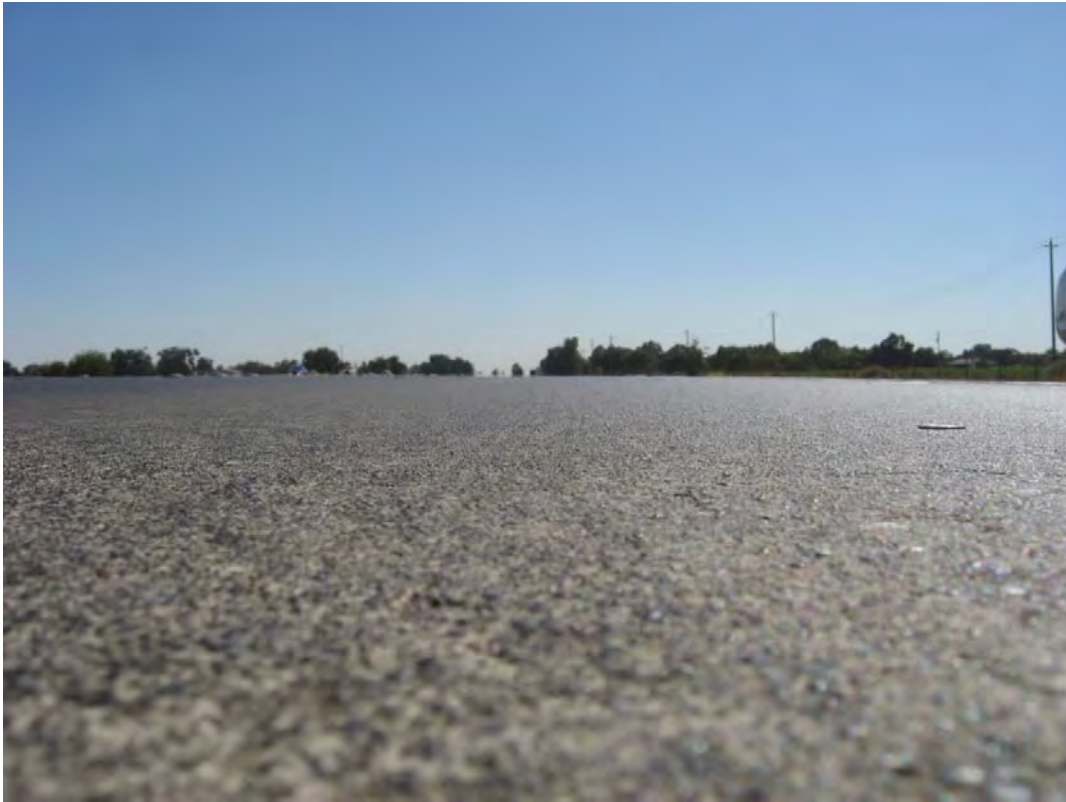
**Figure A.1: Burlap drag, OBSI=103.0 dB(A) (Section QP-102.2).**

Two photographs of the same texture type are shown on each page, displaying the surface texture as observed with the camera held directly on the pavement surface. The top and bottom photographs show respectively sections with low and high OBSI level. Surface type, section ID, and OBSI level are presented in the caption.

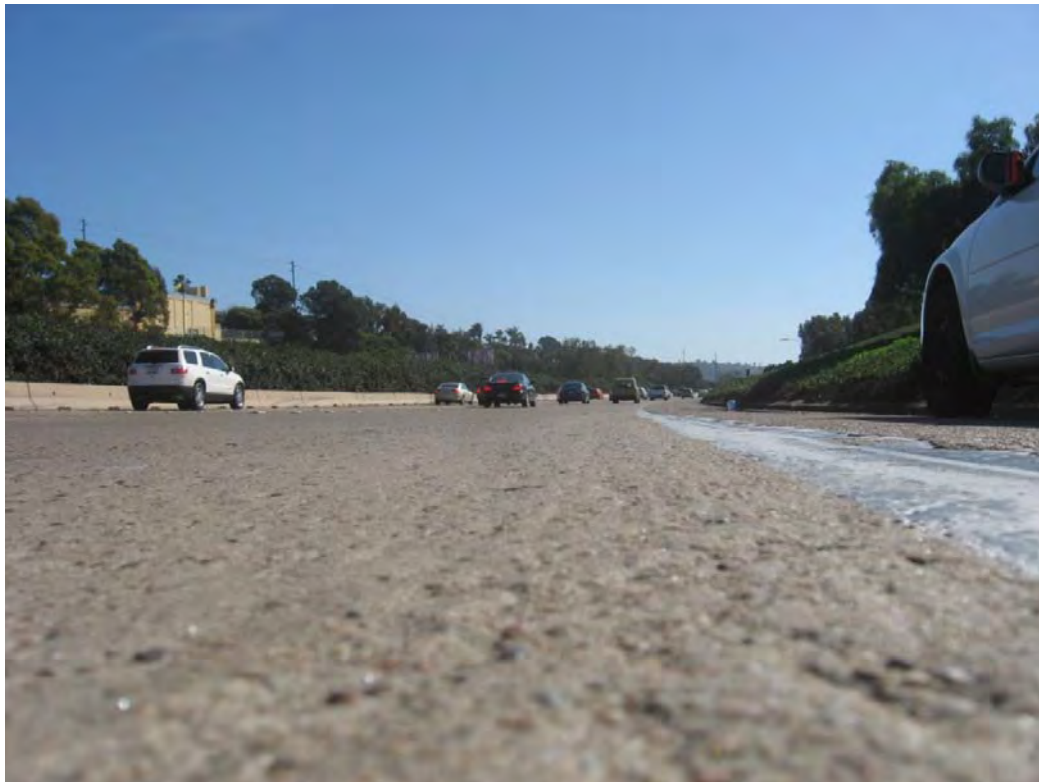
**Figure A.2: Burlap drag, OBSI=107.3 dB(A) (Section QP-130.1).**

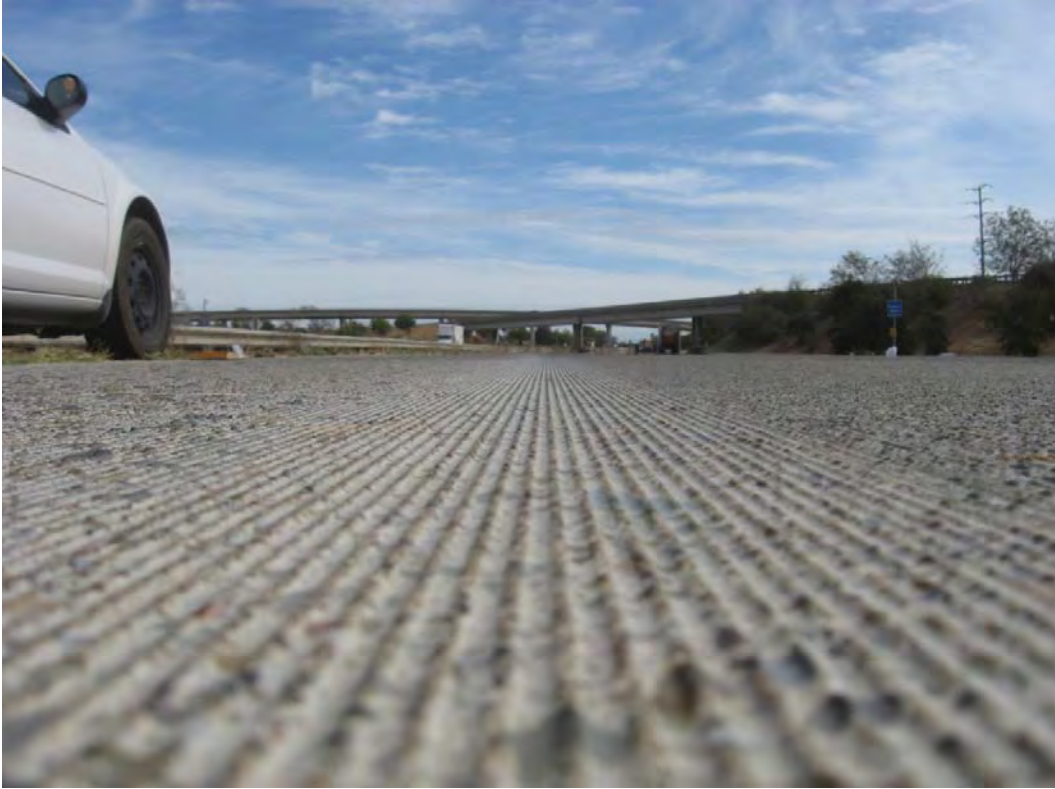
**Figure A.3: Diamond ground, OBSI=99.4 dB(A) (Section QP-103.3).**

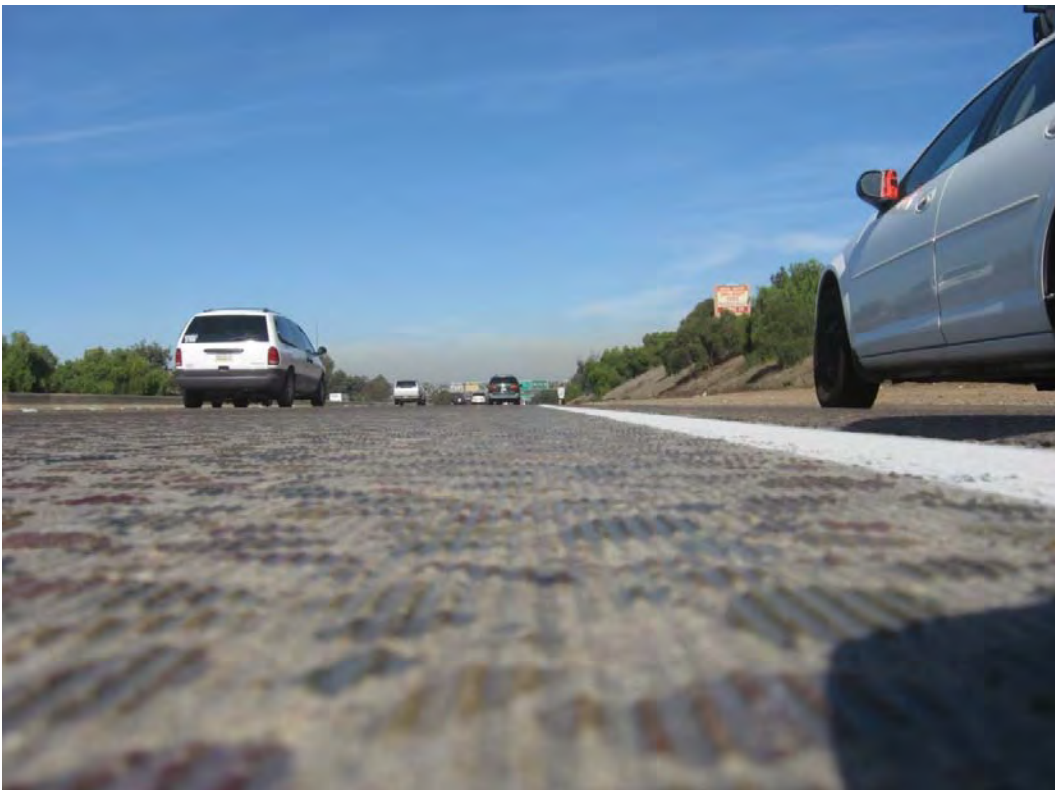
**Figure A.4: Diamond ground, OBSI=107.2 dB(A) (Section QP-132.2).**

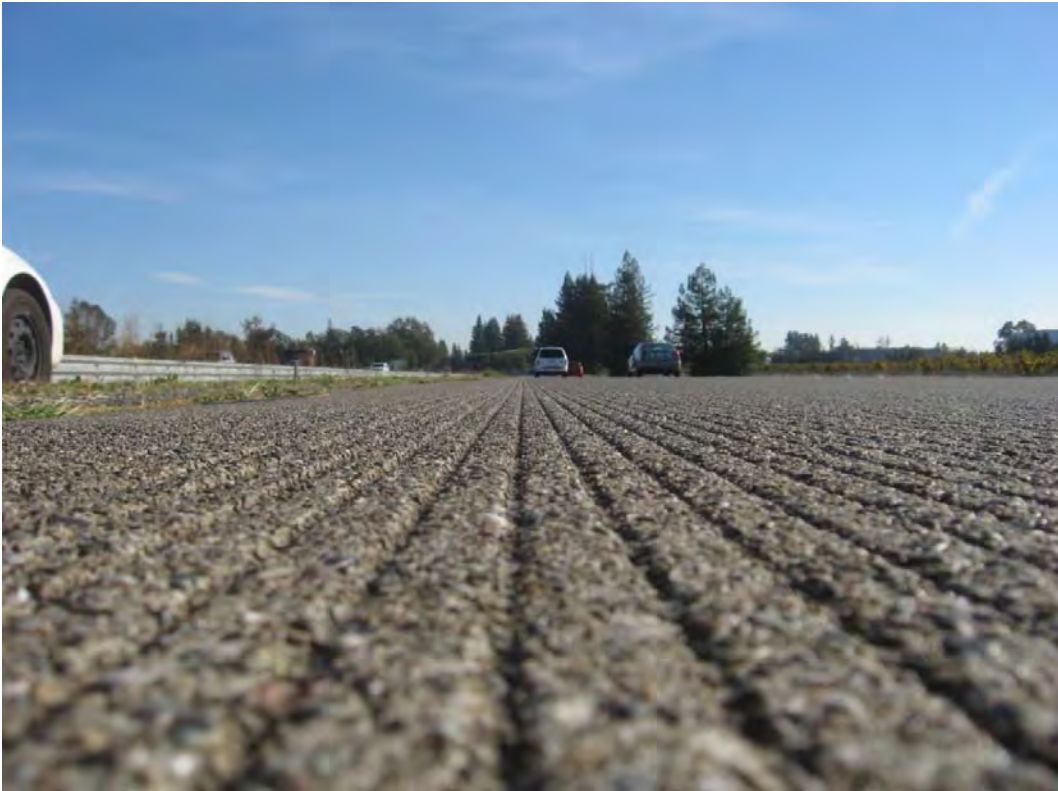
**Figure A.5: Diamond grooved, OBSI=101.7 dB(A) (Section QP-138.3).**

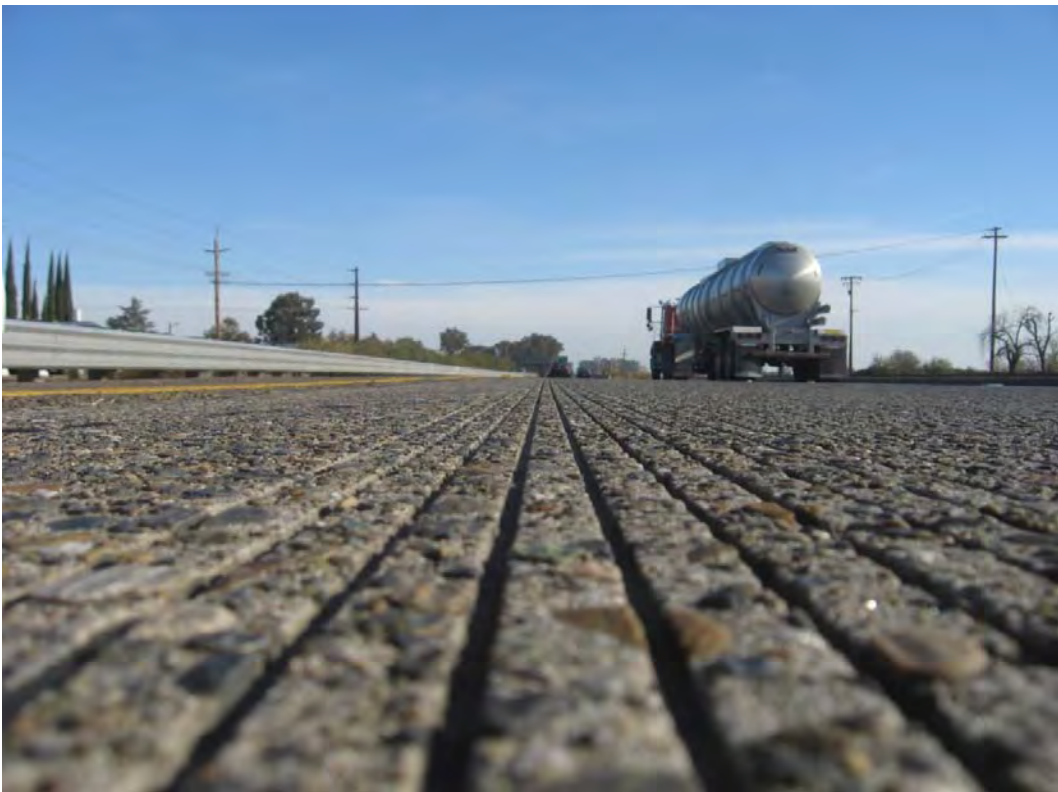
**Figure A.6: Diamond grooved, OBSI=105.6 dB(A) (Section QP-153.2).**

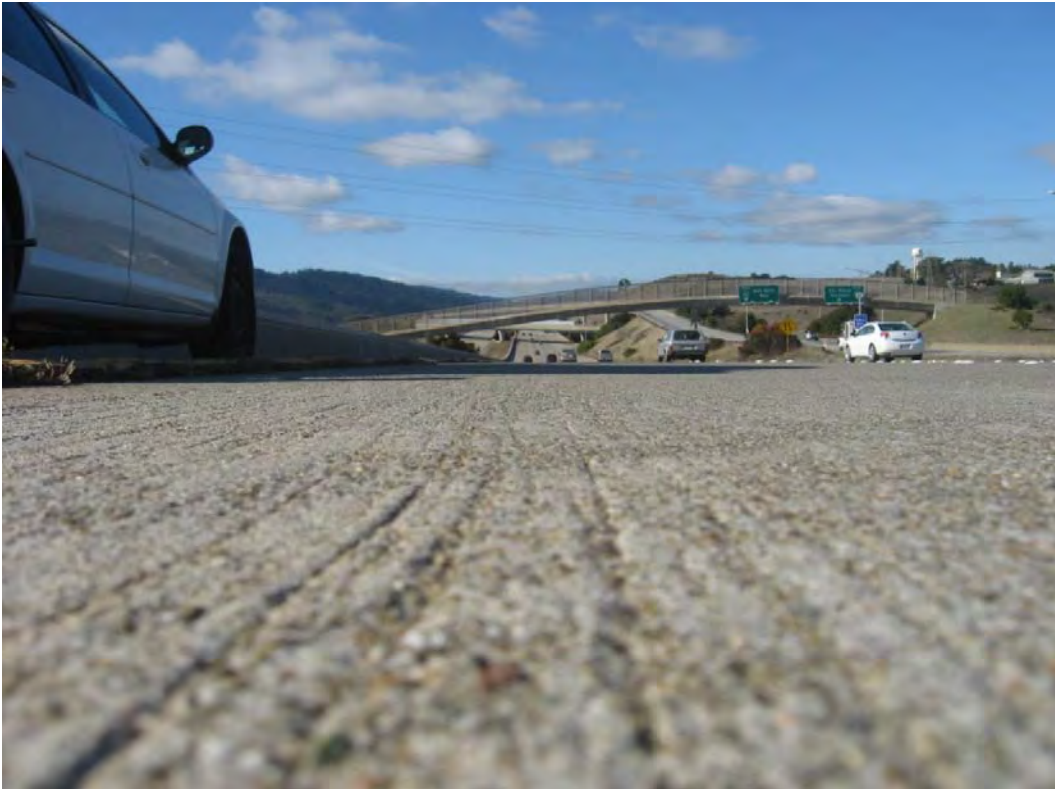
**Figure A.7: Longitudinally broomed, OBSI=101.1 dB(A) (Section QP-146.3).**

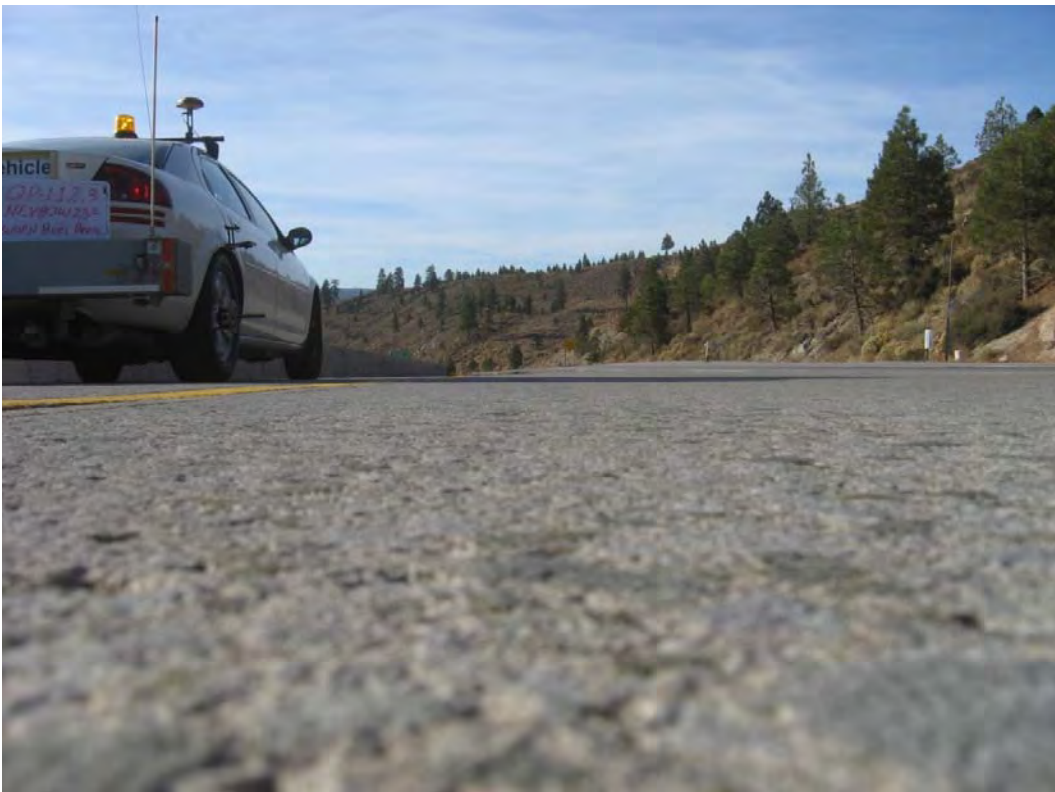
**Figure A.8: Longitudinally broomed, OBSI=104.1 dB(A) (Section QP-112.3).**

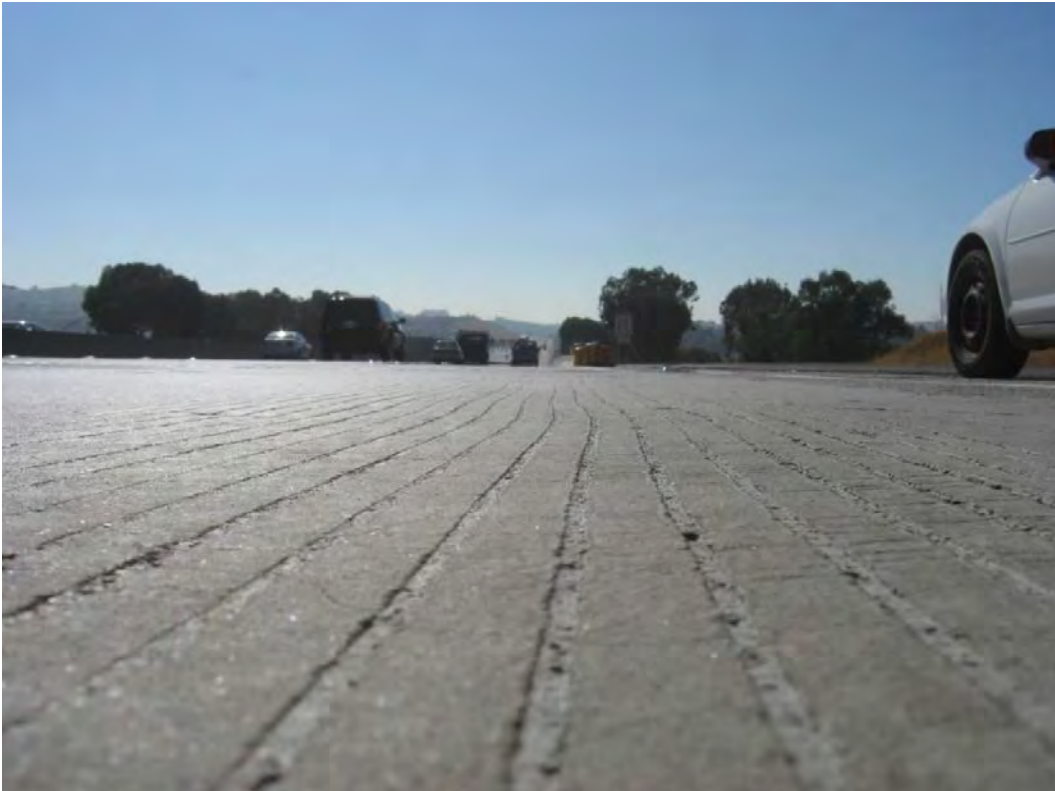
**Figure A.9: Longitudinally tined, OBSI=102.7 dB(A) (Section QP-117.2).**

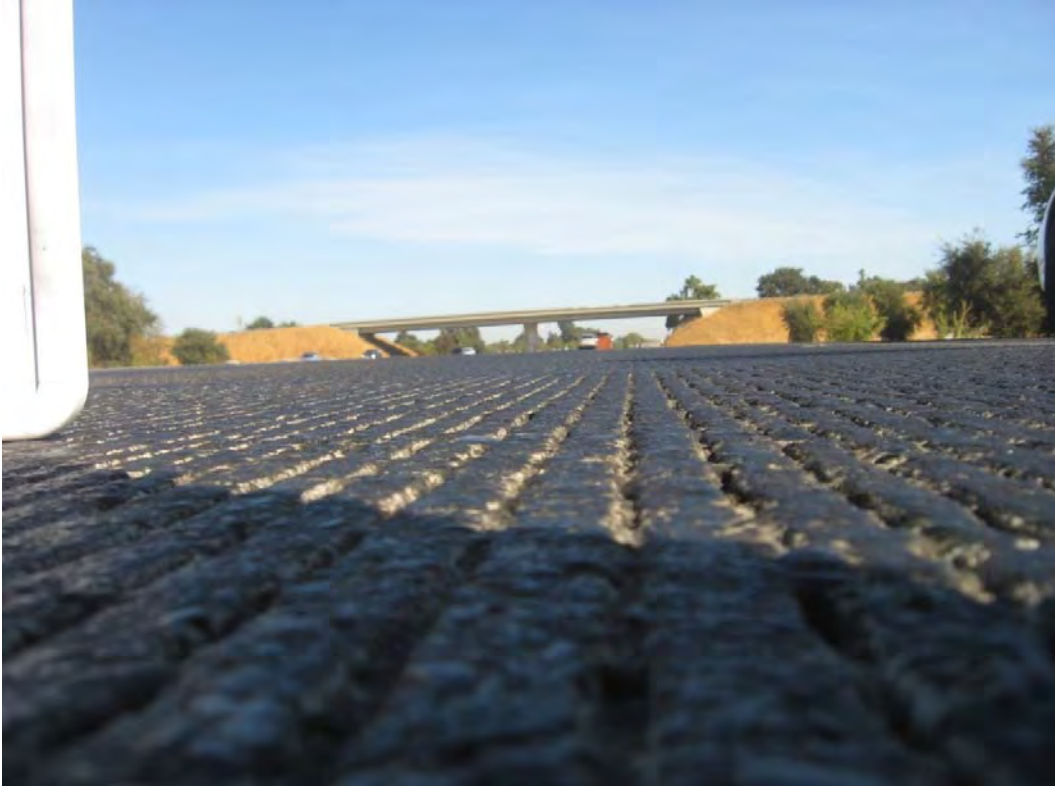
**Figure A.10: Longitudinally tined, SI=105.5 dB(A) (Section QP-101.2).**

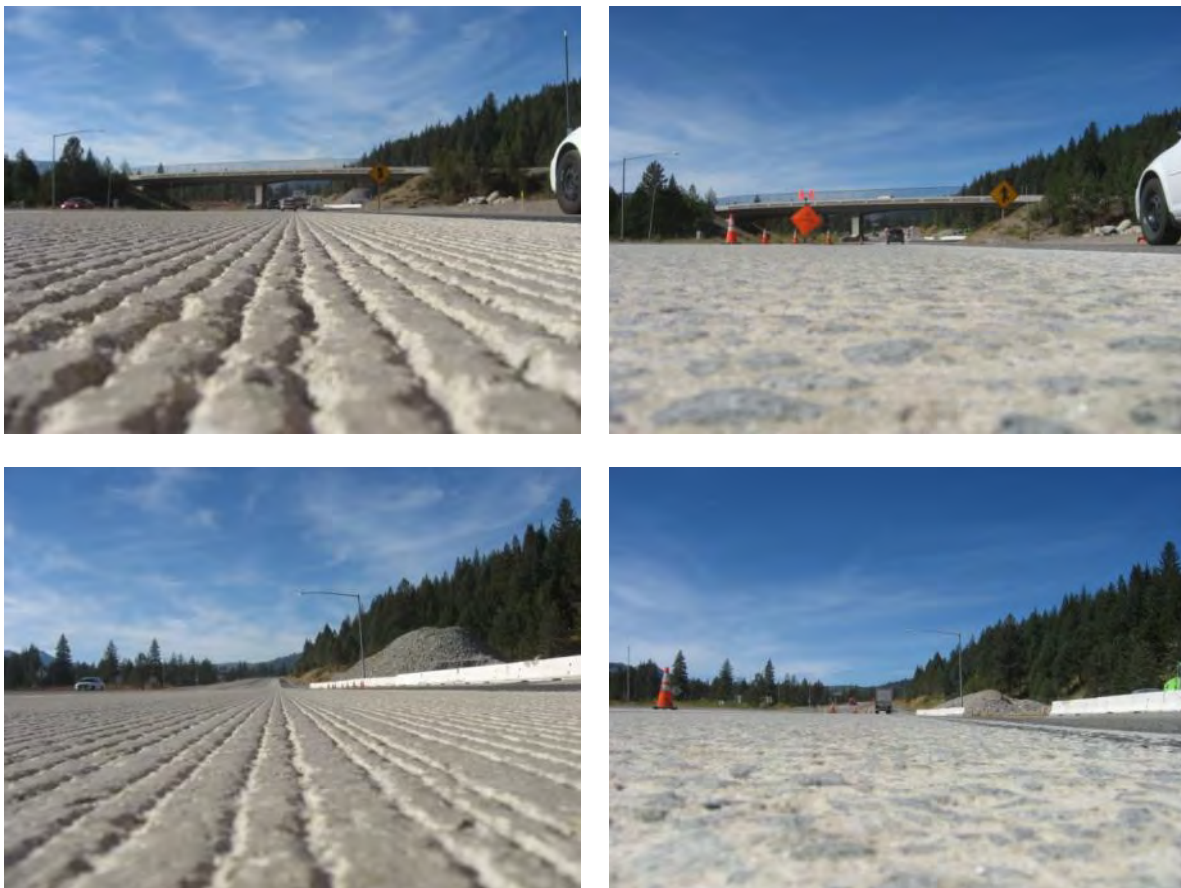
**Figure C.1: Change in texture after one year at Sections QP-142.1 (top) and QP-142.3 (bottom).**

The pavement at Sections QP-142.1, 142.2, and 142.3 all experienced a large increase in noise level from Year 1 to Year 2. The increase was due to an unusual rapid wearing of the longitudinal texture, which disappeared completely, leaving a surface where the concrete paste was recessed and the aggregates were exposed and protruding. The average OBSI values of these sections changed from 104.4 dBA (104.9, 104.5, and 103.9) to 111.8 dBA (111.4, 111.2, and 112.6), an increase of 7.4 dBA.

Images of the surface texture of Sections QP-142.1 and QP-142.3 at approximately the same spots are shown in Appendix D, with the pictures on the left taken in November 2008 and the ones on the right in September 2009. This pavement was new—it had been opened to traffic in the summer of 2008—and is located at 5,900 feet above sea level, where it was subjected to chain wear during snow season. Appendix D shows that the longitudinal tining remains outside the wheelpath, while it has been completely obliterated in the wheelpaths by the chains.

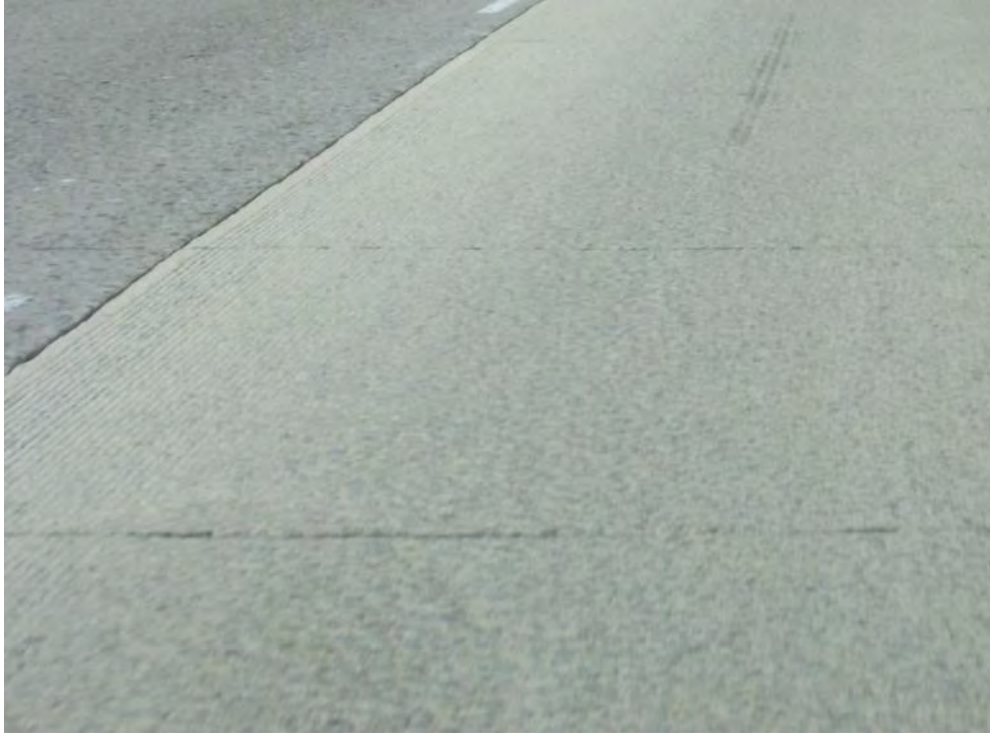
**Figure C.2: Evidence of original longitudinal tines outside of the wheelpaths of Section QP-142.2 after one year of traffic.**

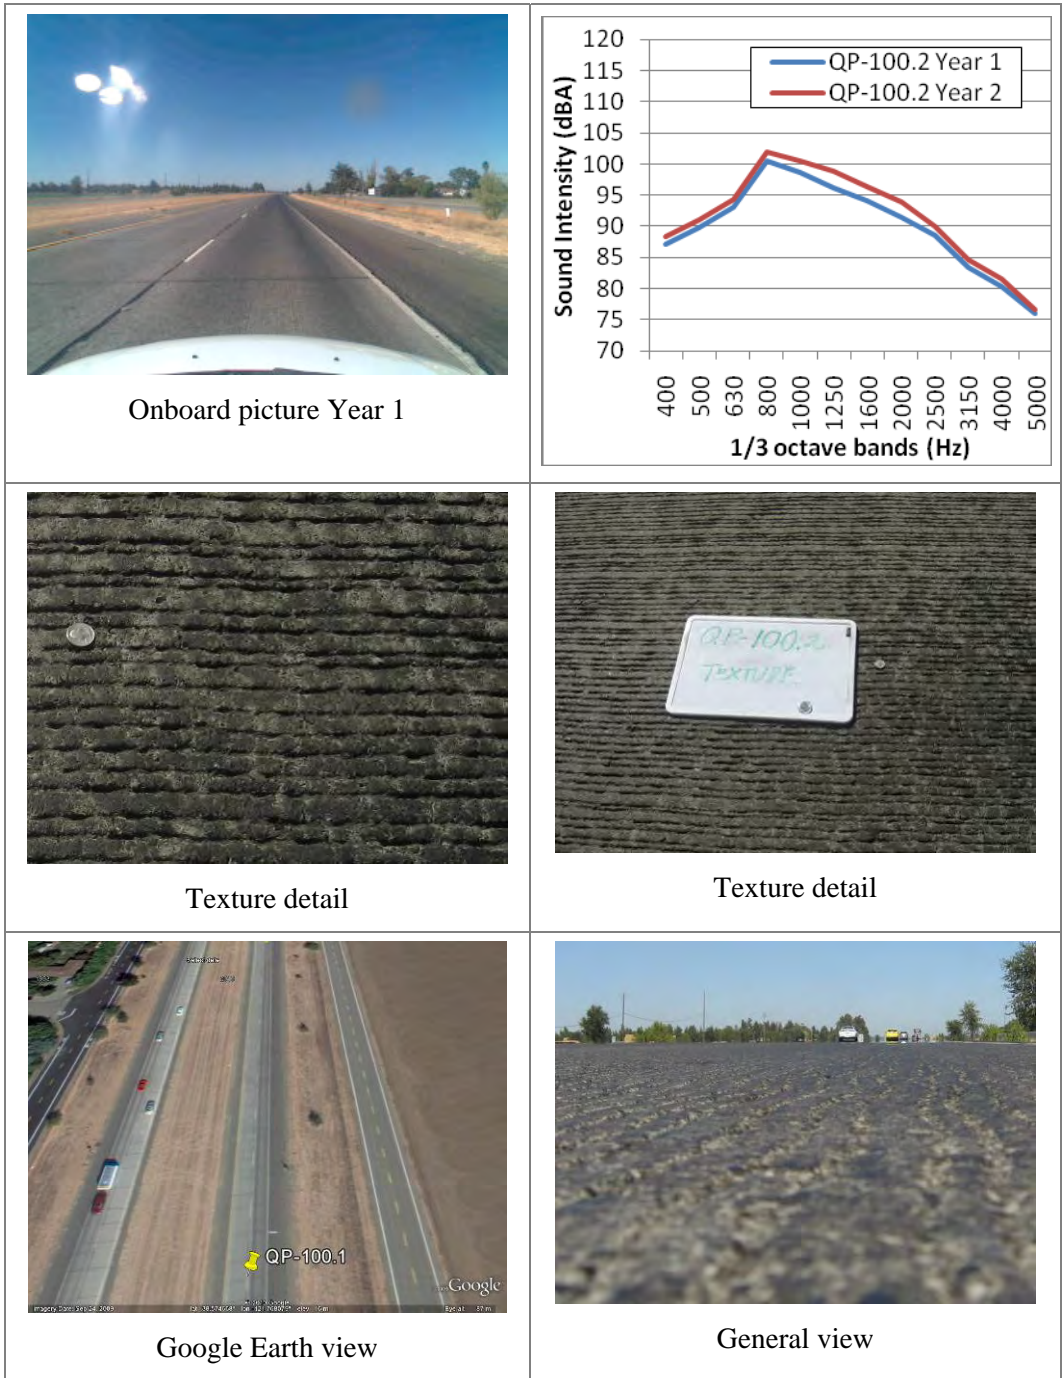
**QP-100.2**

Type of section: Pavement      Field testing Year 1: 9/3/2008 15:59  
 Location: 03Yol113N3.1      Field testing Year 2: 9/4/2009 14:24  
 Comments: Longitudinally tined. Aggressive texture, sealed joints.  
 Surface Year: 1976

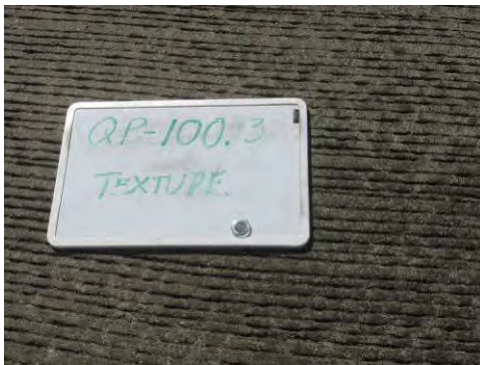
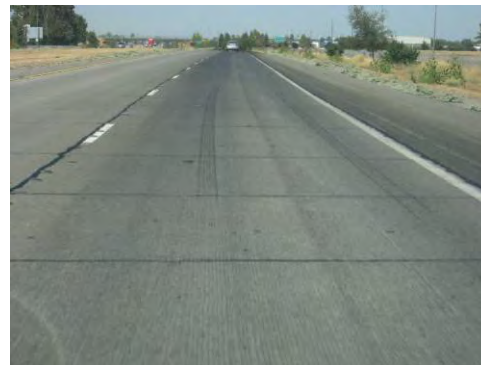
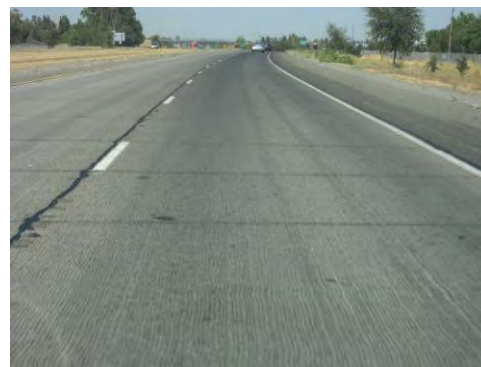
**QP-100.3**

Type of section: Pavement      Field testing Year 1: 9/3/2008 16:10  
 Location: 03Yol113N3.2      Field testing Year 2: 9/4/2009 14:40  
 Comments: Longitudinally tined. Aggressive texture, sealed joints.  
 Surface Year: 1976

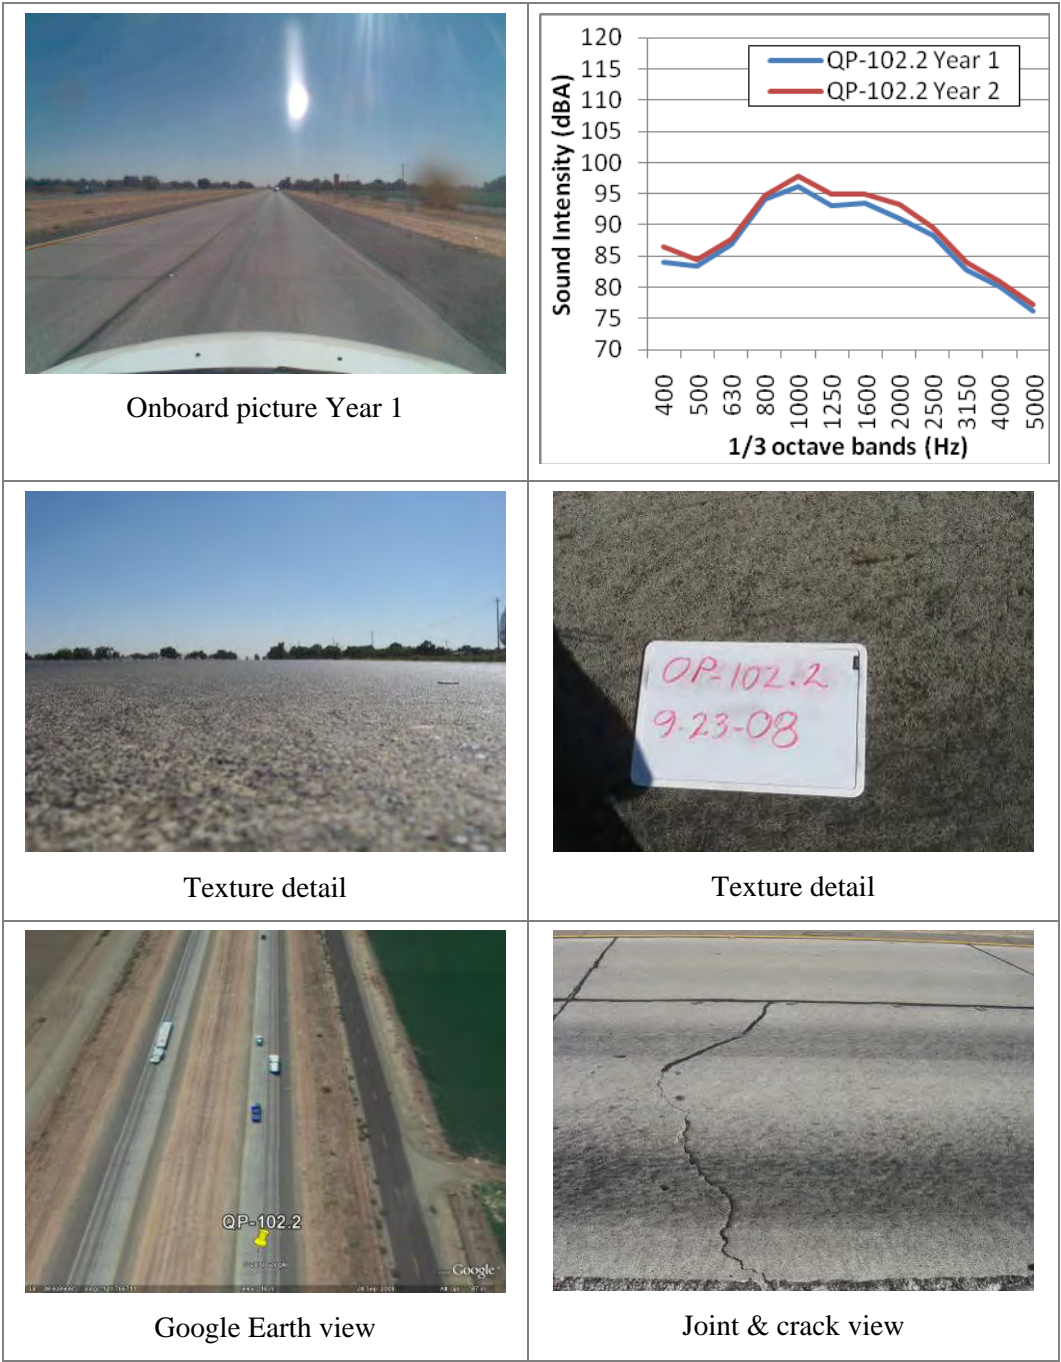
**QP-102.2**

Type of section: Pavement      Field testing Year 1: 9/23/2008 13:46  
 Location: 03Yol113S5.4      Field testing Year 2: 9/4/2009 14:49  
 Comments: Burlap drag. Rubber built-up, some transverse cracks.  
 Surface Year: 1976

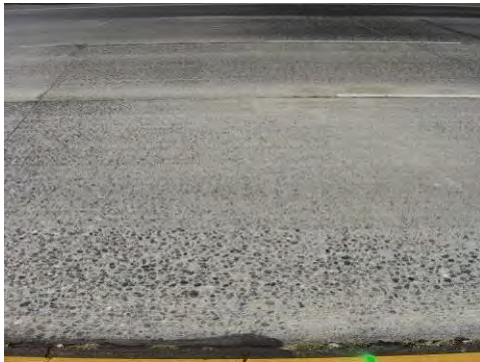
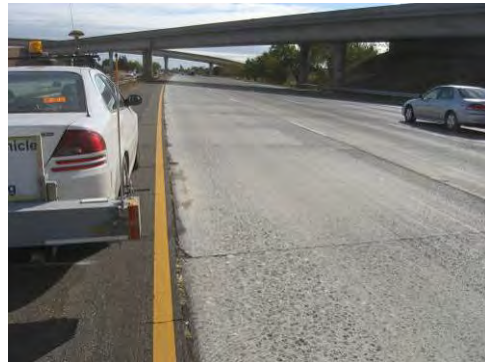
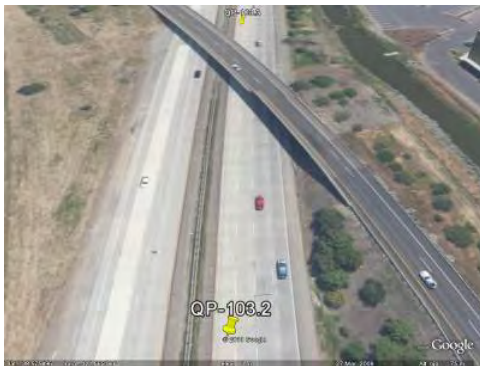
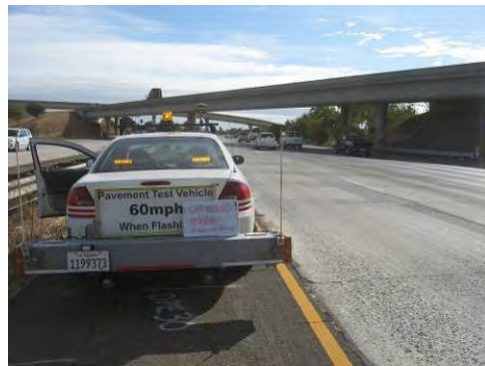
**QP-103.2**

Type of section: Pavement  
 Location: 03Yol50E0.2  
 Comments: Diamond ground.  
 Surface Year: 2005

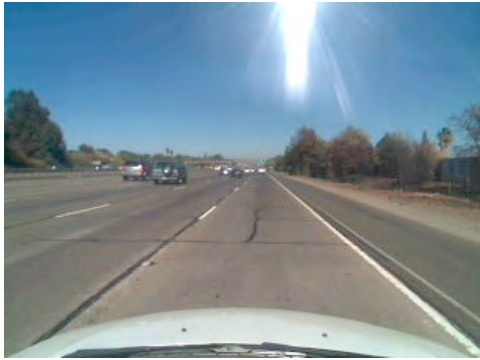
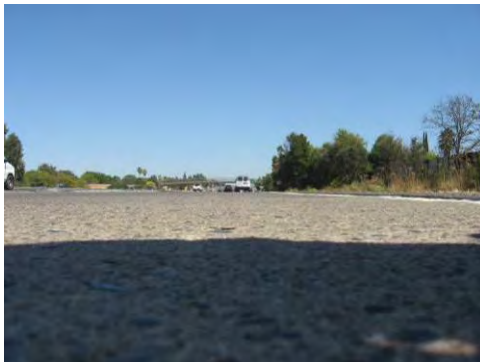
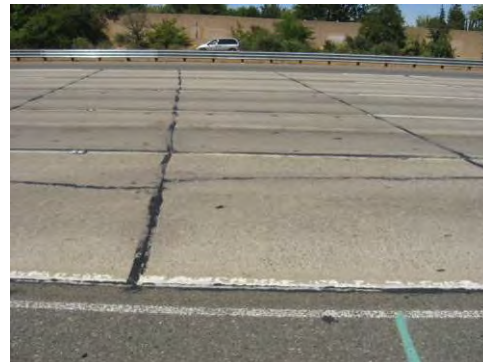
**QP-107.1**

Comments: Burlap drag. Shallow texture.

Joint detail

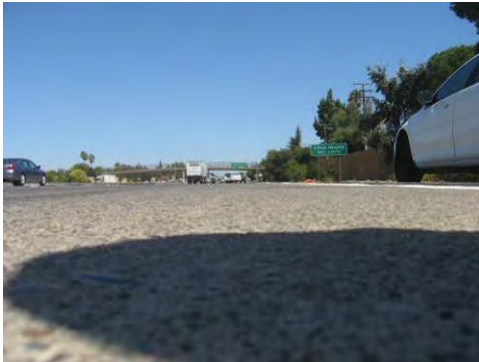
Texture detail

Comments: Burlap drag. Shallow texture.
