# Quieter Pavement Research: Concrete Pavement Tire Noise

**Author:**  
E. Kohler and J. Harvey

Work Conducted as Part of Partnered Pavement Research Center Strategic Plan Element No. 4.22:  
Quiet Concrete Pavement Research

University of California  
Pavement Research Center  
Davis and Berkeley

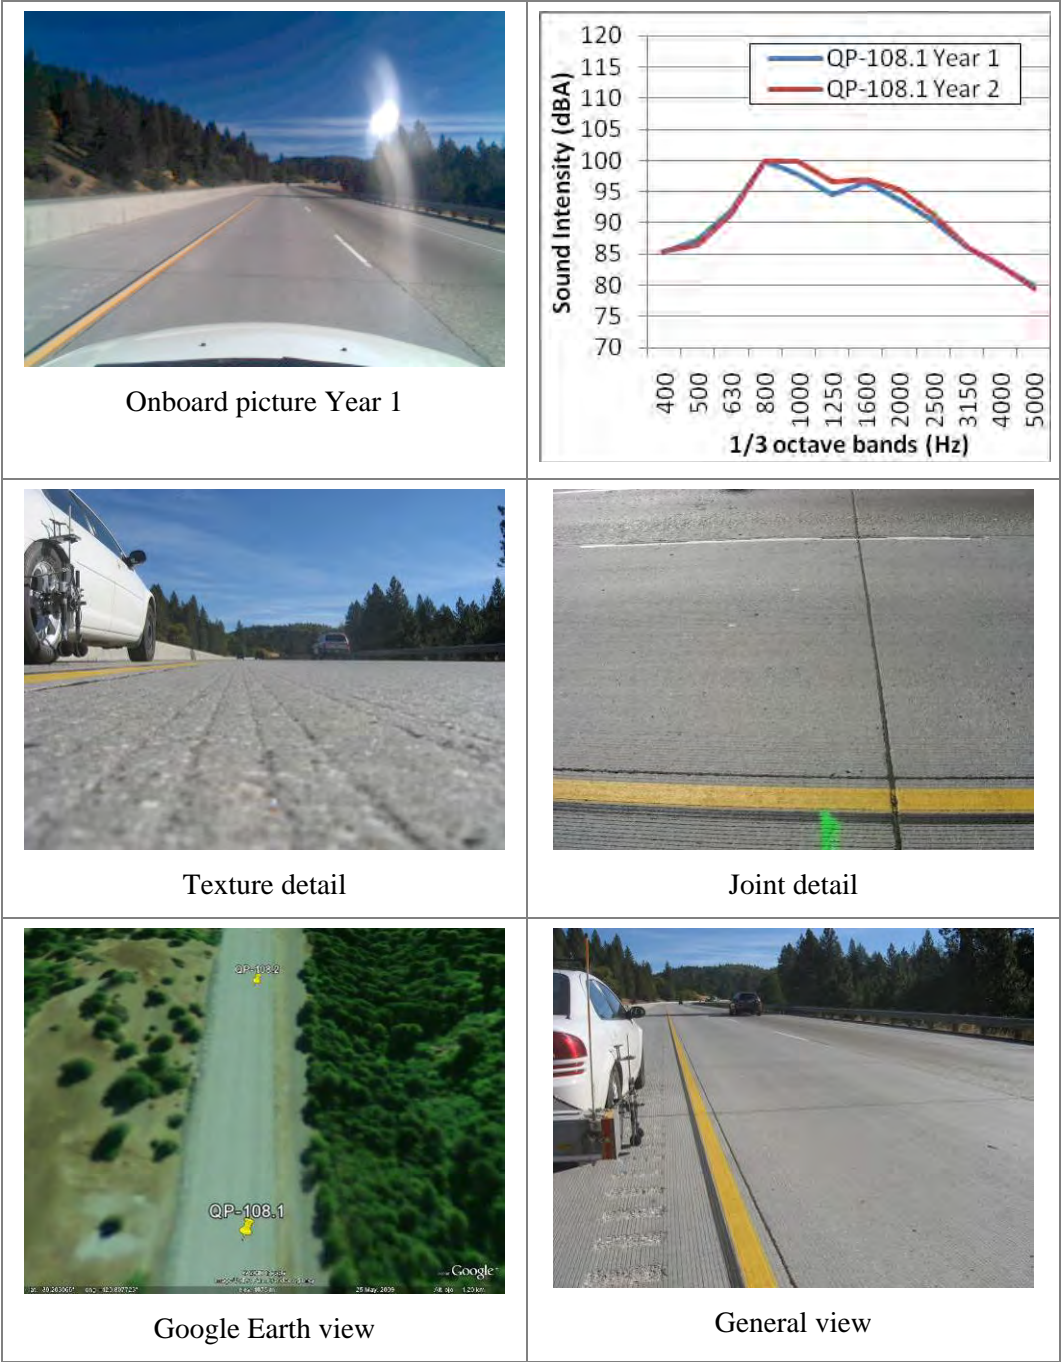
**QP-108.1**

Type of section: Pavement      Field testing Year 1: 10/21/2008 11:24  
 Location: 03Pla80E45.0      Field testing Year 2: 9/16/2009 12:26  
 Comments: Longitudinally tined. Shallow texture, worn out.  
 Surface Year: 2004

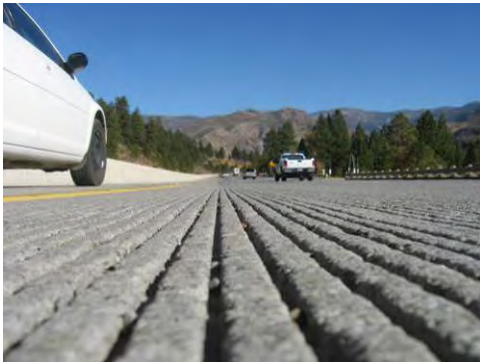
Texture detail

Comments: Diamond grooved.

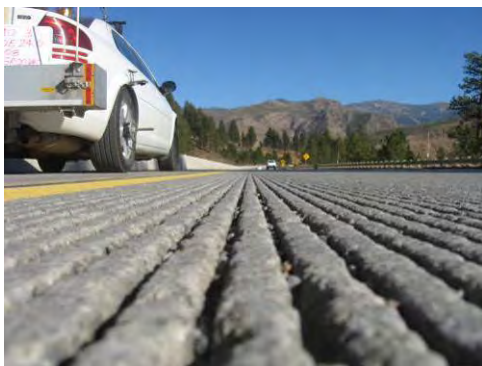
Texture detail

Comments: Diamond grooved.

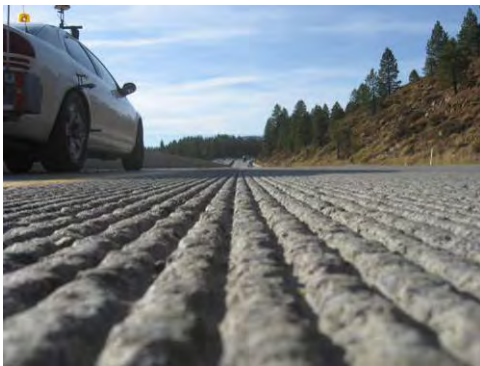
Texture detail

Comments: Diamond grooved.

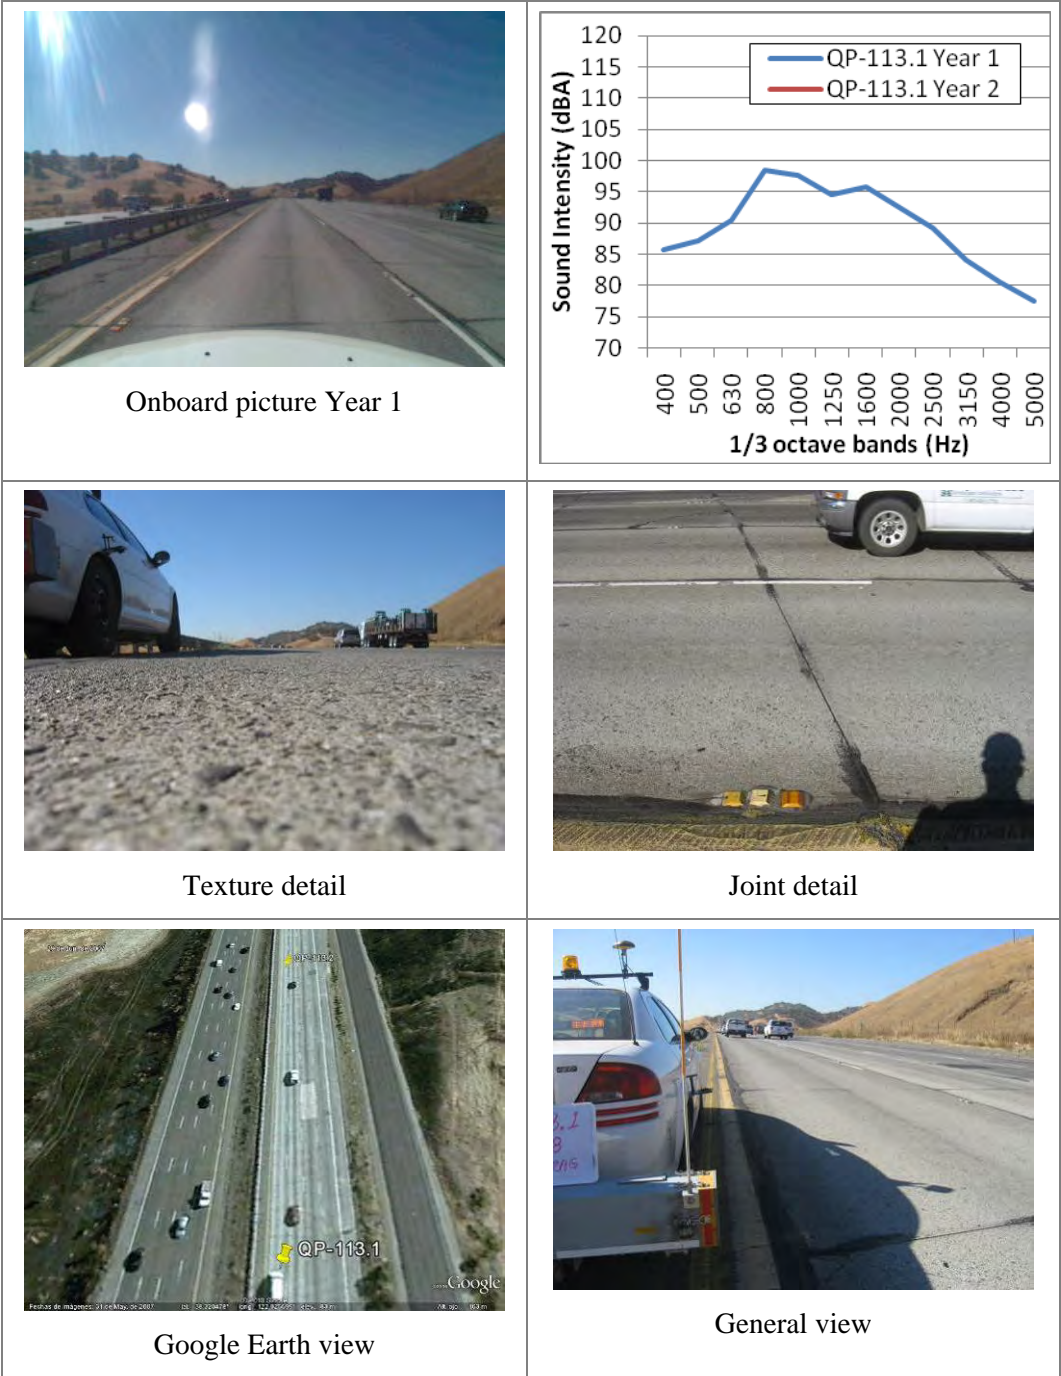
**QP-113.1**

Type of section: Pavement      Field testing Year 1: 10/23/2008 12:37  
 Location: 03Yol80W22.9      Field testing Year 2:  
 Comments: Burlap drag. Worn out texture.  
 Surface Year: 1965

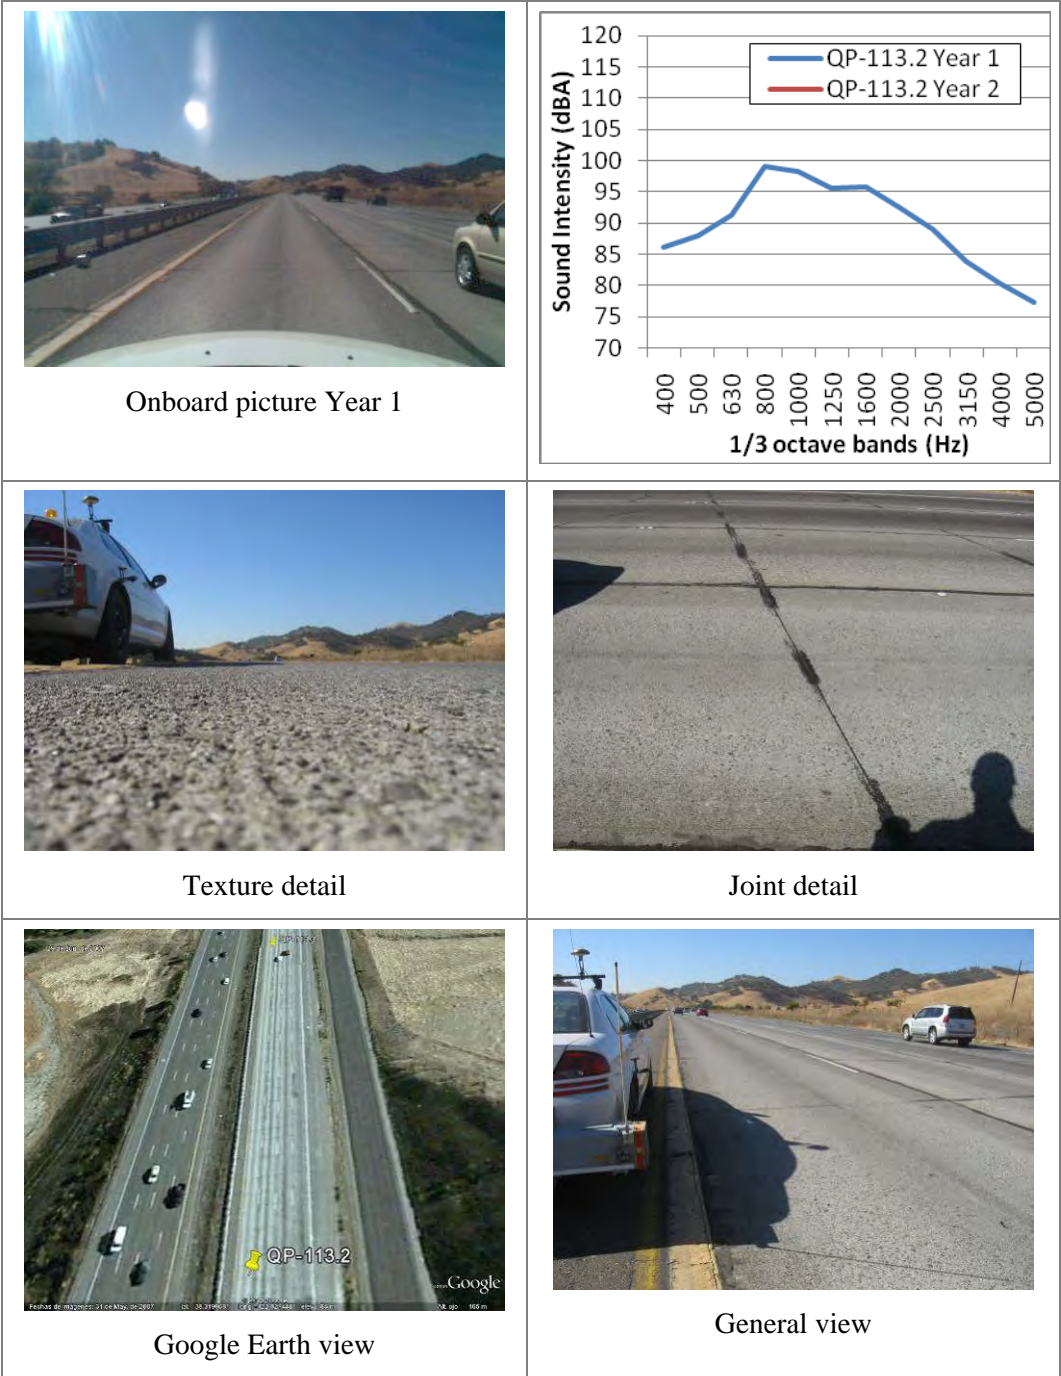
**QP-113.2**

Type of section: Pavement      Field testing Year 1: 10/23/2008 12:45  
 Location: 03Yol80W22.8      Field testing Year 2:  
 Comments: Burlap drag. Worn out texture.  
 Surface Year: 1965

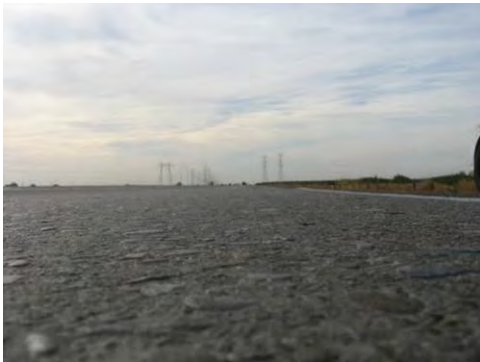
Texture detail

Type of section: Pavement  
Location: 03Yol505S12.9  
Comments: Burlap drag.  
Surface Year: 1977

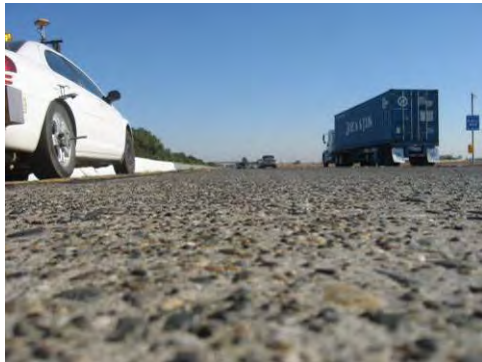
Texture detail

Comments: Burlap drag. Looks like aggressive exposed agg. Maybe no original texture.

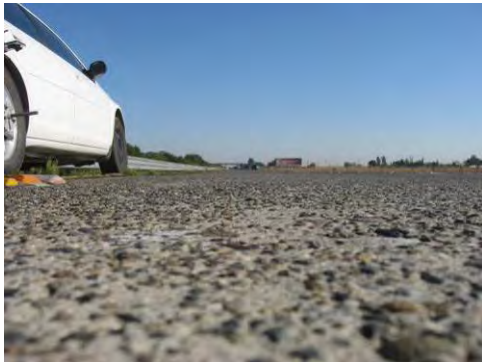
Texture detail

Comments: Burlap drag. Looks like aggressive exposed agg. Maybe no original texture.

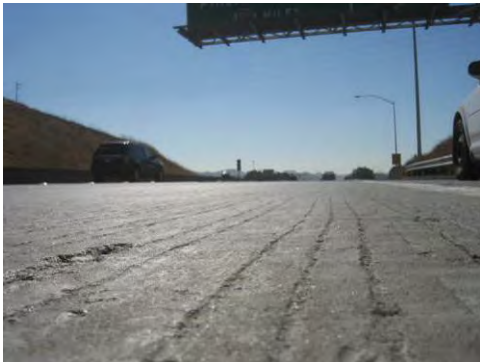
Texture detail

Type of section: Pavement      Field testing Year 1: 10/28/2008 14:14  
 Location: 04CC80W10.3      Field testing Year 2: 10/29/2009 14:57  
 Comments: Longitudinally tined. Shallow and squiggly LT.  
 Surface Year: 2007

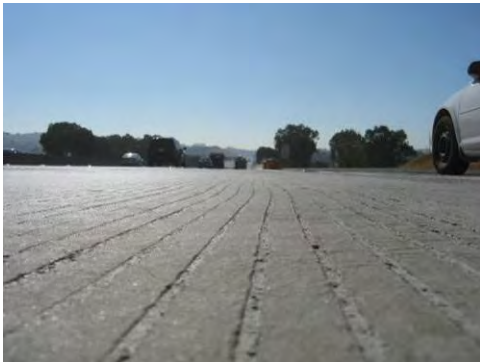
Texture detail

Type of section: Pavement      Field testing Year 1: 10/28/2008 14:45  
 Location: 04CC80W10.2      Field testing Year 2: 10/29/2009 15:03  
 Comments: Longitudinally tined. Shallow and squiggly LT.  
 Surface Year: 2007

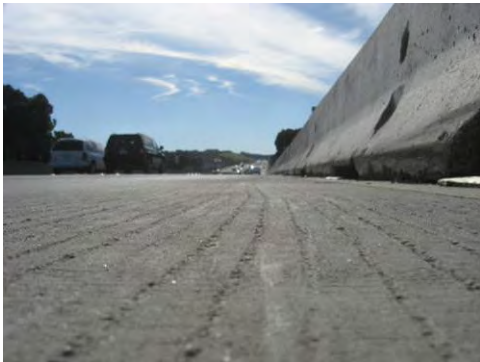
Texture detail

Type of section: Pavement      Field testing Year 1: 10/28/2008 14:54  
 Location: 04CC80W10.1      Field testing Year 2: 10/29/2009 15:12  
 Comments: Longitudinally tined. Shallow and squiggly LT.  
 Surface Year: 2007

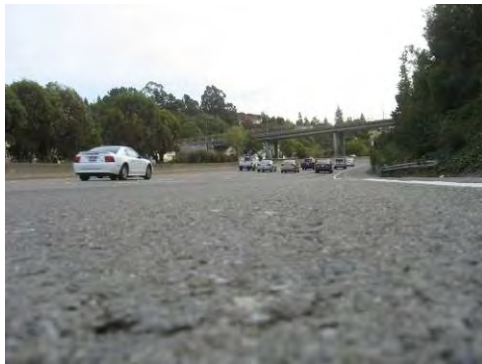
Texture detail

Type of section: Pavement  
Location: 04ALA580E37.2  
Comments: Burlap drag.  
Surface Year: 1965

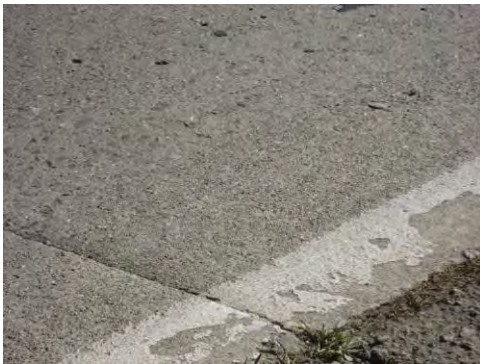
Texture detail

Type of section: Pavement  
Location: 04SCL85S21.5L3  
Comments: Burlap drag.  
Surface Year: 1965

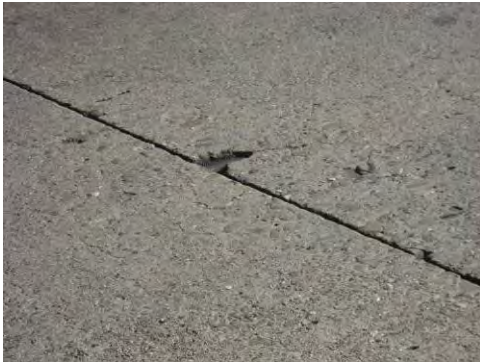
Texture detail

Type of section: Pavement  
Location: 04SCL85S21.3L3  
Comments: Burlap drag.  
Surface Year: 1965

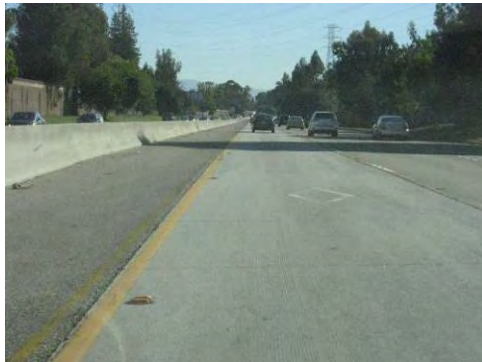
Texture detail

Comments: Longitudinally tined.

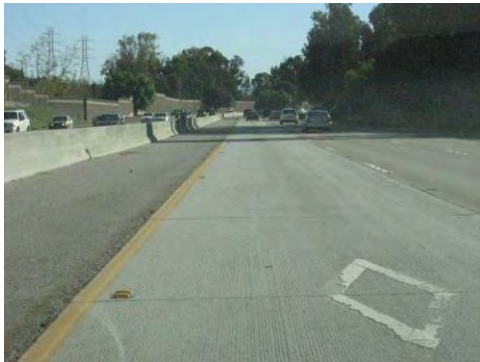
Texture detail

Comments: Longitudinally tined.

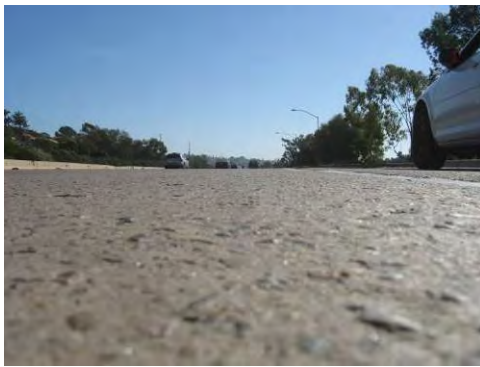
Type of section: Pavement  
 Location: 11SD5S39.5  
 Comments: Burlap drag.  
 Surface Year: 1964

Texture detail

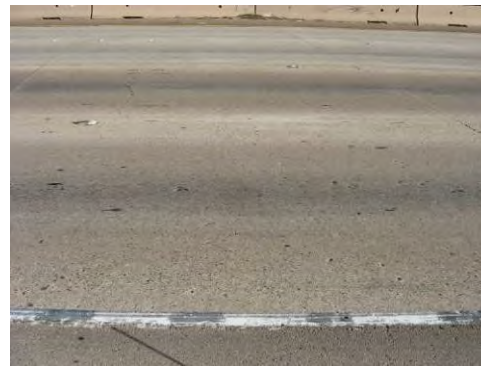
Texture detail

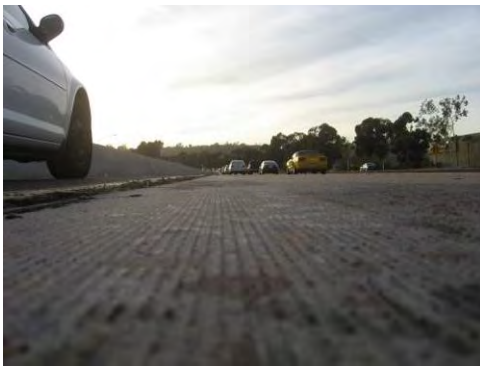
Type of section: Pavement      Field testing Year 1: 11/11/2008 17:01  
 Location: 11SD8W15.5      Field testing Year 2: 11/23/2009 9:33  
 Comments: Diamond ground. DG on LT.  
 Surface Year: 1997

Texture detail

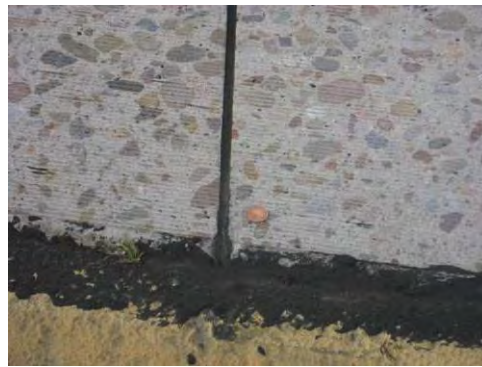
Joint detail

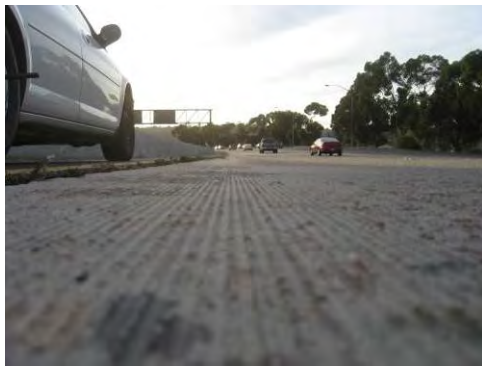
Type of section: Pavement  
Location: 11SD8W15.6  
Comments: Diamond ground.  
Surface Year: 1997

Texture detail

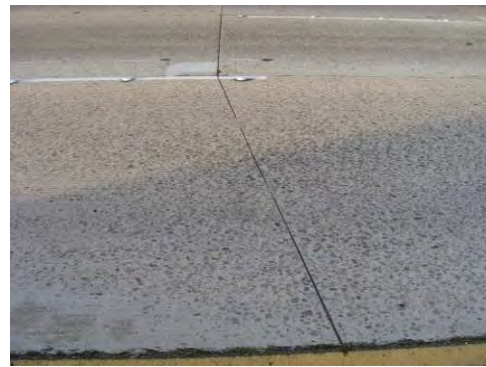
Joint detail

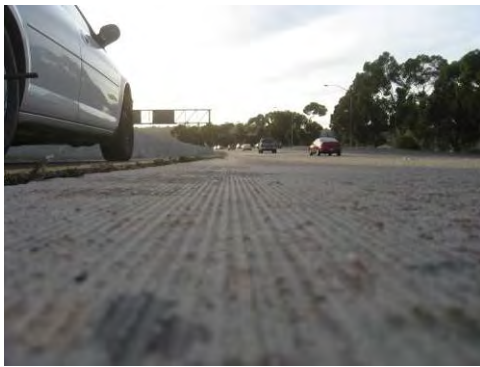
Type of section: Pavement  
Location: 11SD8W15.7  
Comments: Diamond ground.  
Surface Year: 1997

Texture detail

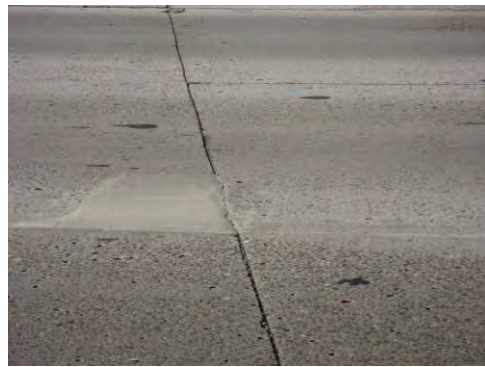
Type of section: Pavement      Field testing Year 1: 11/12/2008 12:39  
 Location: 11SD805N2.1      Field testing Year 2: 11/24/2009 11:06  
 Comments: Diamond ground. DG on LB.  
 Surface Year: 1998

Joint detail

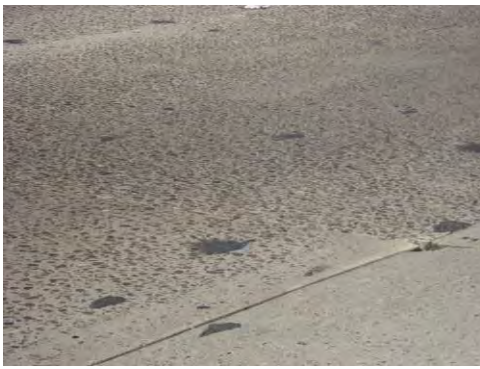
Type of section: Pavement  
 Location: 11SD805N2.2  
 Comments: Diamond ground.  
 Surface Year: 1998

Texture detail

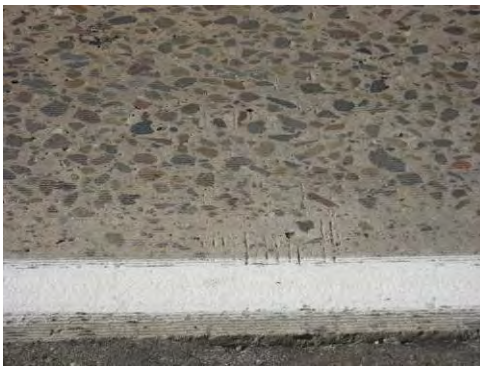
Type of section: Pavement      Field testing Year 1: 11/12/2008 14:36  
 Location: 11SD805N2.3      Field testing Year 2: 11/24/2009 11:50  
 Comments: Diamond ground. DG on transverse tining.  
 Surface Year: 1998

Texture detail

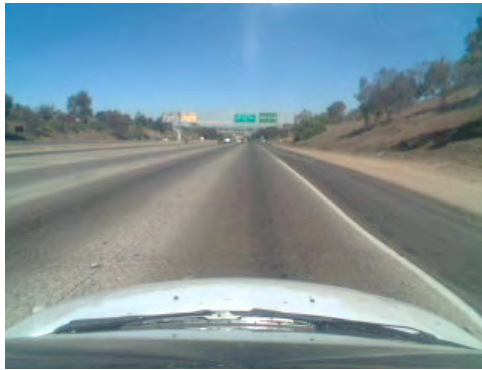
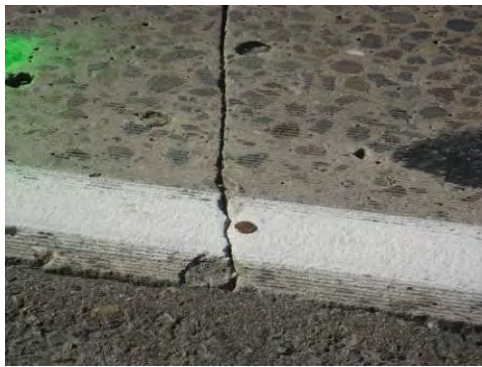
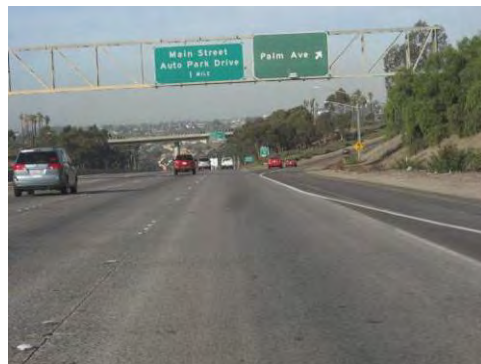
**QP-134.1**

Type of section: Pavement      Field testing Year 1: 11/12/2008 16:03  
 Location: 11SD905W5.2      Field testing Year 2: 11/24/2009 12:21  
 Comments: Diamond ground. DG on deep longitudinal tining. Off-ramp.  
 Surface Year: 2000

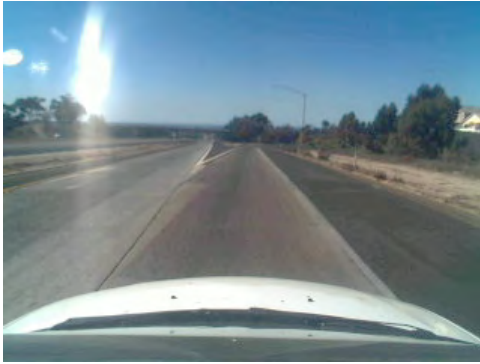
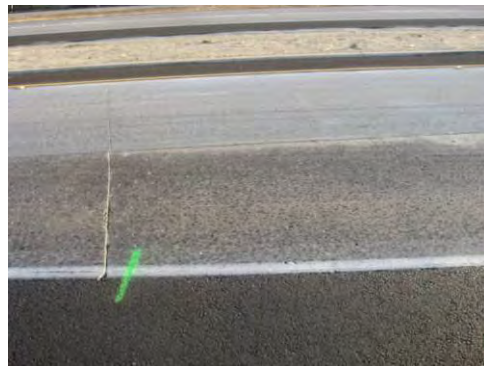
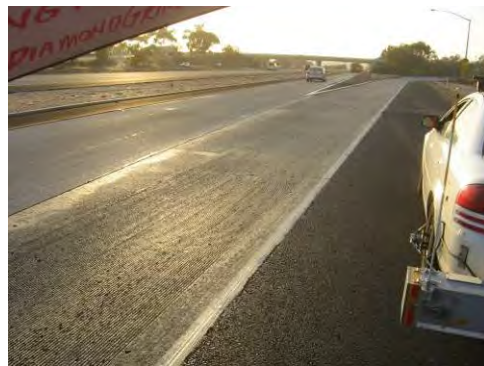
**QP-134.2**

Type of section: Pavement      Field testing Year 1: 11/12/2008 16:35  
 Location: 11SD905W5.1      Field testing Year 2: 11/24/2009 12:31  
 Comments: Diamond ground. DG on deep longitudinal tining. Off-ramp.  
 Surface Year: 2000

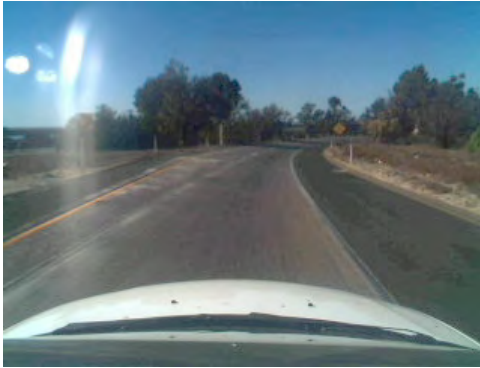
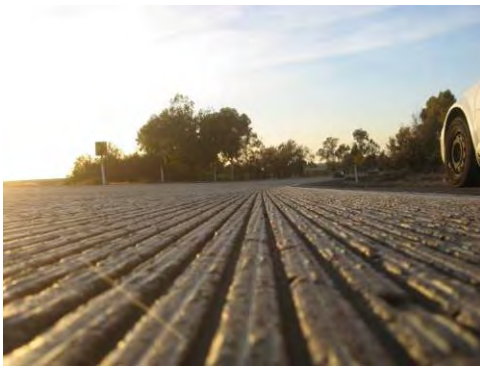
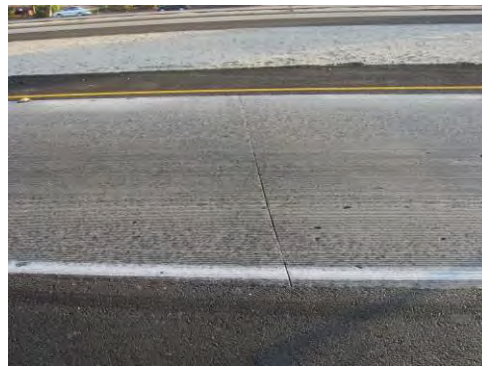
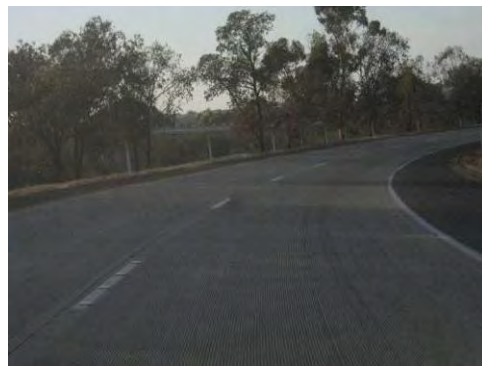
**QP-134.3**

Type of section: Pavement      Field testing Year 1: 11/12/2008 16:39  
 Location: 11SD905W5.0      Field testing Year 2: 11/24/2009 12:35  
 Comments: Diamond ground. DG on deep longitudinal tining. Off-ramp.  
 Surface Year: 2000

Section ID	Location:	Lane <sup>1</sup>	Texture Type <sup>2</sup>	Const. Year	Surfacing Year	Texture Condition <sup>3</sup>	Test Tire Year 1	Uncorrected OBSI Year 1	Test Tire Year 2	Uncorrected OBSI Year 2	Corrected to SRTT #1 OBSI Year 1	Corrected to SRTT #1 OBSI Year 2
	Dist-Cnty-Rte-Dir-PM											
QP-132.1	11SD805N2.1	5 of 5	DG	1975	1998	Aged	SRTT #2	106.8	SRTT #3	106.6	105.4	106.3
QP-132.2	11SD805N2.2	5 of 5	DG	1975	1998	Aged	SRTT #2	107.8	SRTT #3	107.4	106.6	107.2
QP-132.3	11SD805N2.3	5 of 5	DG	1975	1998	Aged	SRTT #2	107.3	SRTT #3	107.4	106	107.3
QP-133.1	11SD805N2.3	4 of 4	DG	1975	1998	Aged	SRTT #2	107.6	SRTT #3	106.6	106.5	106.4
QP-133.2	11SD805N2.4	4 of 4	DG	1975	1998	Aged	SRTT #2	Not Tested	SRTT #3	107.4		107.3
QP-134.1	11SD905W5.2	2 of 2	DG	1975	2000	Aged	SRTT #2	106.3	SRTT #3	106.6	105	106.4
QP-134.2	11SD905W5.1	2 of 2	DG	1975	2000	Aged	SRTT #2	106.2	SRTT #3	105.3	104.9	104.9
QP-134.3	11SD905W5.0	2 of 2	DG	1975	2000	Aged	SRTT #2	107.3	SRTT #3	106.6	106.2	106.4

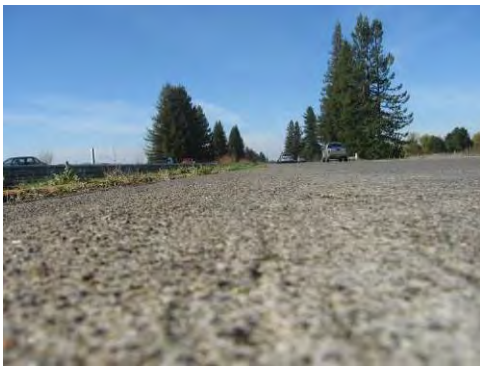
Texture detail

Comments: Burlap drag.

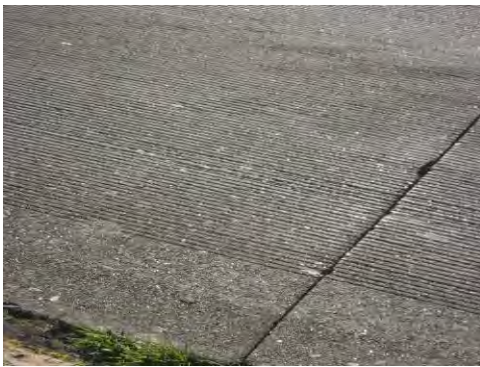
Texture detail

Comments: Diamond grooved.

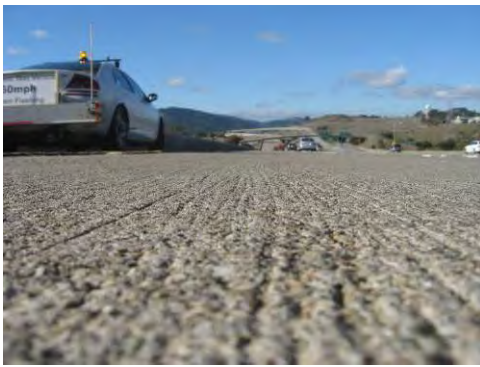
Texture detail

Comments: Longitudinally broomed.

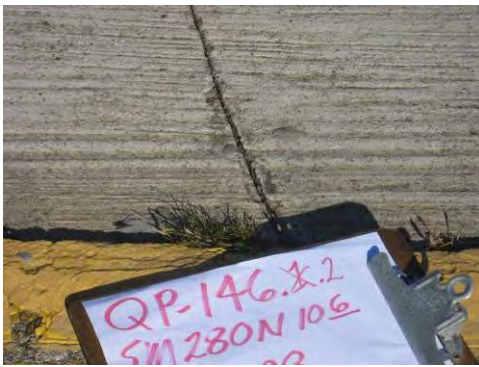
Texture detail

Comments: Longitudinally broomed.

QP-146.2	04SM280N10.7	1 of 4	LB	1974	1974	Aged	SRTT #2	103.0	SRTT #3	102.5	101.2	102.2
QP-146.3	04SM280N10.8	1 of 4	LB	1974	1974	Aged	SRTT #2	102.9	SRTT #3	102.4	101.1	102.1
QP-109.1	03Nev80E22.6	1 of 2	LB	1989	1989	Worn out	SRTT #2	105.5	Not Tested	Not Tested	102.2	
QP-109.2	03Nev80E22.6	1 of 2	LB	1989	1989	Worn out	SRTT #2	105.9	Not Tested	Not Tested	102.7	
QP-109.3	03Nev80E22.6	1 of 2	LB	1989	1989	Worn out	SRTT #2	105.2	Not Tested	Not Tested	101.9	
QP-112.1	03Nev80W23.0	1 of 2	LB	1989	1989	Worn out	SRTT #2	105.5	Not Tested	Not Tested	102.1	
QP-112.2	03Nev80W22.9	1 of 2	LB	1989	1989	Worn out	SRTT #2	105.9	Not Tested	Not Tested	102.7	
QP-112.3	03Nev80W22.8	1 of 2	LB	1989	1989	Worn out	SRTT #2	107.2	Not Tested	Not Tested	104.1	
QP-115.1	03Yol505S13.1	2 of 2	BD	1977	1977	Aged	SRTT #2	105.3	SRTT #3	105.4	104	105
QP-115.2	03Yol505S13.0	2 of 2	BD	1977	1977	Aged	SRTT #2	104.7	SRTT #3	105.5	103.3	105

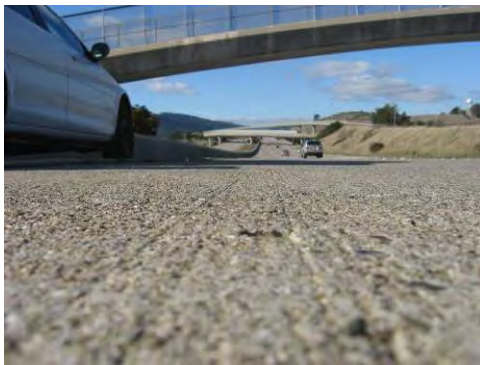
Texture detail

Comments: Longitudinally broomed.

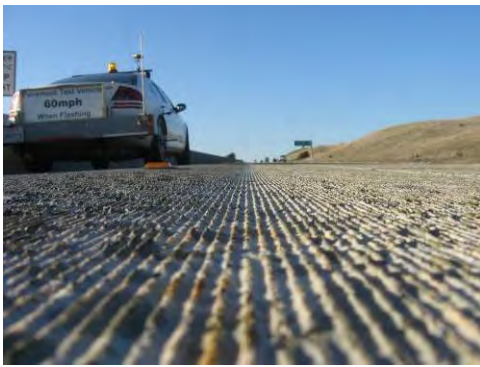
Texture detail

Type of section: Pavement  
 Location: 04SM280N11.6  
 Comments: Diamond ground.  
 Surface Year: 2007

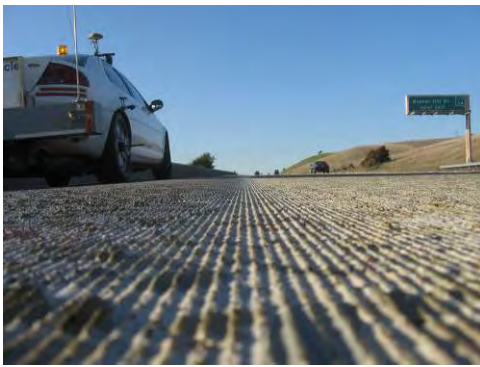
Texture detail

Type of section: Pavement  
 Location: 04SM280N11.7  
 Comments: Diamond ground.  
 Surface Year: 2007

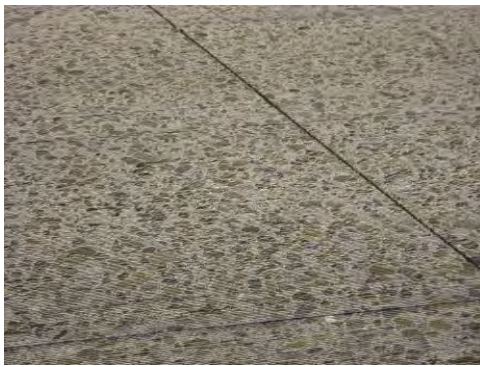
Texture detail

Type of section: Pavement  
 Location: 04SM280N11.8  
 Comments: Diamond ground.  
 Surface Year: 2007

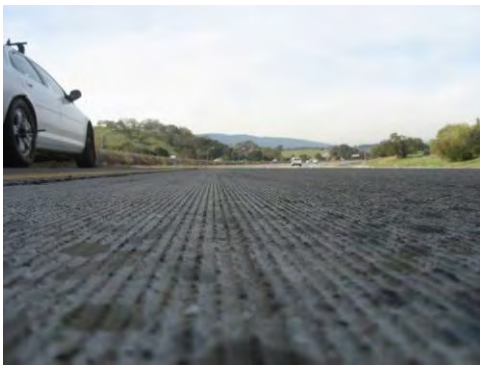
Texture detail

Type of section: Pavement      Field testing Year 1: 12/3/2008 13:07  
 Location: 04SM280N1.6      Field testing Year 2: 11/16/2009 14:36  
 Comments: Diamond ground. Old DG.  
 Surface Year: 2001

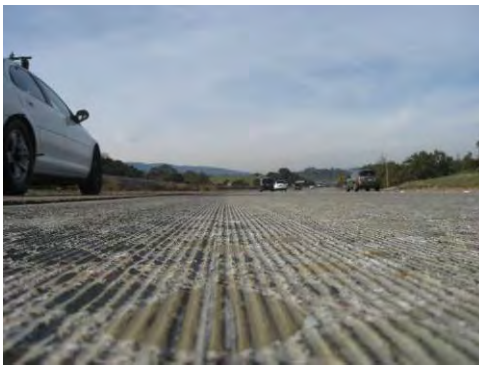
Texture detail

Comments: Diamond ground. Old DG.

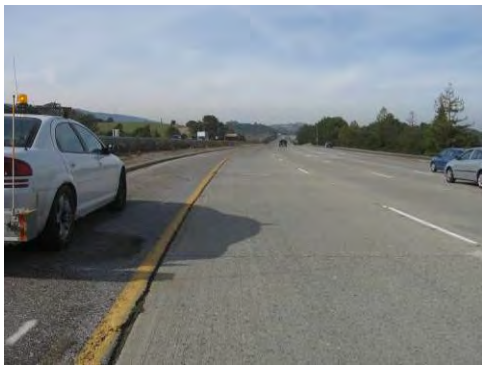
Texture detail

Type of section: Pavement      Field testing Year 1: 12/3/2008 13:34  
 Location: 04SM280N1.6      Field testing Year 2: 11/16/2009 15:00  
 Comments: Diamond ground. Old DG.  
 Surface Year: 2001

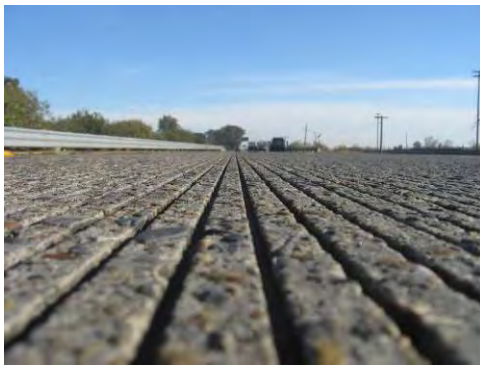
Texture detail

Comments: Diamond grooved.

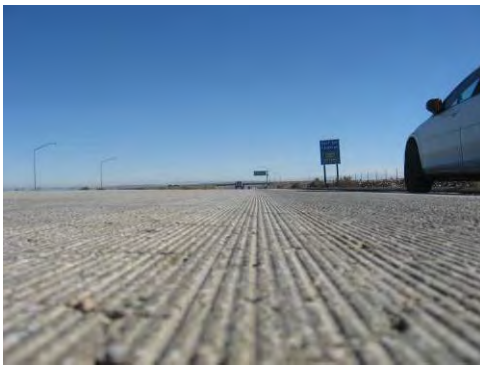
Texture detail

Type of section: Pavement  
Location: 06Ker58E110.6  
Comments: Diamond ground.  
Surface Year: 2006

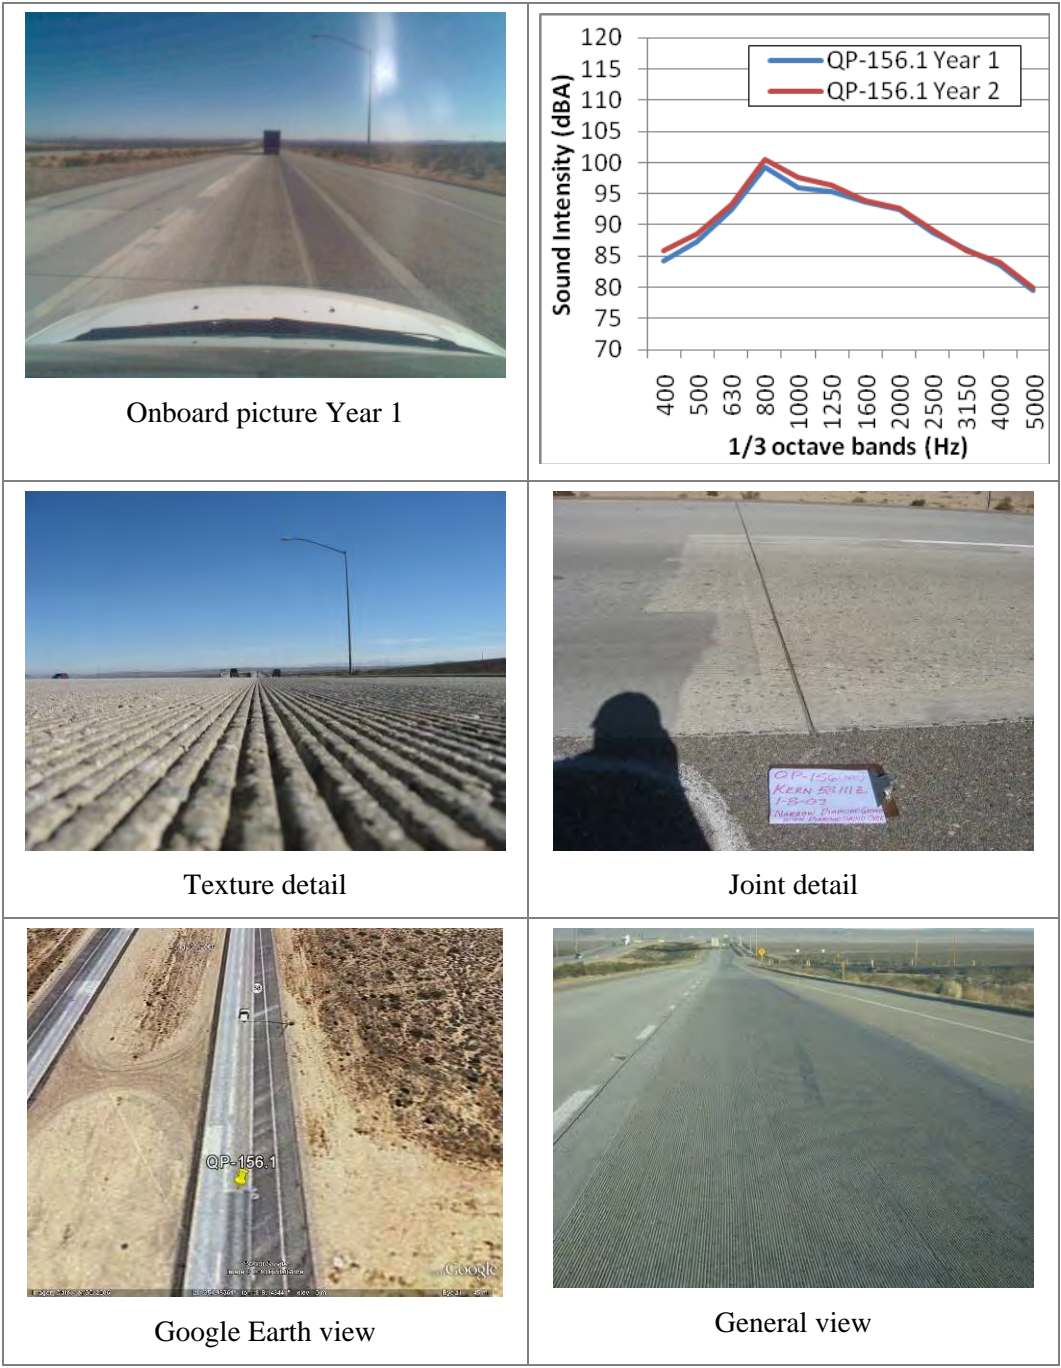
**QP-156.1**

Type of section: Pavement      Field testing Year 1: 1/9/2009 7:57  
 Location: 06Ker58E111.2      Field testing Year 2: 12/2/2009 11:43  
 Comments: Diamond grooved. DG+Gr.  
 Surface Year: 2006

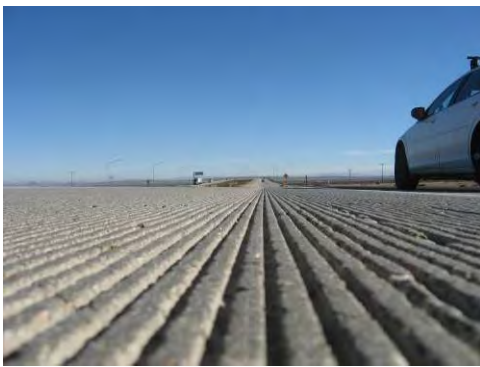
Texture detail

Type of section: Pavement  
 Location: 06Ker58E111.4  
 Comments: Diamond grooved.  
 Surface Year: 2006

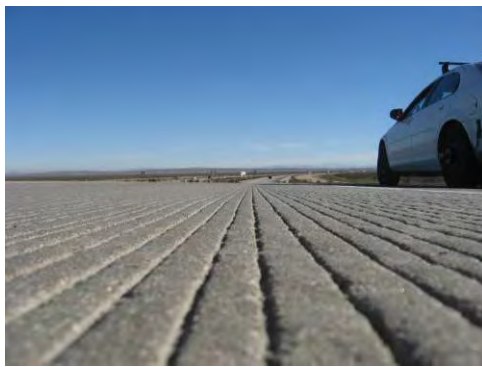
Texture detail

Comments: Longitudinally tined.

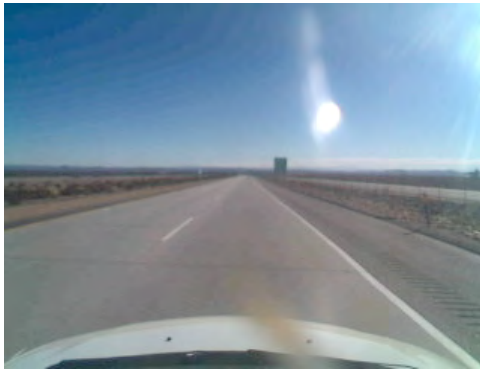
Onboard picture Year 1

Type of section: Pavement  
 Location: 06Ker58E110.3  
 Comments: Burlap drag.  
 Surface Year: 2003

Figure 3.30 shows OBSI results for the burlap drag sections. The vast majority of the burlap drag sections were built in the 1960s and 1970s. The only “young” section, which was about six years old at the time of testing, is QP-159.1 at the Mojave Bypass. The oldest sections, which were 62 years old, are on Interstate 80 in Solano County (QP-116.1, QP-116.2, and QP-116.3). Older sections have higher OBSI levels. Figure 3.31 shows all texture conditions for the burlap drag sections plotted versus the number of years since they were last surfaced, including all Year 1 and Year 2 measurements.

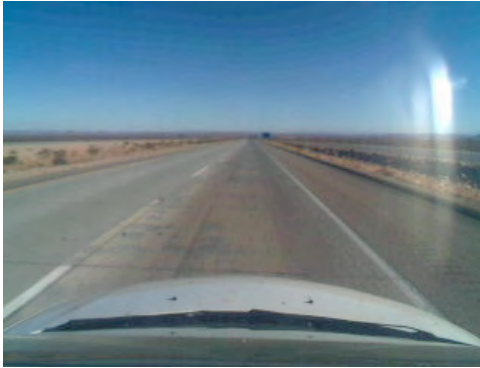
Onboard picture Year 1

Type of section: Pavement      Field testing Year 1: 2/23/2009 17:08  
Location: 06Ker58E110.0      Field testing Year 2: 12/2/2009 14:13  
Comments: Diamond ground. Caltrans section 2, DG 0.12" over burlap drag.  
Surface Year: 2006

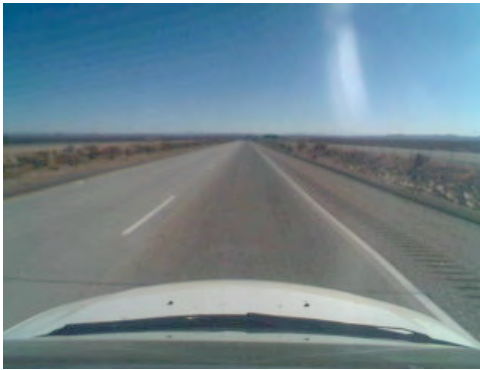
Onboard picture Year 1

Comments: Diamond grooved. CT section 4, 3/4" spacing, 1/4" deep, over burlap drag.

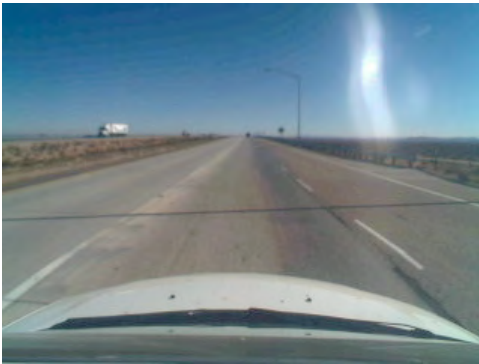
Onboard picture Year 1

Comments: Diamond ground.
